## II. PRE FEASIBILITY STUDIES

# 1. REGIONAL MARITIME TRANSPORTATION SAFETY PROJECT PLAN

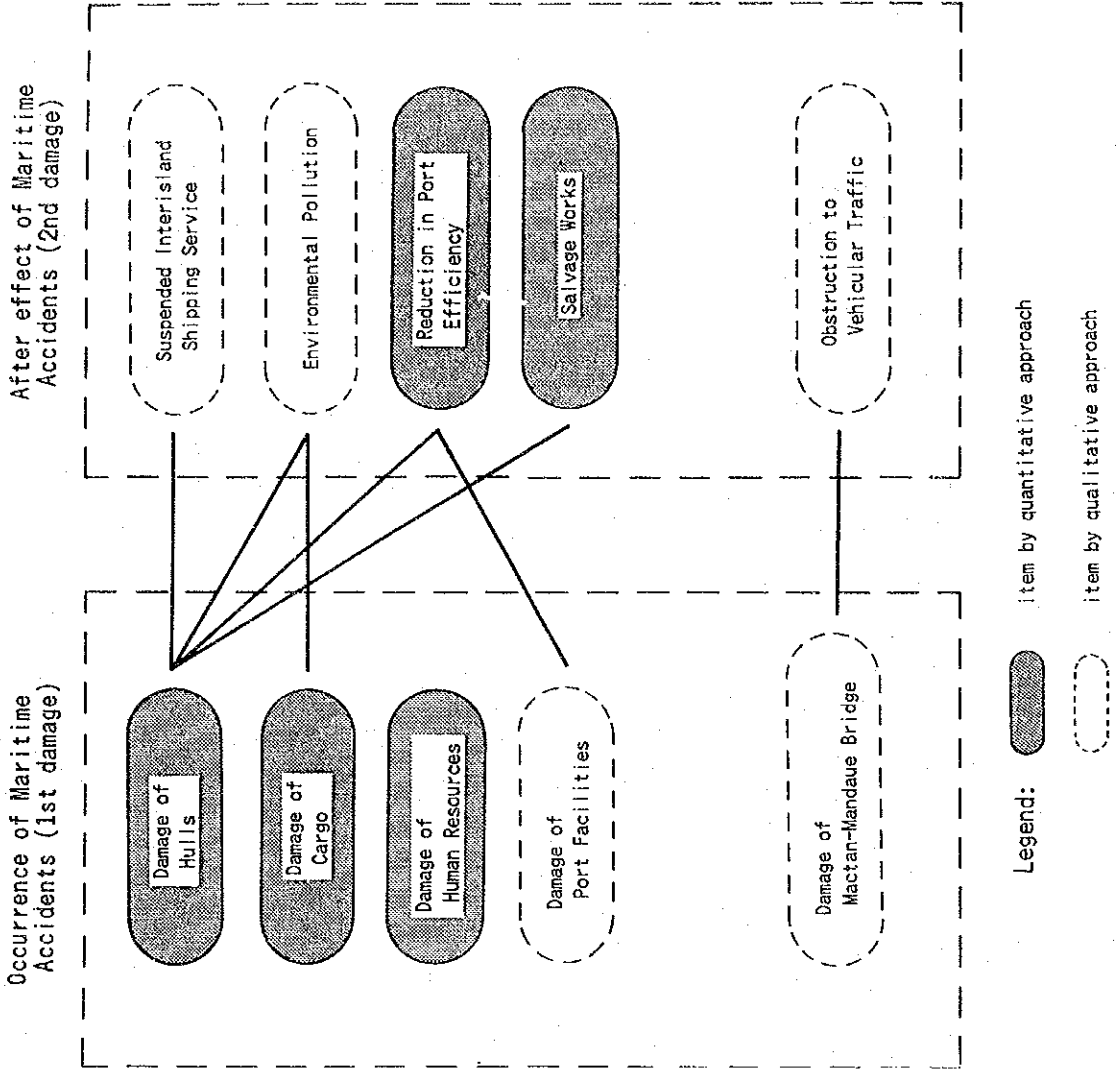
Figure 1.9  
 Components of damage  
 with Typhoon Ruping

Typhoon Ruping  
 (Nov. 12-15, 1990)

The components of the damage are considered as shown in Figure 1-9.
