# EARTHQUAKE BEHAVIOR OF PURAL BUILDINGS IN TURKEY

PREPARED BY  
PROFESSOR DR. RIFAT YARAR  
TECHNICAL UNIVIRSITY OF ISTANBUL  
PROFESSOR OF CIVIL ENGINEERING  
CHAIRMAN OF TURKISH NATIONAL COMMITTEE FOR EARTHQUAKE ENGINEERING

PAPER WRITTEN FOR DISCUSSION IN THE MEETING OF WORKING GROUP OF EUROPEAN ASSOCIATION OF EARTHQUAKE ENGINEERING ON "CONTEMPORARY RURAL HOUSING IN SEISMIC AREAS" HELD DURING THE NATIONAL SEMINAR ON EARTHQUAKE ENGINEERING WHICH WAS ORGANIZED BY TURKISH NATIONAL COMMITTEE ON EARTHQUAKE ENGINEERING BETWEEN 30 SEPTEMBER - 6 OCTOBER 1985 IN ATAKÖY - ISTANBUL

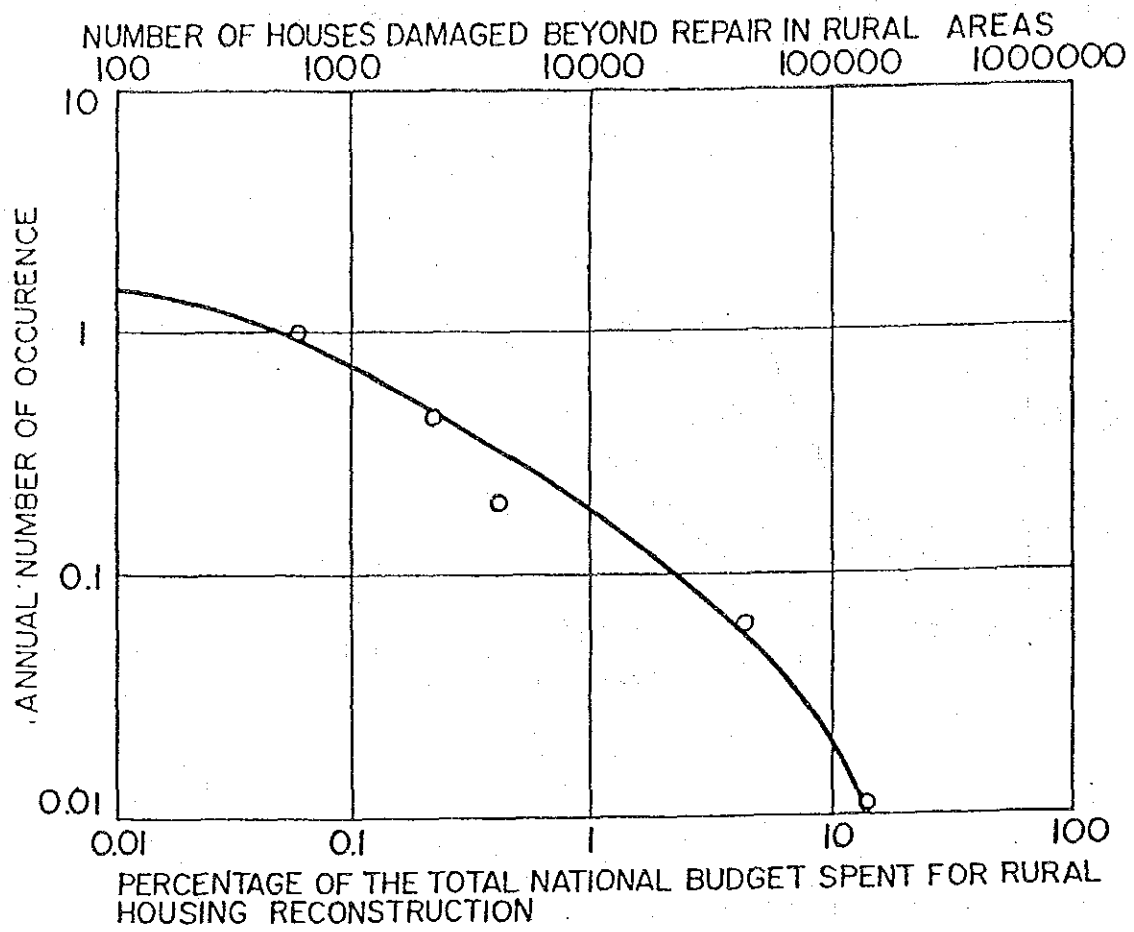
FIGURE 1.6. SEISMIC RISK FOR RURAL BUILDINGS IN TURKEY

Seismic risk in the form of annual number of occurrences of the total number of heavily damaged or collapsed rural houses or of the percentage of the annual national budget spent for rural reconstruction is provided in Figure 1.6. Again assuming Poissonian behaviour of the data, there exists 63% probability of spending 0.07 % of the national budget per year or 1.4% of the national budget for every 10 years for rural post earthquake reconstruction purposes. Figure 1.7 provides the seismic risk in terms of the total annual number of lives lost in all Turkey. Similarly one can expect 63% probability of losing about 10 lives every year or about 800 lives every 10 years or about 8000 lives every 10 years in rural areas with adobe and stone masonry building stock due to earthquakes. As it can be seen the losses in areas wooden frame buildings are much lower.

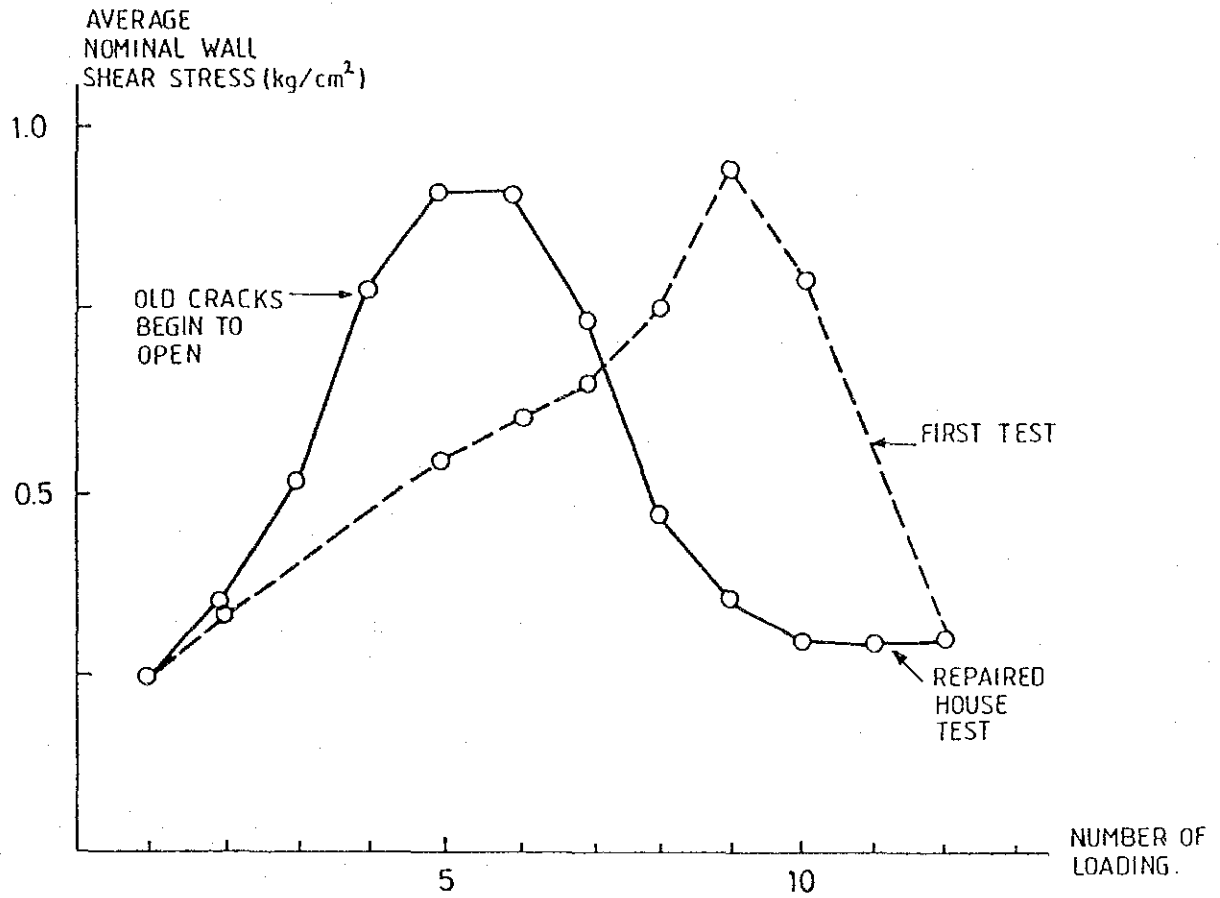
FIGURE:31. NOMINAL SHEAR STRESSES DEVELOPED IN THE ORIGINAL AND REPAIRED TEST HOUSES.

In this test a brick masonry house of plan dimenzions of 415 x 356 cm and 252 cm height which had been tested and partially damaged in a previous set of brick masonry house tests were repaired by two  $\emptyset$  12 mm steel bars in the direction of shaking of the table at mid height of the walls crossing accross the cracks formed in the previous test, and tested to see the effectiveness of the repairing technic. The amount of reinforcing bars were kept at a minimum and the bars did not have any prestress. In order to see the effectiveness of the method of repair the test house was only 'repaired' not strengthened, to its pre-first test strength. In Figure-31 the nominal shear stresses measured in the first and second (after repair) tests are given. As can be seen from the figure the repairing technic brought the shear strength of the test house to its first test level; and after almost the same number and levels of impulsive loadings the repaired house returned to its post first test level of strength.

Another observation from the test is that the cracks from the first test widened below the level of the reinforcing bar, while those above the reinforcement level did not develop any new widening. The test indicated that repairing by bars crossing the former cracks, a kind of crackstitching, would be an effective strengthening method if cracks are crossed by more than one layer of reinforcing bars.
