6. Water Quality Analysis

7. Physical Condition of Each Villages

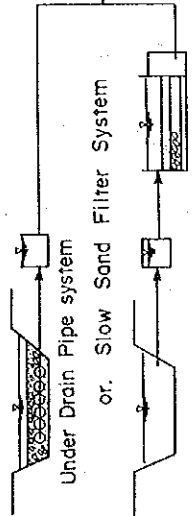
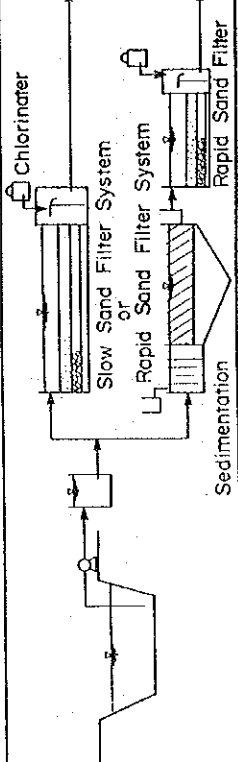
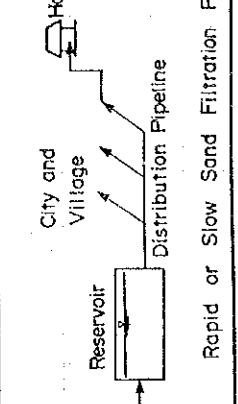
Fig.3.16. Classification of the Water Supply System

Water Source	Water Supply System	Condition
G. Groundwater	I. Hand Pump	1) Broken; Poor Water Quality; not used at present
	II. Mortorized Pump	2) Presently used but with insufficient amount
	III. Windmill Pump	3) Effectively functioning
S. Surface Water	I. Rain Water	1) Insufficient all the year
	II. Spring	2) Insufficient during the dry season
		3) Sufficient
	III. River	1) boiled before drinking
	IV. Stream	2) Plain water treatment system, without chlorine application
	V. Irrigation Canal VI. Reservoir	3) Final water treatment system, with chlorine application

Collected by Person, boiled before Drinking
IV) Stream	2)

Semi Water Treatment Plant. Without Chlorine Application
V) Irrigation Canal	3)

Rapid or Slow Sand Filtration Plant.
VI) Reservoir	3)

Rapid or Slow Sand Filtration Plant.

- 1) The existing Water Supply Systems are shown on Table 2.2; The Classification of the Water Supply Development Plans are shown on Fig.3.16.
- 2) Classification of the target villages into three classes according to the priority of water supply development :
 - A: Villages with grave shortage conditions and very urgent need for water development.
 - B: Villages with a relatively low demand for water in comparison with A.
 - C: Village where a water development plan will be implemented in the future.
- 3) Division of the villages into two groups according to dependable water resources:
 - (G): Villages which can depend on groundwater as their source.
 - (S): Villages depending on surface water as their source.

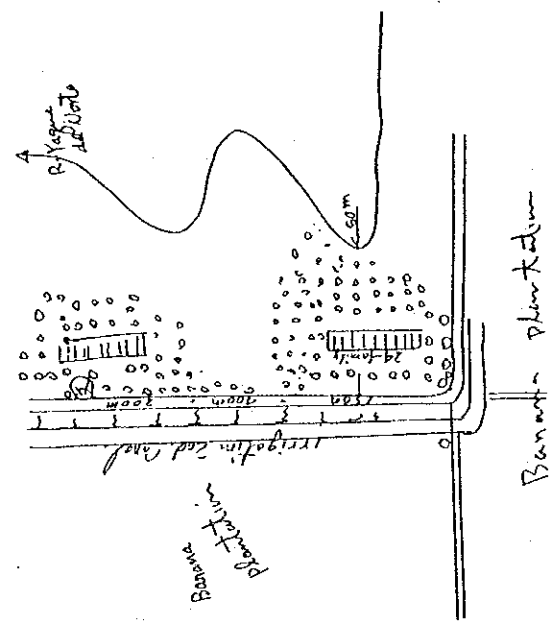
No.	Village	Province	Hydrogeological Classification		Province No.
M - 8	Batey Higuero	Monte Cristi	Llano de Yaque del Norte		II
Water Supply Development Plan for 2000					
Household	Population	Growth Rate 1981-1990	Household	Population	Consumption (L/c/d)
169	743	+203 %	501	2253	100
Source	System	Condition	Potential	Quality	Drilling Access
River	S - III-1)	Very Poor	Very high	Good	Good
Location Map			Motorized Pump System

Classification of the Plan		
			Implementation Program		
Village Condition			A -(G)		
<p>M-8 Batey Higuero</p> <p>Located at the north-eastern end of a government-run banana plantation which is located along the bank of Yaque del Norte. Located at the end of a big banana plantation; a group of houses on the left bank of Yaque del Norte.</p> <p>The majority of the residents work in the plantation as laborers. The residents live in two public housing complexes.</p> <ul style="list-style-type: none"> - 169 families in the northern housing area receive door to door supply of river water; - The residents collect water from the irrigation water canal which is at a shortest range from 10 m - 60-70 meters, or directly collect water from the Yaque del Norte River.

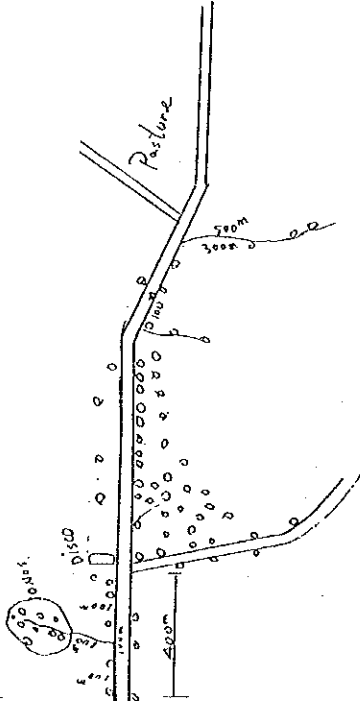
No.	Village	Province	Hydrogeological Classification	Province No.
M-19	Guajubincito	Monte Cristi	Sur del Yaque del Norte	III
Water Supply Development Plan for 2000				
Water Supply Present Condition (1990)				
Household	Population	Growth Rate 1981-1990	Household	Population
75	352	+ 22 %	94	429
Source	System	Condition	Potential	Quality
River	S - III-1)	Poor	Very Low	Poor
Location Map

Development Plan System			Guajubin Treatment Supply System	
Classification of the Plan			S - III-1)	
Implementation Program			C -(S)	
<p>Village Condition</p> <p>M-19 Guayubincito</p> <p>This village corresponds to village M18, Caveza de Toro.</p>
