**A STUDY ON A REGIONAL DEVELOPMENT PLAN
FOR TELECOMMUNICATIONS NETWORKS
IN THE BANGKOK METROPOLITAN AREA
IN THE KINGDOM OF THAILAND**

**FOR
A FEASIBILITY STUDY
ON
AN IMPLEMENTATION PLAN TO UPGRADE
THE TELECOMMUNICATIONS SERVICES QUALITY**

MAIN REPORT

October 1992

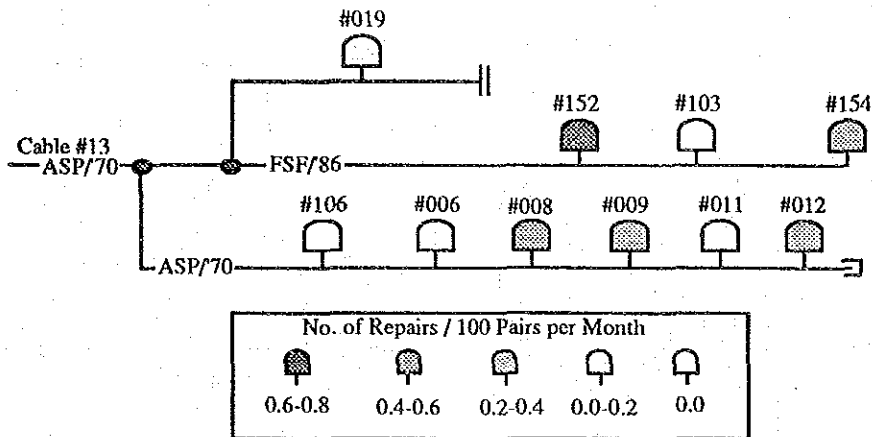
Figure 2.2.2-7 Fault Condition by Cabinet on a Primary Cable in the Krungkasem Exchange Area

The primary cables have some branch cables and the pairs have been connected to some cabinets as shown in Figure 2.2.2-7. It is possible to sort the repair records with the cabinet numbers. Therefore, if some differences in fault occurrence conditions would be found among the cabinet numbers, the facilities to be rehabilitated will be further narrowed down.

Figure 2.2.2-7 shows a result of the above analysis for the primary cable number 13 in the Krungkasem Exchange Area. This figure shows the difference of the number of repairs between the pair groups involved in the same primary cable. For instance, the pair group connected to the cabinet #152 have been repaired more than

the pair groups connected to the cabinet #103 and #154 even though they are connected to the same cable. Accordingly, there is a high probability that the fault points are in the lead up cable between the primary cable and cabinet or in the cabinet.

Note; ASP : Paper or Wood Pulp Insulation STALPETH Sheathed Cable
 FSF : Form/Skin Insulation ALPETH Sheathed Filled Cable

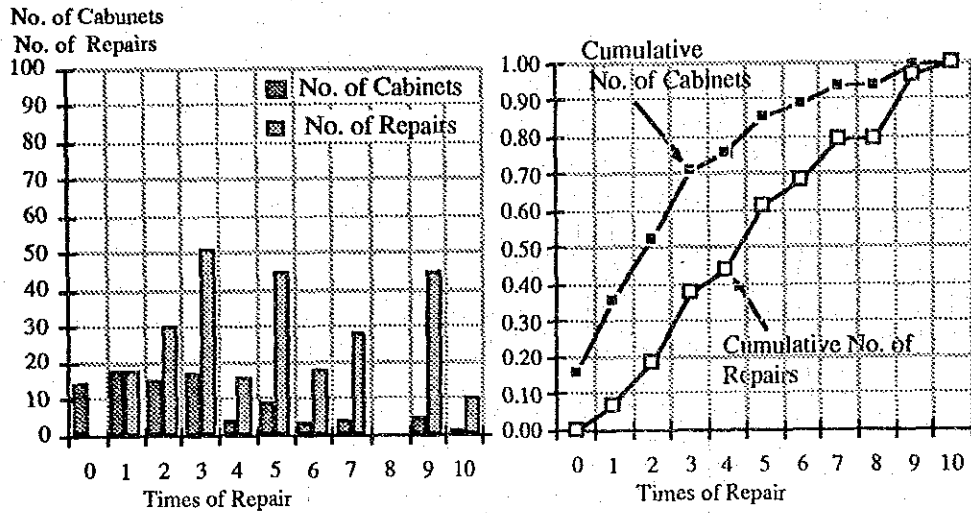
Figure 2.2.2-8 Distribution of the Secondary Cable Faults by Cabinet Area in the Krungkasem Exchange Area

Figure 2.2.2-8 and Table 2.2.2-3 show the results of the above analysis. These results show the faults concentrate on certain cabinet areas. For example, the graph on the right hand side in Figure 2.2.2-8 shows that about fifty (50) percent of the repairs have been done in about twenty (20) percent of the cabinet areas. To understand causes of the faults, some analyses such as a relation ship between the number of closures and the number of faults, a relation ship between the total length

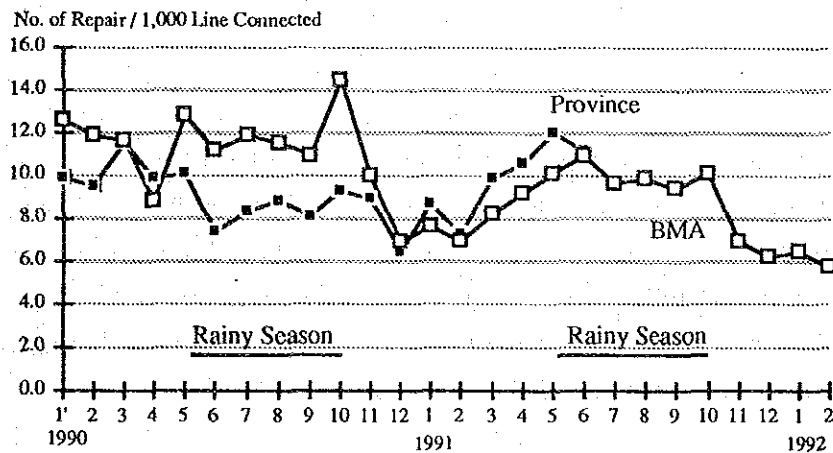
Figure 2.2.2-9 Number of Repaired Drop Wire Fault per 1,000 Lines Connected

The drop wire faults include the faults at the cabinet jumpers. The drop wire faults occupy about thirty (30) percent of the facility faults in the BMA and about twenty (20) percent in the provincial area. Figure 2.2.2-9 shows the number of repaired drop wire faults. This figure shows that the number of repairs has been steadily decreasing but there is an increasing tendency during the rainy season. And also, the average number of repairs in maintenance areas quite different as shown in Figure 2.2.2-10.

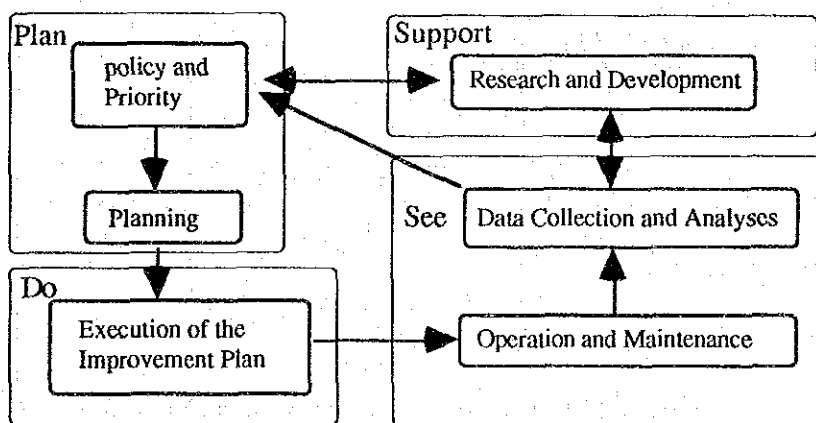
Figure 2.2.3 Cycle for the Improvement of the Quality

It is generally more effective if the improvement in the quality of facilities is carried out with some improvement or development of the materials together as shown in Figure 2.2.3. But the plan aims to achieve the target of 2.5 percent per month within five years. And it is slightly difficult to expect that some materials which suitable for the environment of Thailand can be developed during the plan period. Therefore, the Study Team mainly considers the rehabilitation of the facilities for the improvement plan because the rehabilitation with present technique is the most certain way.

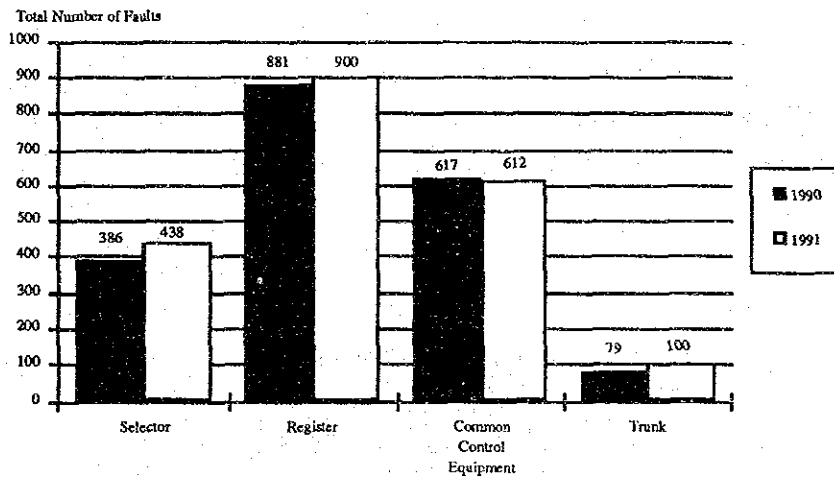
Figure 2.3.1-1 The number of Repaired XB Switch Faults (C400) in the BMA in each Equipment Category

The total numbers of the repaired XB switches (C400) in the BMA are reported to be 1963 in 1990 and 2050 in 1991 according to the Monthly Fault Report. The repaired equipment of the XB switches are classified into the selector, register, common control equipment and trunk categories. Figure 2.3.1-1 shows the total number of repaired faults in each category and Figure 2.3.1-2 shows the number of repaired XB Switch Faults (C400) per 1,000 subscriber lines in each category.

Note: Selector = Switching equipment of XB switch

Source: Monthly Report from the Center of Metropolitan Switching Office
