**THE DEVELOPMENT STUDY  
ON  
THE SEAWALL CONSTRUCTION PROJECT  
FOR  
MALE' ISLAND IN THE REPUBLIC OF MALDIVES**

**SUMMARY REPORT**

**DECEMBER 1992**

**JAPAN INTERNATIONAL COOPERATION AGENCY**

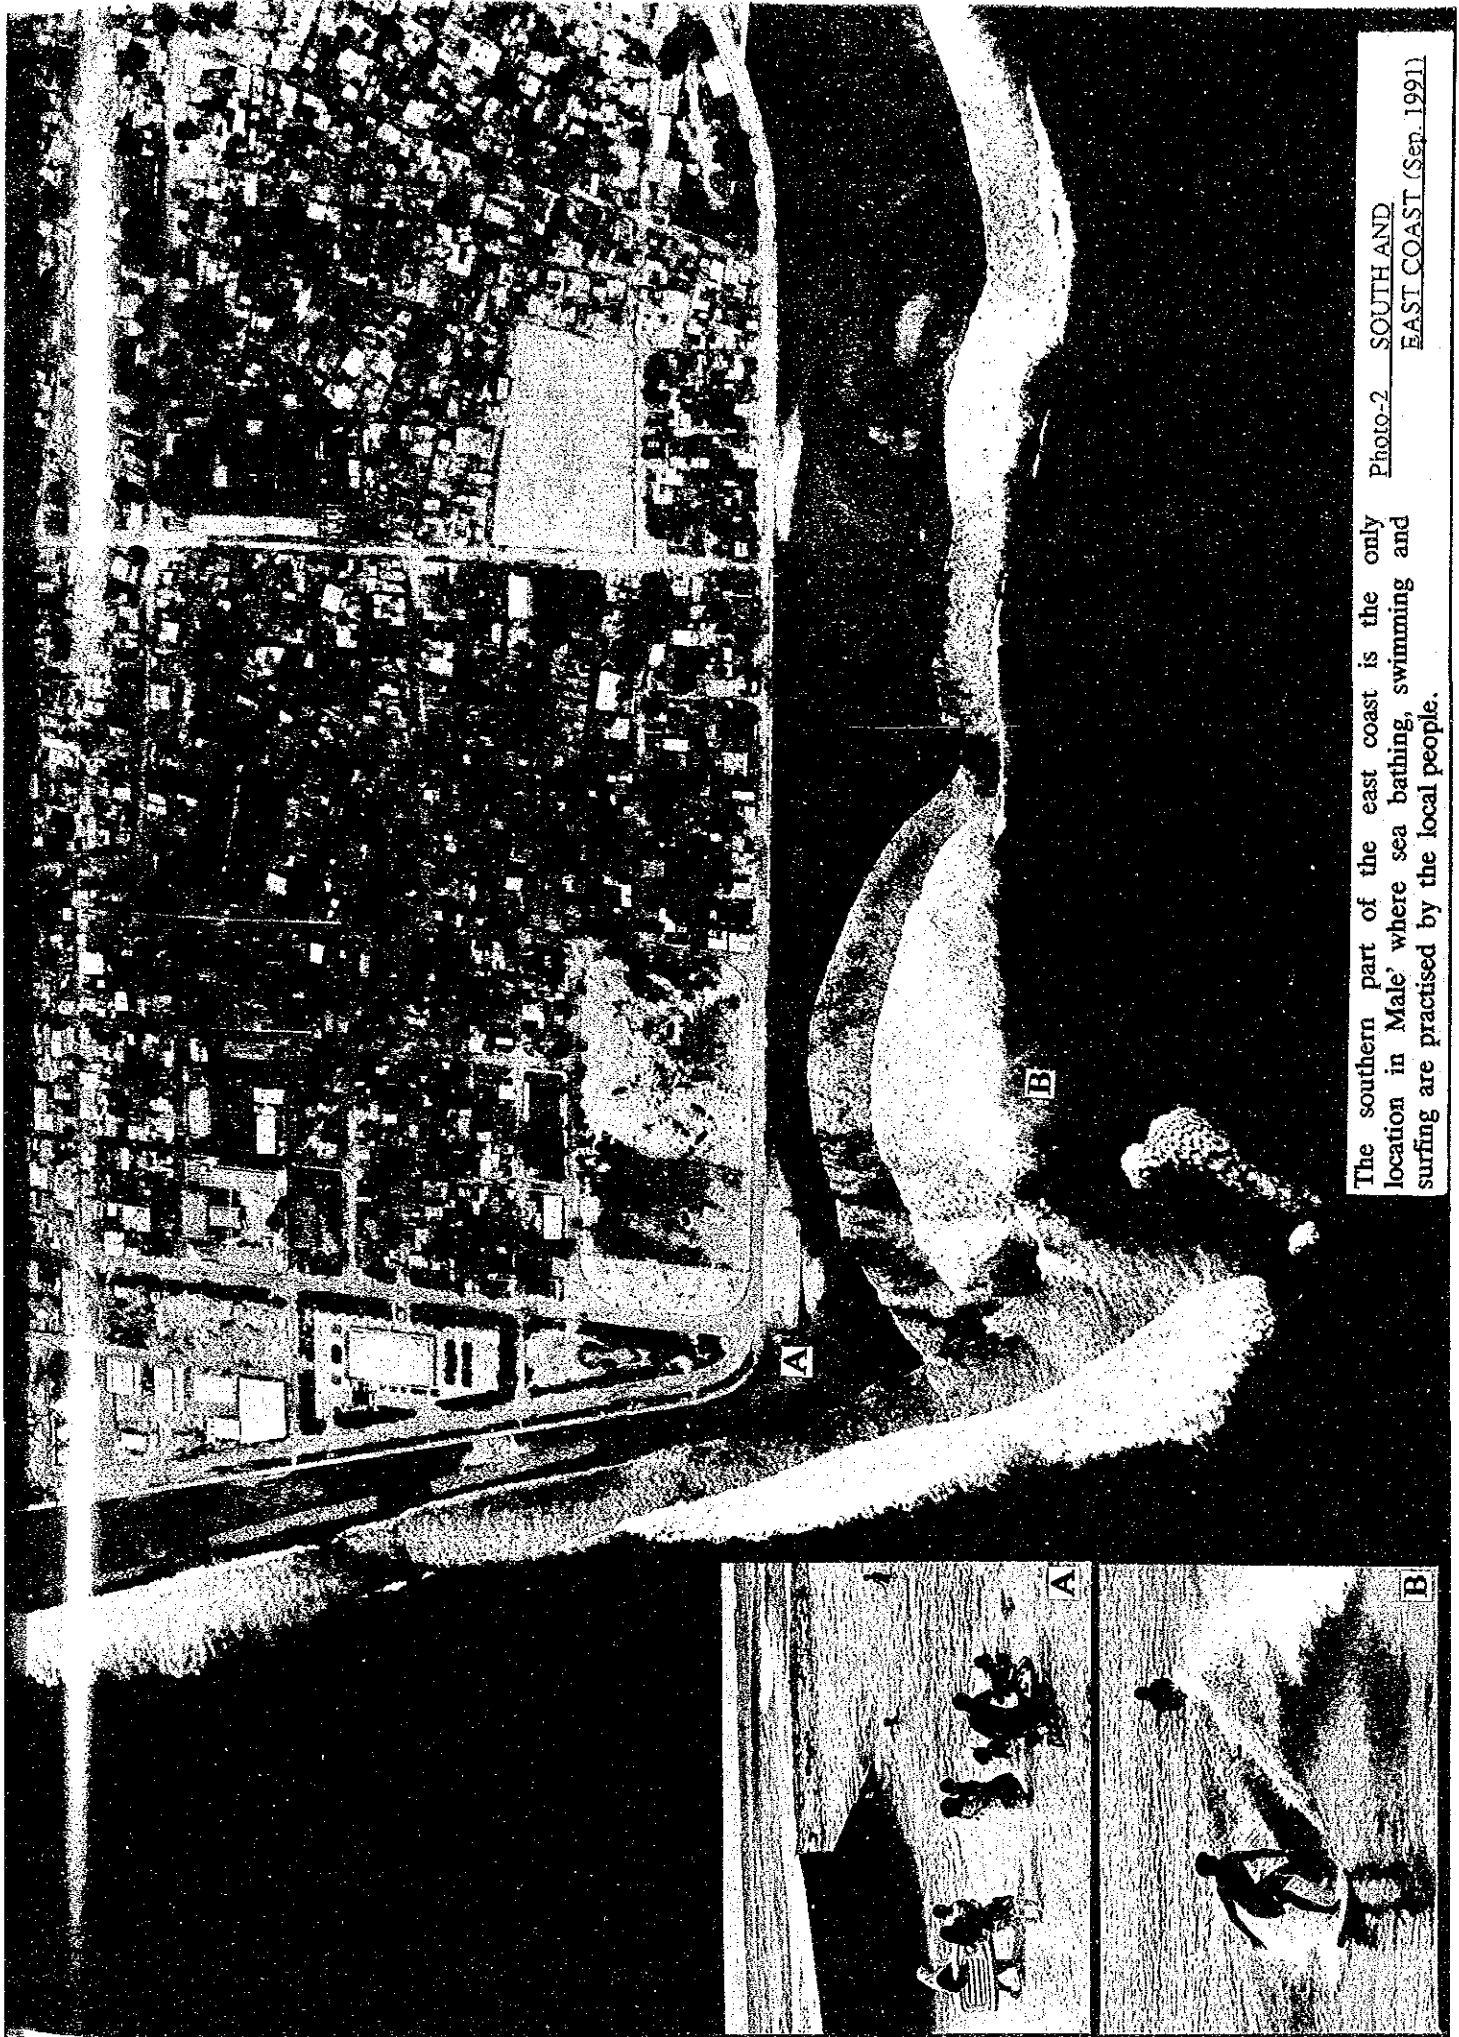
Photo-2 SOUTH AND EAST COAST (Sep. 1991)

The southern part of the east coast is the only location in Male' where sea bathing, swimming and surfing are practised by the local people.

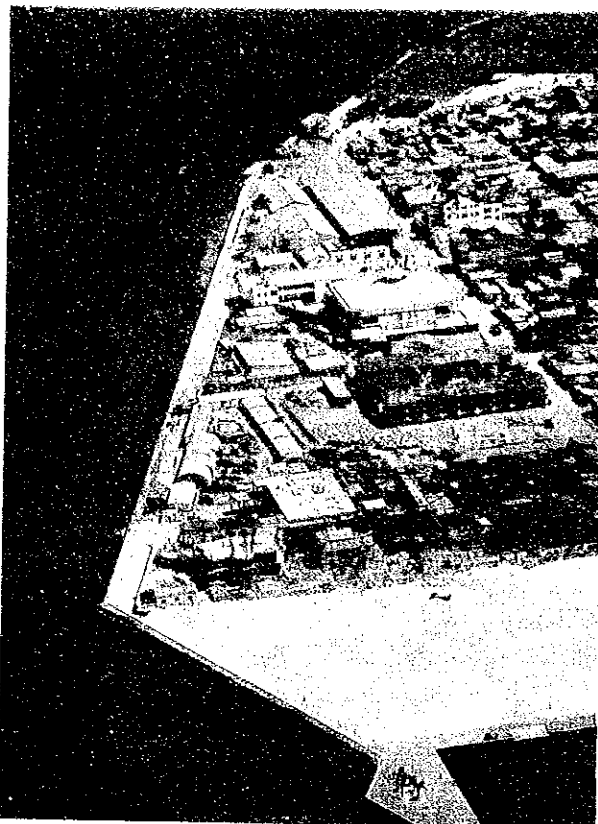
Photo-7 WEST COAST (Oct. 1992)

There are many important public facilities such as hospital, school and education center very close to the seawalls. The Government plans to expand Marine Drive to connect two harbours.

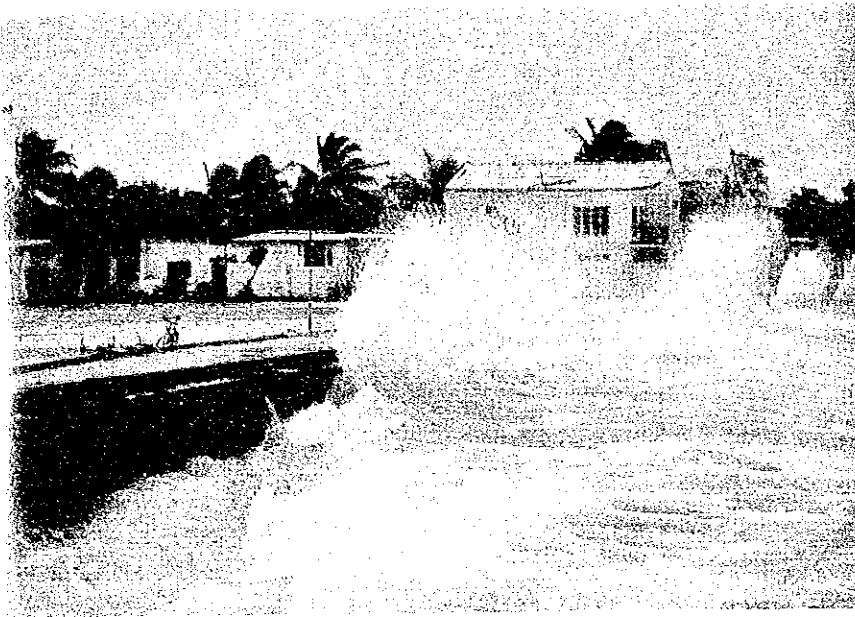
Photo-10 EAST COAST (Jul. 1992)

Wave overtopping occurs very often at the south part of east coast seawall.

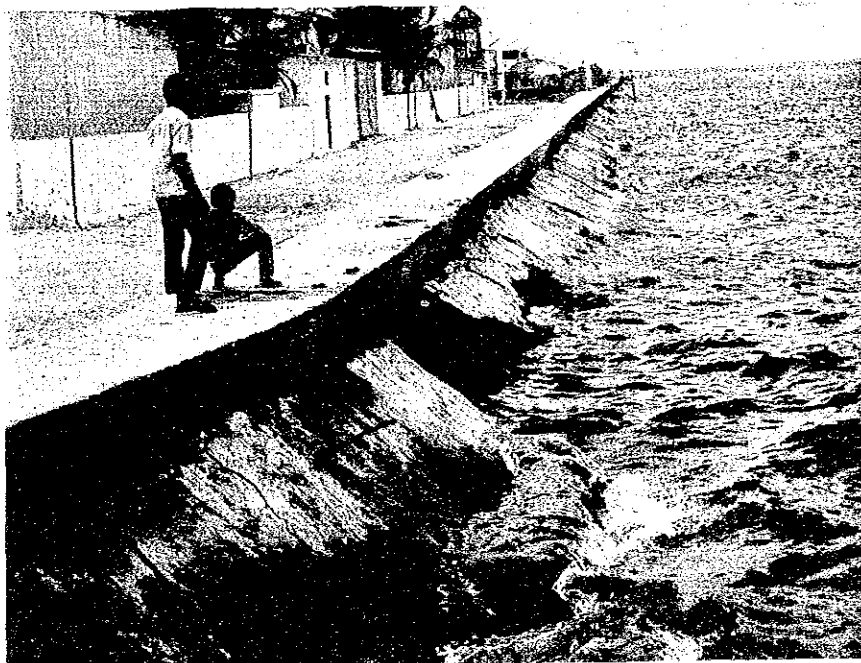
Photo-12 WEST COAST (Sep. 1991)

The existing seawalls are constructed very close to reef edge. There is no room to expand the road seaward although the road is planned to be expanded.

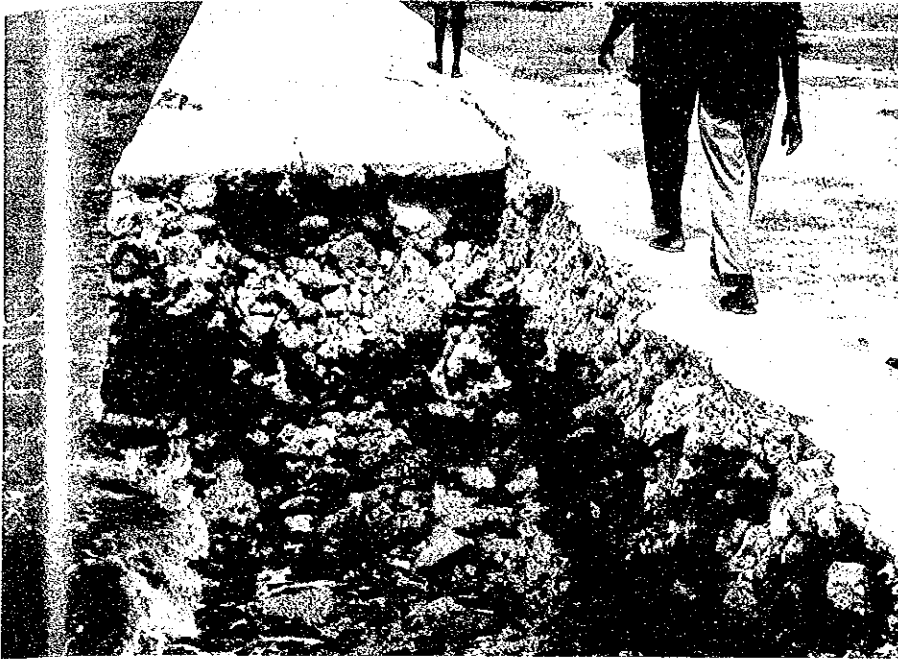
Photo-13 EXISTING SEAWALL  
STRUCTURE (Sep. 1991)

The structure is of coral rocks of 10 to 20 cm in dia. piled with its surface mortared or plastered.

The existing shore protection facilities are schematized as shown in Fig.2.7.1. The old seawalls were constructed on the east, west, north and south coasts and the structures are of coral rocks of 10 to 20 cm in diameter piled with its surface mortared or plastered. They are generally obsolete having holes with the mortar deteriorated and the coral rocks dislodged, especially in the tidal zone. Along the back of the seawalls, the 5 m to 8 m wide road called the "Marine Drive" running around the island is provided.
