#### THE BASIC DESIGN STUDY ON THE PROJECT FOR EMERGENCY REHABILITATION PROGRAM FOR TYPHOON-DAMAGED WATER SUPPLY SYSTEM IN LEYTE IN THE REPUBLIC OF THE PHILIPPINES

The Objective of the Project is to rehabilitate water supply facilities constituting the Leyte Metro Water District water supply system which was damaged by Typhoon Uring in November, 1991, in order to restore the original water supply capacity of the system.

TECHNICAL NOTES  
ON  
THE PROJECT FOR EMERGENCY REHABILITATION PROGRAM  
FOR TYPHOON-DAMAGED WATER SUPPLY SYSTEM IN LEYTE

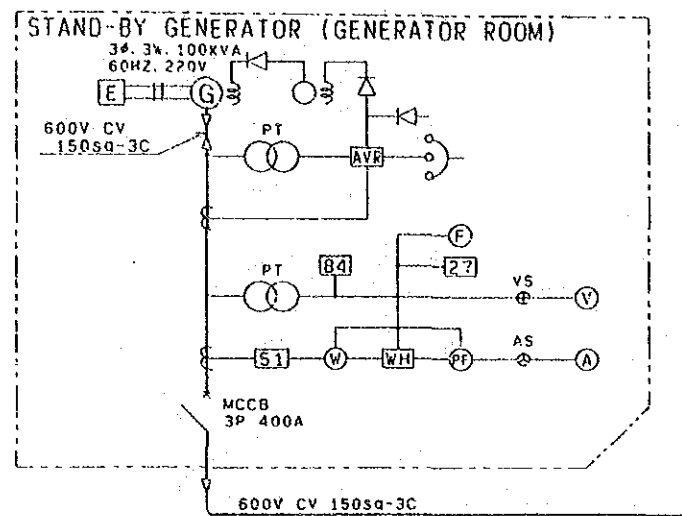
Single Line Diagram of Electrical facility

CONNECTED EQUIPMENT	CAPA (KW)	CONNECTED CABLES	ELCB MCCB	REMARKS
CONTROL CIRCUIT	0.2	-	3P30A	
NO. 1 VACUUM PUMP	2.2	600V CV 3.5sq-3C	3P30A	P2-1
NO. 1 COMPRESSOR	1.5	600V CV 3.5sq-3C	3P30A	M1-1
DEHUMIDIFIER	0.31	600V CV 3.5sq-3C	3P30A	M-2
NO. 1 SLUDGE DISCHARGE PUMP	3.7	600V CV 5.5sq-3C	3P30A	P3-1
NO. 3 SLUDGE DISCHARGE PUMP	3.7	600V CV 5.5sq-3C	3P30A	P3-3
NO. 1 SERVICE WATER PUMP	3.7	600V CV 3.5sq-3C	3P30A	P4-1

SURFACE WASH PUMP	3.7	600V CV 3.5sq-3C	3P30A	P-1
NO. 2 VACUUM PUMP	2.2	600V CV 3.5sq-3C	3P30A	P2-2
NO. 2 COMPRESSOR	1.5	600V CV 3.5sq-3C	3P30A	M1-2
NO. 2 SLUDGE DISCHARGE PUMP	3.7	600V CV 5.5sq-3C	3P30A	P3-2
NO. 4 SLUDGE DISCHARGE PUMP	3.7	600V CV 5.5sq-3C	3P30A	P3-4
NO. 2 SERVICE WATER PUMP	3.7	600V CV 3.5sq-3C	3P30A	P4-2

NO. 2 EJECTOR PUMP	1.5	600V CV 3.5sq-3C	3P30A	P7-2
NO. 1 CHLORINATOR	0.1	600V CV 3.5sq-3C	3P30A	M7-1
NO. 2 CHLORINATOR	0.1	600V CV 3.5sq-3C	3P30A	M7-2
