FEASIBILITY STUDY ON MEMVE ELE HYDROELECTRIC POWER DEVELOPMENT PROJECT

GEOLOGY AND CONSTRUCTION MATERIALS

NIPPON KOEI CO., LTD.

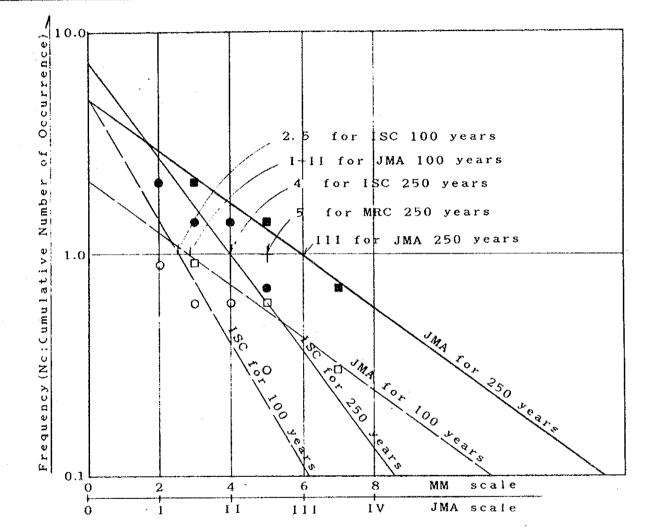
REPUBLIC	OF CAMEROO	TE DU CAMEROUN			
SOCIETE N	ATIONALE D	'ELECTRICITE				
MEMVE E	LE HYDROELECTAN	C FOWER DEVELO				
J.A	PAN INTERNATION	ERNATIONAL COOPERATION AGENCY				
	TITLE OF DRAWING		SCHEME: MEHVE	ttt		
			LOCATION:			
Analysi	s of Ea:	rthquake	e REGENCY: NTEM			
Analysis of Earthquake REGENCY: NYEN Coefficient PROVINCE: BUD						
CHECKED BY		BGALE	CHEET PLANER	BATE		
APPRICATED ST		1/ 000	TOTAL SUSTE	1

Fig. 2.4 shows the analysis for an earthquake coefficient based on the relationship between intensity felt at the site as above listed and frequency of occurrence (Nc) in the period for 100 years and 250 years by ISC method, Japan Meteorological Agency (JMA) method and Munich Reinsurance (M.R.) Company.
