5.1.2 Present State of Transmission Line Facilities

(1) Present State of Existing Transmission Line Facilities

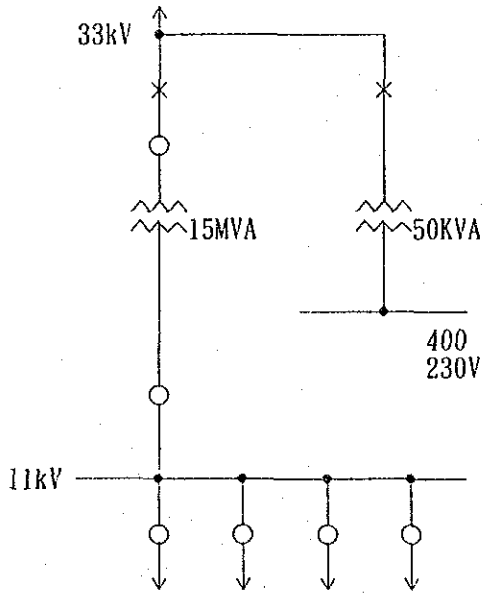
Msasani S/S

33kV • 11kV
Single Bus (both)

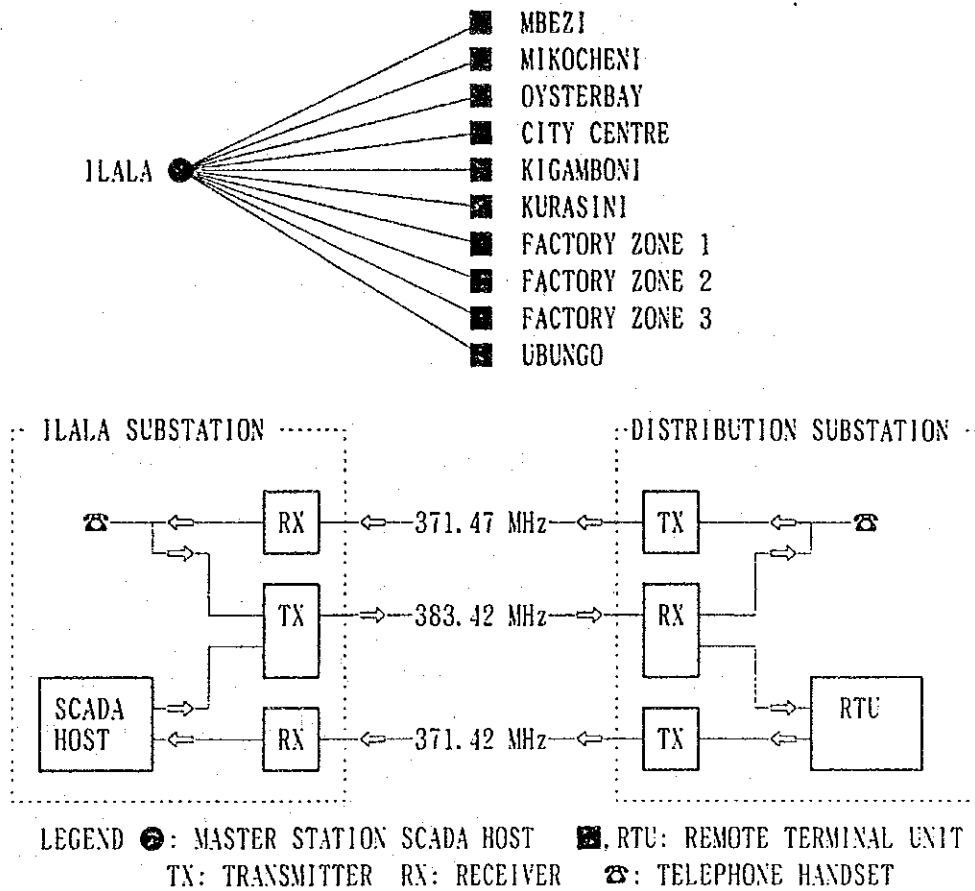
Fig. 5.1.2(4)-1 Distribution monitoring radio communication system

Dar Es Salaam city which is a part of the planned areas and its surrounding districts, consist of 300 MHz zone UHF radio circuits which connect the 10 distribution substations to the central Ilala substation in a radial pattern as shown in Fig.5.1.2(4)-1 Multiplex telecommunication are not applied to this radio system but a duplex operation type in which three frequencies are combined is applied to transmit feed maintenance telephone and SCADA signals.

A duplex operation type 150 MHz band VHF radio circuit is provided between base station and each mobile station as shown in Fig.5.1.2(4)-1 in order to perform maintenance service of transmission and distribution lines in the vicinity of the planned areas.
