**THE FEASIBILITY STUDY ON  
THE NAVIGATION OF THE PARNAÍBA RIVER BASIN**

**VOL. 3 SUPPLEMENTAL REPORT ON  
PILOT SPUR DIKES**

**PACIFIC CONSULTANTS INTERNATIONAL (PCI)**

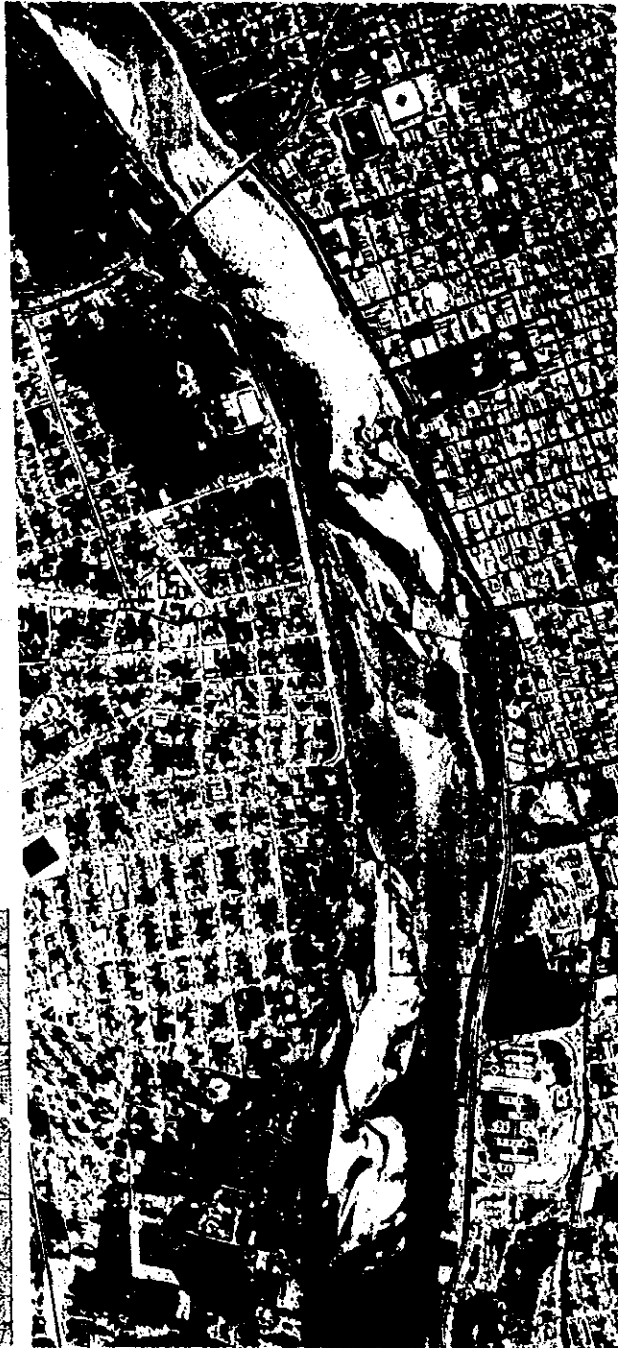
Fig. 1.2 Proposed Spur Dike Site at Teresina

Spur Dike Site at Teresina.

The proposed spur dike sites at Teresina, Uniao and Buriti dos Lopes are shown in Figs. 1.2 - 1.4 .

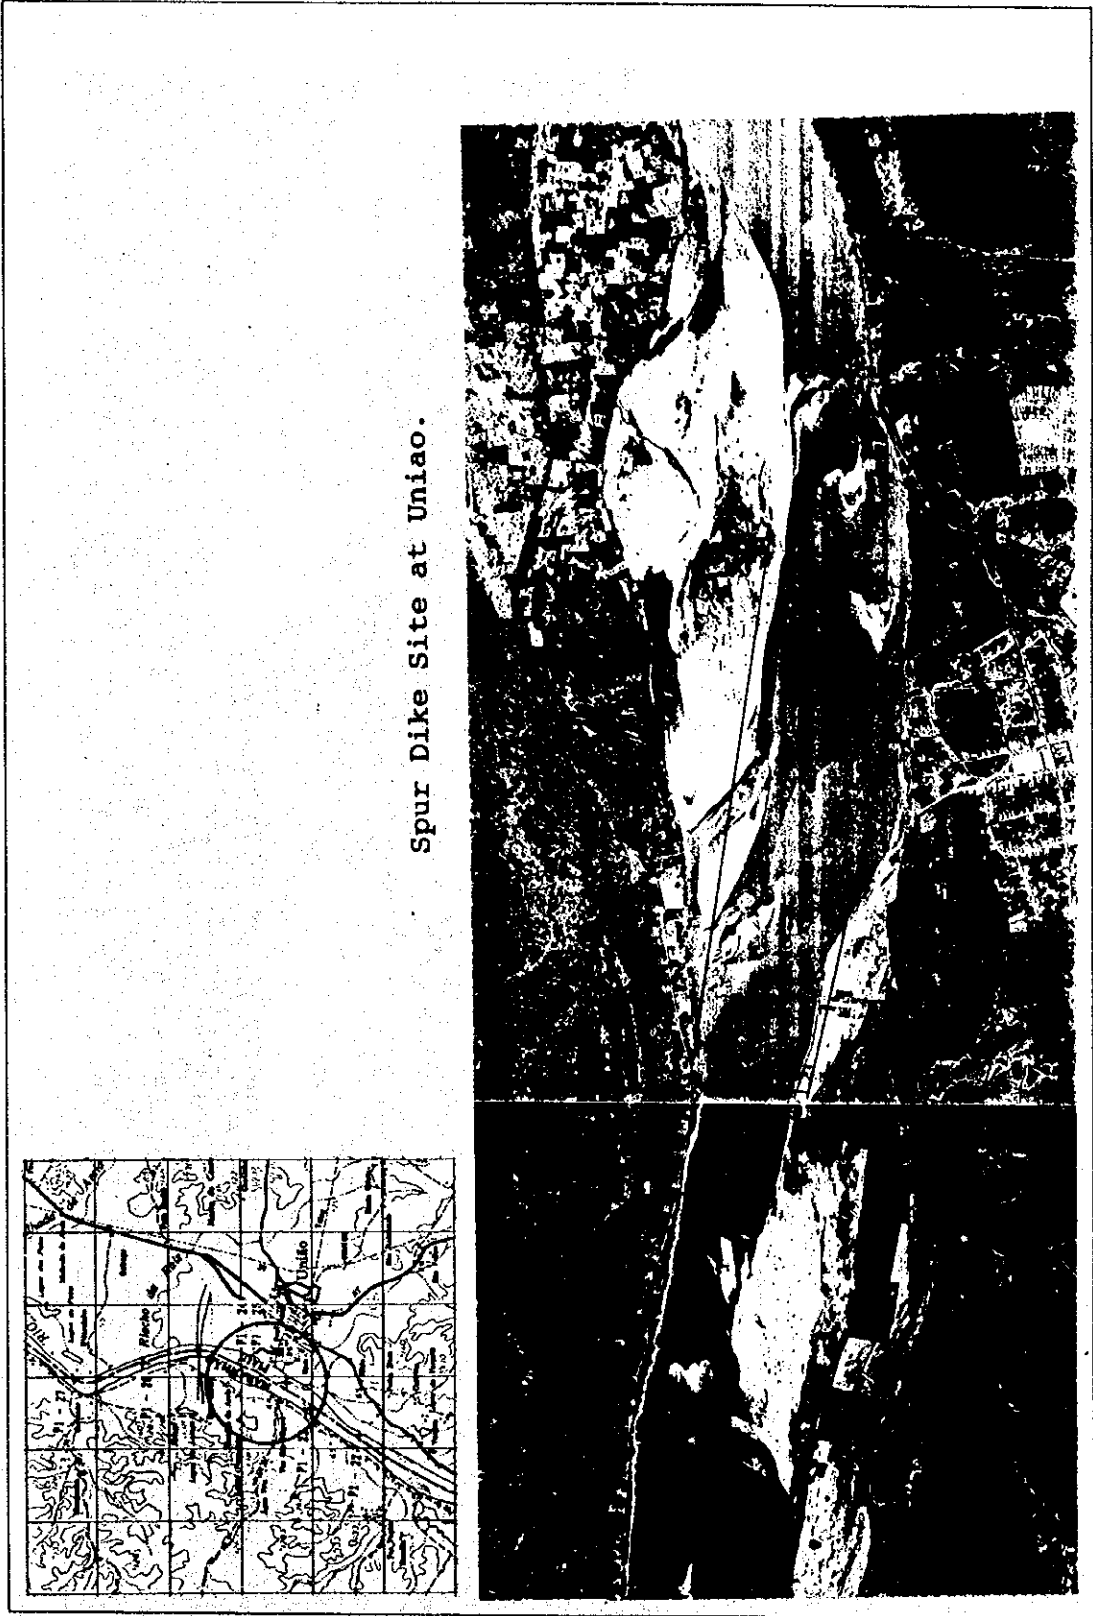
Fig. 1.3 Proposed Spur Dike Site at Uniao

Spur Dike Site at Uniao.

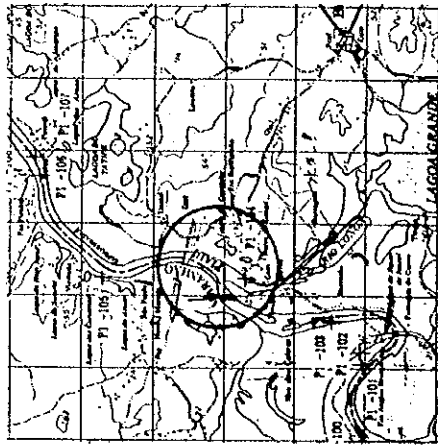
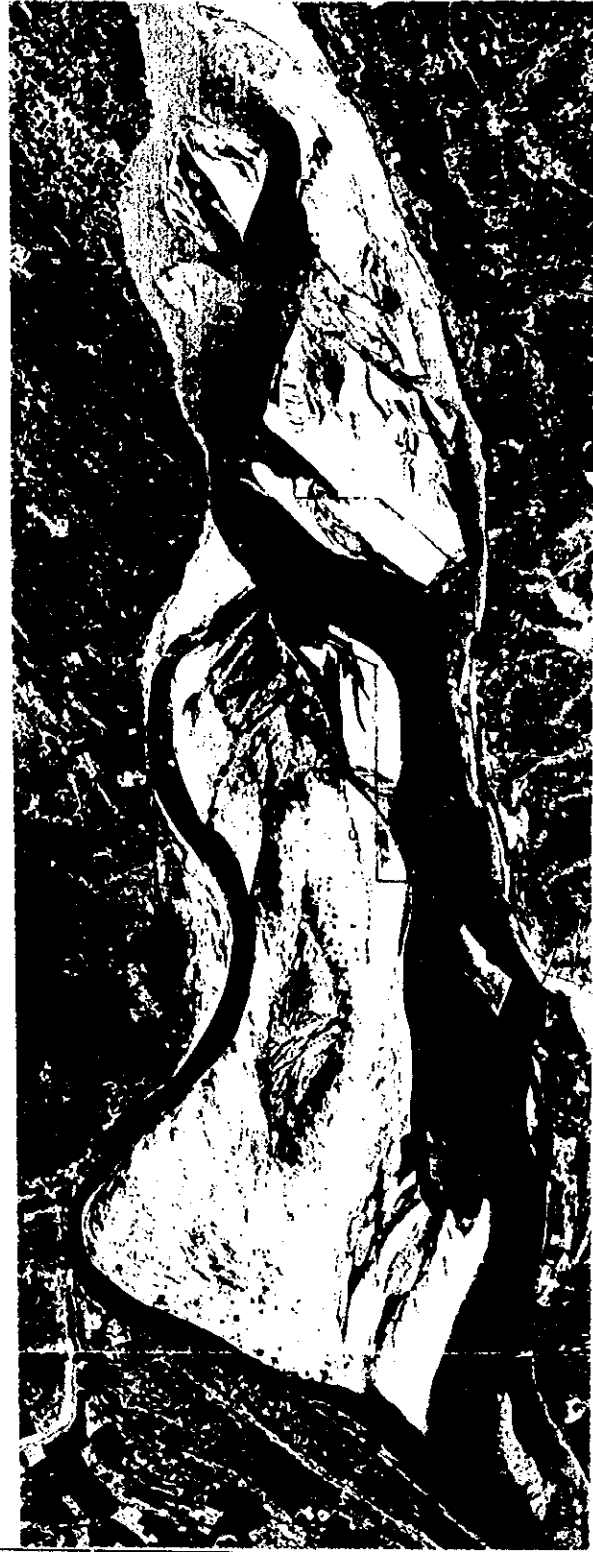
Fig. 1.4 Proposed Spur Dike Site at Buriti dos Lopes

Spur Dike Site at Buriti dos Lopes.

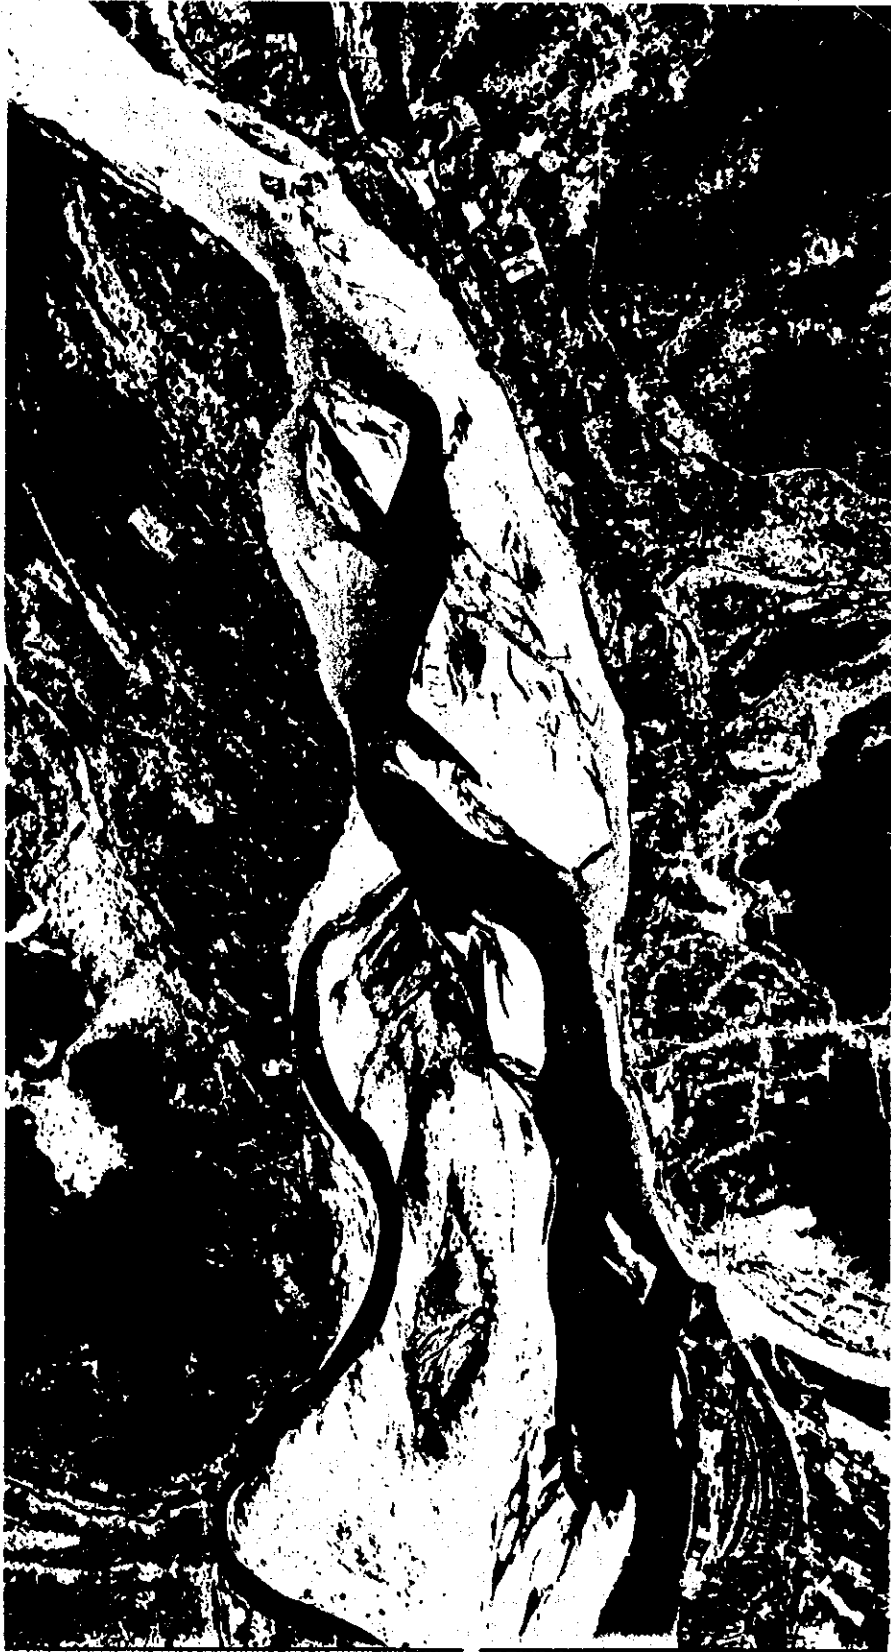
Fig. 2.1 Aerialphotograph at Buriti dos Lopes Site

There is a narrow portion with a river width of 300 meters at a point 2,400 meters on the upstream side of the Rio Longa. Its water course width is 120 meters during the low water period. The river width gradually increases from this point, and a sand bar is found on the left bank side. At this point the water course is divided into two. The water course on the right bank side converges with the Rio Longa, before converges again with the water course passing through the hinterland of the bar on the side of the Province of Maranhão (the bank opposite to the end of the revetment dike). The line of the water course was found to be separating the bar appearing above the water level on the downstream side of this position during the low water period ( Fig. 2.1).

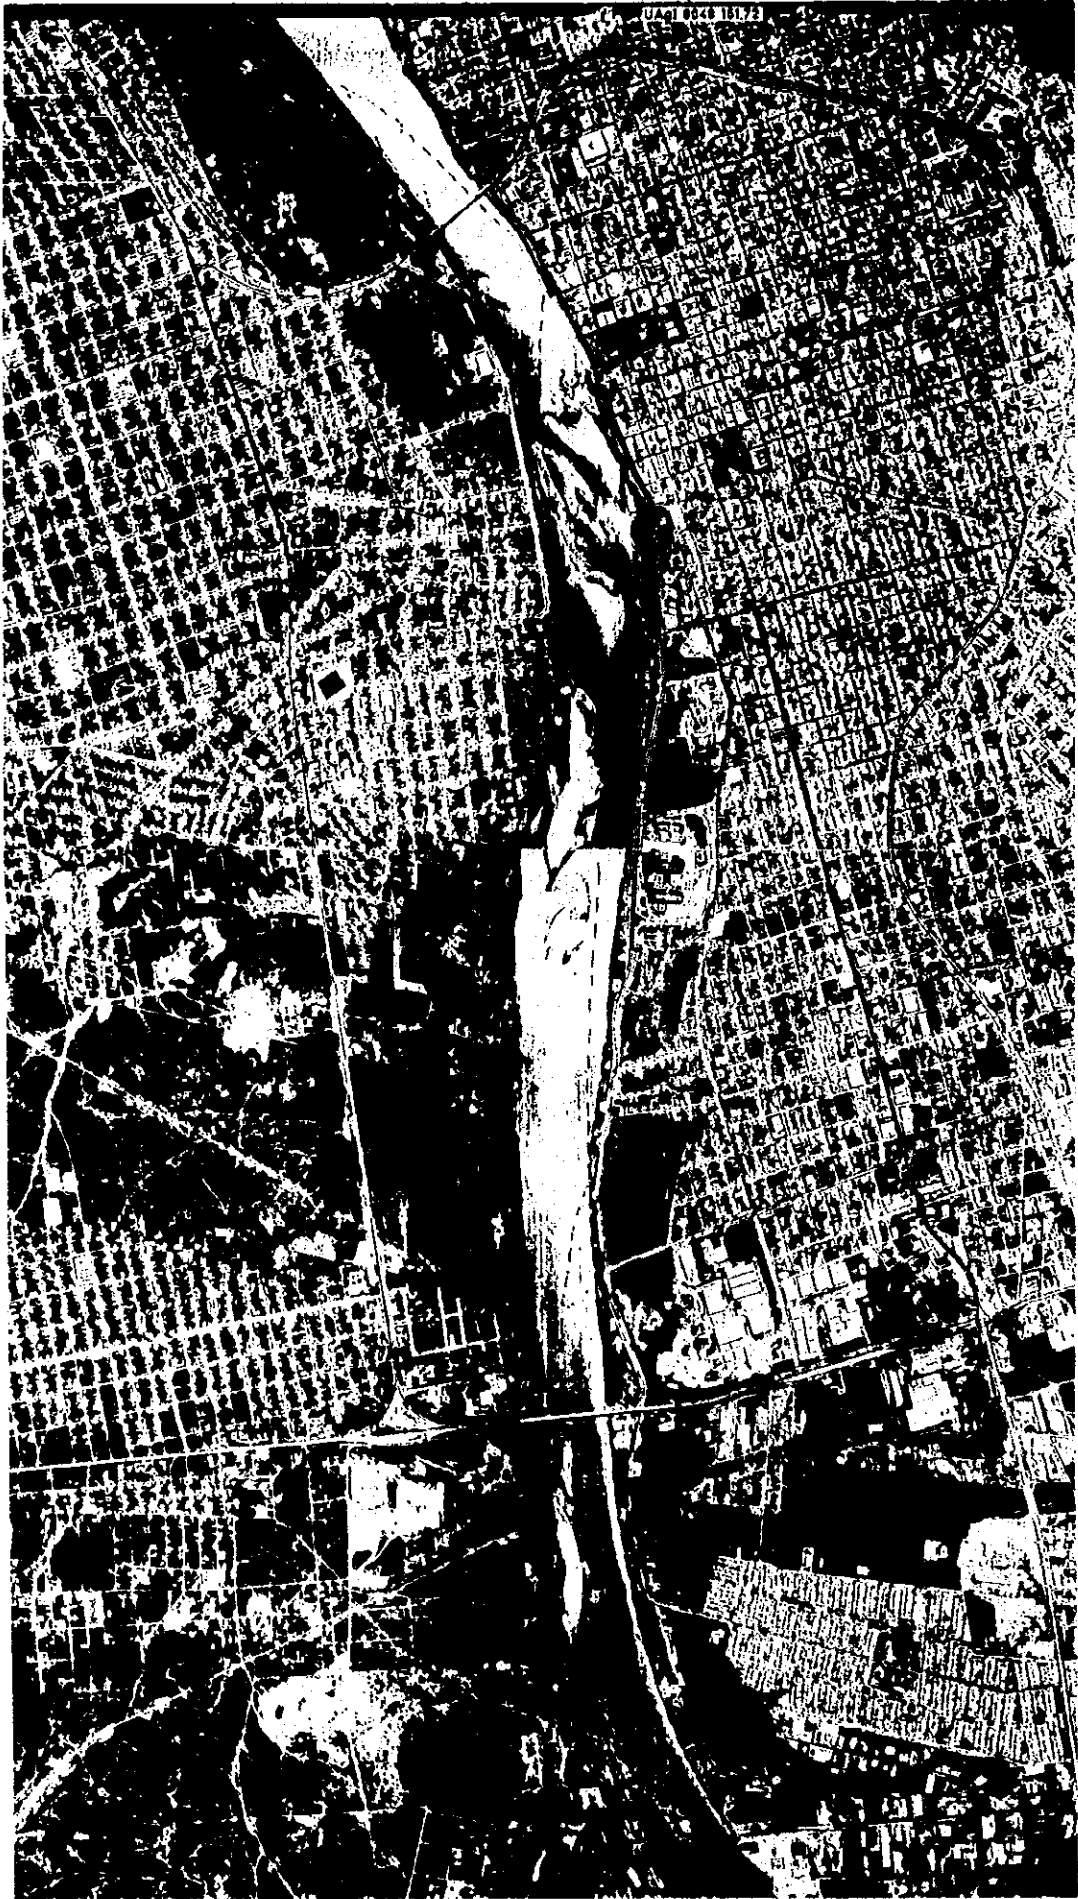
Fig. 2.2 Leading -edge Line for Alternating Bars ( Teresina )

Based on the mosaic photo taken in August 1993, attempts were made to describe the front line of the alternating bar (Fig. 2.2). The bars at this site can be classified as alternating bars, and the wave-length at the alternating bars is estimated at approximately 2,500 meters. Especially, the bar on the immediately upstream side of the construction site is located in the middle region, and the bar length above the water level was 1,170 meters. Plants were observed to grow on this bar.

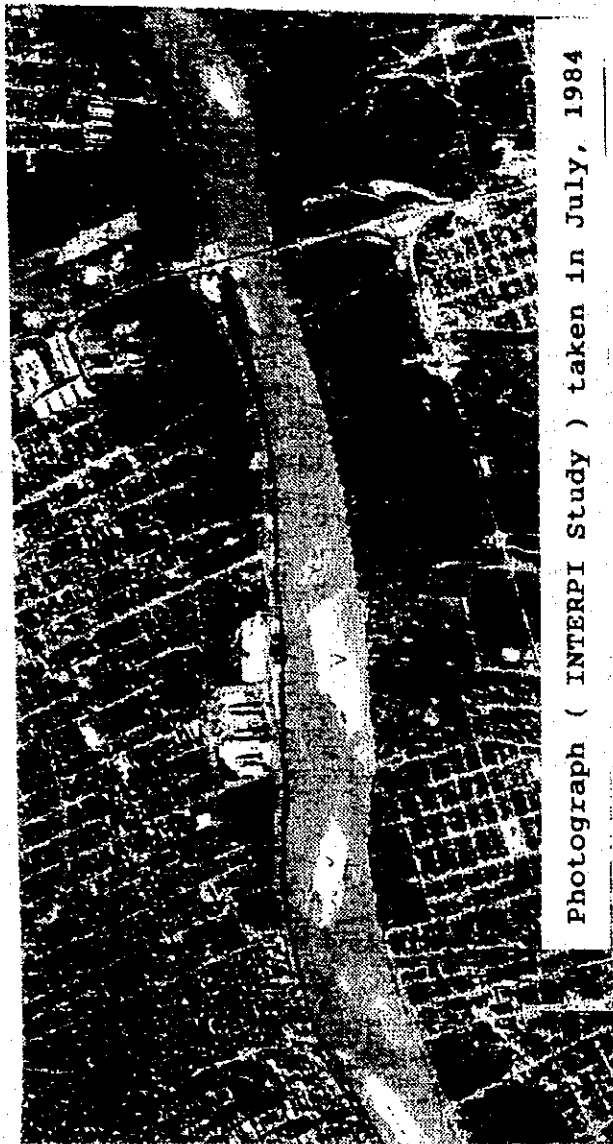
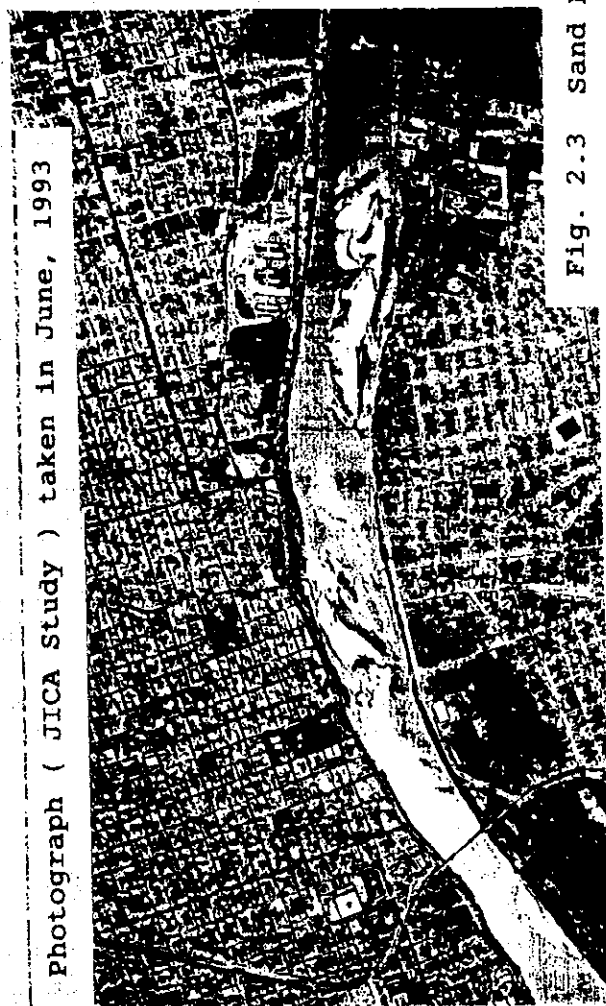
Fig. 2.3 Sand Bar Positions ( Teresina )

Fig. 2.3 show the mosaic photos taken by aerial photography in July 1984 and June 1993. Their comparison reveals that the positions are approximately the same. The shift to the downstream side by the flood ( $Q = 3,800$  m<sup>3</sup>/s) in which Teresina was inundated in 1985 is not shown very clearly. This bar is considered to be generally stable.

Photograph ( INTERPI Study ) taken in July, 1984

Photograph ( JICA Study ) taken in June, 1993

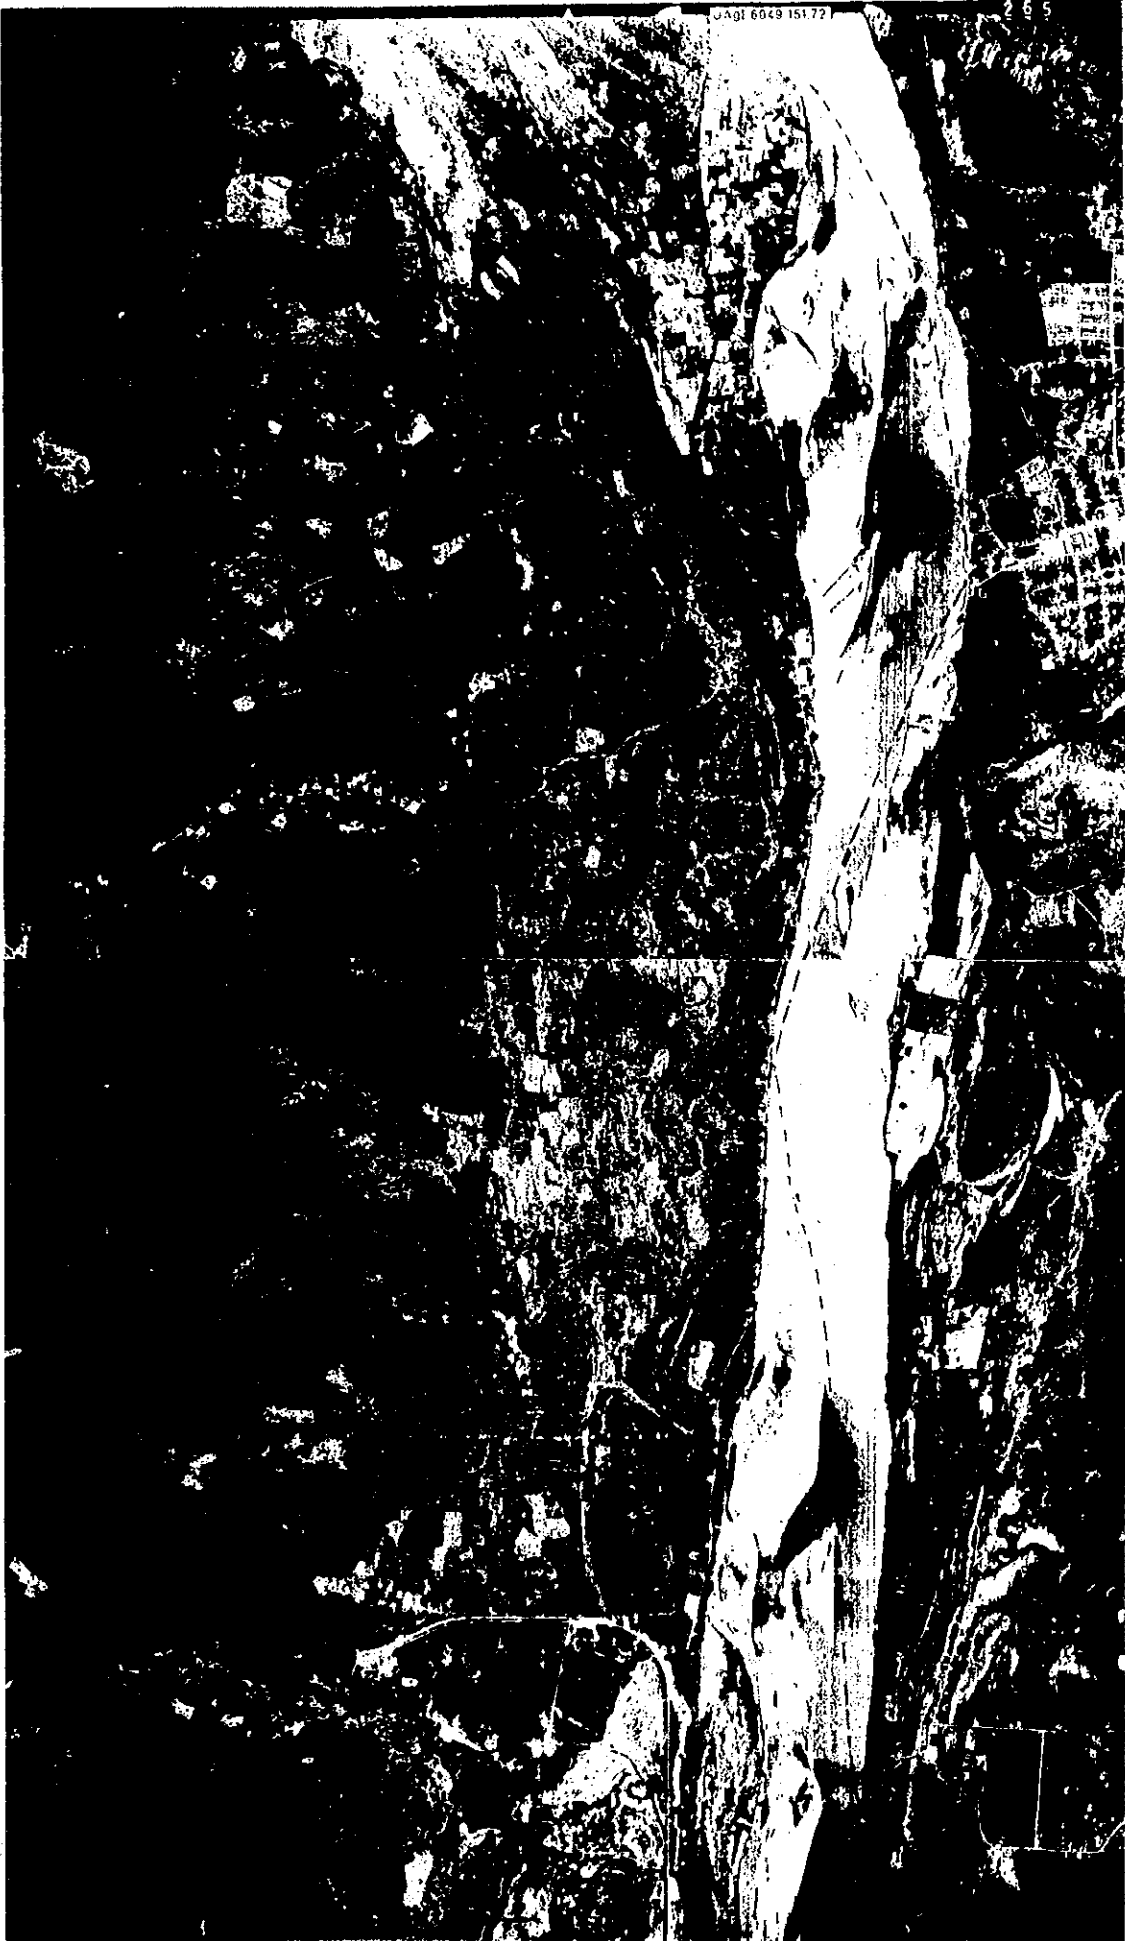
Fig. 2.4 Front Line for Alternating Bars ( Uniao )

When the front line of the alternating bar (Fig. 2.4) is defined, the wave length of the alternating bar is estimated at approximately 4,400 meters. Plants were observed to grow on the downward side of the middle portion of the sand bar on the bank side opposite to the wharf, and ground is considerably high. Sedimentation and erosion are repeated on the upstream side according to the water level. The bar is shifting toward the left bank and is considered to be stable. According to the mosaic photo from INTERPI taken in 1984, the positions of the bars on the right and left banks are almost the same. (Fig. 2.5)

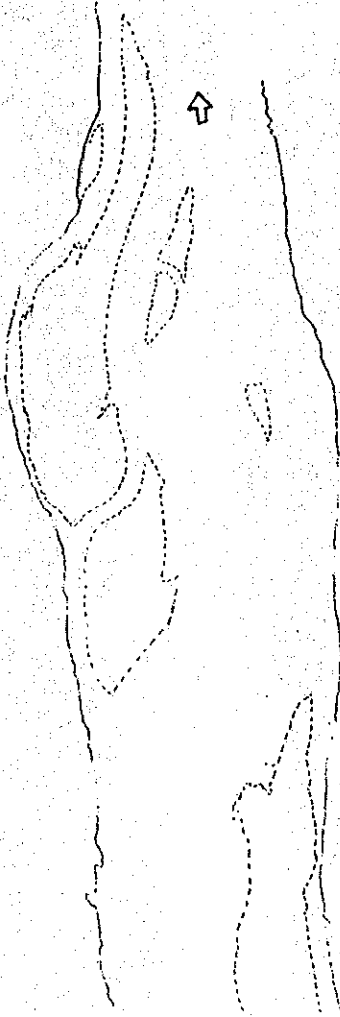
Fig. 2.5 Sand Bar Positions ( Uniao )

Photograph ( INTERPI Study ) taken in July, 1984

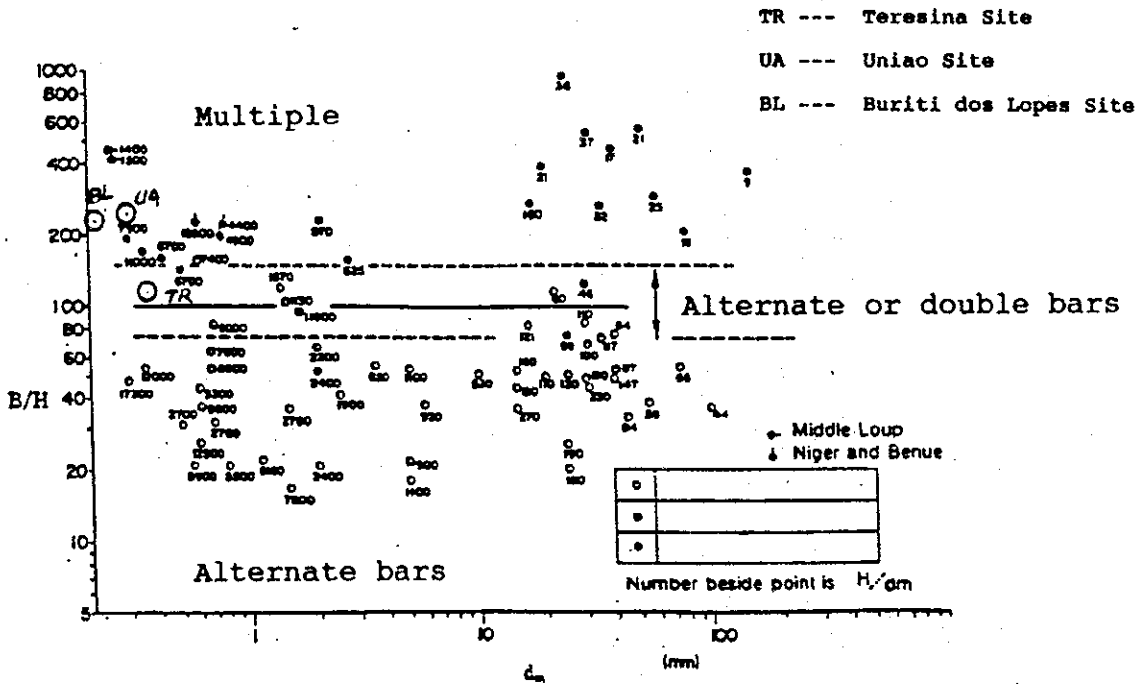
Fig. 2.6 Sand Bar Classification in Japan

Generally, a sand bars condition in Japan is classified into 3 categories , based on the waterway width to water depth ratio (B/Hm) at the average annual maximum discharge.

( Fig. 2.6 : Sand bar classification in Japan).

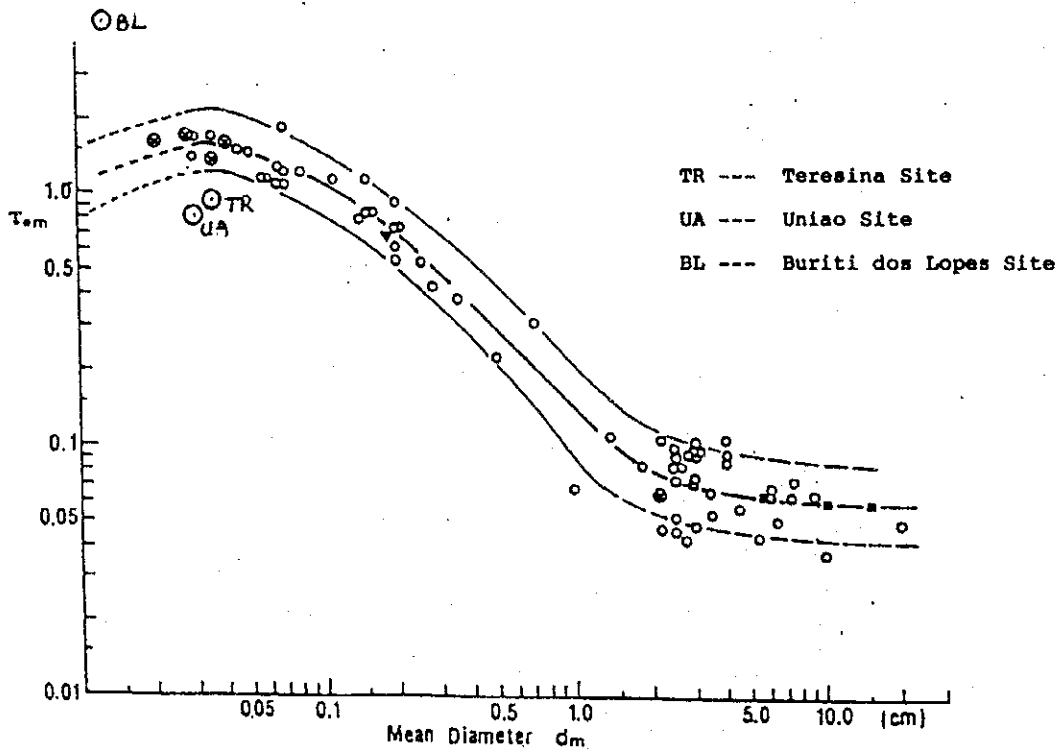
Fig. 2.7 Relationship  $T^*$  and  $d_m$  in Rivers, Japan

( Fig. 2.7 Relationship between T\* and Dm in rivers of Japan)

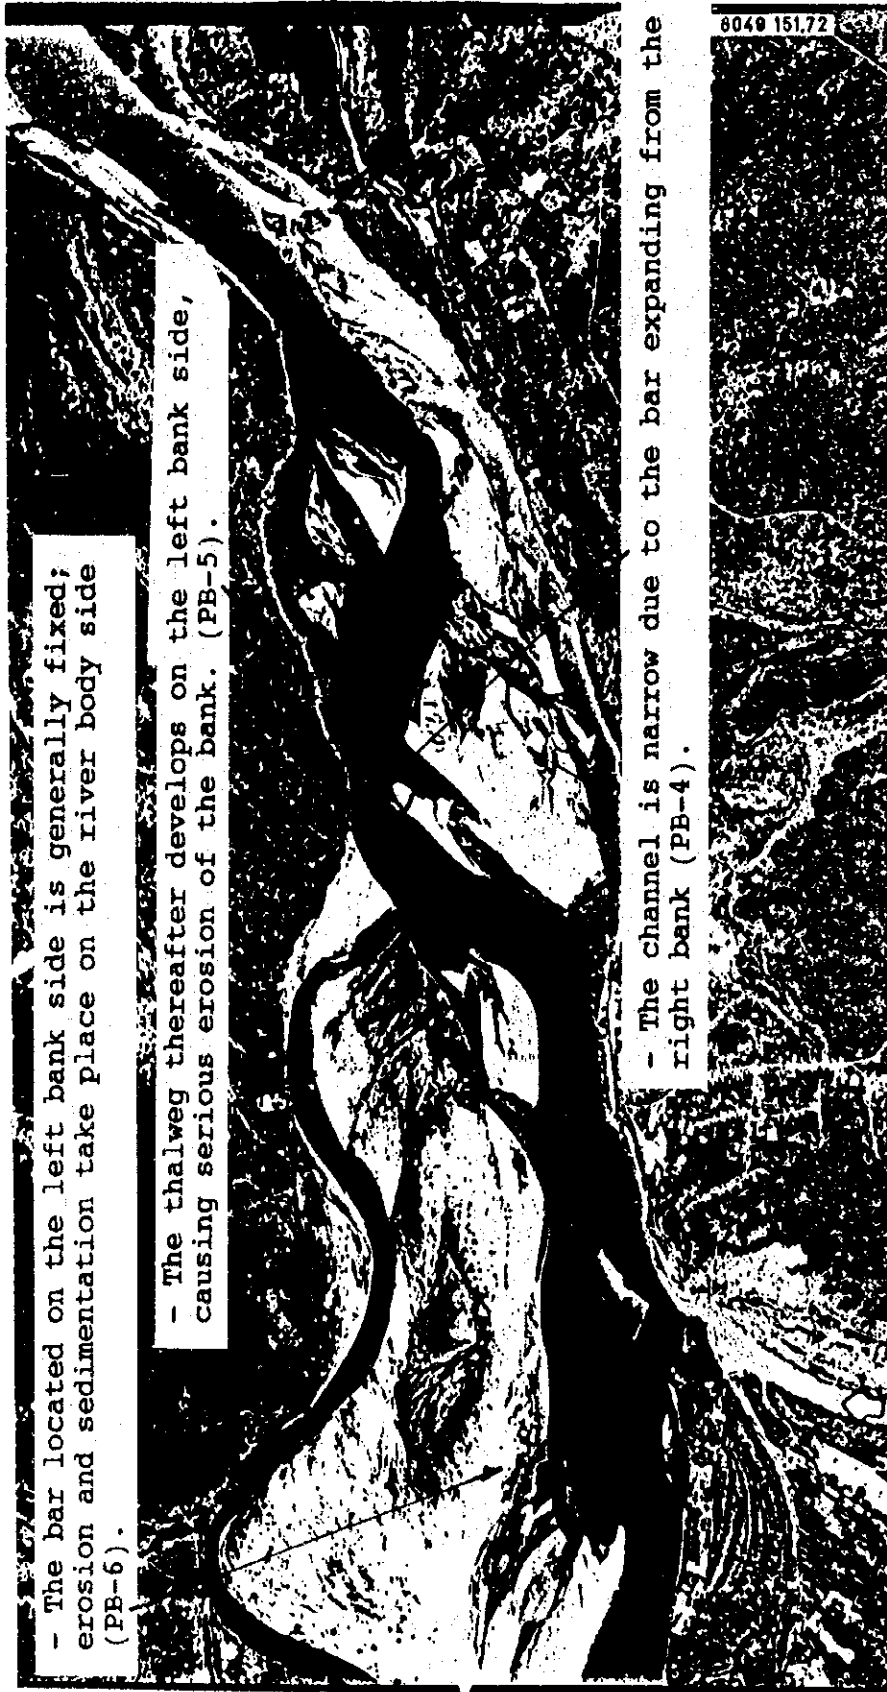
- The bar located on the left bank side is generally fixed; erosion and sedimentation take place on the river body side (PB-6).

- The thalweg thereafter develops on the left bank side, causing serious erosion of the bank. (PB-5).

View points of the Buriti dos Lopes site are illustrated in Fig. 3.3 and Fig. 3.4

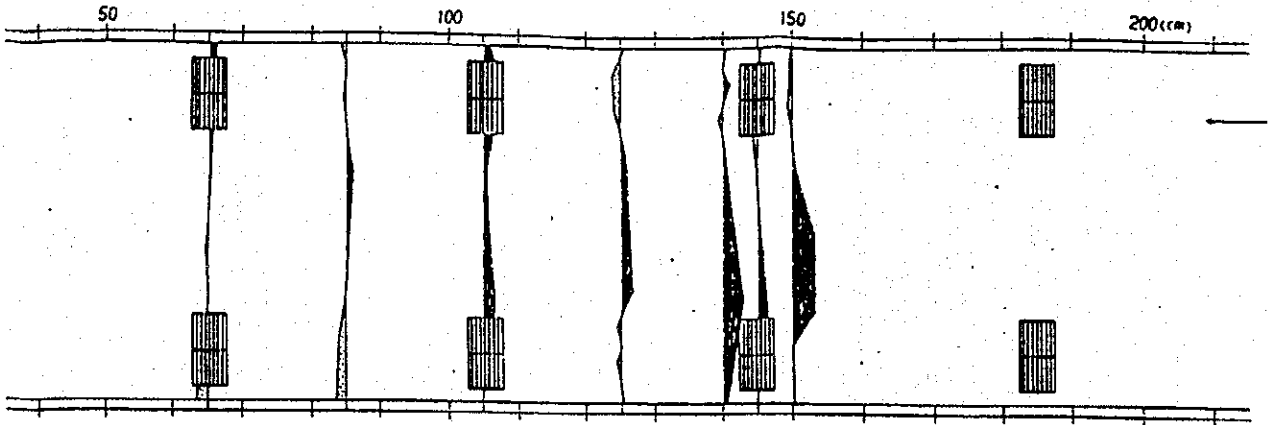
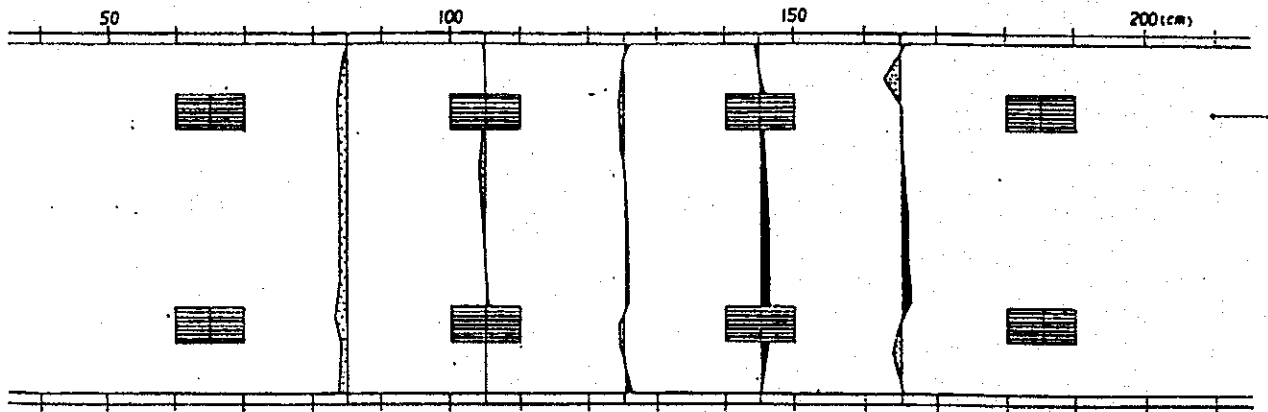
Fig. 3.6 Dike Structure Type

According to " The Manual for River Works in Japan " by the Ministry of Construction Japan , the direction of the spur dike structure is based on the dike construction objectives, the site river condition, etc. Fig. 3.6 shows the cross dike structure and longitudinal dike structure samples.

Cross Dike Structure Arrangement

Longitudinal Dike Structure Arrangement

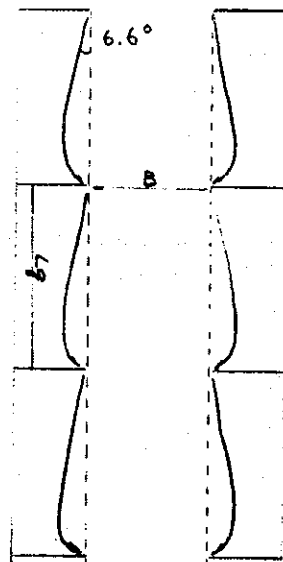
Waterway Width between the Dikes

- DHL experiment

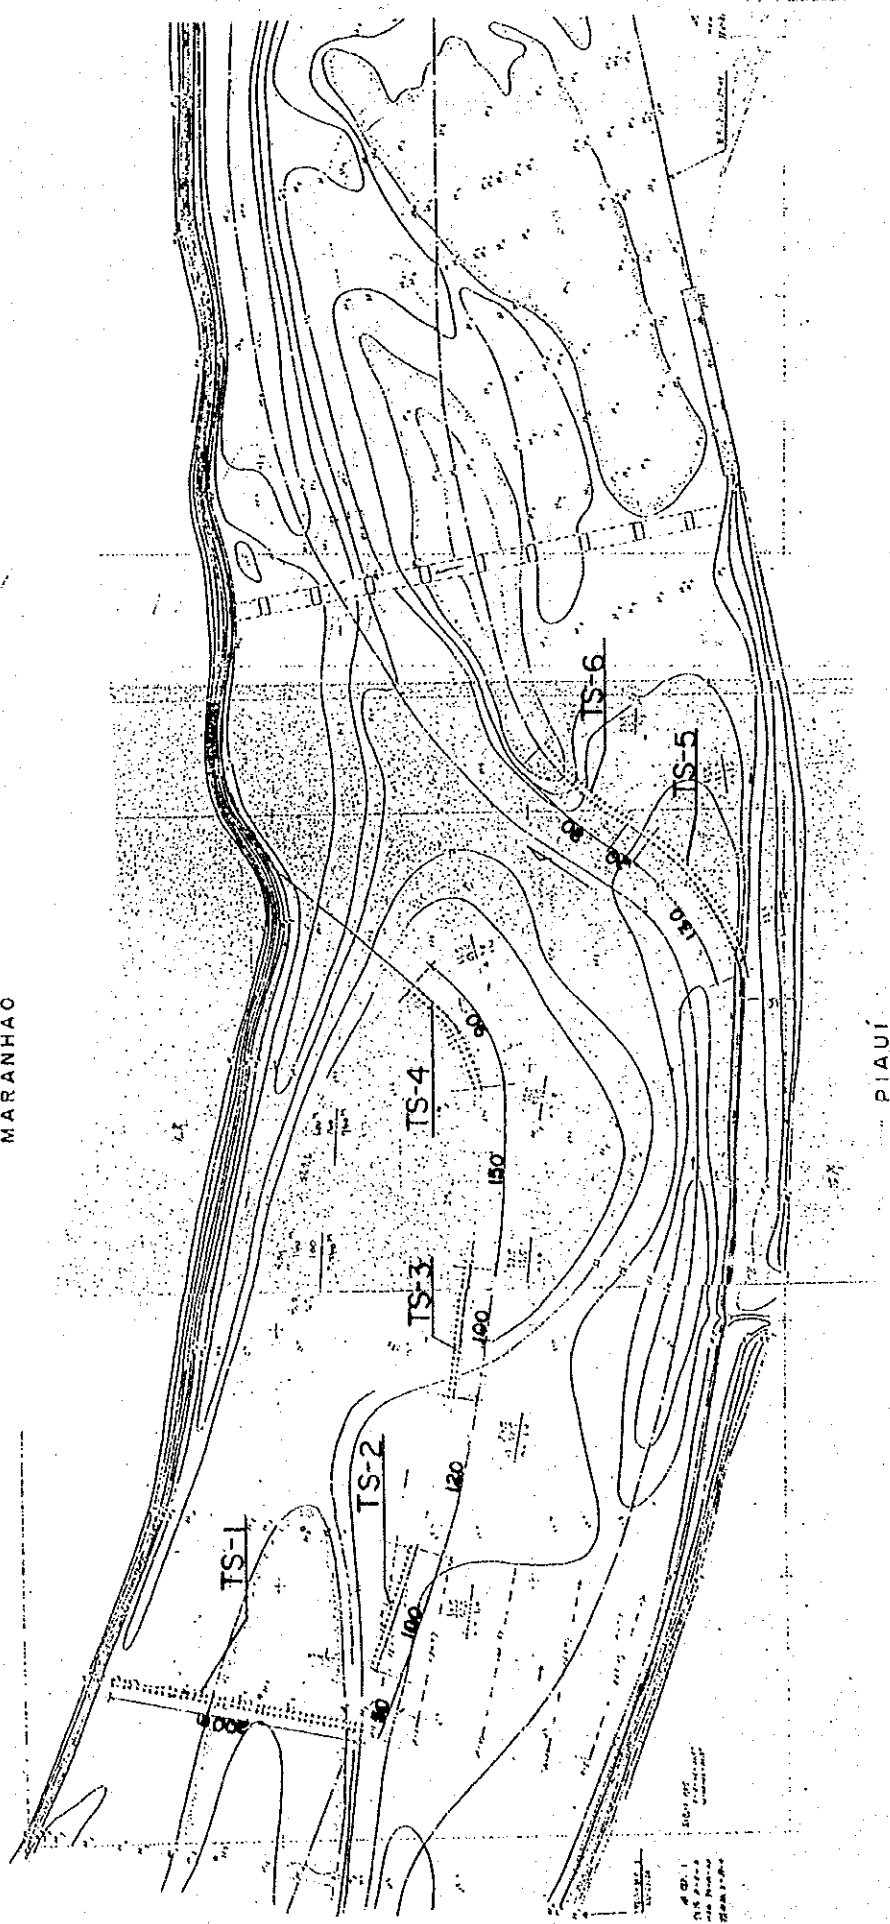
Fig. 3.7 General Plan for Teresina

Figs. 3.7 - 3.9 show the general plans at the 3 sites.
