THE ROAD IMPROVEMENT
AND
REHABILITATION STUDY
IN
NICARAGUA

FINAL REPORT
ANNEXES I
MASTER PLAN

CONTENTS OF ANNEXES

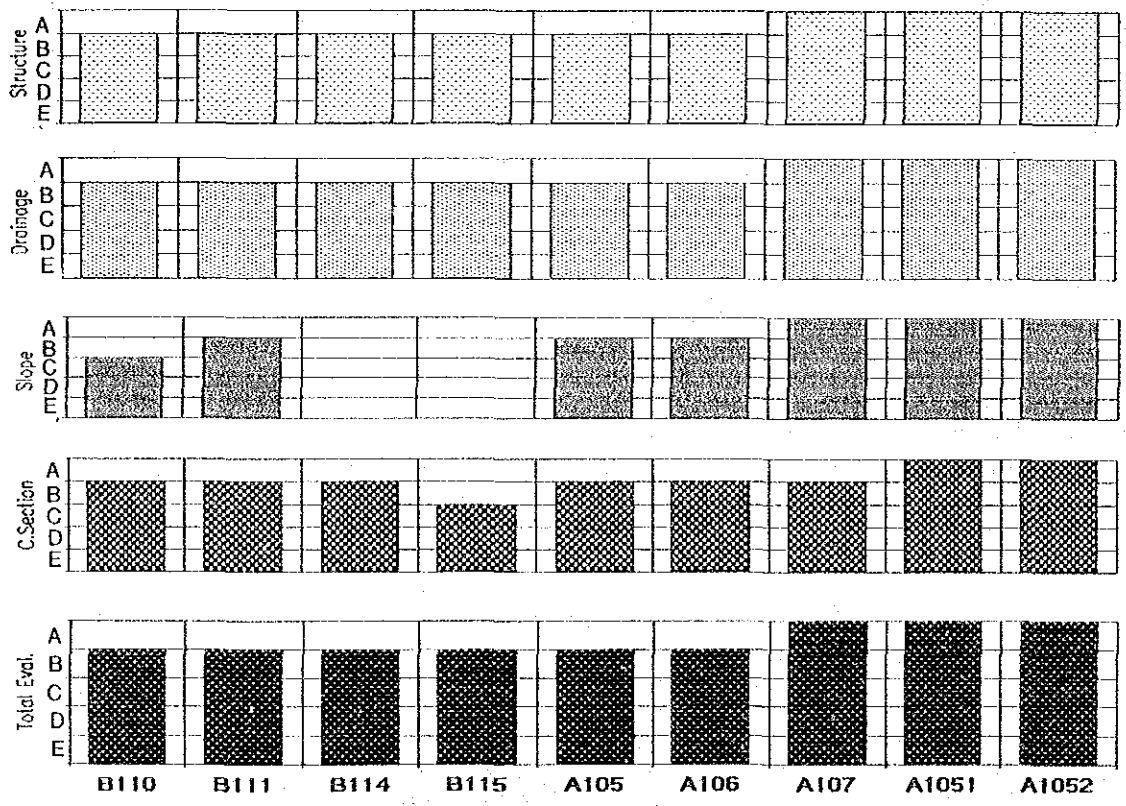
Annex 3-4(b) Existing Conditions Evaluation Charts

Surface Type	Asphalt Pavement	Gravel	Earth
Remarks:
