JAPAN INTERNATIONAL COOPERATION AGENCY (JICA)  
THE MINISTRY OF COMMUNICATIONS,  
THE REPUBLIC OF INDONESIA

**BASIC DESIGN STUDY REPORT**  
**ON**  
**THE PROJECT FOR IMPROVEMENT OF**  
**THE BAROMBONG RATING SCHOOL**  
**IN**  
**THE REPUBLIC OF INDONESIA**

December, 1994

**NIPPON TETRAPOD CO., LTD**

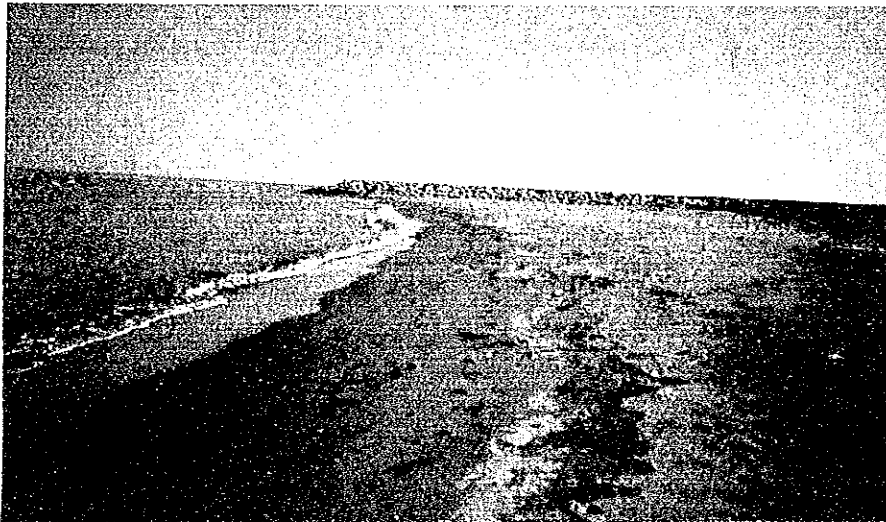
Photo 6: Estuary of the Jeneberan River and the Retaining Jetty

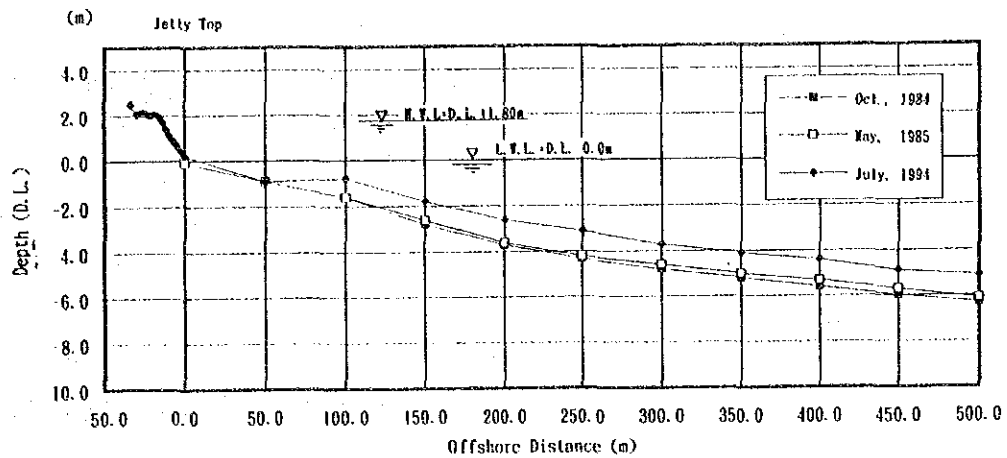
Fig. 2-3-18 Changes in the Sea Bottom in Front of the School

Fig. 2-3-18 shows the cross sections of the sea bottom extending from the jetty based on the result of the bathymetric surveys. As shown, the depth of the sea bottom decreased by about 1 m during the 10 year period from 1984 to 1994, suggesting a large amount of sand accumulation over an extensive area of the beach.
