1. Seminar on maintenance and inspection of thermal power plant (November, 1994)

Maintenance and Inspection of Thermal Power Plants

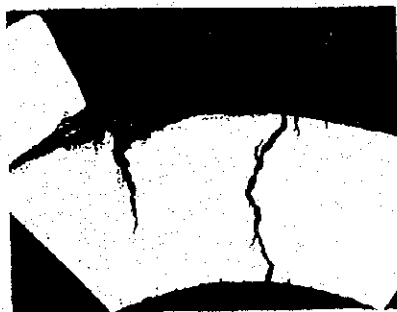
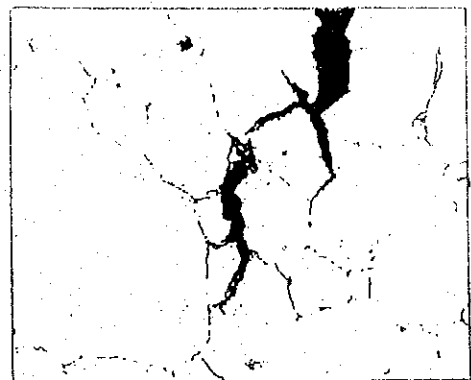
FIG. B-2

Example : Long Term Creep Rupture
Location of Failure : Weld Portion between Superheater Tube and Support Lug
Type of Boiler / Fuel : Once-Through Boiler / Heavy Oil
Cause : Long Term Creep Rupture
Time of Failure Occurrence : 21 Years After Commercial Operation

Appearance of failure portion

Microphotograph of 400 magnifications

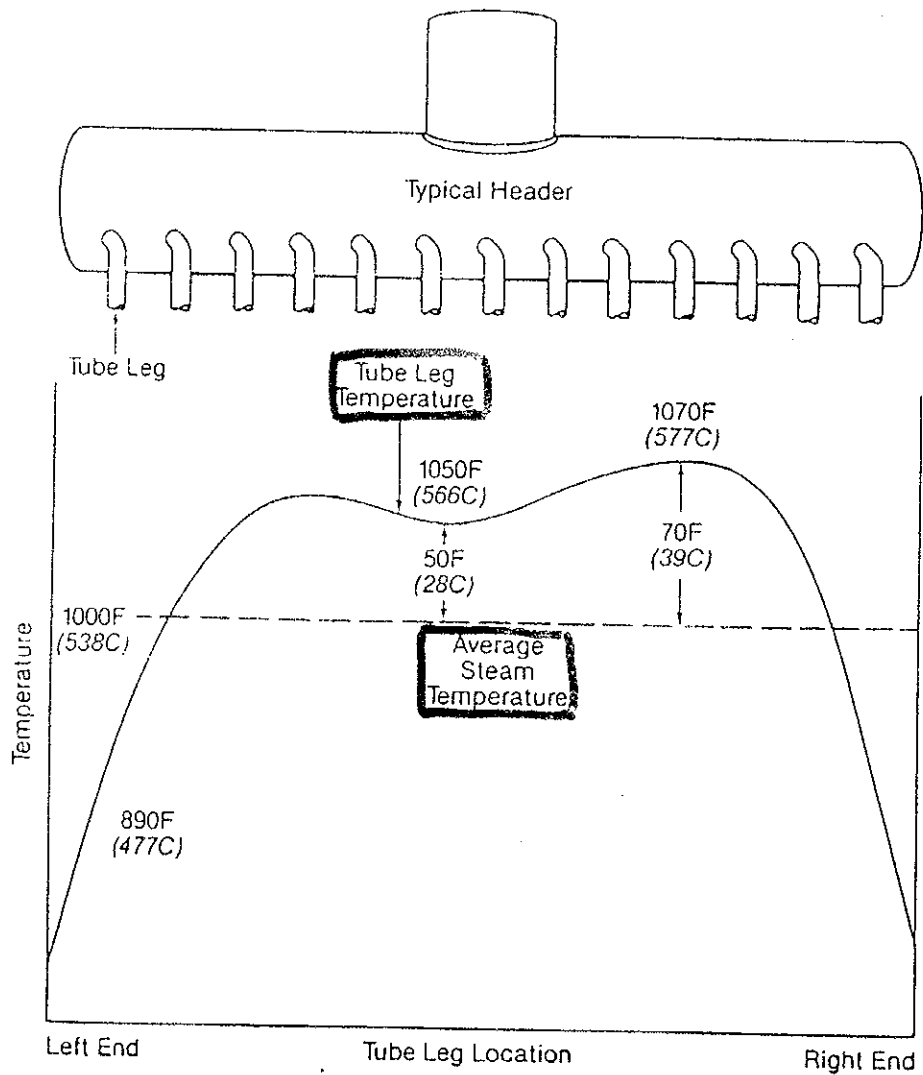
FIG. B-5

Header locations susceptible to cracking.

Steam temperature variation in a header.

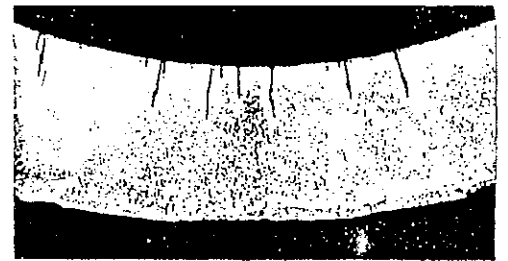
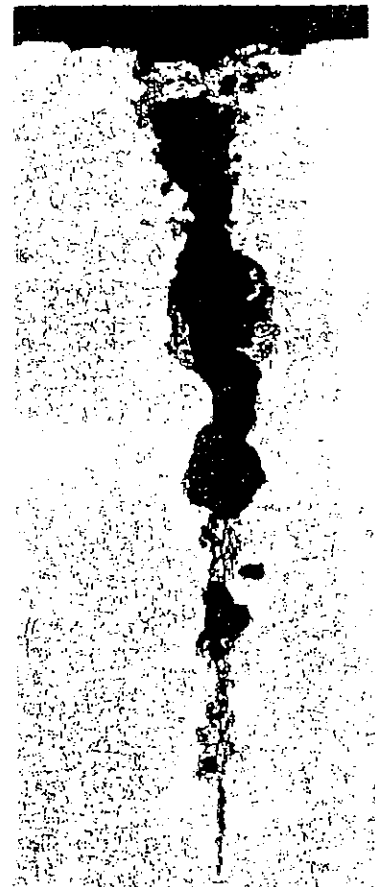
FIG. B-8

Example : Tube Stub Internal Crack
Location of Failure : Economizer Inlet Header
Type of Boiler / Fuel : Natural Circulation Boiler / Heavy Oil
Cause : Corrosion Fatigue
Time of Failure Occurrence : 13 Years After Commercial Operation

Failure Portion (

Appearance of internal crack

Macrograph of 5 magnification:

Micrograph of 100 magnification:

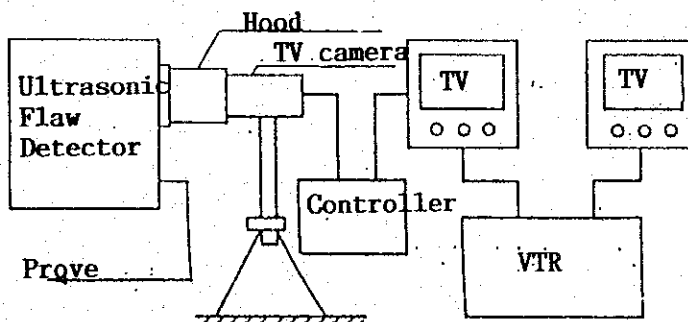
2) Ultrasonic Flaw Inspection

Inserting a special prove into the bore in rotor and observe the condition inside the bore by ultrasonic flaw testing device or television camera. Video record can also be made.
