## 10.2 REHABILITATION DESIGN CRITERIA

### 10.2.1 Basic Considerations in Establishment of Rehabilitation Criteria

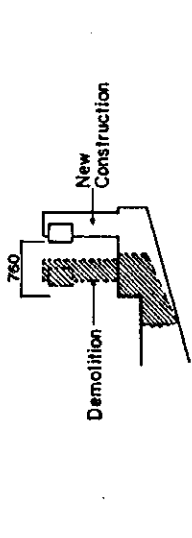
6. Widening of Sidewalk	6. Widening of Sidewalk

<p>The diagram shows a cross-section of a sidewalk. A hatched area is labeled 'Demolition' and a new, wider area is labeled 'New Construction'. A dimension line indicates a width of 750.</p>	Demolish existing sidewalk and railing, widen substructure if necessary, construct additional girders if necessary, and construct new sidewalk and railing.	o Bridge is located in residential area and has less than 60cm wide sidewalk.

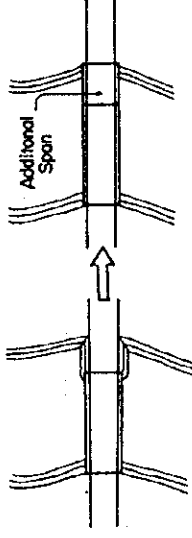
D. Extension	7. Construction of Additional Span

<p>The diagram shows a cross-section of a bridge with two spans. An arrow points to the right, indicating the direction of extension. A new span is shown being added to the right end of the existing bridge.</p>	Take necessary measures to convert the existing abutment into pier or reconstruct it, and construct substructure and superstructure of additional span(s).	o Approach road embankment encroaches on waterway causing flooding upstream and erosion of approach road embankment.

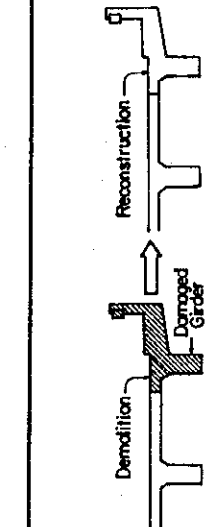
10. Reconstruction of Concrete Girder

Demolish damaged girder(s) and reconstruct them. Partial or total reconstruction of supported slab will be accompanied.	<ul style="list-style-type: none"> <li>o A certain concrete girder has shearing or bending cracks for lack of structural capacity.</li> </ul>

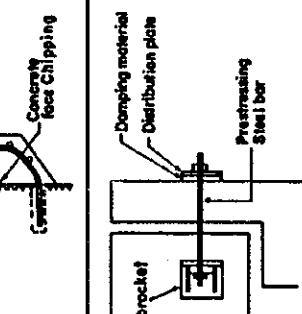
30. Provision of Mechanical Connection Device

<p>The diagram shows a cross-section of a steel girder connected to a concrete substructure. Labels include: 'Steel bracket' pointing to a component on the girder; 'Damping material' pointing to a layer between the girder and the substructure; 'Distribution plate' pointing to a plate on the substructure; and 'Prestressing Steel bar' pointing to a bar passing through the substructure.</p>	Install device for connecting girder with substructure or adjacent girder to prevent superstructure from falling.	o This is applied to all steel girder bridges of 35m or more in length.

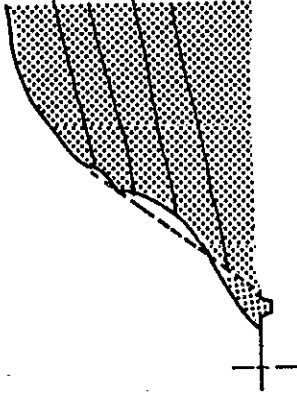
TYPE OF DISASTER	CAUSE OF DISASTER	ILLUSTRATION	APPLICABLE WORKS
CUT SLOPE FAILURE	Failure of highly weathered layer due to drying up or erosion by surface water.

<p>a) Re-cutting with stable gradient</p> <p>b) Protection works:                      - Concrete spraying                      - Concrete crib                      - Anchor work                      - Wattling                      - Concrete catch wall</p> <p>c) Catch Work:                      - Concrete catch wall</p>
	Failure of slope due to developed cracks.

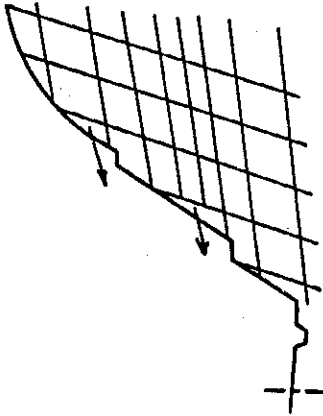
<p>a) Re-cutting with stable gradient</p> <p>b) Protection Works:                      - Concrete spraying                      - Concrete crib                      - Anchor work                      - Concrete catch wall</p> <p>c) Catch Work:                      - Concrete catch wall</p>

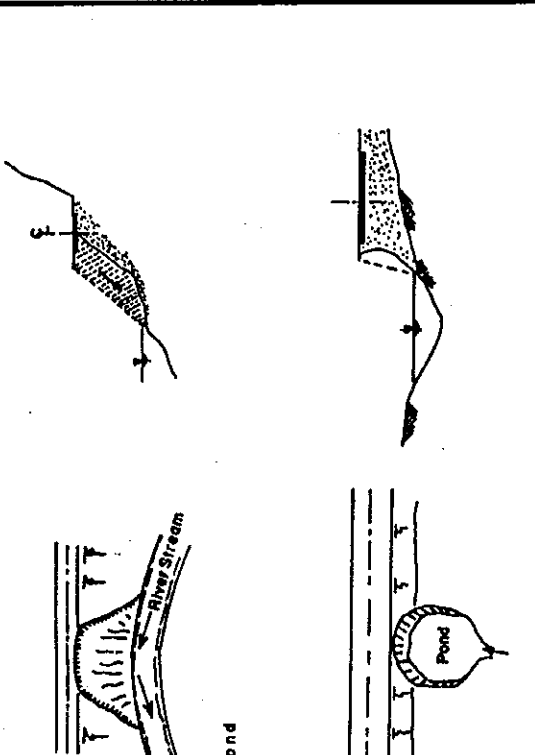
TYPE OF DISASTER	CAUSE OF DISASTER	ILLUSTRATION	APPLICABLE WORKS
<p>EMBANKMENT SLOPE FAILURE</p>	<p>Failure of slope caused by scour due to effect of river stream, or due to rising/lowering of pond water level.</p>

<p>The illustration consists of two parts. The top part shows a cross-section of a river stream with a steep bank on the left. Arrows indicate the flow of water, and a dashed line shows the original slope, while a solid line shows the eroded slope. The bottom part shows a cross-section of a pond with a curved embankment. Arrows indicate the water level rising and then falling, causing the embankment to fail.</p>	<p><b>Retaining Walls:</b></p> <ul style="list-style-type: none"> <li>- Gabion wall</li> <li>- Concrete wall</li> </ul> <p><b>Protection works:</b></p> <ul style="list-style-type: none"> <li>- Grouted riprap</li> <li>- Concrete crib</li> <li>- Concrete pitching</li> <li>- Cylinder gabion</li> </ul>

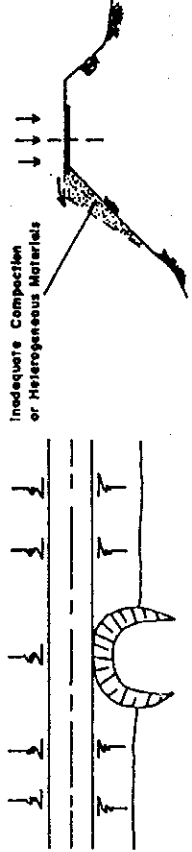
TYPE OF DISASTER	CAUSE OF DISASTER	ILLUSTRATION	APPLICABLE WORKS
EMBANKMENT SLOPE FAILURE	<p>Failure due to inadequate compaction of embankment or use of heterogeneous materials.</p>

<p>a) Earth Work: - Re-filling - Concrete wall</p> <p>b) Retaining Wall: - Grouted riprap - Concrete crib - Concrete pitching - Concrete pavement of shoulder</p> <p>c) Drainage Works: - Vertical ditch - Water channel</p>
	<p>Failure of embankment at valley due to inadequate capacity or lack of cross drainage.</p>

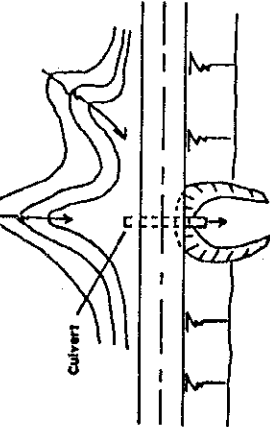
<p>a) Retaining Walls: - Concrete wall - Stone masonry wall</p> <p>b) Protection Works: - Grouted riprap - Concrete crib - Concrete pitching - Concrete pavement of shoulder</p> <p>c) Drainage Works: - Gabion foot protection - Vertical ditch - Water channel - RCPC/RCBC</p>
	<p>Failure of embankment in mountainous area due to effect of groundwater permeating the embankment.</p>

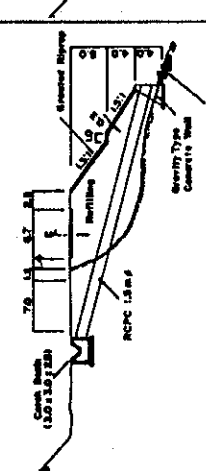
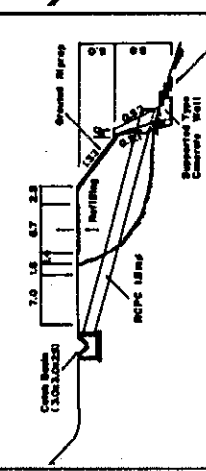
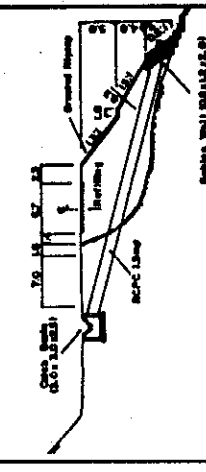
Major cause of disaster: Concentration of surface water, Pipe culvert not functioning due to clogging at inlet

Alternative - 1 Drainage Work + Gravity Type Concrete Wall + Grouded Riprap	Alternative - 2 Drainage Work + Supported Type Concrete Wall + Grouded Riprap	Alternative - 3 Drainage Work + Gabion Wall + Grouded Riprap
Cross-section

Description of Works	<p>After refilling, protect the slope with grouded riprap and provide gravity type concrete wall at the toe of slope to assure the stability of embankment. Replace RCPC with the one with sufficient capacity.</p>	<p>Same as Alternative-1 except provision of supported type concrete wall instead of gravity type concrete wall to reduce the earth work volume.</p>	<p>Same as Alternative-1 except provision of gabion wall instead of gravity type concrete wall to simplify the construction work.</p>	
Technical Aspect	Construction is easy.	Earth work volume is lower than that in Alternative-1. However, it takes longer time because of more structural work.	Construction period is the shortest.

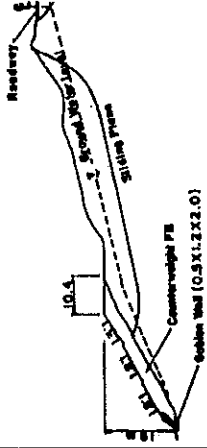
<p>Counterweight PB Gabion Wall (0.9 x 1.2 x 2.0)</p>

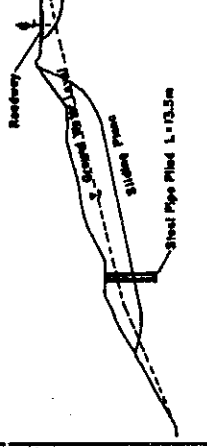
<p>Sliding Plane Steel Pipe Piled L = 13.5m</p>

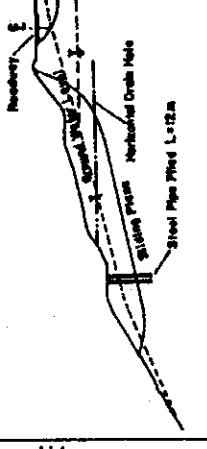
<p>Sliding Plane Horizontal Drain Hole Steel Pipe Piled L = 12m</p>
Description of Works		<p>Construct counterweight fill at foot portion of slope to resist sliding force. Place gabion wall at the toe of fill to prevent a rise of groundwater level taking advantage of permeability of gabion.</p>	<p>Bore holes using large-diameter boring machine and install steel pipe piles at the lower portion of sliding mass to resist the sliding force.</p>	<p>In addition to the piling similar to Alternative-2 but using smaller and shorter piles, install horizontal drain holes to drain ground-water and lower its level.</p>
Technical Aspect		<p>Construction site is distant from road (about 100m), needing temporary road for construction.</p>	<p>Same as Alternative-1, in addition large-diameter boring machine is not commonly used in the Philippines.</p>	<p>Same as Alternative-2. Furthermore, horizontal boring machine is seldom used in the Philippines.</p>

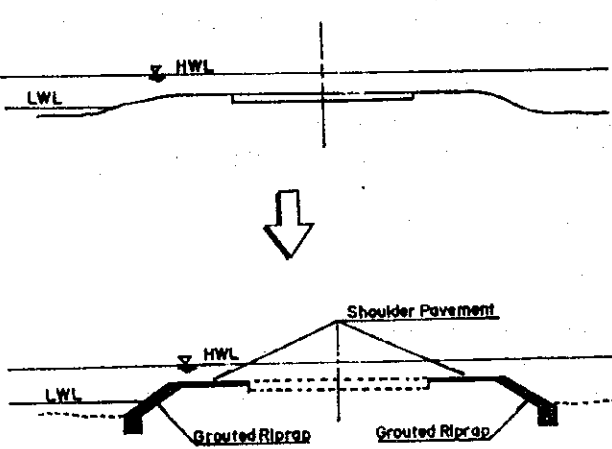
Sample Illustration	Description of Method	Application Criteria
<p><b>COUNTERMEASURE 1 Protection of Road</b></p>

<p>The diagram illustrates the implementation of countermeasure 1. The top part shows a road cross-section with a dashed line for the Low Water Level (LWL) and a solid line for the High Water Level (HWL). The road surface is flat. A downward arrow indicates the transition to the bottom part of the diagram, which shows the road with a raised shoulder pavement. The HWL is now below the shoulder pavement. Grouted riprap is installed on the slopes of the shoulder pavement. The LWL is shown as a dashed line below the road surface.</p>	<ul style="list-style-type: none"> <li>- Protect the road with grouted riprap and shoulder pavement.</li> <li>- Adequate capacity of side ditch and cross drainage facilities shall be installed.</li> </ul>	<ul style="list-style-type: none"> <li>- Flood elevation is not so high.</li> <li>- No mud/debris flow.</li> <li>- Suitable to urbanized area.</li> <li>- Suitable to area where flood interception canal doesn't work properly.</li> </ul>

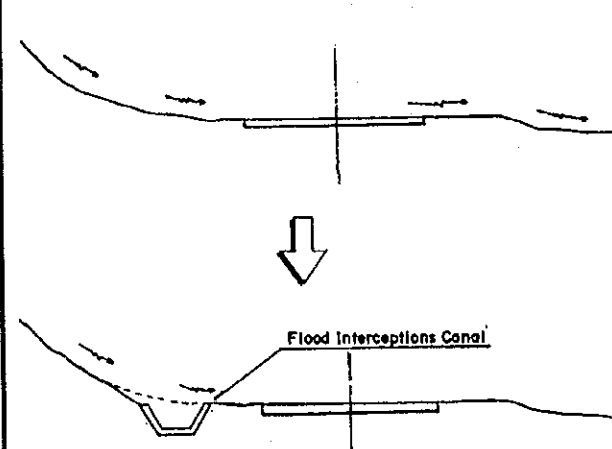
<p><b>COUNTERMEASURE 2 Flood Interception Canal</b></p>

<p>The diagram illustrates the implementation of countermeasure 2. The top part shows a road cross-section with a dashed line for the Low Water Level (LWL) and a solid line for the High Water Level (HWL). A downward arrow indicates the transition to the bottom part of the diagram, which shows a road with a flood interception canal. The canal is a trapezoidal structure that intercepts flood water. The HWL is shown as a solid line above the canal. The LWL is shown as a dashed line below the road surface.</p>	<ul style="list-style-type: none"> <li>- Install adequate capacity of flood interception canal.</li> <li>- Size of canal is dependent on flood discharge and distance to convey flood water.</li> <li>- Grouted riprap and shoulder pavement may be provided if there still be possibility of overflow.</li> <li>- Cross drainage facility such as RCPC, RCBC shall be installed at proper location.</li> </ul>	<ul style="list-style-type: none"> <li>- Flood depth is not so deep.</li> <li>- No mud/debris flow accompanied.</li> <li>- Suitable to urbanized area.</li> <li>- Periodic dredging of canal is required.</li> </ul>

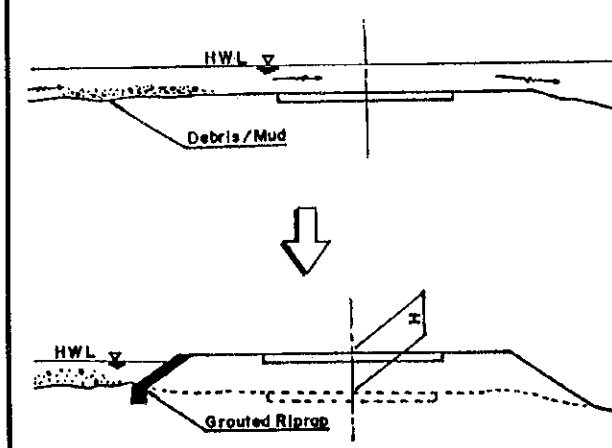
<p><b>COUNTERMEASURE 3 Raise of Road</b></p>

<p>The diagram illustrates the implementation of countermeasure 3. The top part shows a road cross-section with a dashed line for the Low Water Level (LWL) and a solid line for the High Water Level (HWL). The road surface is low, and there is a layer of debris/mud on the road. A downward arrow indicates the transition to the bottom part of the diagram, which shows a raised road. The road surface is higher, and the HWL is now below the road surface. Grouted riprap is installed on the slopes of the raised road. The LWL is shown as a dashed line below the road surface.</p>	<ul style="list-style-type: none"> <li>- Raise the road above expected high water level.</li> <li>- Height of embankment is dependent on elevation of flood water.</li> <li>- Embankment slope exposed to flood water may be protected by grouted riprap.</li> <li>- Cross drainage facility such as RCPC, RCBC shall be installed at proper location.</li> </ul>	<ul style="list-style-type: none"> <li>- Flood elevation is high.</li> <li>- Mud/debris flow accompanied.</li> <li>- Suitable to not urbanized area.</li> </ul>

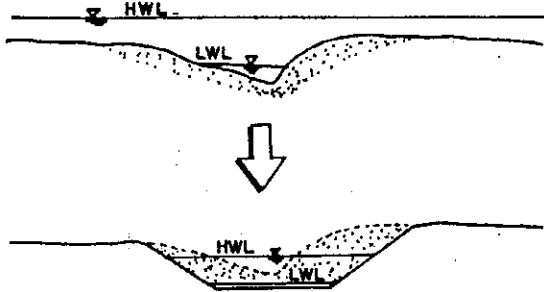
Sample Illustration	Description of Method	Application Criteria
<p>COUNTERMEASURE 4 Riverbed Dredging</p>

<ul style="list-style-type: none"> <li>- Remove sediments on the river by excavation.</li> <li>- Dimension of river is determined based on amount of discharge and nature of river channel.</li> </ul>	<ul style="list-style-type: none"> <li>- Applicable to rivers in alluvial fan which exhibits excessive sedimentation and aggradation of riverbed.</li> <li>- Periodic dredging is required to maintain stream steady.</li> </ul>
<p>COUNTERMEASURE 5 Sabo Dam</p>

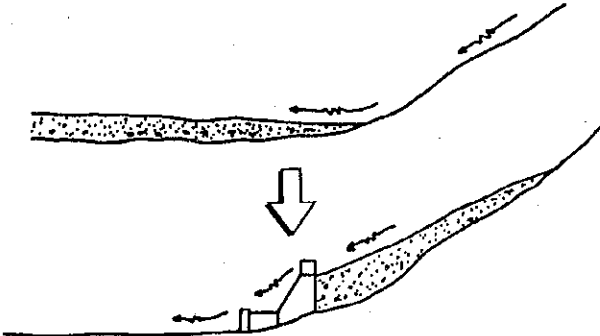
<ul style="list-style-type: none"> <li>- Construct sabo dam at top of an alluvial fan.</li> <li>- Exact location and size of dam shall be determined by experienced engineer after thorough investigation.</li> </ul>	<ul style="list-style-type: none"> <li>- Applicable to middle or minor rivers in alluvial fan.</li> <li>- Additional sabo dam may be required at upstream when downstream dam is filled with sediments.</li> </ul>

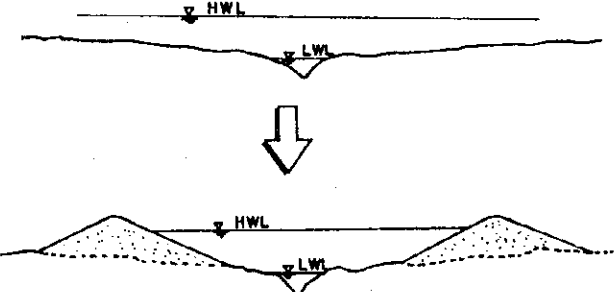
<p>COUNTERMEASURE 6 Dike</p>

<ul style="list-style-type: none"> <li>- Construct earth dike high enough to prevent flood water spilling-out.</li> <li>- Embankment slope may be protected by grouted riprap if velocity of flood is high.</li> </ul>	<ul style="list-style-type: none"> <li>- Applicable to rivers in flat plain.</li> <li>- Rivers whose surrounding area has economically high value.</li> </ul>
<p>COUNTERMEASURE 7 Cut-off Channel</p>

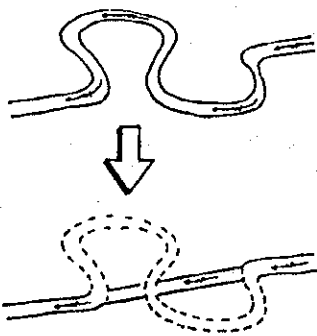
<ul style="list-style-type: none"> <li>- Straighten river channel at meandering section by introducing man-made canal.</li> </ul>	<ul style="list-style-type: none"> <li>- Applicable to rivers in flat plain whose water course meanders significantly.</li> </ul>

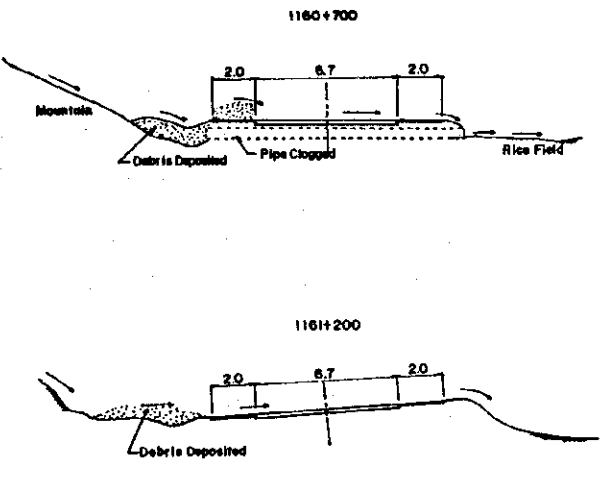
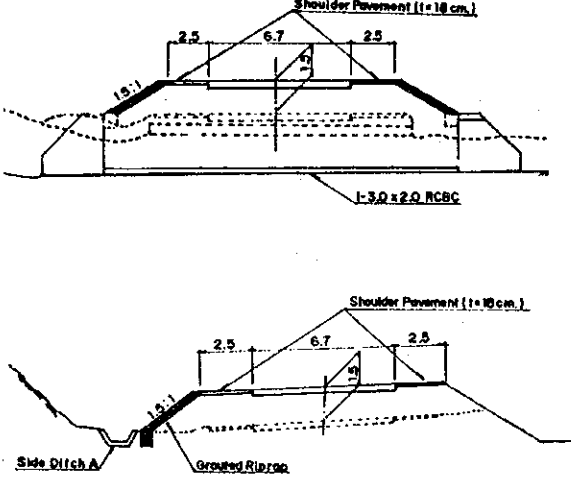
<p><b>COUNTERMEASURE 3 (Raising the Road)</b></p>

<p>Depth : 60cm      Duration : 6 hrs.                      Frequency : 3/year      Traffic : Impassable to all vehicles                      Mud and debris deposit on the road.                      Existing side canal is buried by debris.                      Shoulder is scoured at 1161 + 250</p>	<p>Raise the road by 1.5m      L = 1,200m (1160+600~1161+800)                      RCBC 1.30 x 2.0      at 1160.7                      RCPC 1.22 dia.      9 Locations                      Side ditch Type A      L = 1,200m                      Excavation of Creek      L = 60m</p>

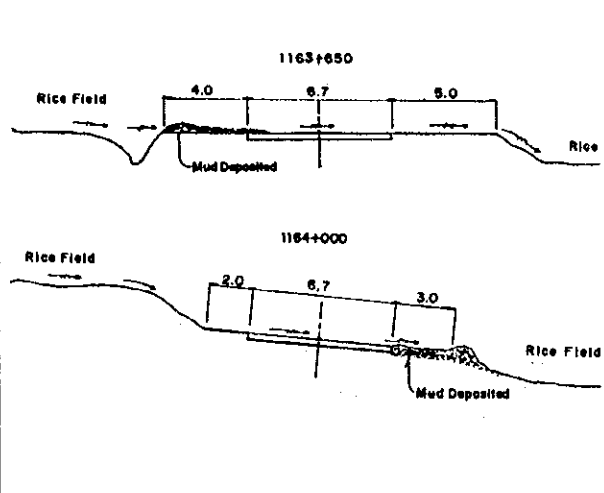
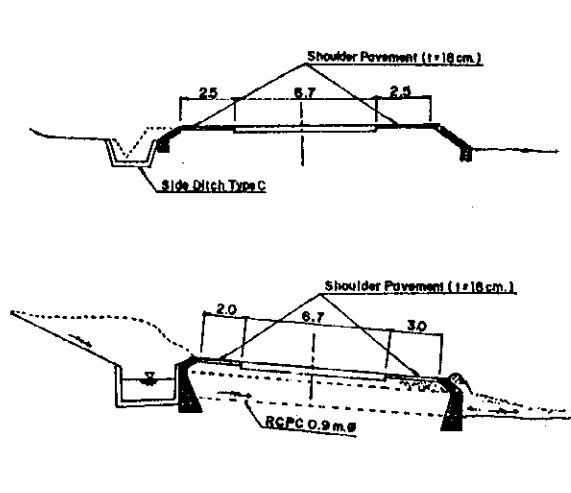
<p><b>COUNTERMEASURE 2 (Flood Interception Canal)</b></p>

<p>Depth : 30cm      Duration : 4 hrs.                      Frequency : 3/year      Traffic : Passable to bus &amp; truck                      Mud deposits on the road surface.                      Only one cross drainage pipe at 1163+900.                      Existing earth canal is heavily silted.</p>	<p>Install side ditch Type C      L = 590m (1163+510~1164+100)                      Shoulder pavement      L = 500m                      Riprap protection (both side)      L = 500m                      RCPC 1.22 dia.      4 Locations                      RCPC 1.91 dia.      1 Location</p>

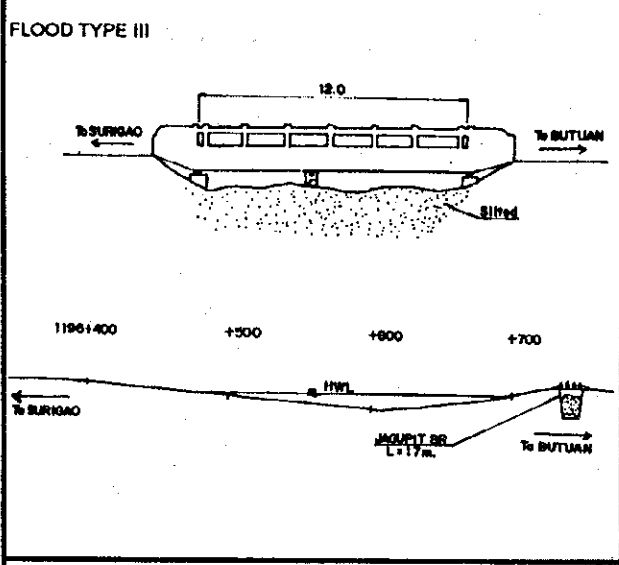
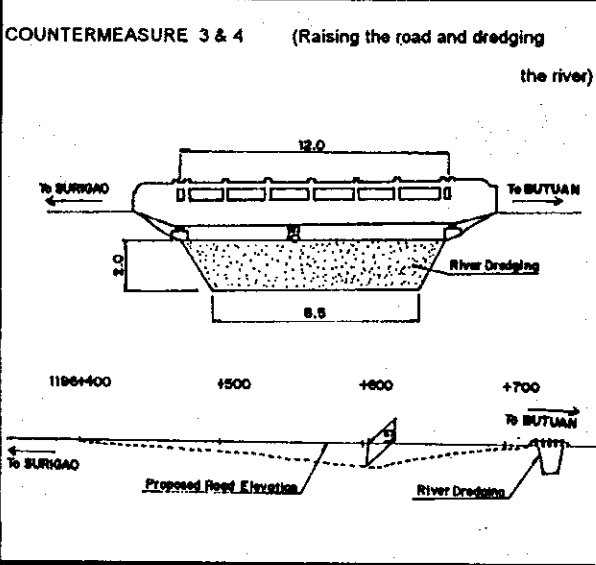
<p><b>COUNTERMEASURE 3 &amp; 4</b> (Raising the road and dredging the river)</p>

<p>Depth : 30cm      Duration : 4 hrs.                      Frequency : 3/year      Traffic : Close to passenger car                      Jagupit river is heavily silted.                      No clearance below Jagupit bridge.                      Water of the river spills out to the adjacent area.</p>	<p>Raise the Road by 1.5m max.      L = 320m (1196 + 400 ~ 720)                      Dredge Jagupit River      L = 2,260m                      Construct Sabo dam      1 Location</p>

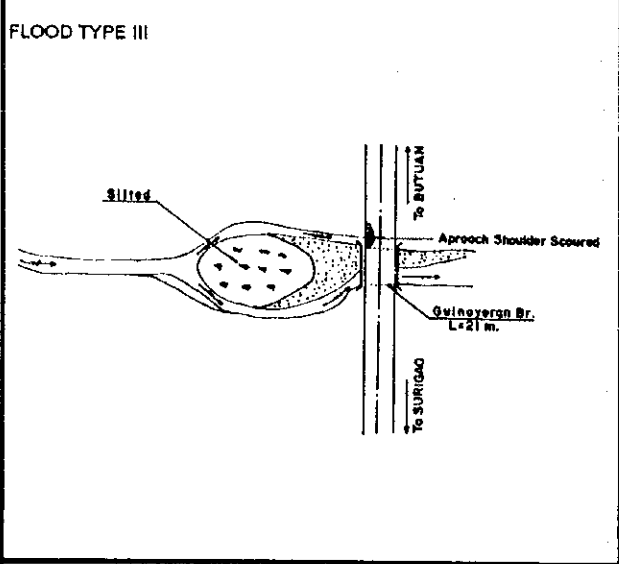
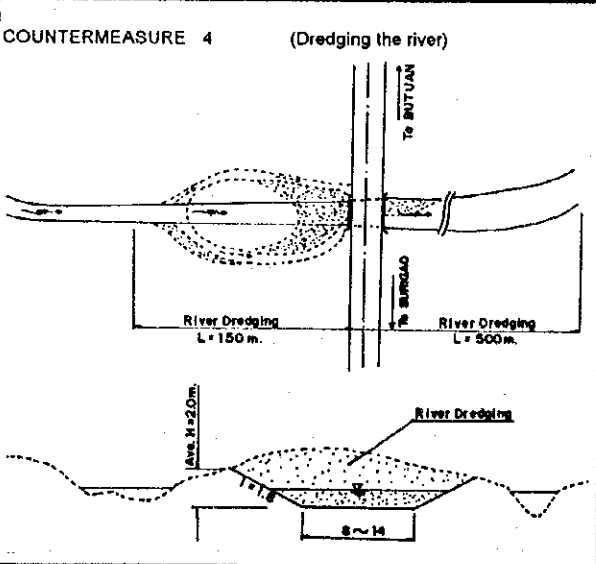
<p><b>COUNTERMEASURE 4</b> (Dredging the river)</p>

<p>Embankment of the bridge approach scoured.      L = 15m                      Pavement is destroyed (one lane)      L = 10m                      River is silted and its waterway is distorted left and right.</p>	<p>Dredge Guinoyoran River      L = 150m upstream                      L = 500m downstream</p>

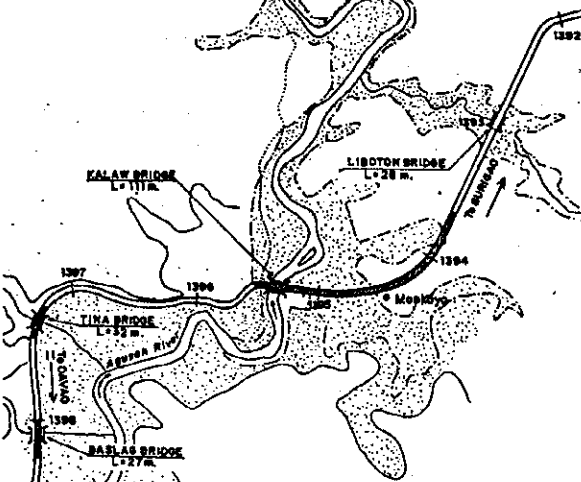
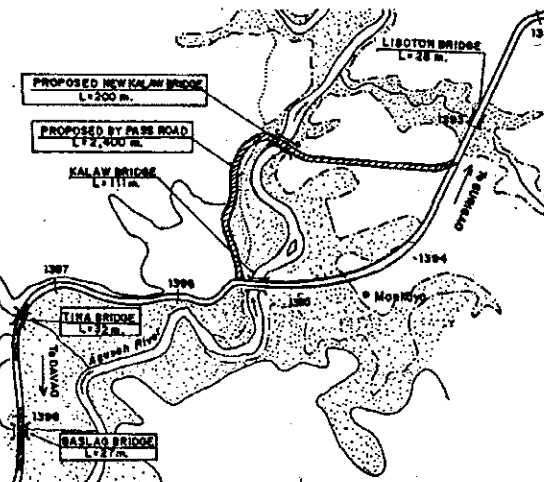
<p><b>COUNTERMEASURE 3 (Raising the road elevation)</b></p>

<p>Depth : 2.0m      Duration : 3 days                      Frequency : 1/5 years      Traffic : Impassable to all vehicles                      Overflow from Agusan river.                      Monkayo town proper totally submerged under flood water.</p>	<p>Construction of bypass road L = 2,200m                      Construction of new Kalaw Bridge L = 200m                      Raising the road L = 850m                      Raising Tina Bridge L = 32m                      Raising Baslag Bridge L = 27m</p>

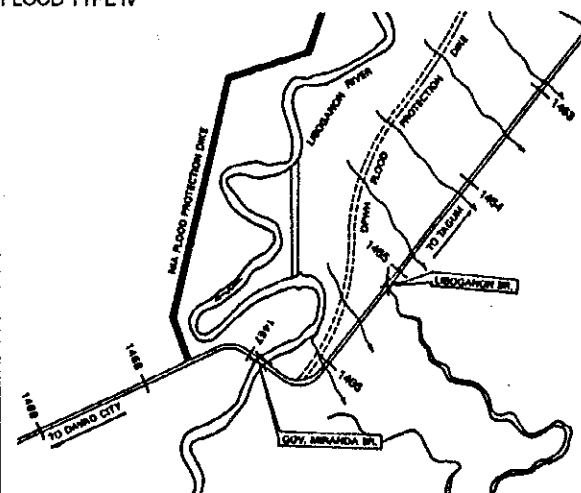
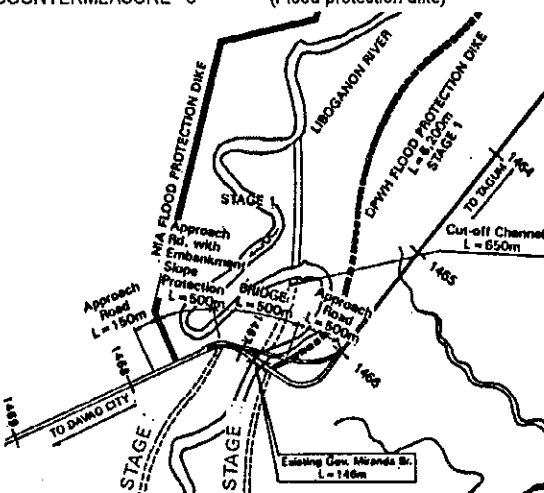
<p><b>COUNTERMEASURE 6 (Flood protection dike)</b></p>

<p>Depth : 60cm      Duration : 24 hrs.                      Frequency : 1/year      Traffic : Impassable to all vehicles                      Overflow from Liboganon river.                      Shoulder severely scoured for 1,600m.</p>	<p><b>Stage I</b>                      Flood protection dike (DPWH) L = 6,200m                      Bridge L = 500m                      Cut-off Channel L = 650m                      Approach Road Including Embankment slope protection L = 1,050m  <b>Stage II</b>                      Flood protection dike (Downstream) L = 14,500m</p>
