MINISTRY OF ENERGY
JAPAN INTERNATIONAL COOPERATION AGENCY

FEASIBILITY STUDY ON
REHABILITATION OF DA NHIM
POWER SYSTEM

CHAPTER 7 HYDROLOGICAL DATA ACQUISITION SYSTEM

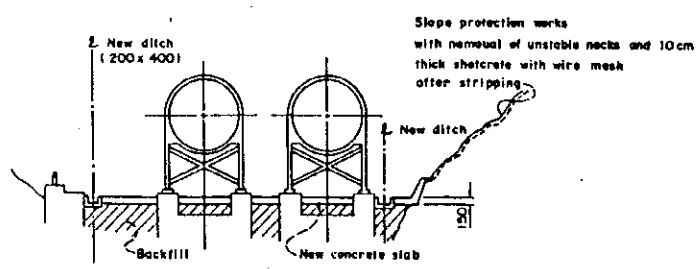
TYPICAL SECTION OF NEW SLAB CONCRETE UNDER PENSTOCK LINE
