FIGURES SECTOR I HYDROLOGY

FIG. I. 5.2.2 HYETOGRAPH OF MONTHLY BASIN AVERAGE RAINFALL

# 1. PRESENT RIVER CONDITION

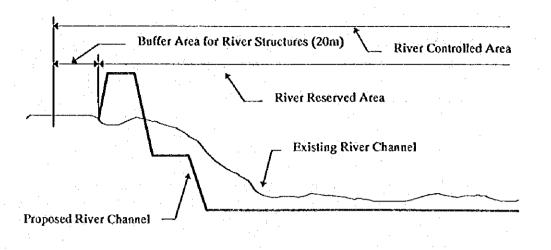
A river structure such as dike shall be protected from undesirable activities which may affect it. In Japan, a buffer/belt area with a width of 20 m along a dike is designated as a river controlled area as shown below:
