J.2.2 Environmental Data for 11 Potential Landfill Sites

In the following, general information and technical/environmental data compiled for each of the potential landfill sites is presented in a systematic way.

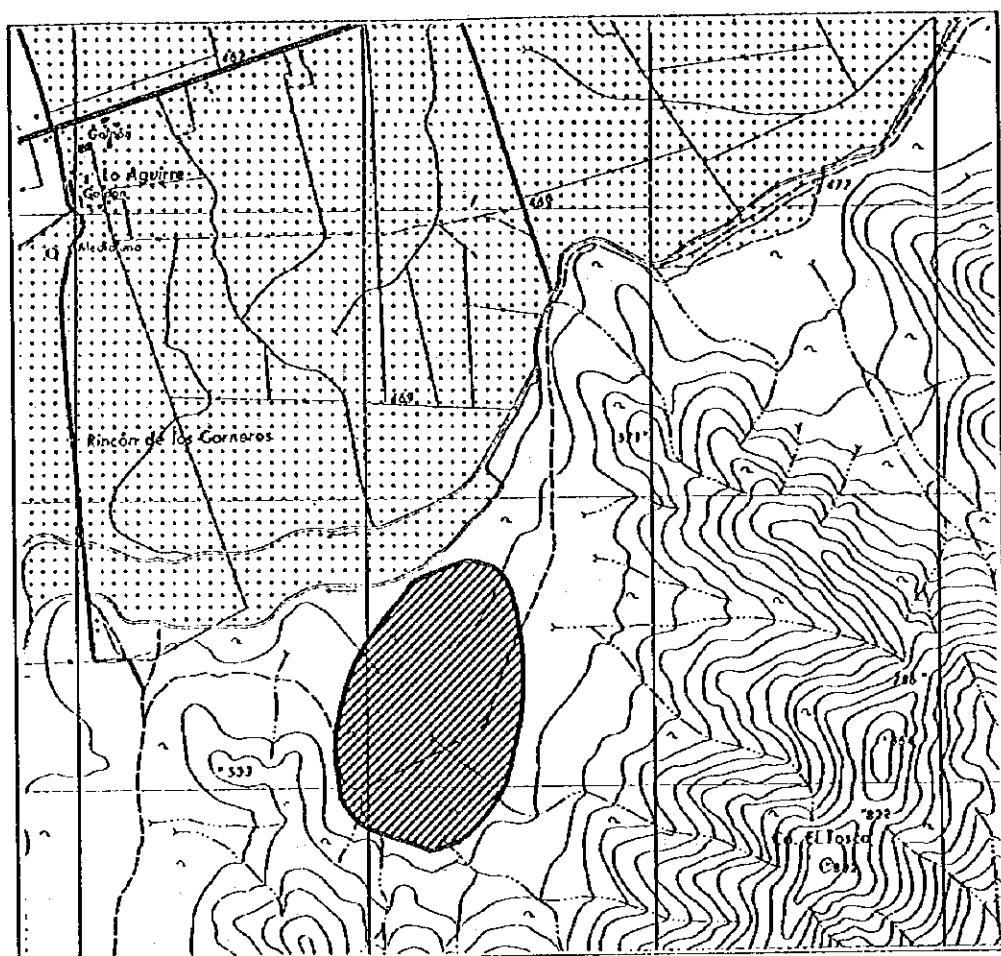
Figure J.2.2b Outline and surrounding of potential landfill site 2, Cerro Carneros

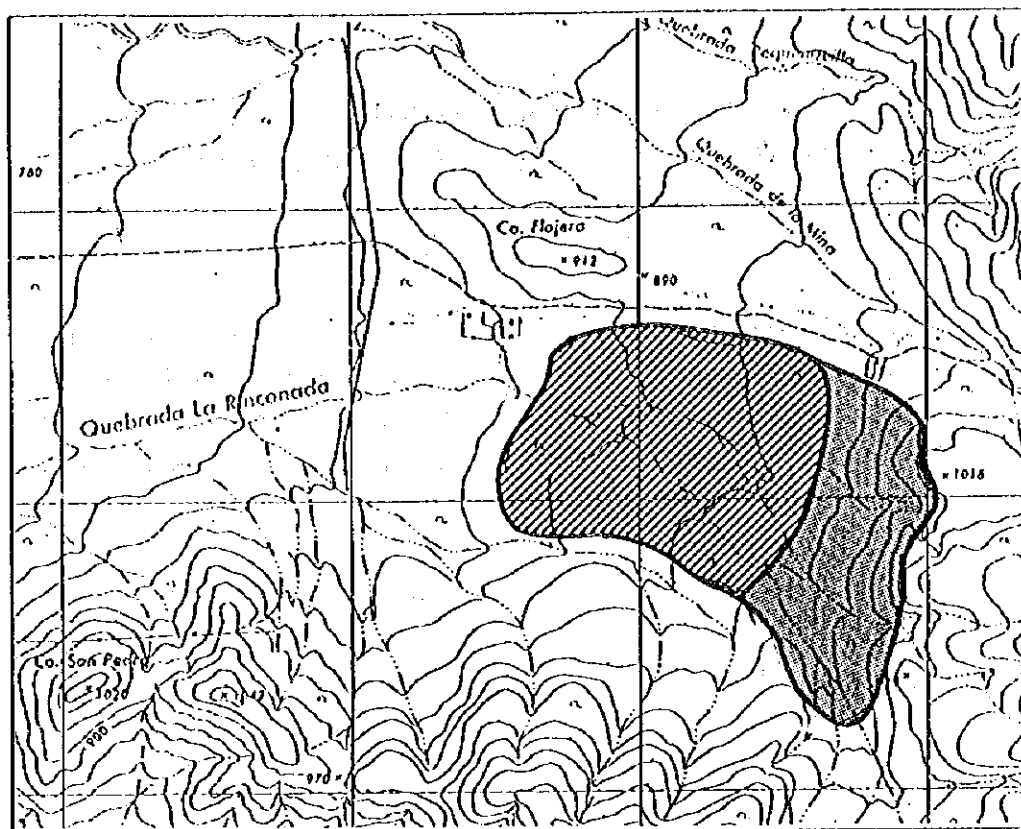
Figure J.2.2c Outline and surrounding of potential landfill site 3, Quilapilún (Tres Orejas)

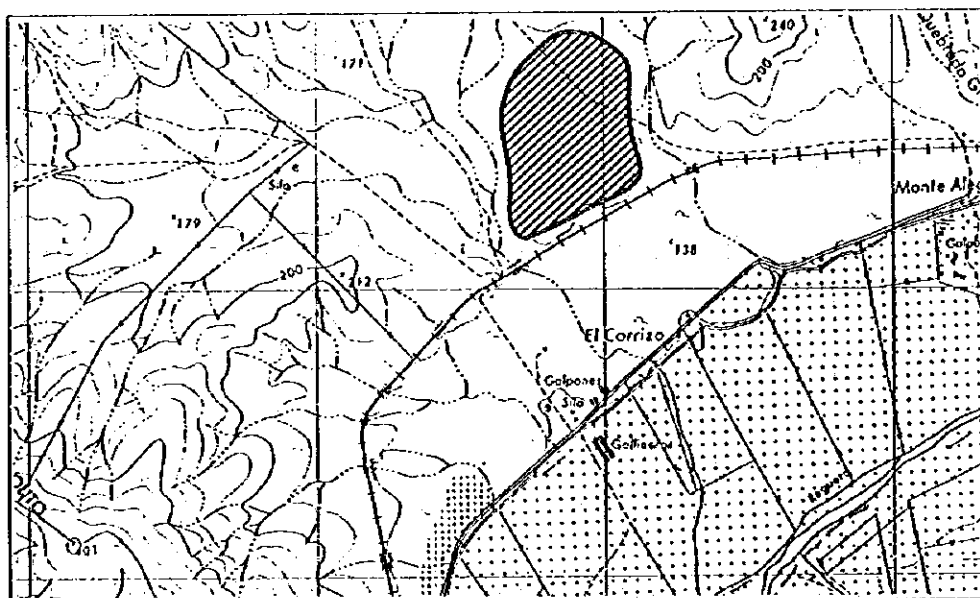
A section of the general map of the area in scale 1:25,000 (figure J.2.2d below) shows the outline and the immediate surroundings of the possible landfill site.

Figure J.2.2d Outline and surrounding of potential landfill site 4, Estación Puangue

continuing the natural slopes into a artificial hill. The area of this landfill would be about 500 x 500 metres or about 250,000 m². With an average height of about 25 metres this would result in a volume of about 6 million m³.

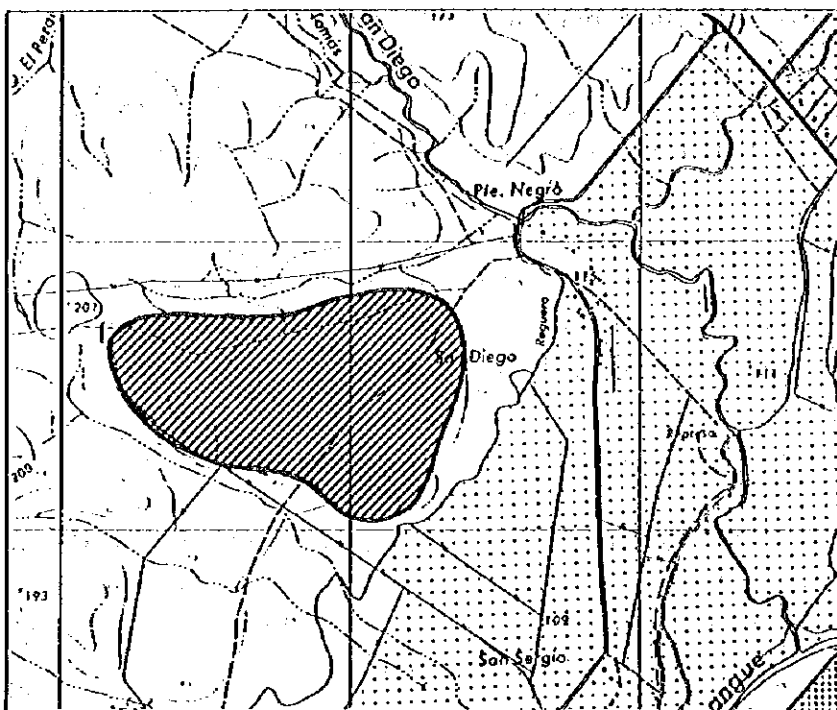
Figure J.2.2e Outline and surrounding of potential landfill site 5, San Diego

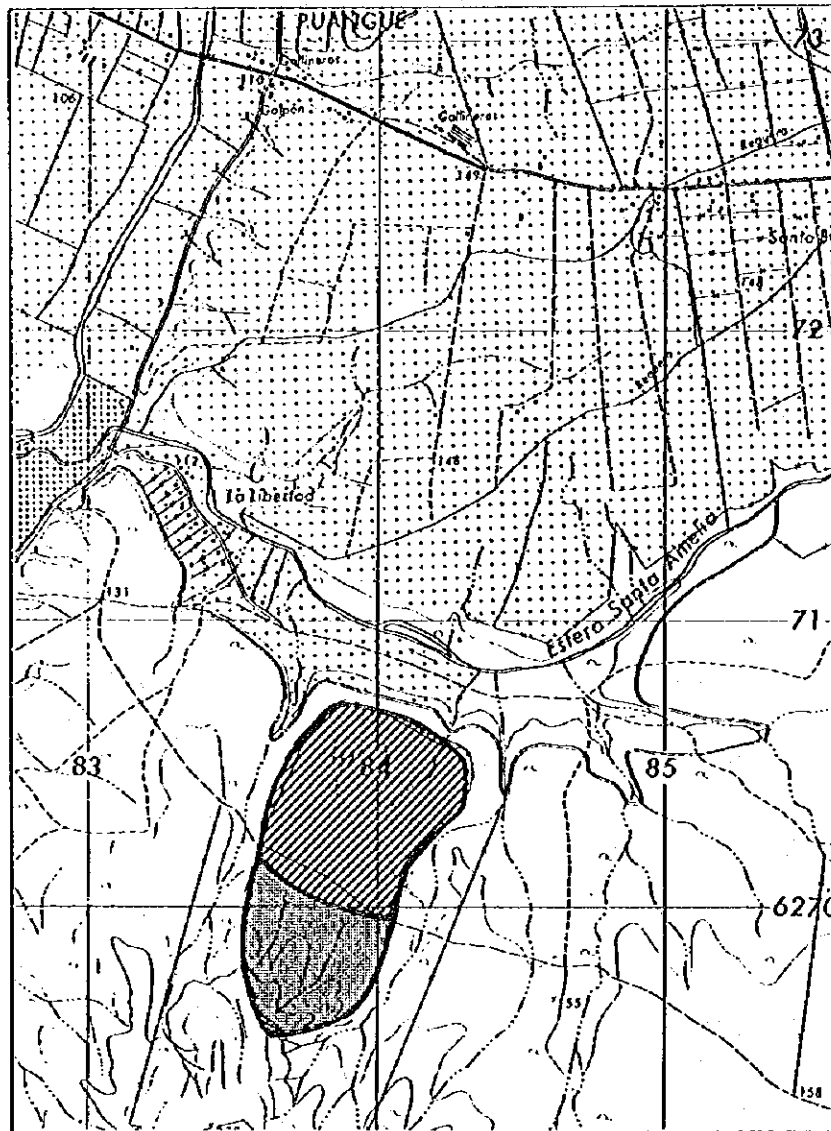
Figure J.2.2f Outline and surrounding of potential landfill site 6, Santa Amelia

The smaller site would be situated on the flat area at the foot of the slopes. It would be an area of about 700 metres north-south and 500 metres east-west, totalling 350,000 m², constructed as an artificial hill as an extension of the hills in the north. The slopes would be relatively steep all the way around and continue naturally in the landscape into the quebradas/enteros to the east, north and west. To the south it would be easy - if necessary - to intercept the quebradas from the slopes. The average height could amount to about 25 metres, resulting in a total volume of about 9 million m³.

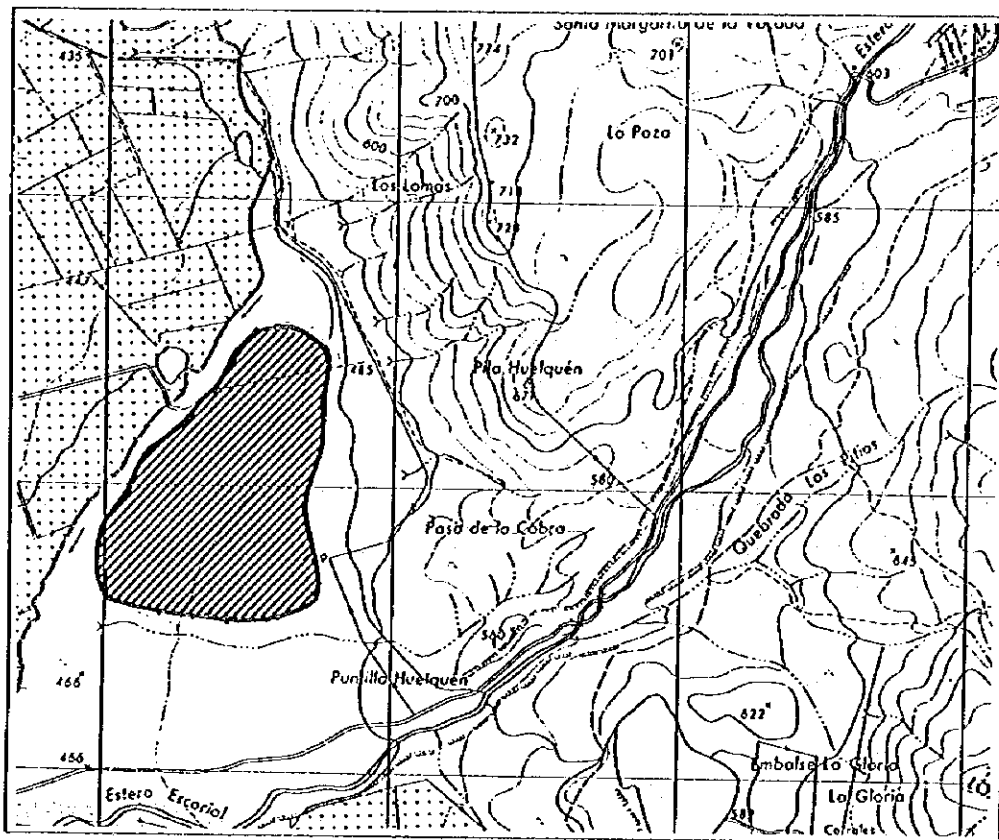
A section of the general map of the area in scale 1:25,000 (figure J.2.2h overlaid) shows the outline and the immediate surroundings of the possible landfill site.

Figure J.2.2h Outline and surrounding of potential landfill site 8, Escorial Norte

A landfill on the area would follow the limitations set by the small watercourses. This would result in an artificial hill of triangular shape, about 1,000 metres north-south and 700 metres east-west. The total area would be about 400,000 m². With an estimated average height of 30 metres this would result in a landfill volume of about 12 million m³.

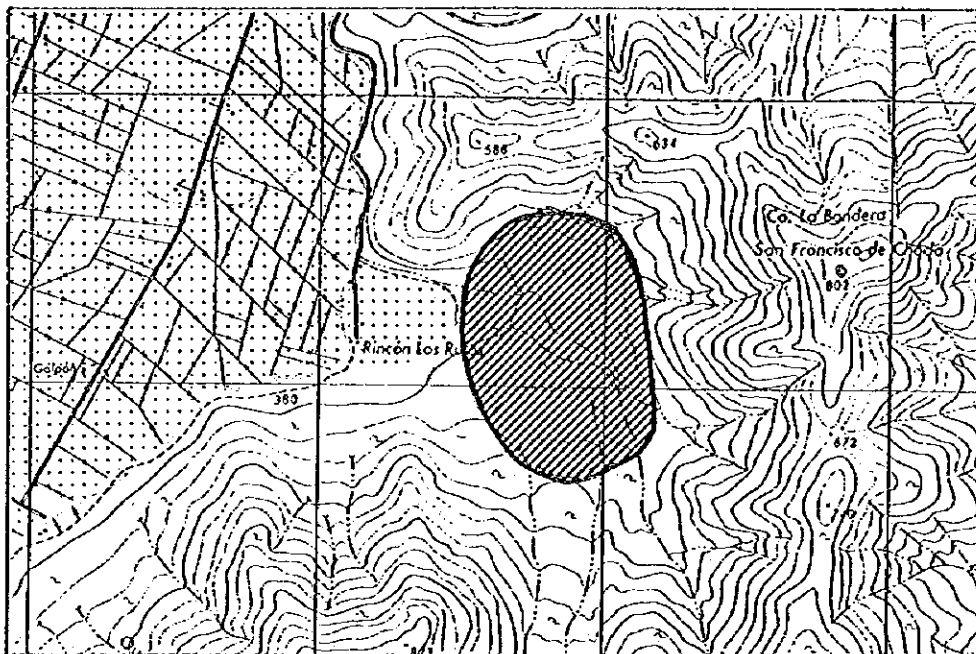
A section of the general map of the area in scale 1:25,000 (figure J.2.2i overleaf) shows the outline and the immediate surroundings of the possible landfill site.

Figure J.2.2i Outline and surrounding of potential landfill site 9, Rincón los Rulos

It is most likely that establishing a landfill that reaches up the slopes of the surrounding hills - although maybe technically possible - will result in serious water problems in the wet season. It is therefore assumed that a landfill should be established as an artificial hill on the bottom of the area, with a cut-off draining ditch along the perimeter. This would result in an almost circular, cone-shaped hill with a diameter of about 800 metres, which means an area of about 500,000 m². The total height could be about 100 metres, the average height 35 metres, leaving a total volume of about 17 million m³.

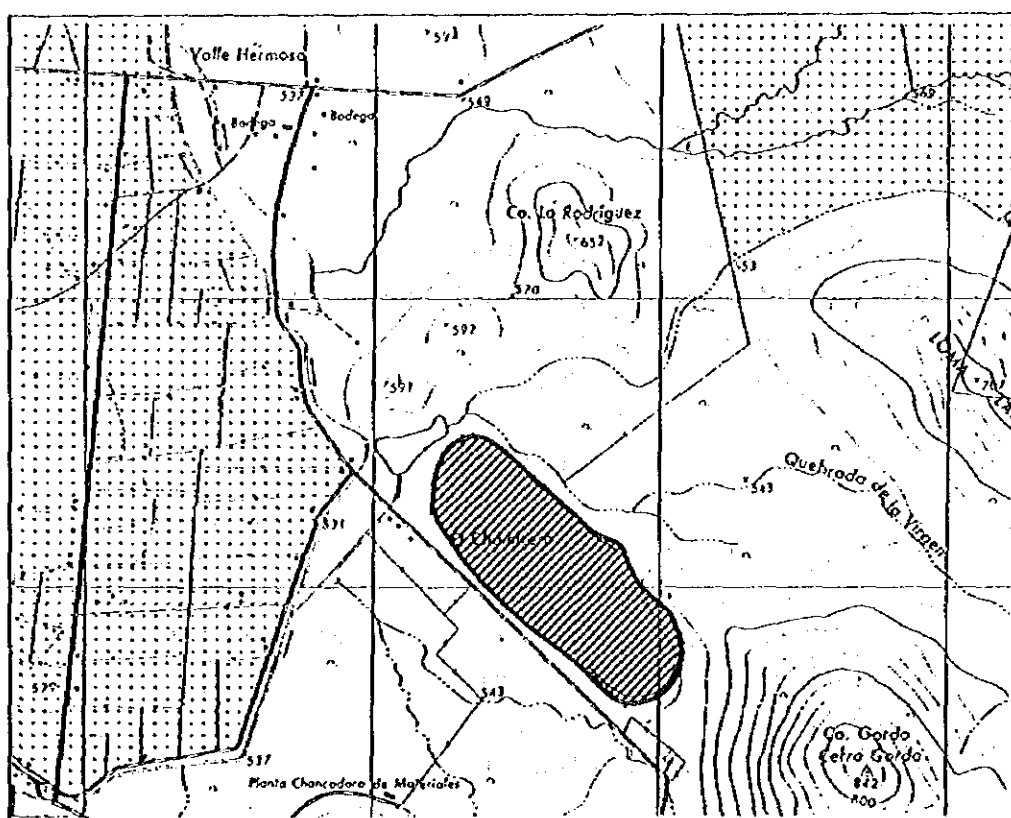
A section of the general map of the area in scale 1:25,000 (figure J.2.2k overleaf) shows the outline and the immediate surroundings of the possible landfill.

Figure J.2.2j Outline and surrounding of potential landfill site 10, Las Canteras

Establishing a landfill on the area could be done avoiding the existing road and the quebradas by constructing it as a long, artificial hill along the road. This would not fit well into the landscape but is the only reasonable solution. The extension could be 1,100 metres northwest-southeast and 400 metres northeast-southwest. The area would thus be around 400,000 m², and with an average height of about 20 metres the total volume would be 8 million m³.

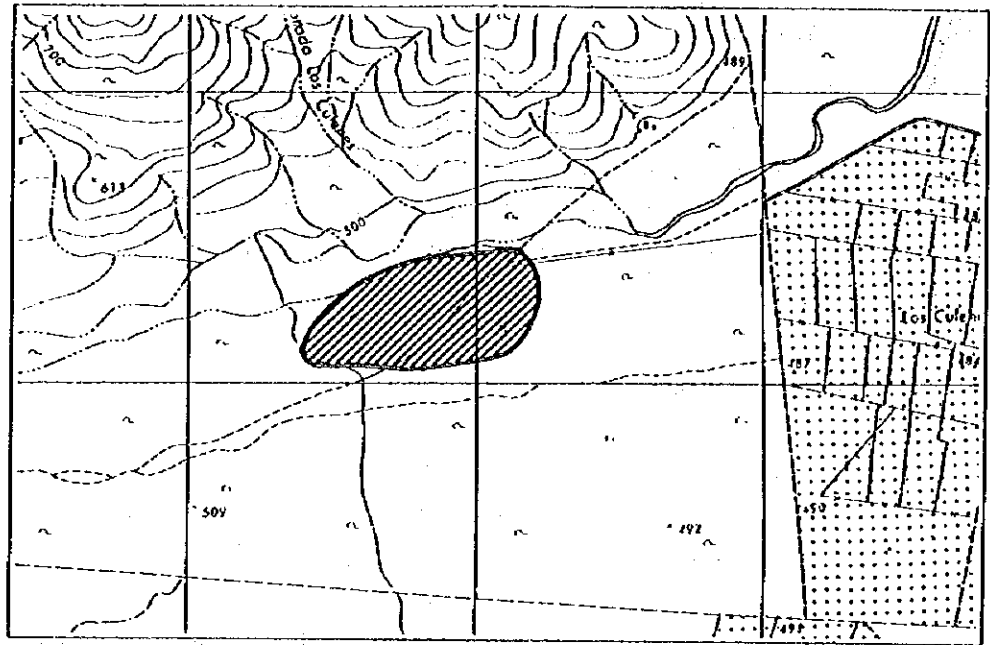
A section of the general map of the area in scale 1:25,000 (figure J.2.21 overleaf) shows the area.

Figure J.2.2k Area for candidate landfill site 11, El Convento

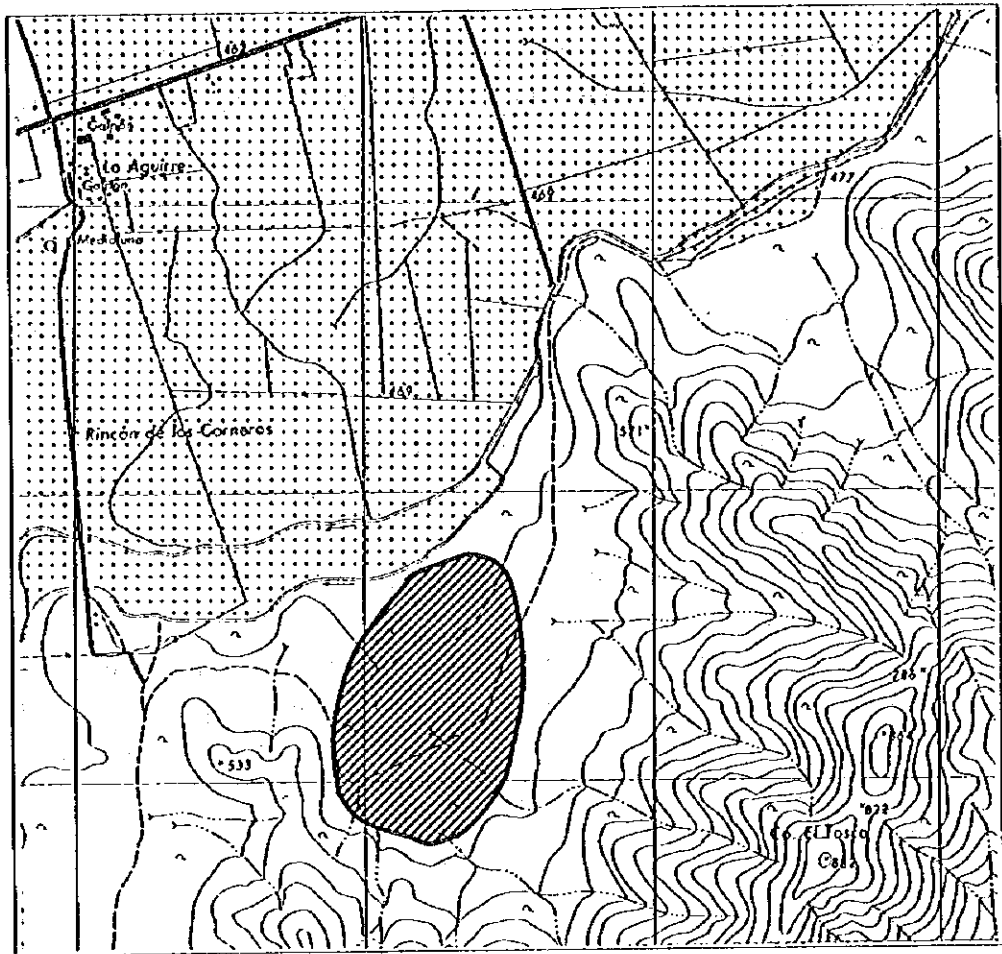
The localization and potential lay-out of the landfill is shown on figure J.3.2a overleaf.

Figure J.3.2a Outline and surrounding of potential landfill Cerro Carneros

The landfill on the site could be an elliptical or egg-shaped cone on the lower slopes of the mountain, extending about 1,100 metres north-south and 600 metres east-west. The average height could be about 40 metres, allowing for a total landfill volume of about 20 million m³.

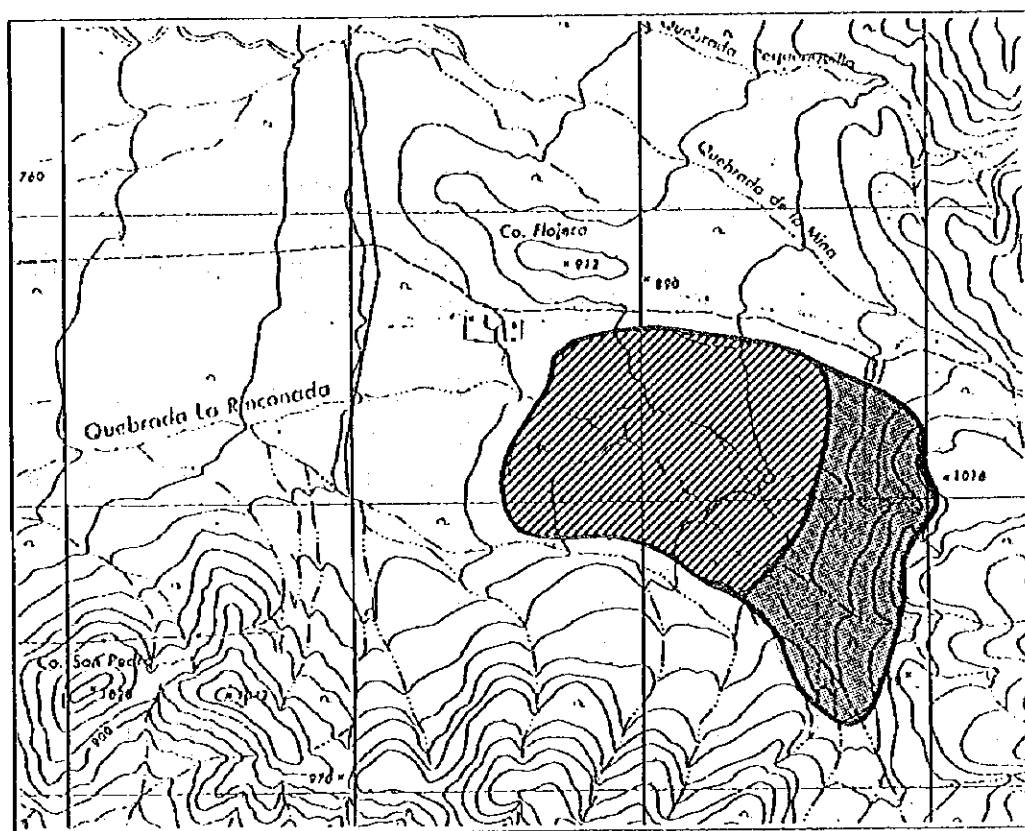
The localization and potential lay-out of the landfill is shown on figure J.3.3a below.

Figure J.3.3a Outline and surrounding of potential landfill Quilapilún

mountain slopes. The former would be about 1,000 metres east-west and 750 metres north-south, have an average height of about 40 metres and contain up to 30 million m^3 . The latter would be extended in the easterly direction to about 1,500 metres of length, the average height would increase to about 80 metres, and the volume thus be up to 90-100 million m^3 .
