5.2.5 Environment Issues

5.3 Muruthawela Reservoir Scheme

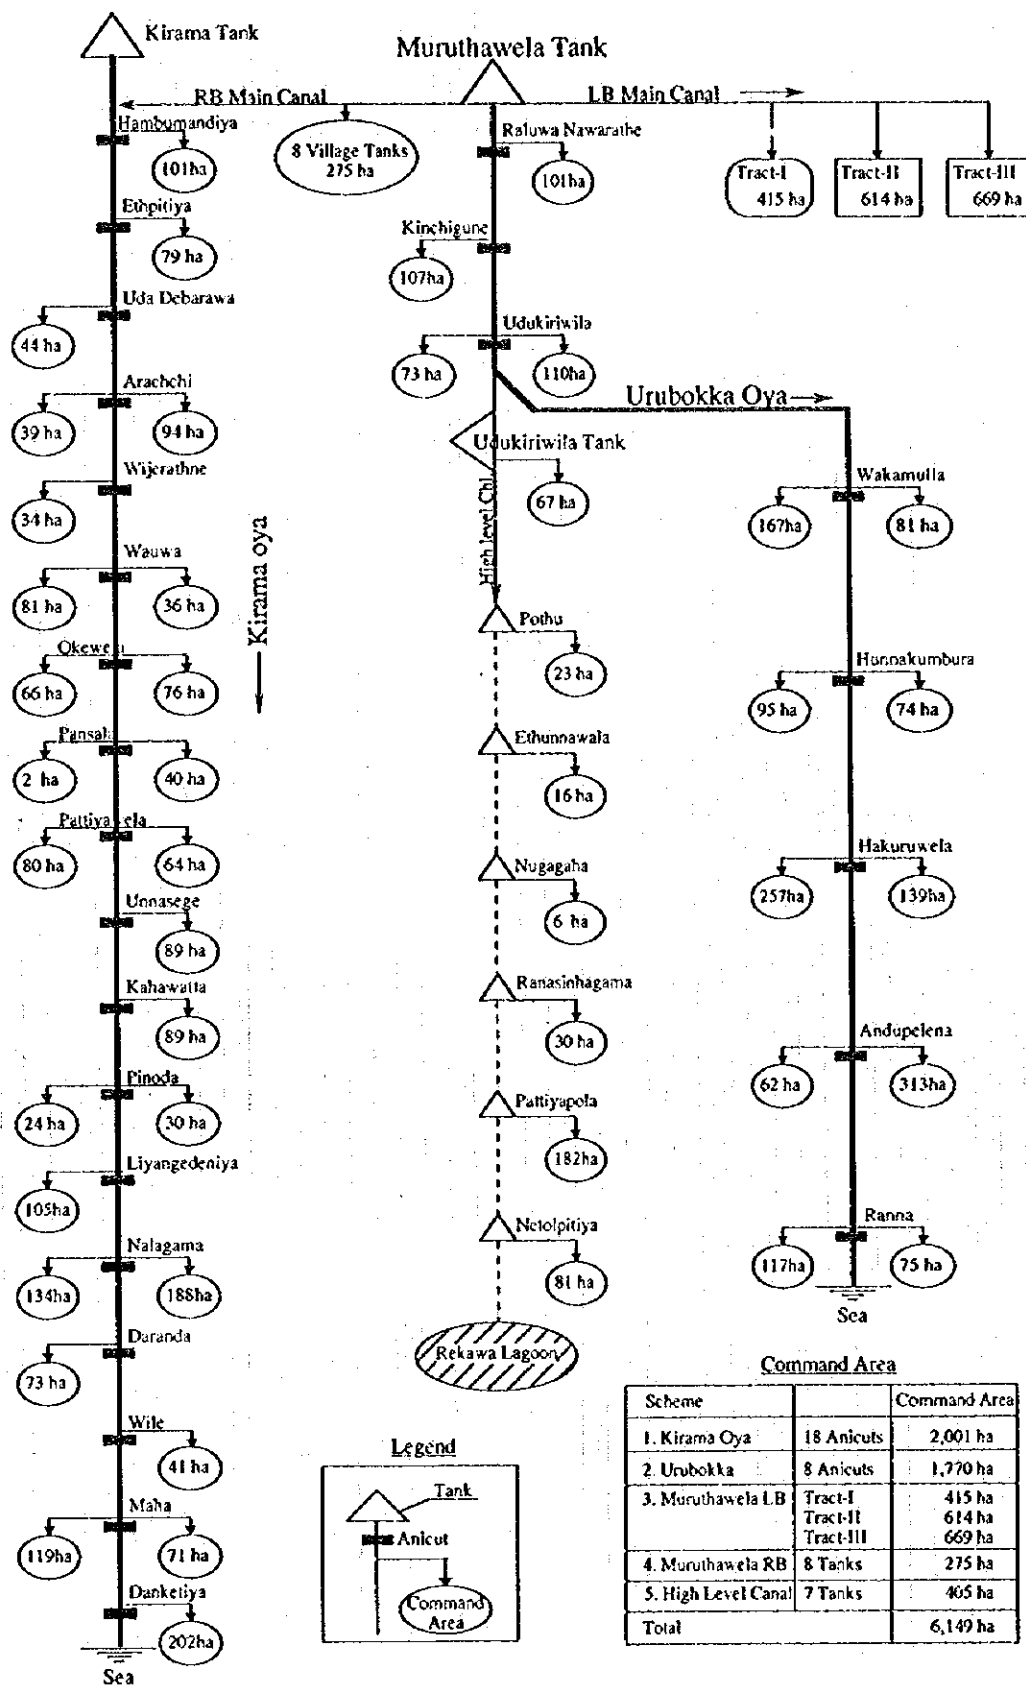
Figure 5.3.1-1 Schematic Diagram of Muruthawela Reservoir Scheme

Command Area	
Tract-I	415 ha
Tract-II	
D-1	131 ha
D-2	36 ha
D-3	36 ha
D-4	49 ha
D-5	24 ha
D-6	65 ha
D-7	70 ha
D-8	62 ha
D-9	141 ha
Sub-total	614 ha
Tract-III	
D-1	214 ha
D-2	117 ha
D-3	44 ha
D-4	24 ha
D-5	33 ha
D-6	75 ha
D-7	32 ha
D-8	93 ha
D-9	37 ha
Sub-total	669 ha
Total	1,698 ha

The Schematic Diagram of Muruthawela Reservoir Scheme is shown in Fig. 5.3.1-1.
