5.6 Benthara Ganga Right Bank Scheme

5.6.1 Irrigation and Drainage System

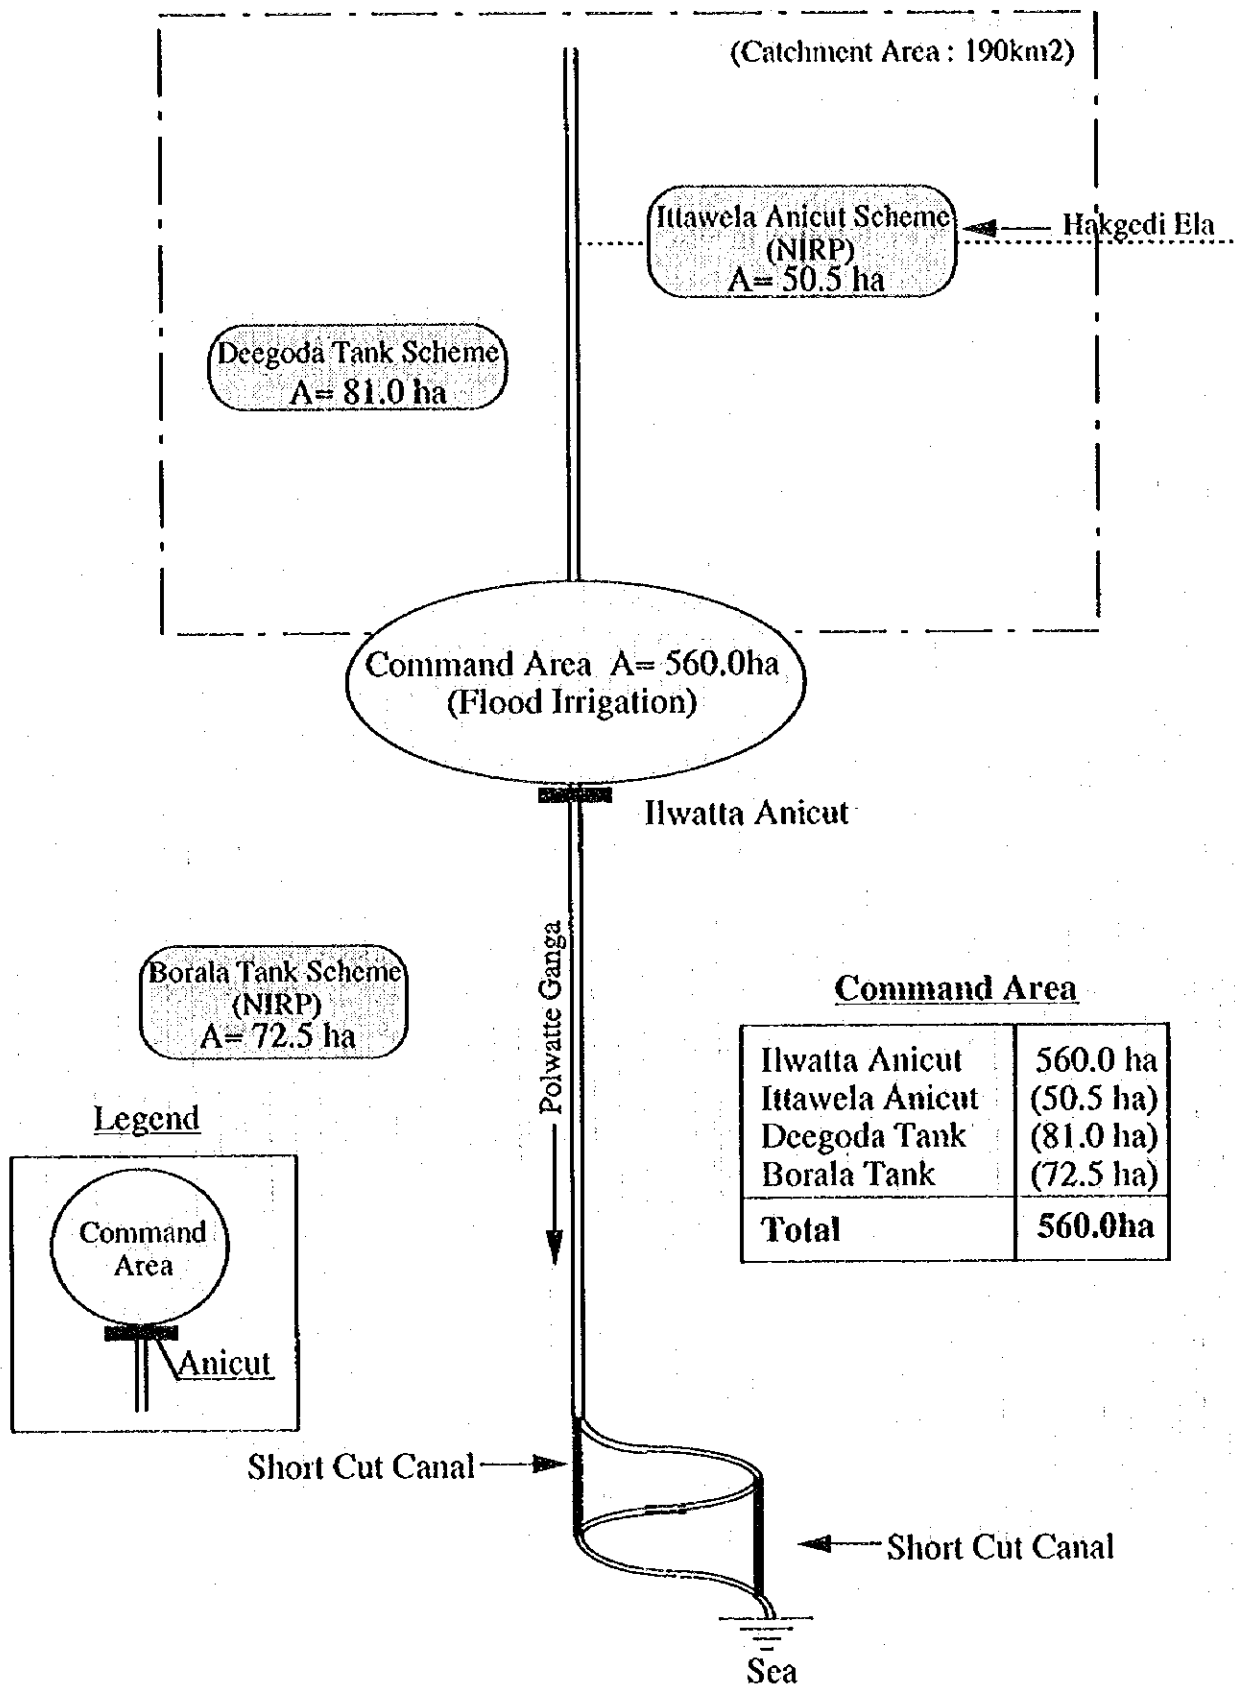
Fig. 5.7.1-1 Schematic Diagram of Polwatte Ganga Scheme

The schematic diagram of the scheme is given in Figure 5.7.1-1. The diagram was prepared based on the field observation during phase-I field survey and further study at home office.
