APPENDIX E

FIGURES

APPENDIX F
GEOLOGICAL HAZARDS ASSESSMENT

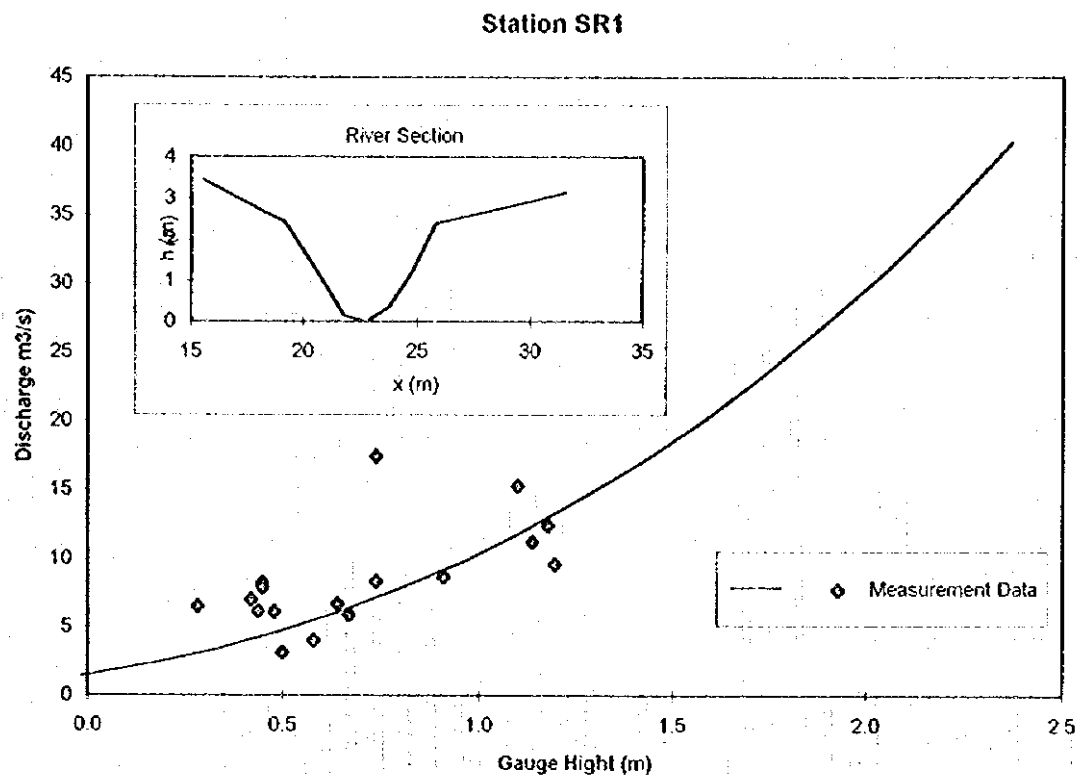
Fig. E.5.5 ESTIMATED H-Q RATING CURVE AT STREAM GAUGE STATION NEWLY INSTALLED (1/4)

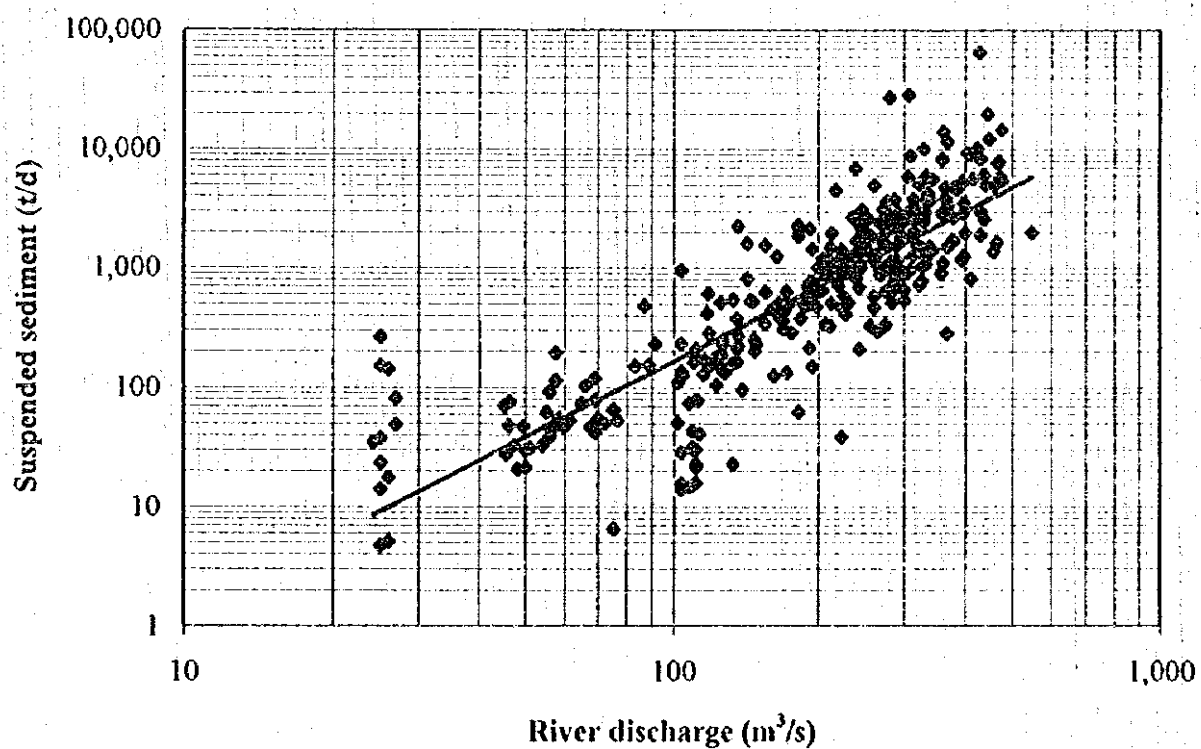
Wangdue Rapids

Yebesa

**Fig. E.5.9 RELATIONSHIP BETWEEN RIVER DISCHARGE AND
SUSPENDED SEDIMENT RUNOFF (1/2)**
