3.2.4 Maintenance management and operation

THE STUDY ON
 THE MAINTENANCE AND REHABILITATION OF
 HIGHWAY BRIDGES IN THE REPUBLIC OF TURKEY
 AUGUST, 1998
 ORIENTAL CONSULTANTS COMPANY LIMITED
 in association with
 JAPAN OVERSEAS CONSULTANTS COMPANY LIMITED

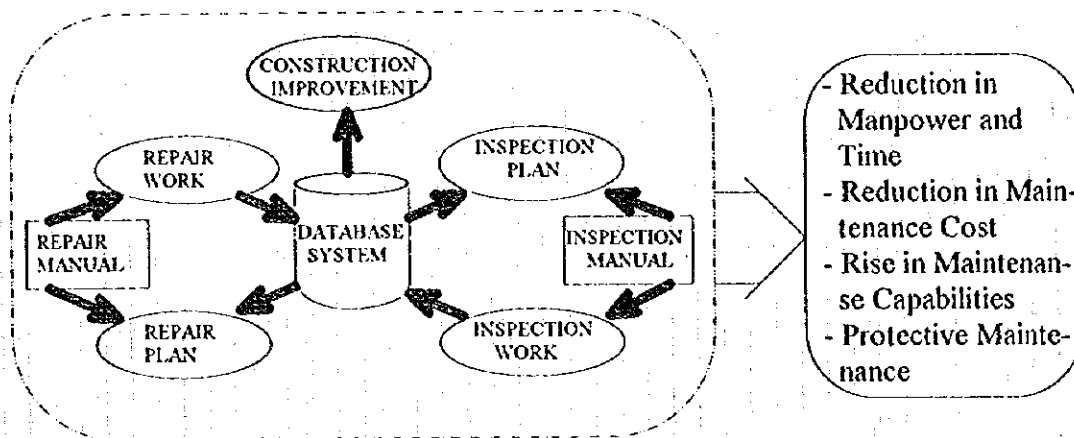
Figure - 4.1.1 Systemalized Maintenance Work Flow

The system aims to achieve its stated objectives using inspection and repair manuals and computer databases to handle maintenance work from after the construction stage through to the inspection, repair and improvement stages. An inventory database is established after construction while inspections and repairs are carried out efficiently with the aid of manuals and information stored in the same database. This will lead to rationalization and improvement of maintenance work as shown in Figure - 4.1.1.

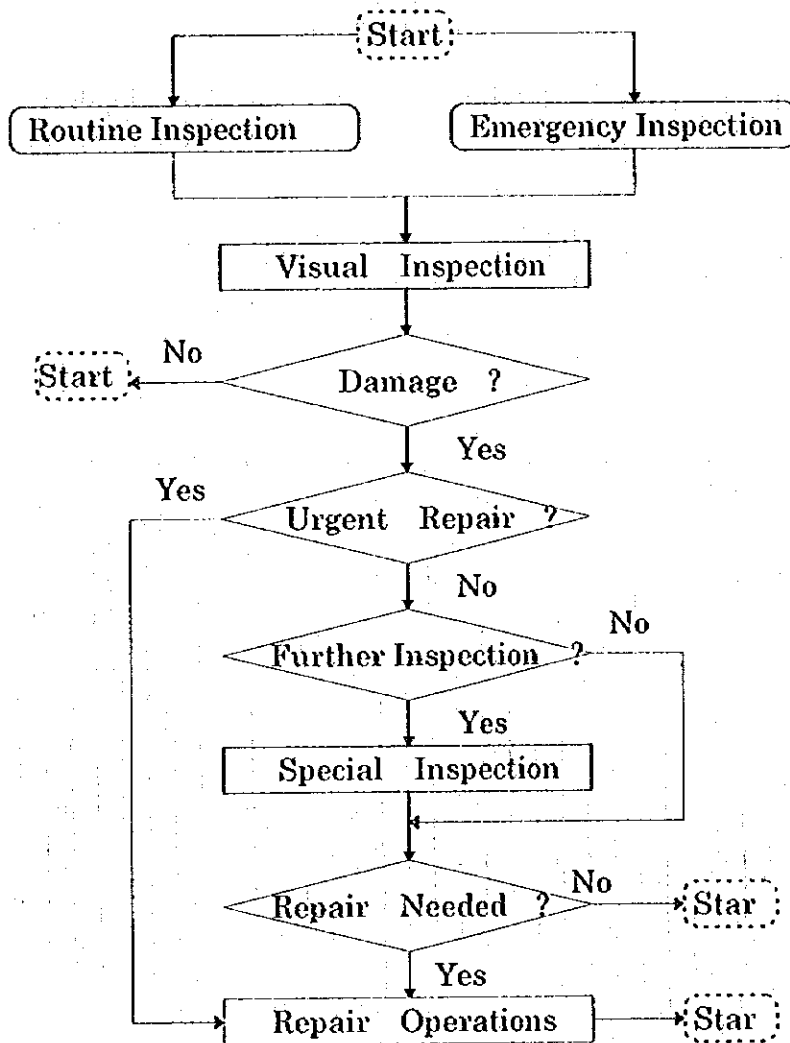
Figure - 4.2.1
 Inspection and Maintenance Procedures

Maintenance work on highway bridges is conducted to keep them in good condition in order to achieve smoother vehicle traffic flows and to preserve public property for a longer period of time. Maintenance work is composed of inspection and repair work, and is shown in the flow chart of Figure - 4.2.1.

Routine inspection forms the basis of the inspection manual and it is carried out as a preventive maintenance measure for highway bridges. All inspection results of the bridge components are stored in the database, even when no damage or defects are found.

When damage or deterioration is found by a routine inspection, the work procedure differs depending on whether it is a primary or secondary member of the bridge and are discussed as follows:
