Annex-RB Results of Laboratory Analysis

Summary of Results

SUPPORTING REPORT S
ENVIRONMENTAL IMPACT ASSESSMENT

The Study on the Improvement of Wastewater Management in the Guatemala Metropolitan Area

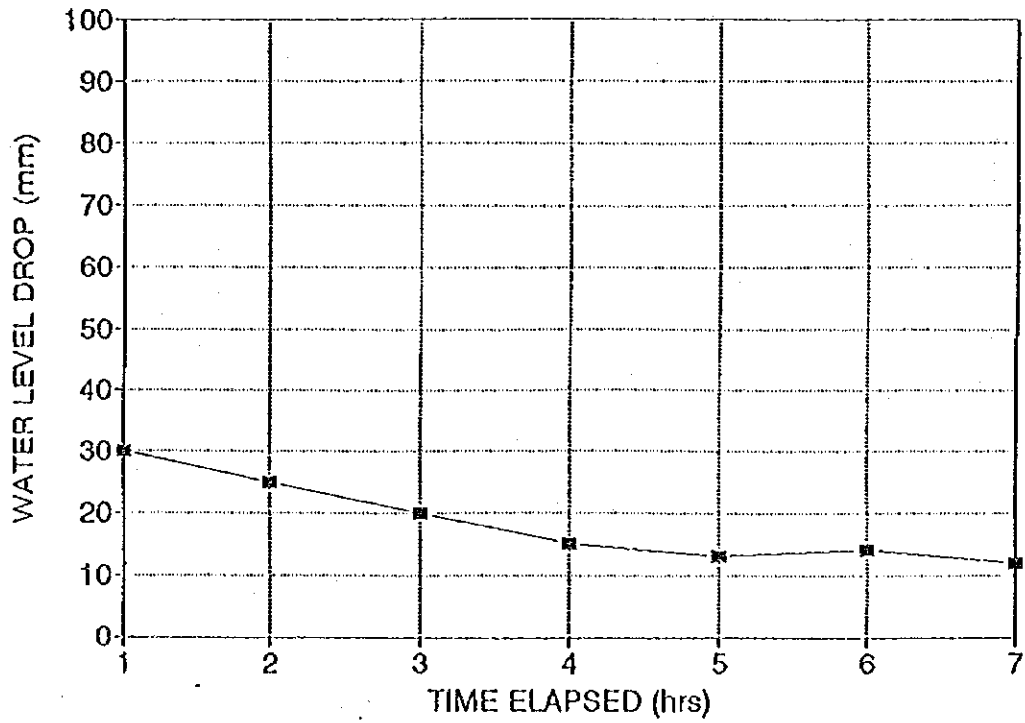
TIME ELAPSED (hrs) Tiempo transcurrido	WATER LEVEL (m) nivel de agua	WATER LEVEL DROP (mm) Intervalo en descenso
START UP inicio en superficie	5.45	
1.0	5.51	65
2.0	5.57	60
3.0	5.62	50
4.0	5.66	40
5.0	5.70	40
6.0	5.73	30
7.0	5.76	30

SOIL PERCOLATION TEST
BETHANIA I

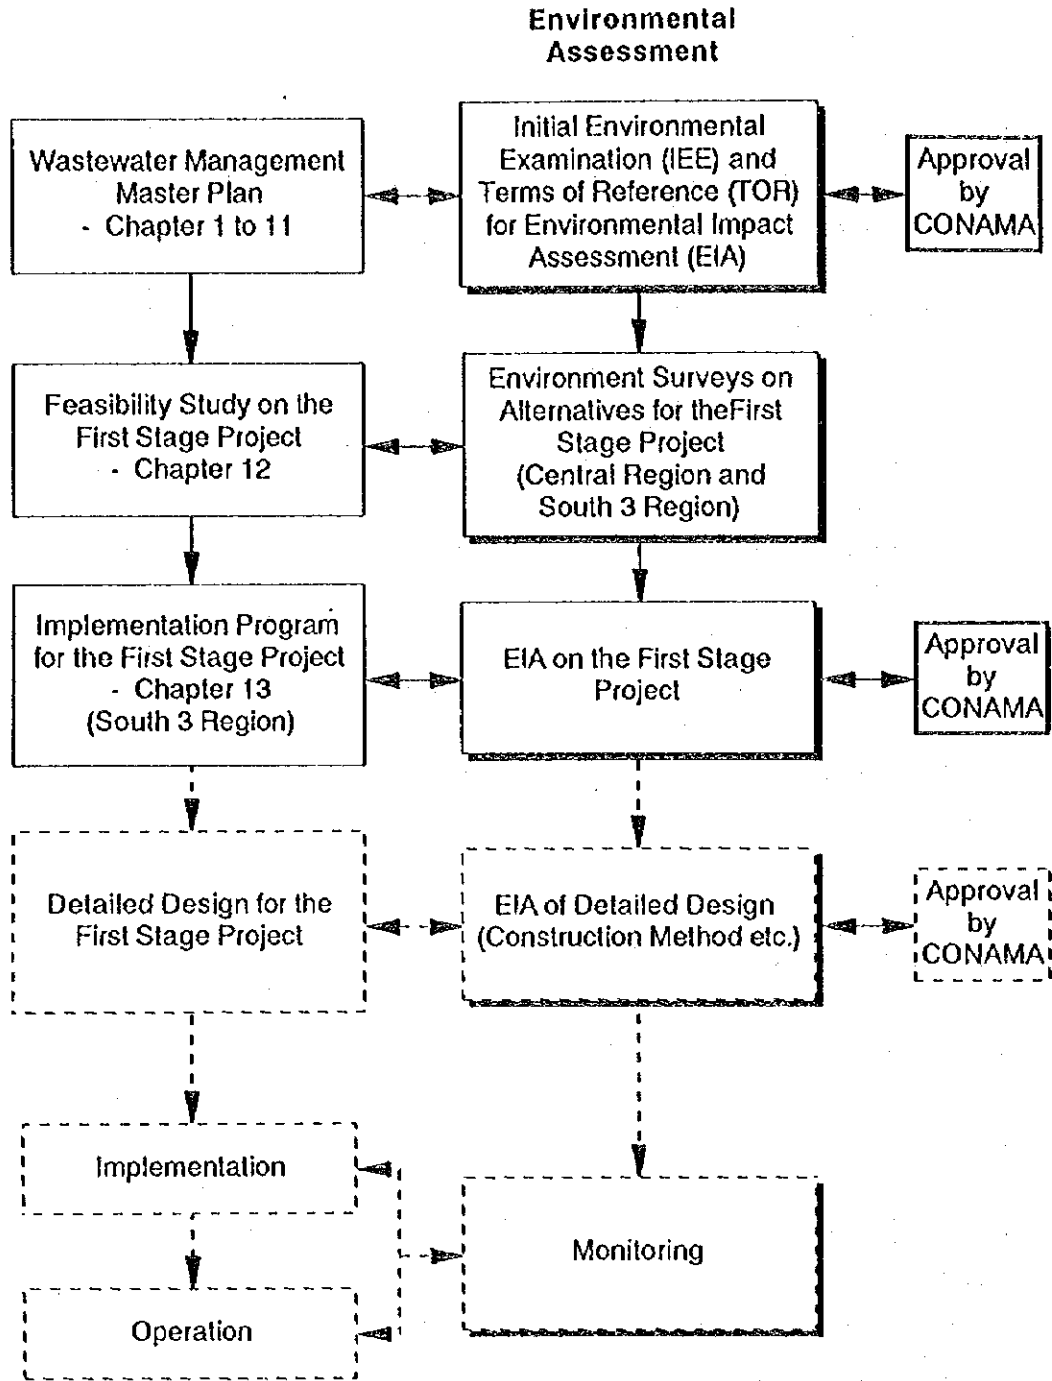
<p><i>THE REPUBLIC OF GUATEMALA</i></p> <p>GUATEMALA MUNICIPAL WATER SUPPLY PUBLIC CORPORATION (EMPAGUA)</p>	<p>THE STUDY ON THE IMPROVEMENT OF WASTEWATER MANAGEMENT IN THE GUATEMALA METROPOLITAN AREA</p> <hr/> <p>JAPAN INTERNATIONAL COOPERATION AGENCY</p>	<p>TITLE</p> <p>STEPS IN EIA FOR THE WASTEWATER MANAGEMENT STUDY</p>
--	---	---

Due to the scale of the proposed Wastewater Management Master Plan and the First Stage Project, an EIA is necessary.
