CHAPTER 10

BRIDGE REHABILITATION/IMPROVEMENT

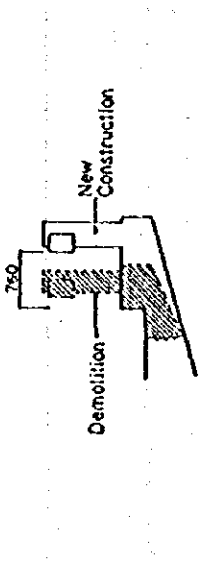
D. Extension	6. Widening of Sidewalk

<p>The diagram shows a cross-section of a sidewalk. A section of the existing sidewalk is labeled 'Demolition'. A new, wider sidewalk is being constructed next to it, labeled 'New Construction'. A dimension line indicates a width of '750' for the new sidewalk.</p>	Demolish existing sidewalk and railing, widen substructure if necessary, construct additional girders if necessary, and construct new sidewalk and railing.	<ul style="list-style-type: none"> o Bridge is located in residential area and has less than 60cm wide sidewalk.

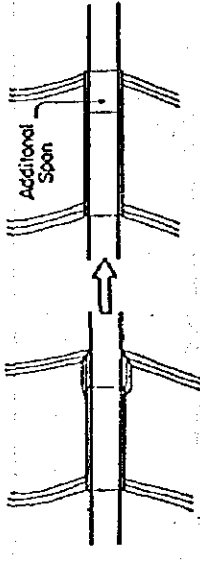
D. Extension	7. Construction of Additional Span

<p>The diagram shows a cross-section of a bridge with two spans. An arrow points to the right, indicating the direction of a new 'Additional Span' being added to the existing bridge structure.</p>	Take necessary measures to convert the existing abutment into pier or reconstruct it, and construct substructure and superstructure of additional span(s).	<ul style="list-style-type: none"> o Approach road embankment encroaches on waterway causing flooding upstream and erosion of approach road embankment.

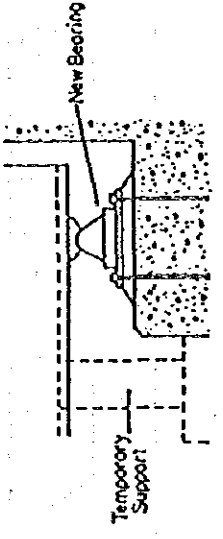
Category	Rehabilitation Method	Sample Illustration	Description of Method	Criteria for Application
E. Major Repair (continued)	12. Replacement of Bearing

Provide temporary support in the vicinity of the bearing, jack up superstructure evenly, demolish and reinforce bridge seat, and install new bearing. If the width of bridge seat is insufficient from the aseismic point of view, widen it.	<ul style="list-style-type: none"> Bearing, especially roller or rocker expansion bearing, is seriously damaged to fall in its function and induce stresses in superstructure and substructure.

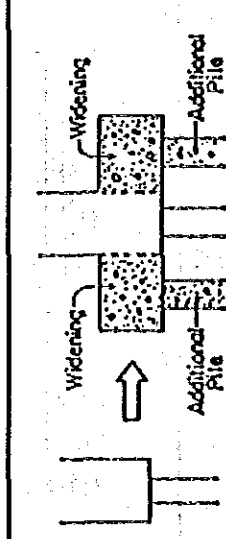
15. Reinforcement of Foundation

Widen footing with piles if necessary.	<ul style="list-style-type: none"> Bearing capacity of foundation is insufficient or will be insufficient due to reconstruction of superstructure.

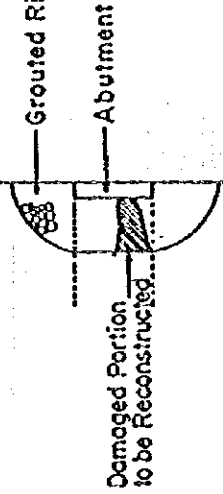
Category	Rehabilitation Method	Sample Illustration	Description of Method	Criteria for Application
G. Protection from Scour	21. Repair of Abutment Slope Protection

Remove damaged portion of existing abutment slope protection and reconstruct it.	<ul style="list-style-type: none"> o Abutment slope protection is damaged and/or its foundation is scoured. But the damage is still repairable.

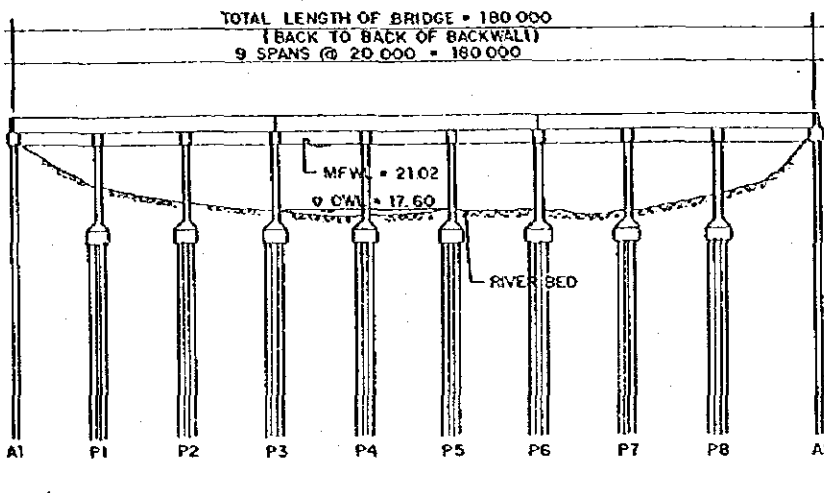
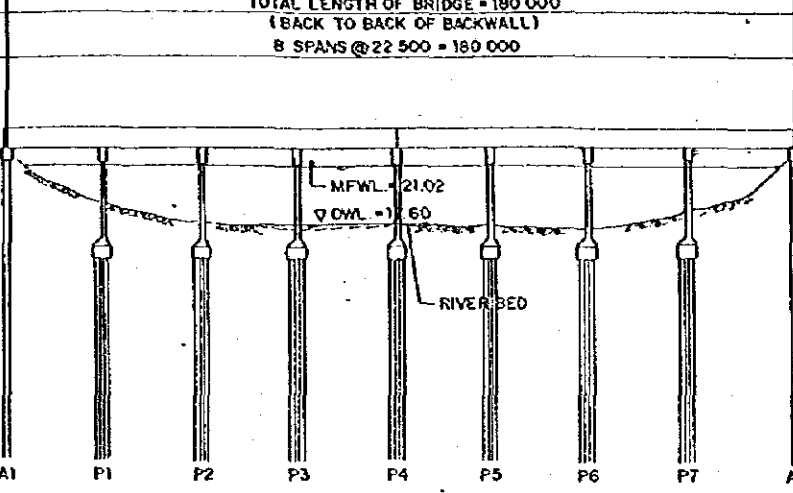
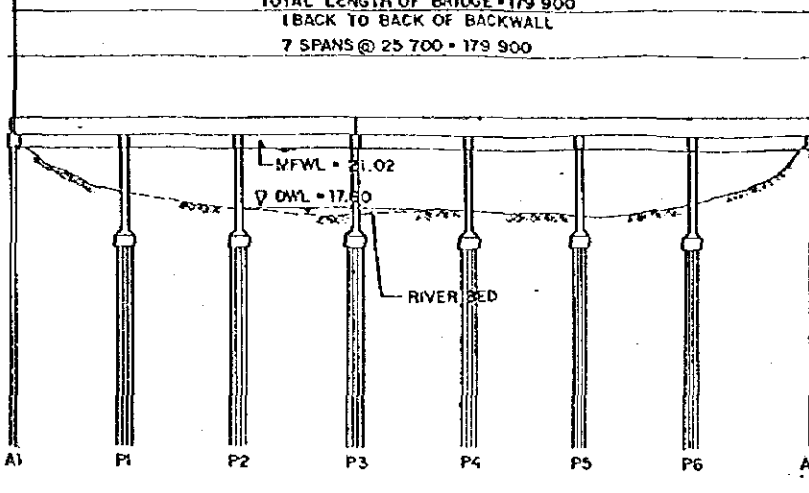
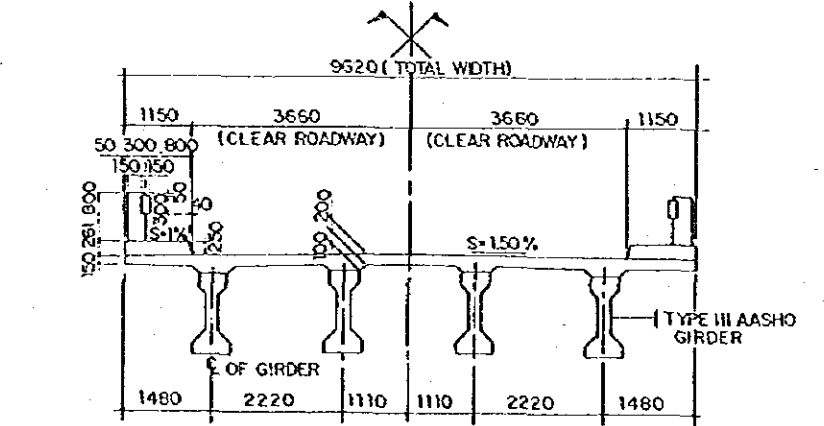
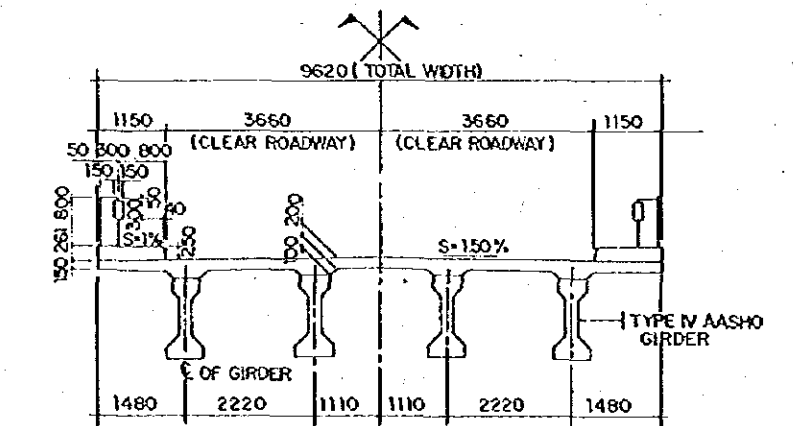
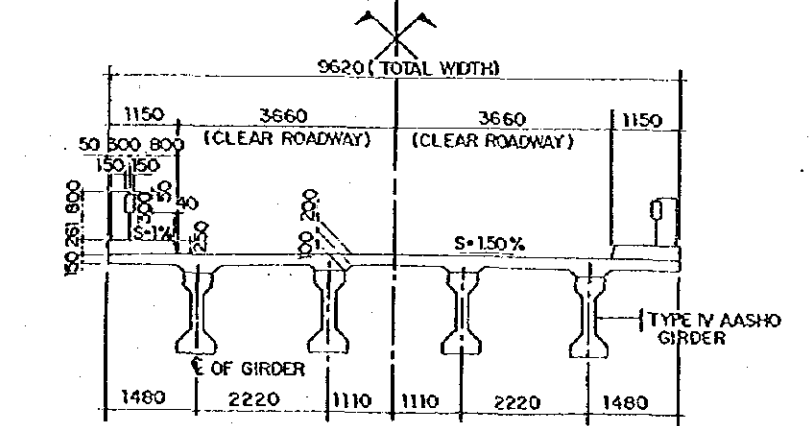
FIGURE 10.4-2 ALTERNATIVE SCHEMES FOR ANDANAN BRIDGE

SCHEME	1	2	3
BRIDGE ELEVATION	<p>PCDG TYPE III BRIDGE</p> <p>TOTAL LENGTH OF BRIDGE = 180 000 (BACK TO BACK OF BACKWALL) 9 SPANS @ 20 000 = 180 000</p>

<p>PCDG TYPE IV BRIDGE</p> <p>TOTAL LENGTH OF BRIDGE = 180 000 (BACK TO BACK OF BACKWALL) 8 SPANS @ 22 500 = 180 000</p>

<p>PCDG TYPE IV BRIDGE</p> <p>TOTAL LENGTH OF BRIDGE = 179 900 (BACK TO BACK OF BACKWALL) 7 SPANS @ 25 700 = 179 900</p>

<p>TYPICAL CROSS SECTION</p>
CONSTRUCTION COST (₹)	42,700,000	41,700,000	38,400,000
%	111	109	100
REMARKS	<p>ADVANTAGES :</p> <ol style="list-style-type: none"> PCDG BEAMS ARE EASY TO PRECAST, TRANSPORT AND ERECT BECAUSE OF THEIR SHORT LENGTH (20.0m.) <p>DISADVANTAGES :</p> <ol style="list-style-type: none"> PROVIDES MOST COSTLY SCHEME, ALTHOUGH COST DIFFERENCE IS SMALL. PIERS MOST CLOSELY SPACE, SCOUR PRONE. LONGEST CONSTRUCTION PERIOD WITH MOST NUMBER OF PIERS. 	<p>ADVANTAGES :</p> <ol style="list-style-type: none"> PROVIDES LEAST COSTLY SCHEME BUT COST CLOSE TO SCHEME 3. PCDG BEAMS (22.5m. LENGTH) EASY TO PRECAST AT THE SITE AND TO ERECT. <p>DISADVANTAGES :</p> <ol style="list-style-type: none"> INTERMEDIATE CONSTRUCTION PERIOD (7 PIERS) INTERMEDIATE SCOUR OF MEANDERING RIVER. 	<p>ADVANTAGES :</p> <ol style="list-style-type: none"> COST IS COMPARABLE TO SCHEME 2. SHORTEST CONSTRUCTION PERIOD WITH LEAST NUMBER OF PIERS (6). EASY ERECTION OF 25.7 m. LENGTH PCDG FROM RIVER BED HELPED BY RELATIVELY DRY RIVER BED. LESS PIERS MEANS LESS SCOUR. SITE IS VERY SCOUR PRONE DUE TO MEANDERING STREAM.

Figure 10.4-2 shows a comparison of three schemes. Results of comparison can be summarized as follows:

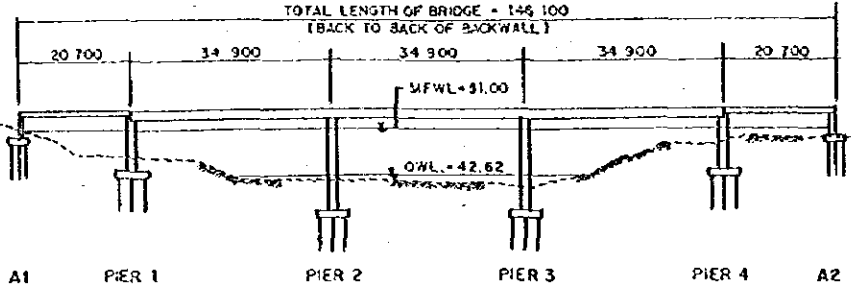
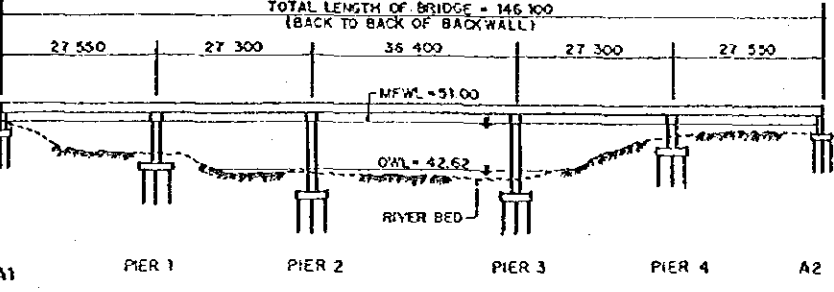
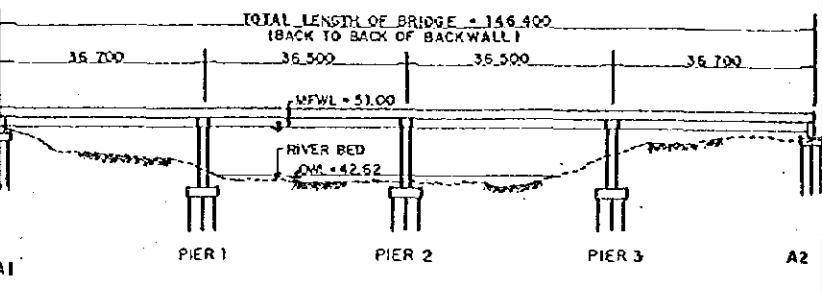
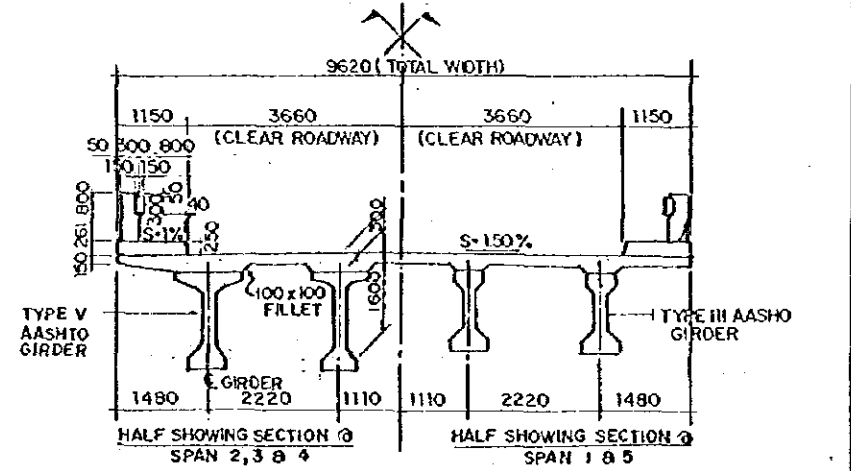
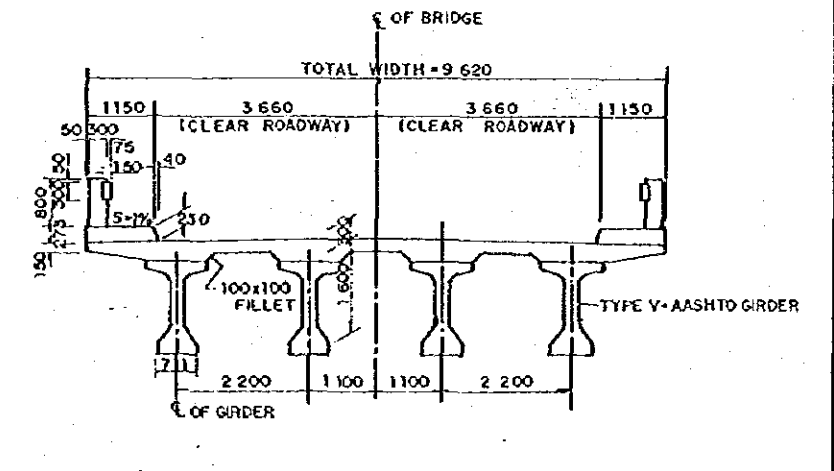
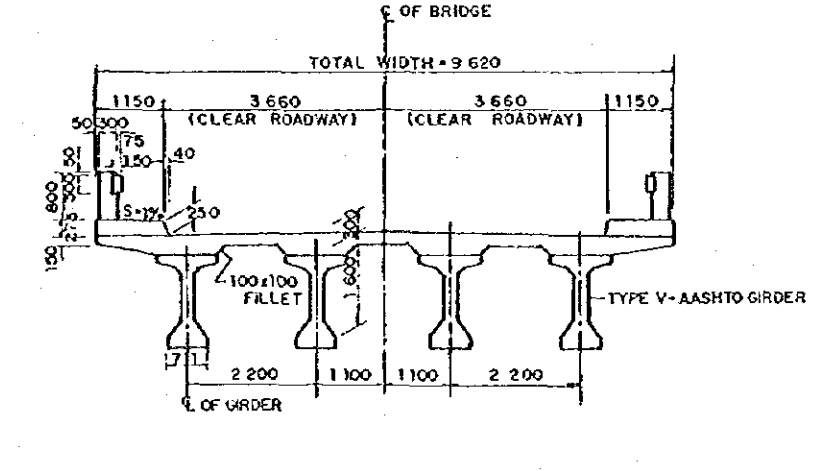
FIGURE 10.4-3 ALTERNATIVE SCHEMES FOR MONKAYO BYPASS 2 BRIDGE

SCHEME	1	2	3
BRIDGE ELEVATION	<p>COMBINATION OF PCOG TYPE III & TYPE V BRIDGE</p>

<p>PCOG TYPE V BRIDGE</p>

CONSTRUCTION COST (P)	29,300,000	30,100,000	26,600,000
	NOTE: (CONSTRUCTION COST DOES NOT INCLUDE POST & RAILINGS, TEMPORARY JETTY, ABUTMENT, ETC.)		
%	110	113	100
REMARKS	<p>ADVANTAGES:</p> <ol style="list-style-type: none"> CENTER PIERS ARE EASILY CONSTRUCTED WITH SAND ISLANDS AT THE EDGE OF WATER TO PROVIDE ACCESS TO FOOTING FOUNDATION CONSTRUCTION. <p>DISADVANTAGES:</p> <ol style="list-style-type: none"> TWO CENTER PIERS OCCURS IN NORMAL RIVER CHANNEL. MORE PIERS (4) CAUSE MORE OBSTRUCTION TO RIVER FLOW AND THUS MORE SCOUR THAN ONLY THREE (3) PIERS. 	<p>ADVANTAGES:</p> <ol style="list-style-type: none"> CENTER PIERS ARE EASILY CONSTRUCTED WITH SAND ISLANDS AT THE EDGE OF WATER TO PROVIDE ACCESS TO FOOTING FOUNDATION CONSTRUCTION. SHORT END SPANS MAKE SINGLE 36.4 m. CENTER SPAN EASIER TO ERECT BY LIFTING AT EACH END FROM SHORT SPAN DECK. <p>DISADVANTAGES:</p> <ol style="list-style-type: none"> TWO CENTER PIERS OCCUR IN NORMAL RIVER CHANNEL. MORE PIERS (4) CAUSE MORE OBSTRUCTION TO RIVER FLOW AND THUS MORE SCOUR. 	<p>ADVANTAGES:</p> <ol style="list-style-type: none"> ONLY ONE CENTER PIER OCCURS IN NORMAL RIVER CHANNEL. LEAST PIERS (3) MAKE SUBSTRUCTURES EASIEST TO CONSTRUCT AND CUTS CONSTRUCTION TIME. LEAST PIERS (3) LESS OBSTRUCTION OF RIVER FLOW AND THUS LEAST SCOUR. ALL BEAMS HAVE SAME LENGTH AND MAYBE CAST ON SITE WITH SAME FORMWORK AND SAME PRESTRESSING.

Figure 10.4-3 shows comparison of three schemes. Results of comparison can be summarized as follows:

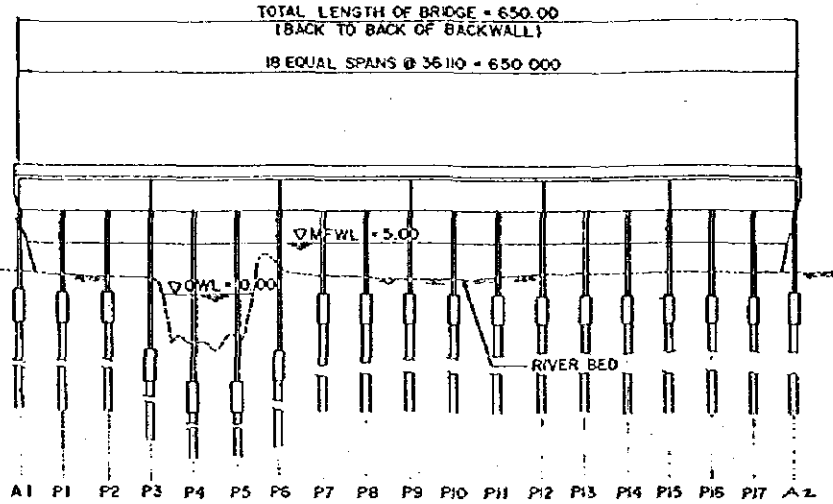
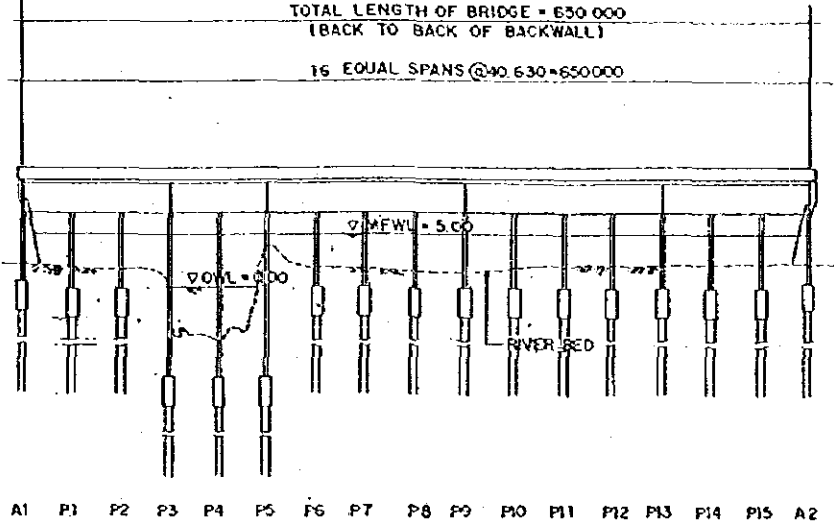
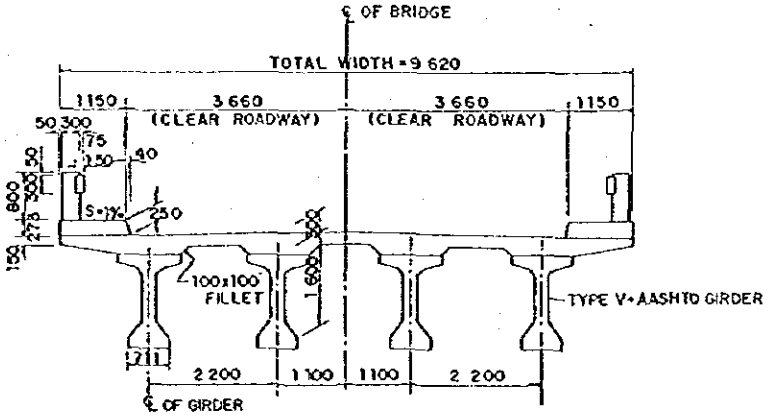
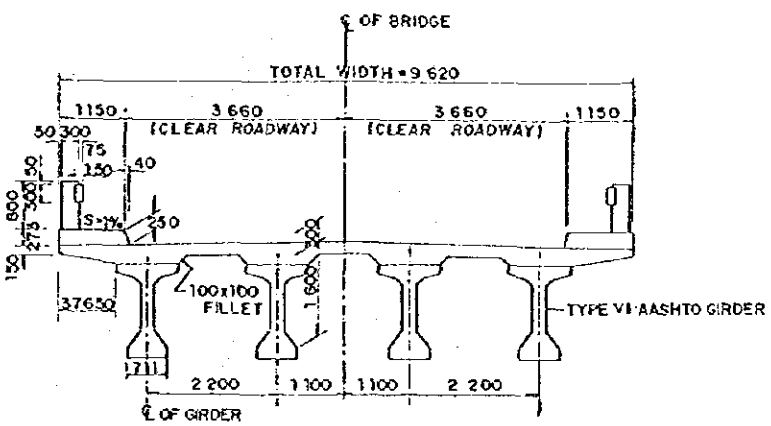
FIGURE 10.4-4 ALTERNATIVE SCHEMES FOR GOVERNOR MIRANDA BRIDGE (1/2)

<p>TOTAL LENGTH OF BRIDGE = 650.00 (BACK TO BACK OF BACKWALL) 18 EQUAL SPANS @ 36.10 = 650.00</p> <p>MEWL = 5.00 RWL = 0.00 RIVER BED</p> <p>A1 P1 P2 P3 P4 P5 P6 P7 P8 P9 P10 P11 P12 P13 P14 P15 P16 P17 A2</p>	<p>PCDG TYPE VI BRIDGE</p>

<p>TOTAL LENGTH OF BRIDGE = 650.000 (BACK TO BACK OF BACKWALL) 16 EQUAL SPANS @ 40.630 = 650.000</p> <p>MEWL = 5.00 RWL = 0.00 RIVER BED</p> <p>A1 P1 P2 P3 P4 P5 P6 P7 P8 P9 P10 P11 P12 P13 P14 P15 A2</p>
SUPERSTRUCTURE CROSS - SECTION

<p>☉ OF BRIDGE</p> <p>TOTAL WIDTH = 9.620</p> <p>1.150 (CLEAR ROADWAY) 3.660 (CLEAR ROADWAY) 3.660 1.150</p> <p>50.300 1.75 1.20 40 5.7% 250 1.600 300</p> <p>☉ OF GIRDER</p> <p>2.200 1.100 1.100 2.200</p> <p>TYPE V-AASHTO GIRDER</p>

<p>☉ OF BRIDGE</p> <p>TOTAL WIDTH = 9.620</p> <p>1.150 (CLEAR ROADWAY) 3.660 (CLEAR ROADWAY) 3.660 1.150</p> <p>50.300 1.75 1.20 40 5.7% 250 1.600 300 376.50</p> <p>☉ OF GIRDER</p> <p>2.200 1.100 1.100 2.200</p> <p>TYPE VI-AASHTO GIRDER</p>

CONSTRUCTION COST (P)	<p>141,400,000</p> <p>NOTE: (CONSTRUCTION COST NOT INCLUDE POST AND RAILINGS, TEMPORARY JETTY, ABUTMENT, ETC.)</p>	<p>146,700,000</p>
%	<p>100</p>	<p>104</p>
REMARKS	<p>ADVANTAGES :</p> <ol style="list-style-type: none"> 1. PROVIDES COMPETITIVE COSTWISE. 2. SHORT SPANS ARE EASY TO FABRICATE & EASIEST TO ERECT SUPERSTRUCTURES. 3. ONLY TWO (2) PIERS ON RIVER STREAM AT NORMAL WATER LEVEL. <p>DISADVANTAGES :</p> <ol style="list-style-type: none"> 1. PIERS UNDER ORDINARY WATER LEVEL IS DIFFICULT TO CONSTRUCT. 2. MOST PIERS (17) LENGTHENS CONSTRUCTION PERIOD AND OBSTRUCT STREAM FLOW THE MOST. 	<p>ADVANTAGES :</p> <ol style="list-style-type: none"> 1. COST IS COMPARABLE TO OTHER SCHEME. <p>DISADVANTAGES :</p> <ol style="list-style-type: none"> 1. PCDG BEAMS ARE LONG & DIFFICULT FOR ERECTION. 2. THREE (3) PIERS ARE ERECTED IN THE STREAM COMPARED TO TWO (2) IN SCHEME 1.
ADOPTED SCHEME	<p>RECOMMENDED</p>	<p>NOT RECOMMENDED</p>

Figure 10.4-4 shows comparison of four schemes. Results of comparison can be summarized as follows:

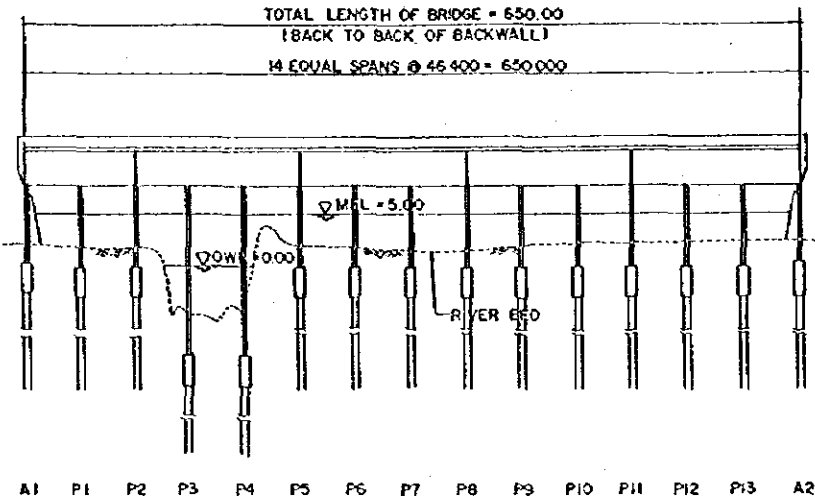
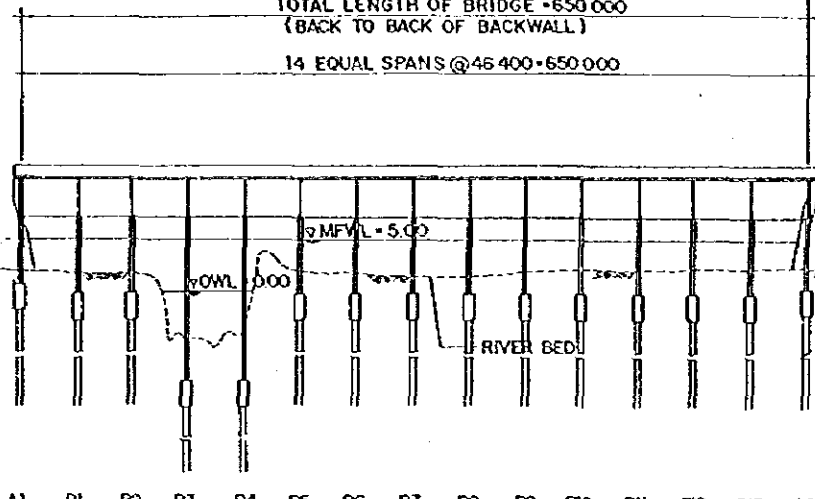
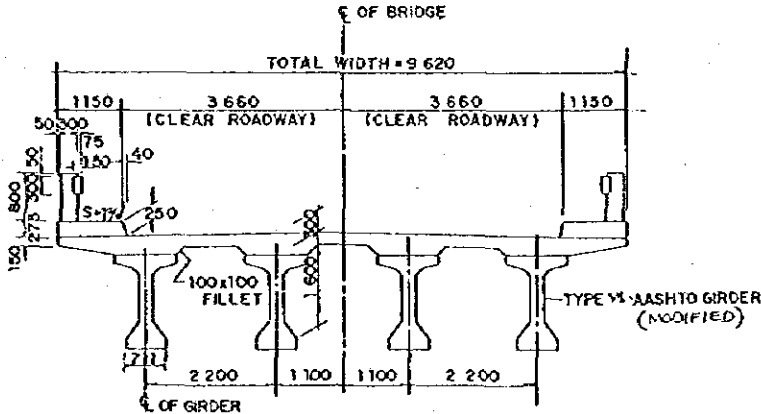
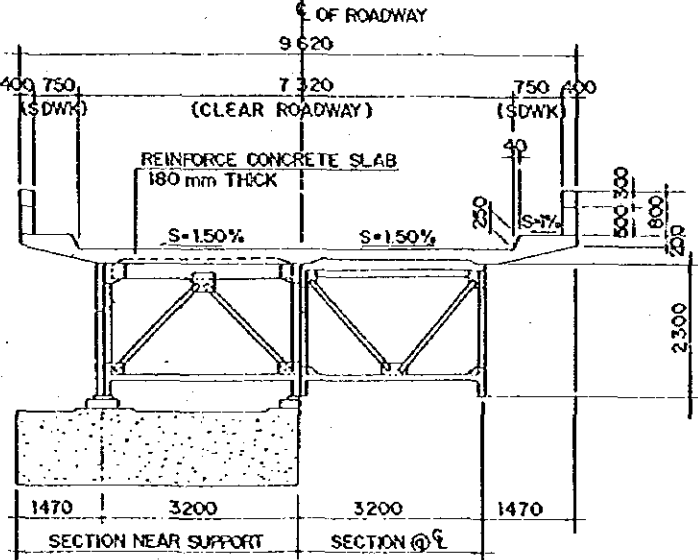
FIGURE 10.4-4 ALTERNATIVE SCHEMES FOR GOVERNOR MIRANDA BRIDGE (2/2)

<p>TOTAL LENGTH OF BRIDGE = 650.00 (BACK TO BACK OF BACKWALL) 14 EQUAL SPANS @ 46.400 = 650.000</p> <p>Δ MHL = 5.00 Δ OWL = 0.00 RIVER BED</p> <p>A1 P1 P2 P3 P4 P5 P6 P7 P8 P9 P10 P11 P12 P13 A2</p>	<p>STEEL PLATE GIRDER BRIDGE</p>

<p>TOTAL LENGTH OF BRIDGE = 650.000 (BACK TO BACK OF BACKWALL) 14 EQUAL SPANS @ 46.400 = 650.000</p> <p>Δ MFWL = 5.00 Δ OWL = 0.00 RIVER BED</p> <p>A1 P1 P2 P3 P4 P5 P6 P7 P8 P9 P10 P11 P12 P13 A2</p>
SUPERSTRUCTURE CROSS - SECTION

<p>€ OF BRIDGE</p> <p>TOTAL WIDTH = 9.620</p> <p>1.150 3.660 3.660 1.150</p> <p>50.000 (CLEAR ROADWAY) (CLEAR ROADWAY)</p> <p>100x100 FILLET</p> <p>TYPE V-AASHTO GIRDER (MODIFIED)</p> <p>€ OF GIRDER</p> <p>2.200 1.100 1.100 2.200</p> <p>S=1.7% S=7%</p>

<p>€ OF ROADWAY</p> <p>9.620</p> <p>400 750 750 400 (SDWK) (SDWK)</p> <p>7.320 (CLEAR ROADWAY)</p> <p>REINFORCE CONCRETE SLAB 180 mm THICK</p> <p>S=1.50% S=1.50% S=7%</p> <p>500 300 800 200</p> <p>2.300</p> <p>SECTION NEAR SUPPORT SECTION @ €</p> <p>1470 3200 3200 1470</p>

CONSTRUCTION COST (P)	142,800,000	157,600,000
%	101	112
REMARKS	<p>ADVANTAGES :</p> <ol style="list-style-type: none"> 1. LEAST NUMBER OF PIERS (13) MAKES CONSTRUCTION OF SUBSTRUCTURES SHORTEST. 2. LEAST PIERS MEANS LEAST DISTURBANCE TO WATER FLOW AND LEAST SCOUR. <p>DISADVANTAGES:</p> <ol style="list-style-type: none"> 1. MORE COST THAN SCHEME 1 2. LONG PCDG BEAMS, DIFFICULT FOR ERECTION. 	<p>ADVANTAGES :</p> <ol style="list-style-type: none"> 1. FEWER NUMBER OF PIERS (13) AND LEAST DISTURBANCE TO WATER FLOW. 2. EASIEST TO ERECT BECAUSE OF LIGHTWEIGHT. <p>DISADVANTAGES :</p> <ol style="list-style-type: none"> 1. MATERIAL MUST BE IMPORTED MEANING LONG LEAD TIME AND PAID FOR IN FOREIGN CURRENCY THUS INCREASING FOREIGN COST OF THE PROJECT. 2. STEEL BRIDGE REQUIRE MORE MAINTENANCE AND FREQUENT PAINTING. 3. STEEL CORRODES IF NOT PROPERLY MAINTAINED. 4. MOST EXPENSIVE SCHEME.
ADOPTED SCHEME	NOT RECOMMENDED	NOT RECOMMENDED

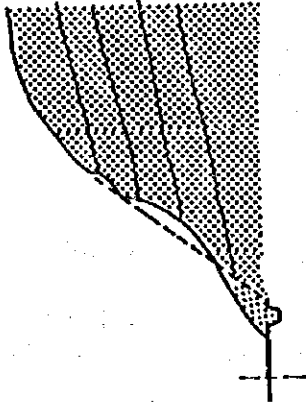
TYPE OF DISASTER	CAUSE OF DISASTER	ILLUSTRATION	APPLICABLE WORKS
CUT SLOPE FAILURE	Failure of highly weathered layer due to drying up or erosion by surface water.

<p>a) Re-cutting with stable gradient</p> <p>b) Protection works: <ul style="list-style-type: none"> - Concrete spraying - Concrete crib - Anchor work - Walling </p> <p>c) Catch Work <ul style="list-style-type: none"> - Concrete catch wall </p>
	Failure of slope due to developed cracks.

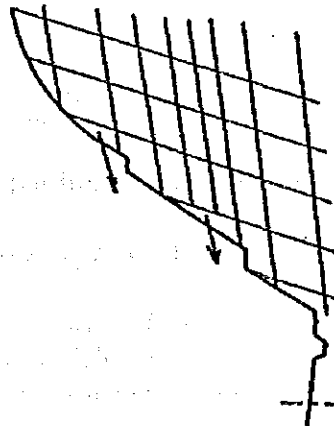
<p>a) Re-cutting with stable gradient</p> <p>b) Protection Works: <ul style="list-style-type: none"> - Concrete spraying - Concrete crib - Anchor work </p> <p>c) Catch Work <ul style="list-style-type: none"> - Concrete catch wall </p>

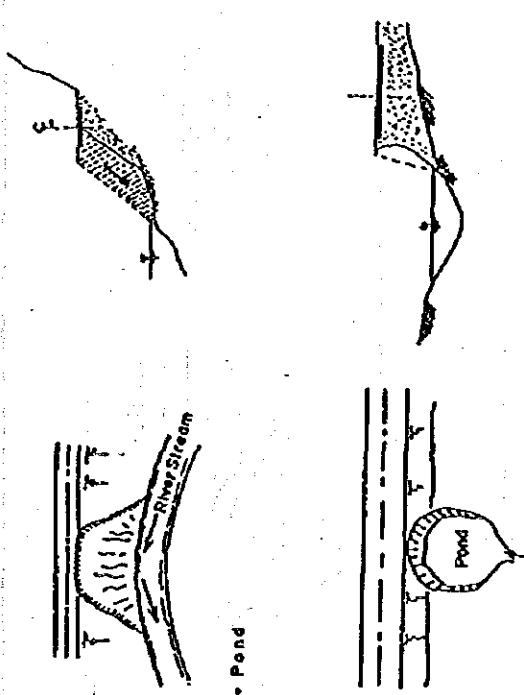
TYPE OF DISASTER	CAUSE OF DISASTER	ILLUSTRATION	APPLICABLE WORKS
<p>EMBANKMENT SLOPE FAILURE</p>	<p>Failure of slope caused by scour due to effect of river stream, or due to rising/lowering of pond water level.</p>

<p>a) Retaining Walls: - Gabion wall - Concrete wall - Grouted riprap</p> <p>b) Protection works: - Concrete crib - Concrete pitching - Cylinder gabion</p>
	<p>Failure caused by erosion due to concentrated surface water, especially on curved or sagged portion.</p>

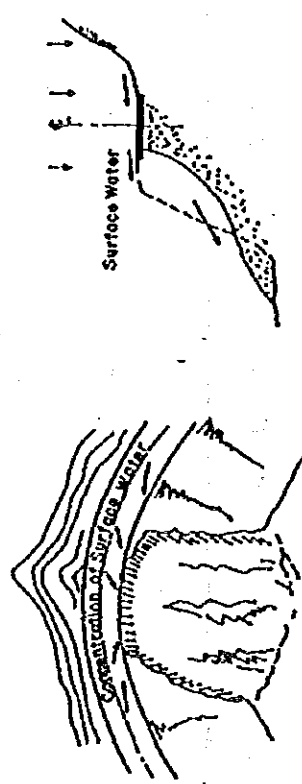
<p>a) Retaining Wall: - Concrete wall</p> <p>b) Protection Works: - Grouted riprap - Concrete crib - Concrete pitching - Concrete pavement of shoulder</p> <p>c) Drainage Works: - Vertical ditch - Water channel - RCP/RIBC</p>

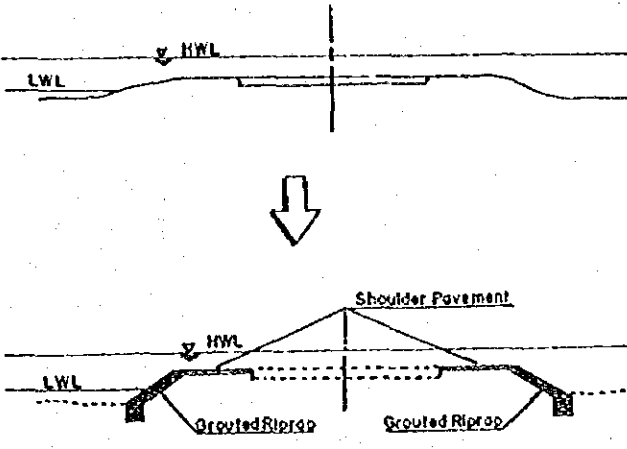
Sample Illustration	Description of Method	Application Criteria
<p>COUNTERMEASURE 1 Protection of Road</p>

<ul style="list-style-type: none"> - Protect the road with grouted riprap and shoulder pavement. - Adequate capacity of side ditch and cross drainage facilities shall be installed. 	<ul style="list-style-type: none"> - Flood elevation is not so high. - No mud/debris flow. - Suitable to urbanized area. - Suitable to area where flood interception canal doesn't work properly.
<p>COUNTERMEASURE 2 Flood Interception Canal</p>

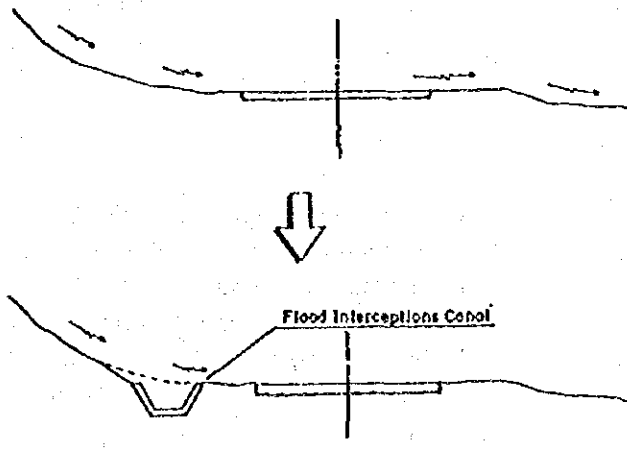
<ul style="list-style-type: none"> - Install adequate capacity of flood interception canal. - Size of canal is dependent on flood discharge and distance to convey flood water. - Grouted riprap and shoulder pavement may be provided if there still be possibility of overflow. - Cross drainage facility such as RCPC, RCBC shall be installed at proper location. 	<ul style="list-style-type: none"> - Flood depth is not so deep. - No mud/debris flow accompanied. - Suitable to urbanized area. - Periodic dredging of canal is required.

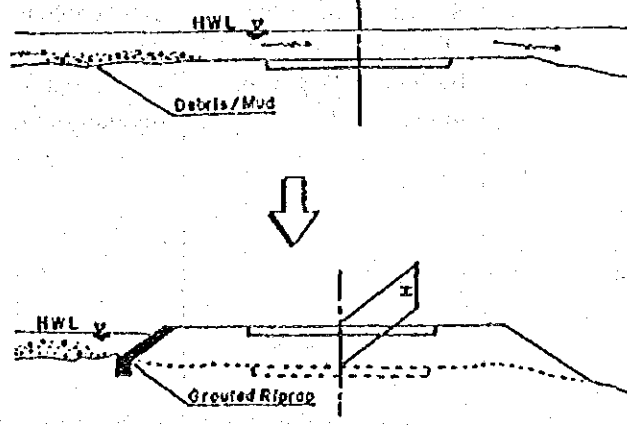
<p>COUNTERMEASURE 3 Raise of Road</p>

<ul style="list-style-type: none"> - Raise the road above expected high water level. - Height of embankment is dependent on elevation of flood water. - Embankment slope exposed to flood water may be protected by grouted riprap. - Cross drainage facility such as RCPC, RCBC shall be installed at proper location. 	<ul style="list-style-type: none"> - Flood elevation is high. - Mud/debris flow accompanied. - Suitable to not urbanized area.

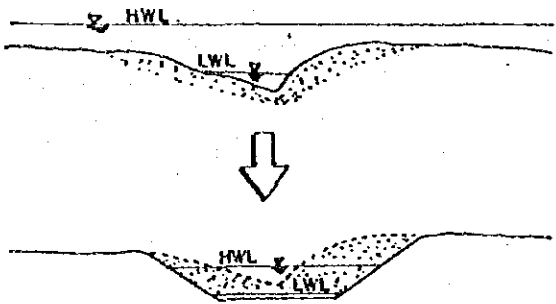
Sample Illustration	Description of Method	Application Criteria
<p>COUNTERMEASURE 4 Riverbed Dredging</p>

<ul style="list-style-type: none"> - Remove sediments on the river by excavation. - Dimension of river is determined based on amount of discharge and nature of river channel. 	<ul style="list-style-type: none"> - Applicable to rivers in alluvial fan which exhibits excessive sedimentation and aggradation of riverbed. - Periodic dredging is required to maintain stream steady.
<p>COUNTERMEASURE 5 Sabo Dam</p>

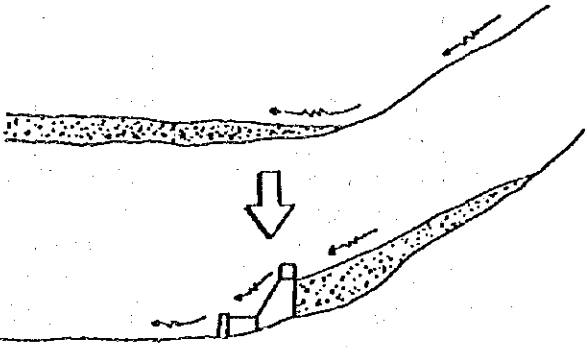
<ul style="list-style-type: none"> - Construct sabo dam at top of an alluvial fan. - Exact location and size of dam shall be determined by experienced engineer after thorough investigation. 	<ul style="list-style-type: none"> - Applicable to middle or minor rivers in alluvial fan. - Additional sabo dam may be required at upstream when downstream dam is filled with sediments.
<p>COUNTERMEASURE 6 Dike</p>

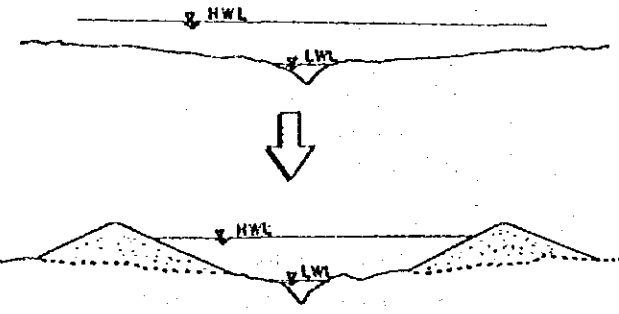
<ul style="list-style-type: none"> - Construct earth dike high enough to prevent flood water spilling-out. - Embankment slope may be protected by grouted riprap if velocity of flood is high. 	<ul style="list-style-type: none"> - Applicable to rivers in flat plain. - Rivers whose surrounding area has economically high value.

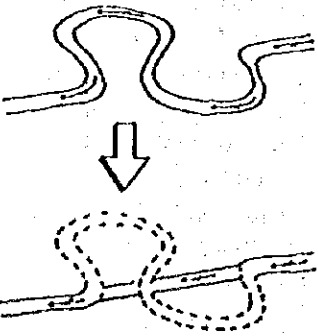
<p>COUNTERMEASURE 7 Cut-off Channel</p>

<ul style="list-style-type: none"> - Straighten river channel at meandering section by introducing man-made canal. 	<ul style="list-style-type: none"> - Applicable to rivers in flat plain whose water course meanders significantly.
