JAPAN INTERNATIONAL COOPERATION AGENCY (JICA)
 THE STUDY ON THE DEVELOPMENT OF
 WATER SUPPLY SYSTEM FOR THE DAMASCUS CITY
 Figure E-1.1 Key Plan of Service Districts
 NIPPON KOEI CO., LTD.

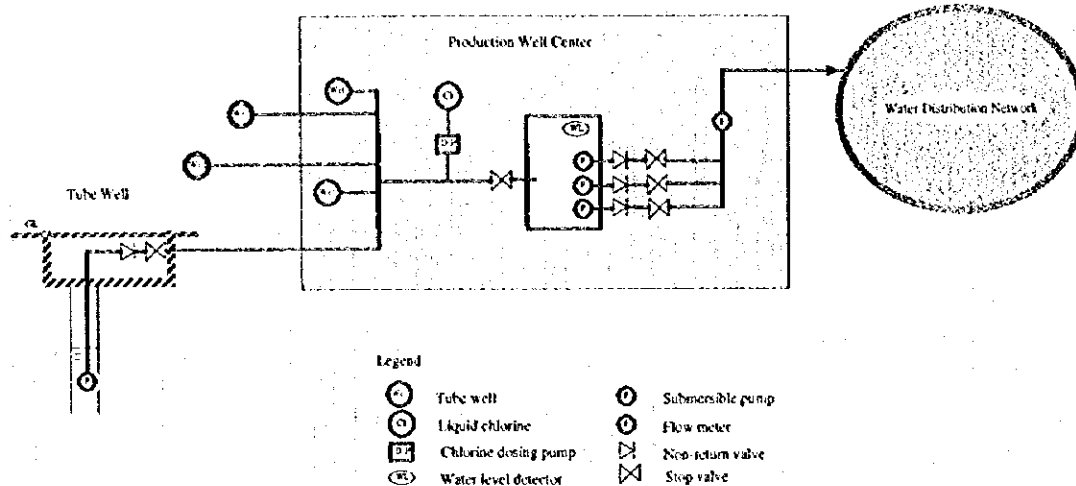
Typical System Diagram

JAPAN INTERNATIONAL COOPERATION AGENCY (JICA)
 THE STUDY ON THE DEVELOPMENT OF
 WATER SUPPLY SYSTEM FOR THE DAMASCUS CITY
 Figure E-3.3 Typical System Diagram
 of Production Well Center
 NIPPON KOEI CO., LTD.

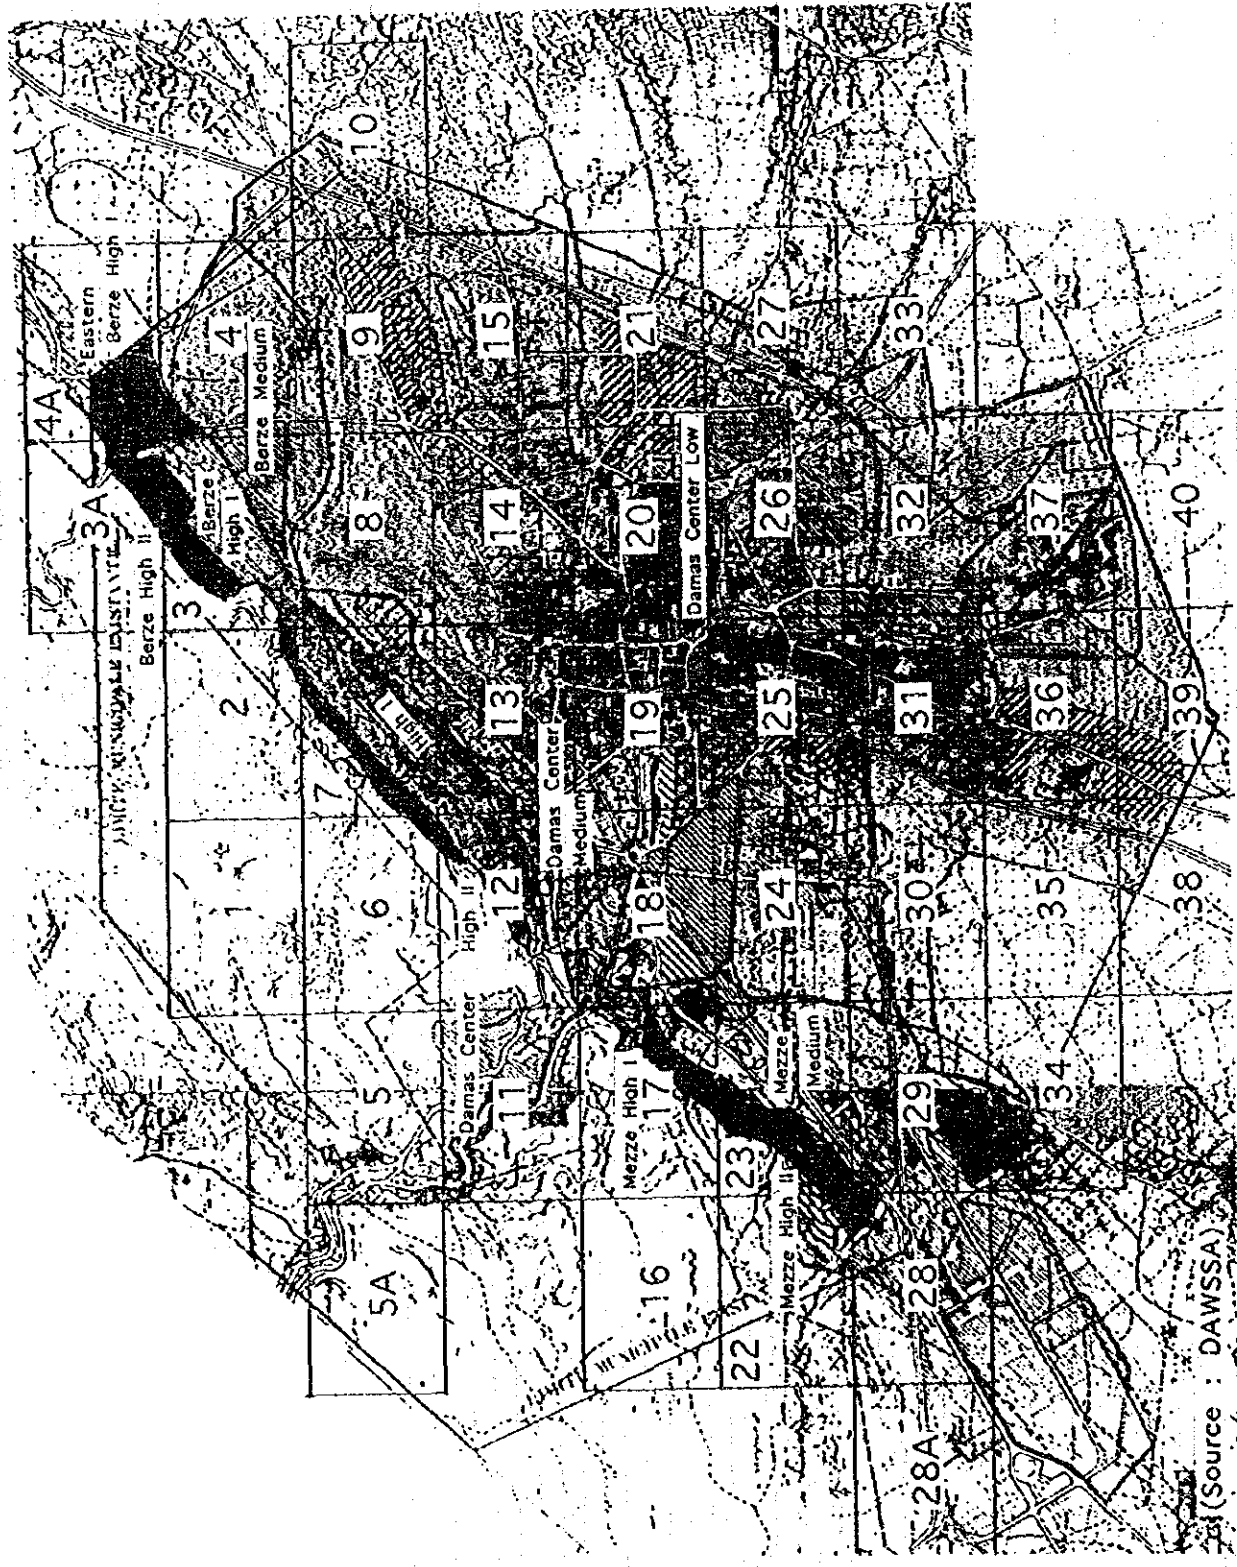
JAPAN INTERNATIONAL COOPERATION AGENCY (JICA)
 THE STUDY ON THE DEVELOPMENT OF
 WATER SUPPLY SYSTEM FOR THE DAMASCUS CITY
 Figure E-4.1 Pressure Zones and Official Area No.
 NIPPON KOEI CO., LTD.
