THE STUDY ON THE DEVELOPMENT PLAN OF THE PORT OF BALBOA IN THE REPUBLIC OF PANAMA

FINAL REPORT

PART III SHORT-TERM PLAN

THE OVERSEAS COASTAL AREA DEVELOPMENT INSTITUTE OF JAPAN (OCDI)
PACIFIC CONSULTANTS INTERNATIONAL (PCI)

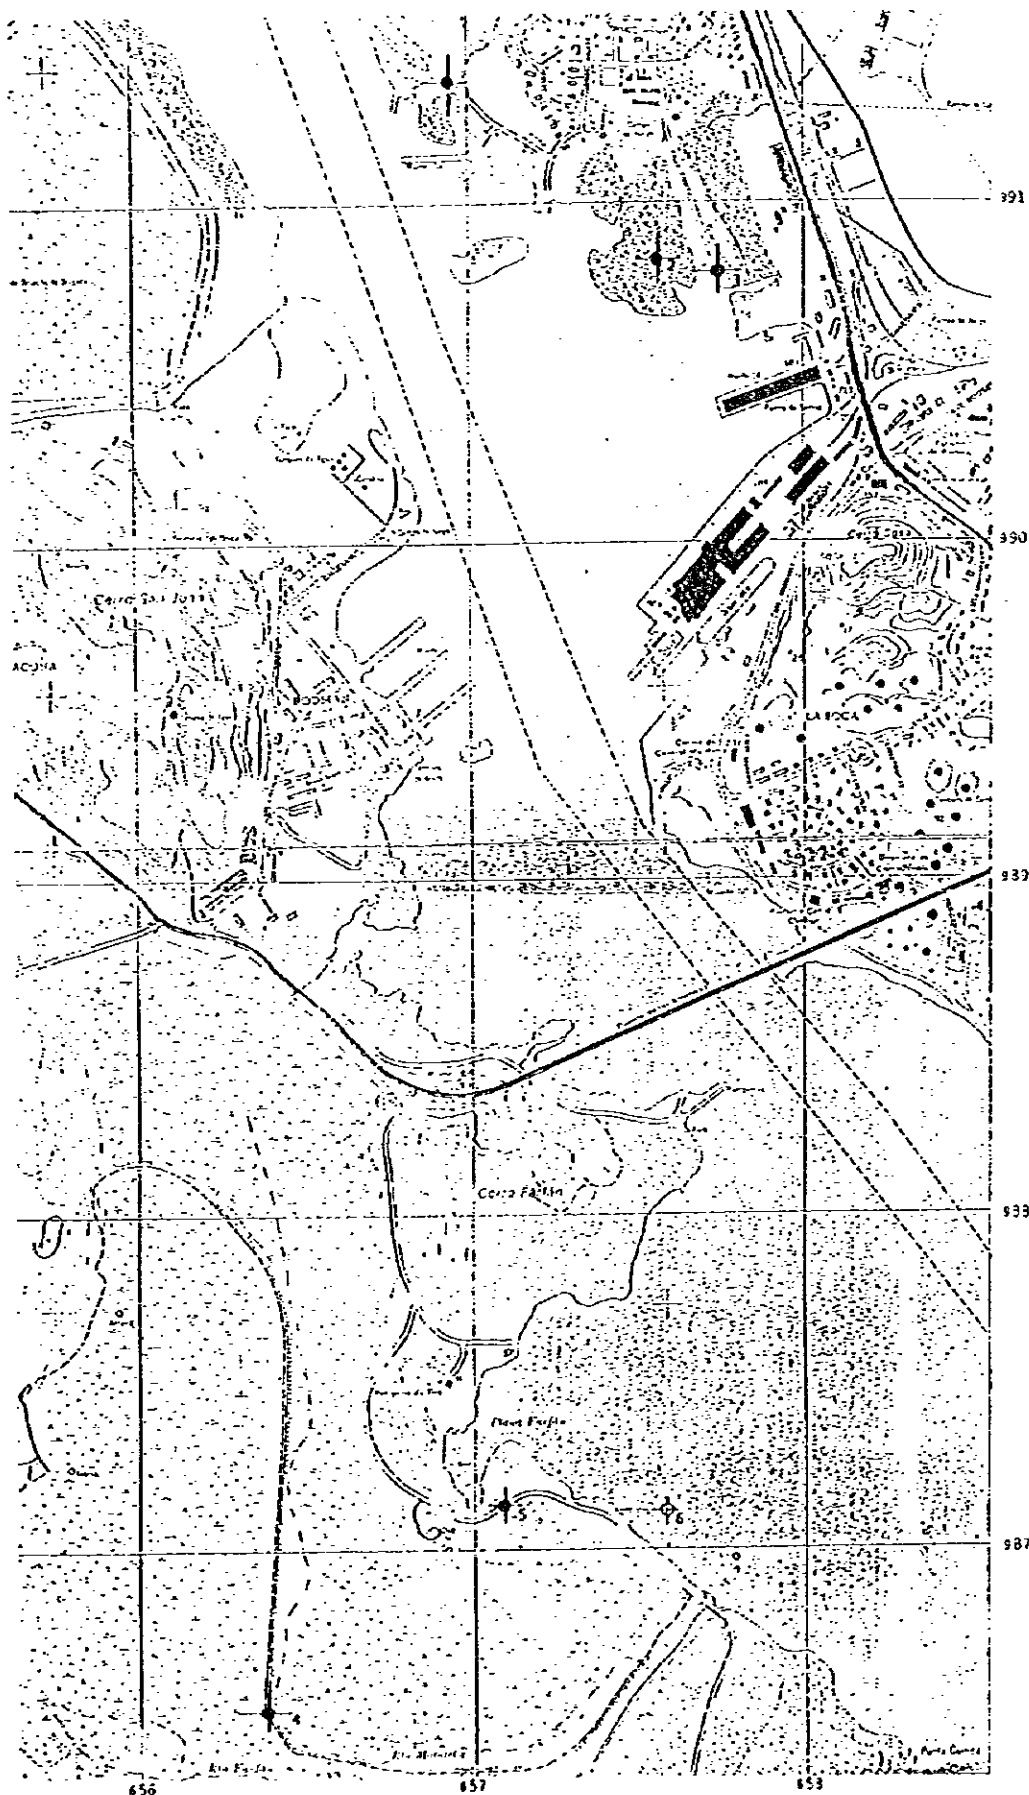
Figure 2-1-7 Location of Borehole Exploration

LOCATION DETAIL

Job No. 4-171
 Project : Development of the Port of Balboa
 Location: The Bay of Panama, entrance to the Panama Canal, Republic of Panama
 Client : PACIFIC CONSULTANTS INTERNATIONAL
 Date : December 1996

9. The JICA Study Team conducted at Diablo three borehole subsoil exploration at the locations shown on Figure 2-1-7. The boring logs are also shown in Figure 2-1-8 to Figure 2-1-10.
