APPENDIX E

**RIVER
CONDITIONS**

THE STUDY ON SABO AND FLOOD CONTROL
IN THE LAOAG RIVER BASIN

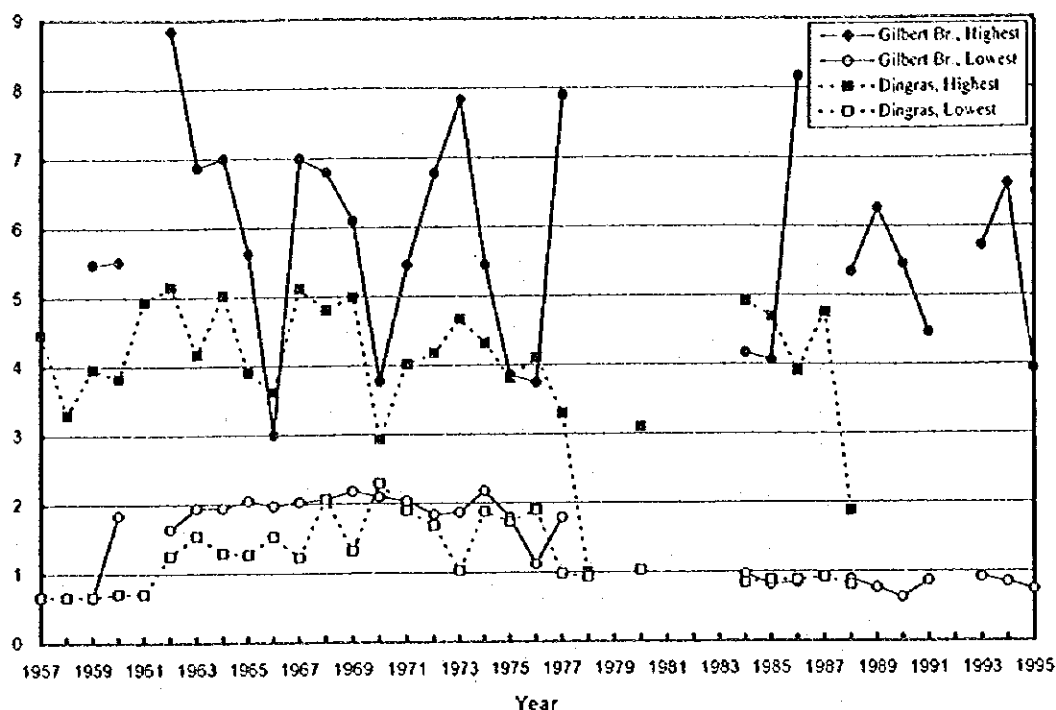
Observed Water Level by Region I Office, DPWH

Observed Water Levels at Laoag City and Dingras
from 1957 to 1995

Fig. E.1.14 shows the historical change of lowest water level at both stations. The data are adjusted in accordance with replacement of water gauge. With only observed lowest water level as tool for examining historical change, riverbed variation cannot be verified significantly.

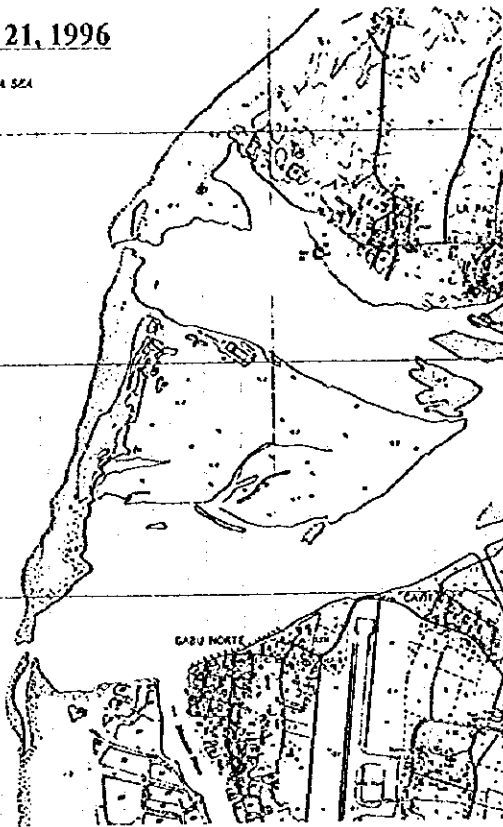
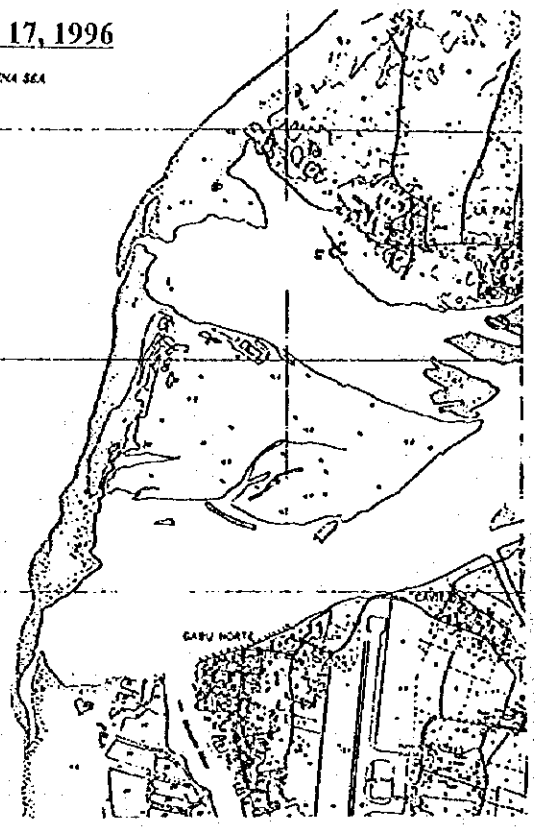
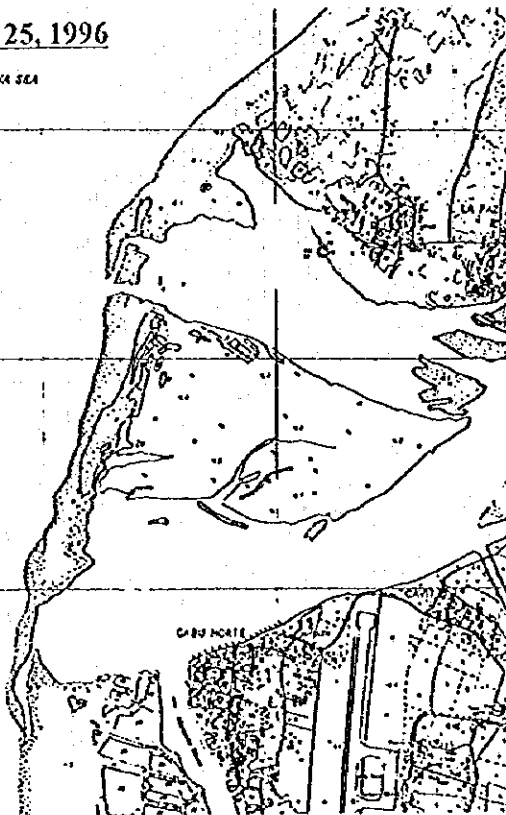
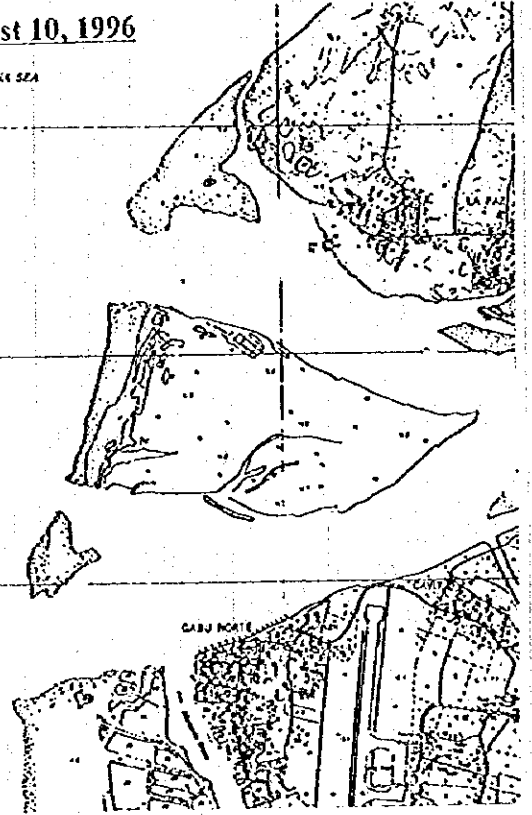
March 21, 1996

May 17, 1996

May 25, 1996

August 10, 1996

Topographic Changes of River Mouth in 1996

Topographic change of the river mouth was continuously observed during this study period. Fig. E.1.15 illustrates the topographic changes of the river mouth from the end of March to the beginning of August, 1996. The monitoring results are summarized below.

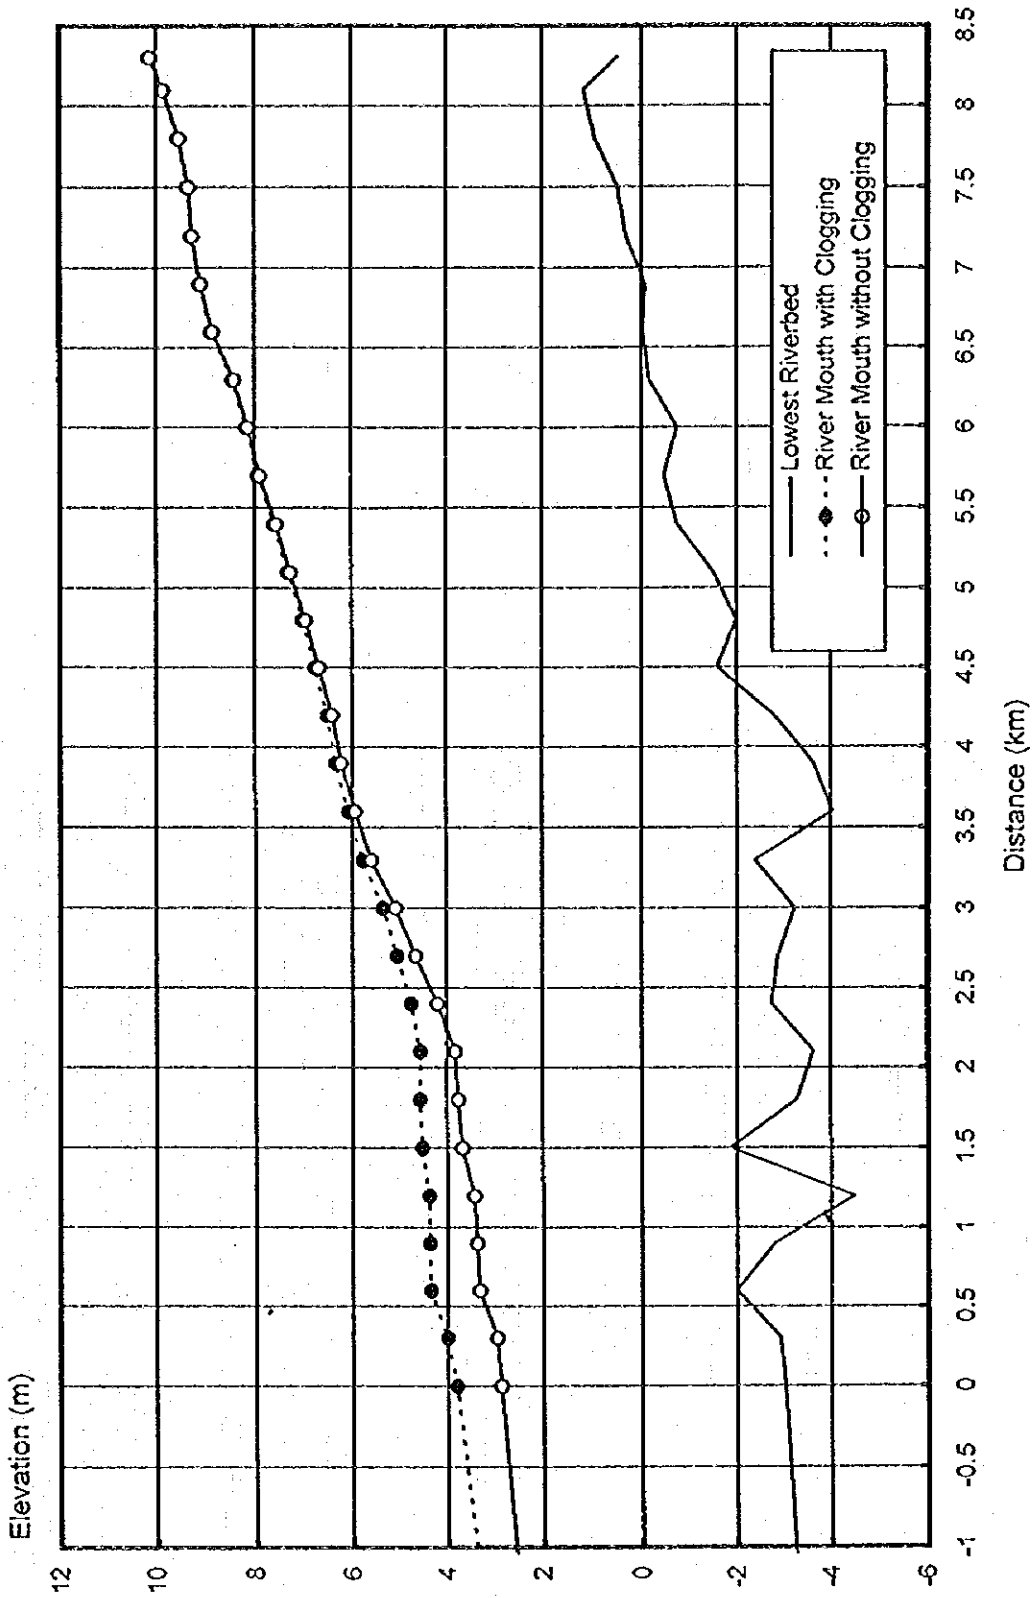
Fig. E.1.16

Backwater Effects Due to River Mouth Clogging

During the heavy rains due to Typhoon Gloring, the river-mouth bar may have been washed out in the early stage of the flood, because no inundation occurred in the two villages of La Paz and Gabu which are located along both banks near the river mouth. If there were any effects of backwater caused by river mouth clogging, these villages should have been inundated during the flood.

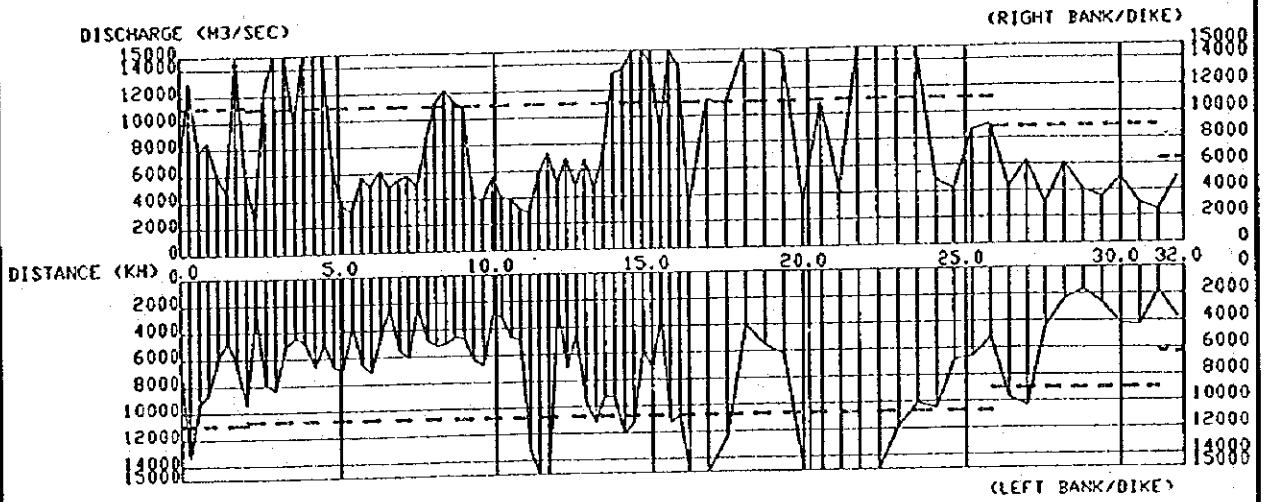
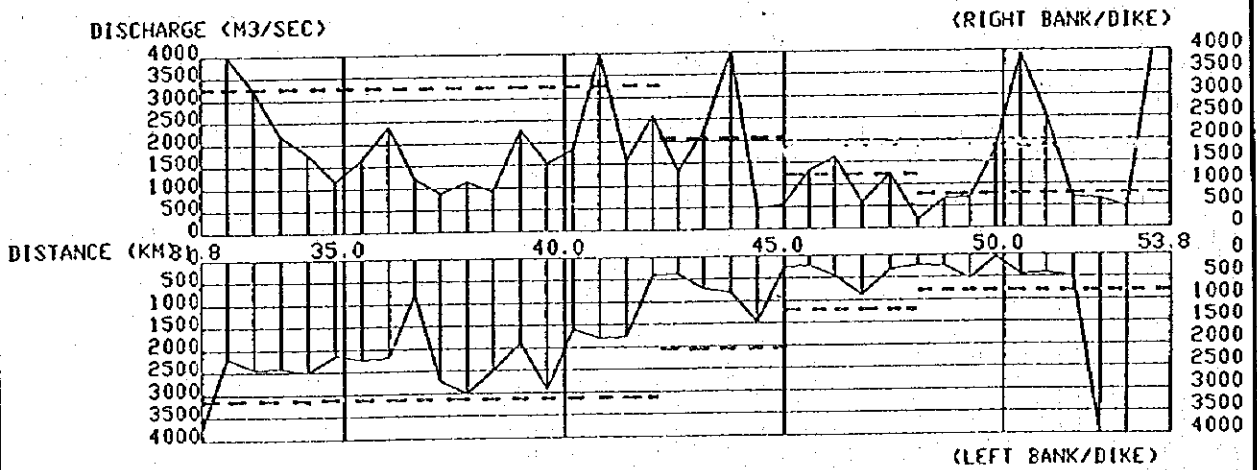
Fig. E.1.17

LAOAG RIVER PRESENT FLOW CAPACITY

BONGO RIVER PRESENT FLOW CAPACITY

-----: 25-YEAR PROBABILITY DISCHARGE

Present Flow Capacity of Laoag and Bongo Rivers

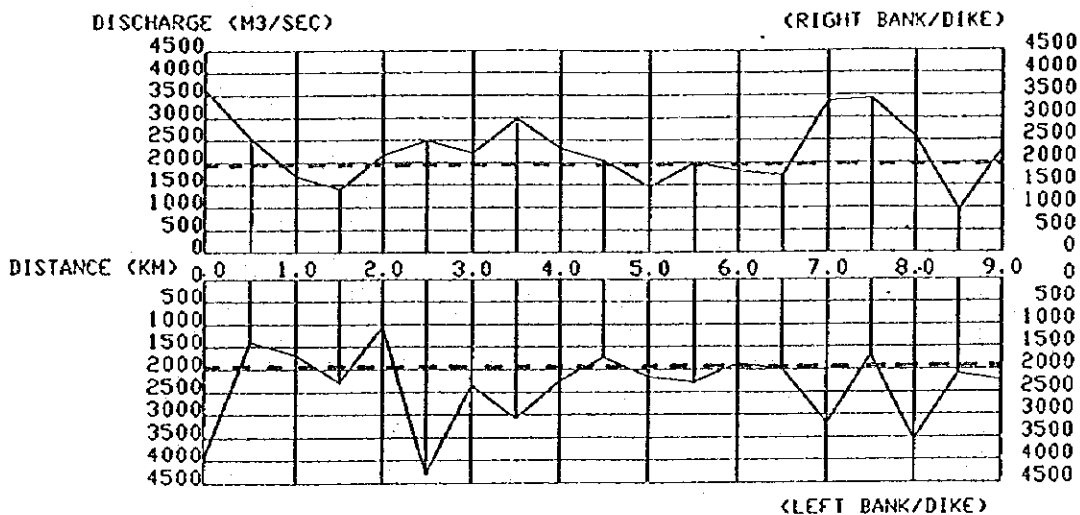
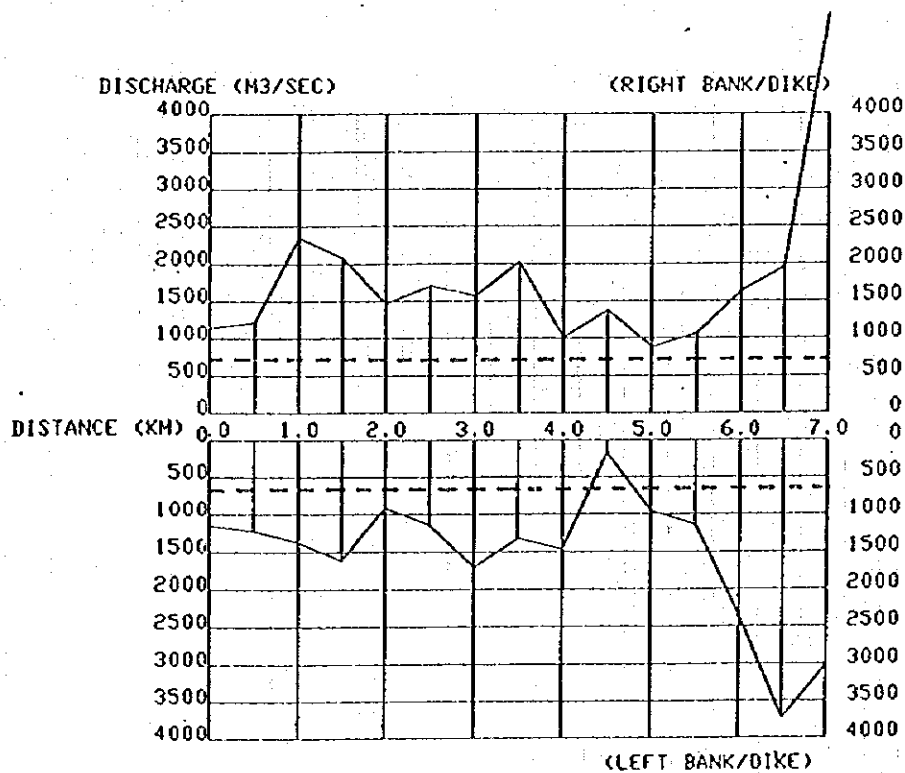
Fig. E.1.19

MADONGAN RIVER PRESENT FLOW CAPACITY

PAPA RIVER PRESENT FLOW CAPACITY

Present Flow Capacity of Madongan and Papa Rivers

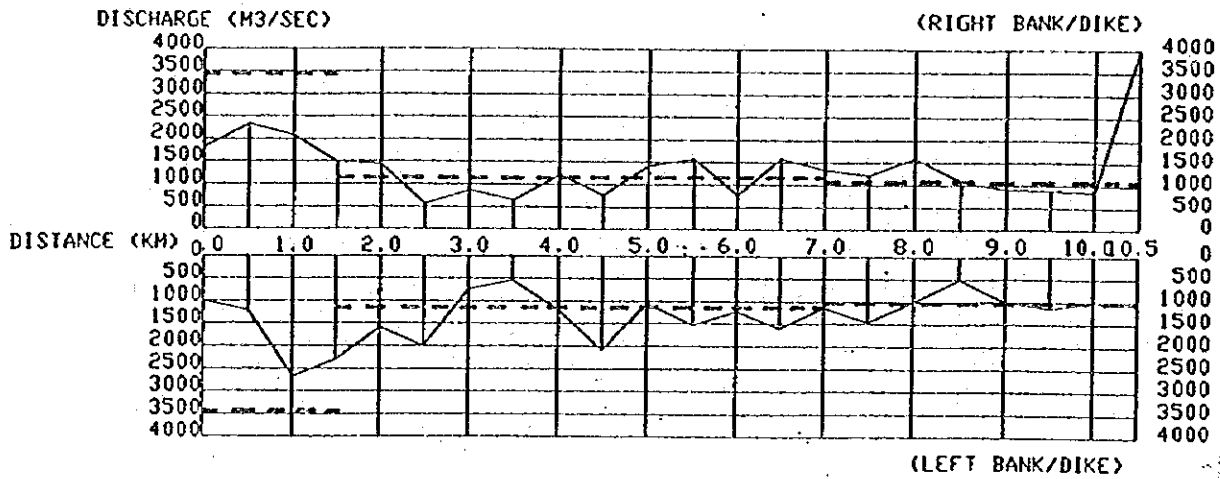
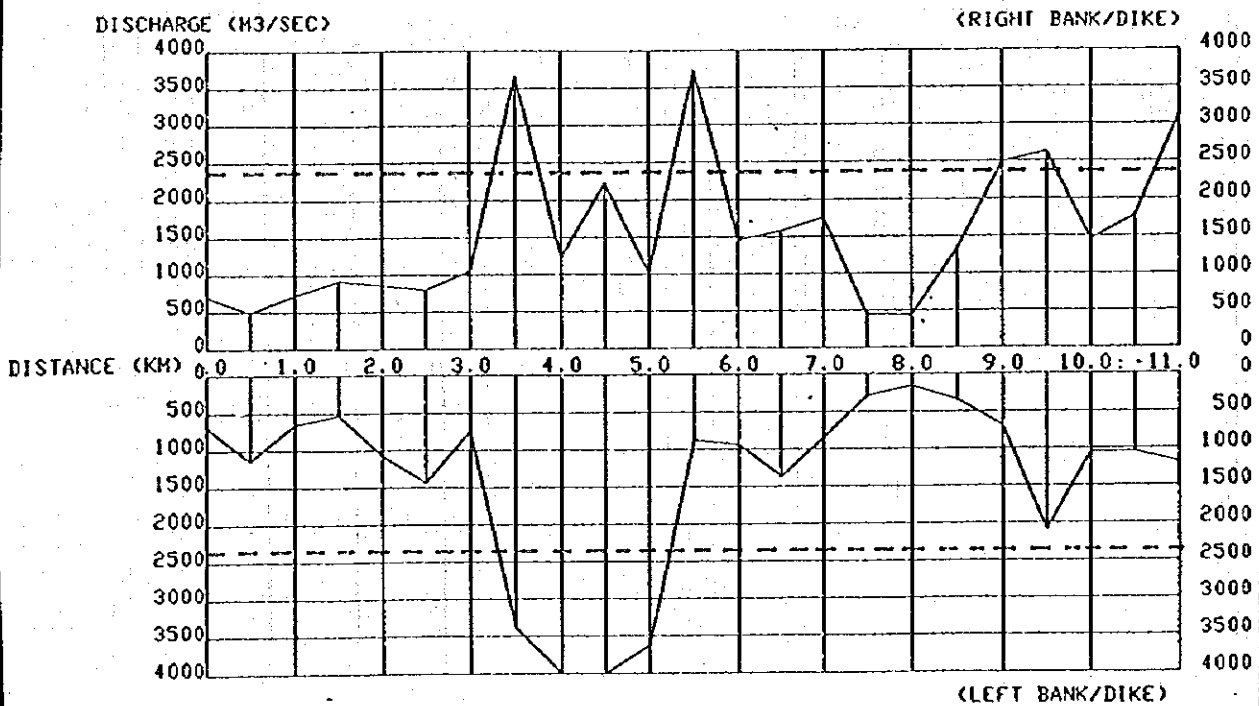
Fig. E.1.20

SOLSONA RIVER PRESENT FLOW CAPACITY

CURA RIVER PRESENT FLOW CAPACITY

Present Flow Capacity of Solsona and Cura Rivers

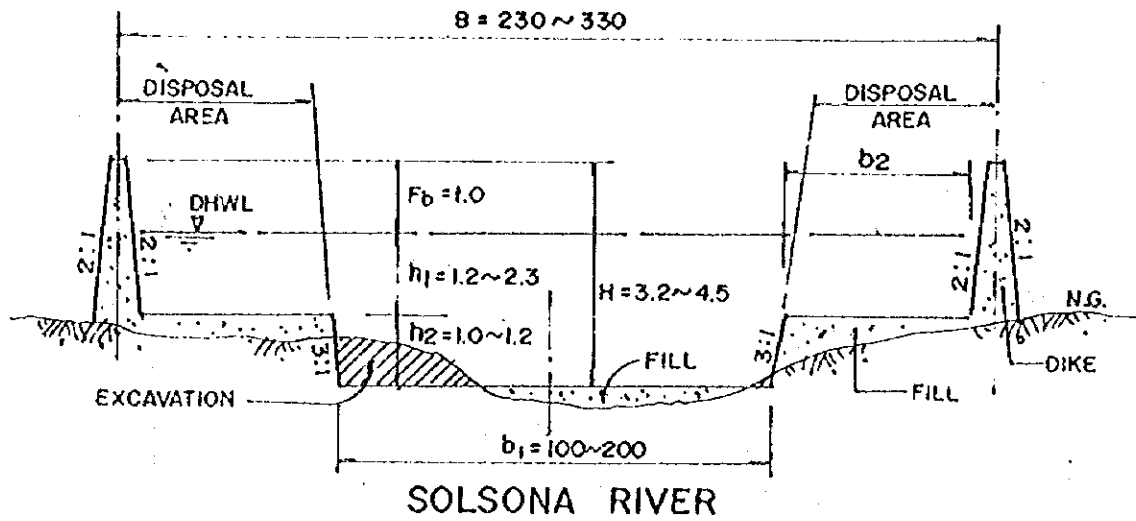
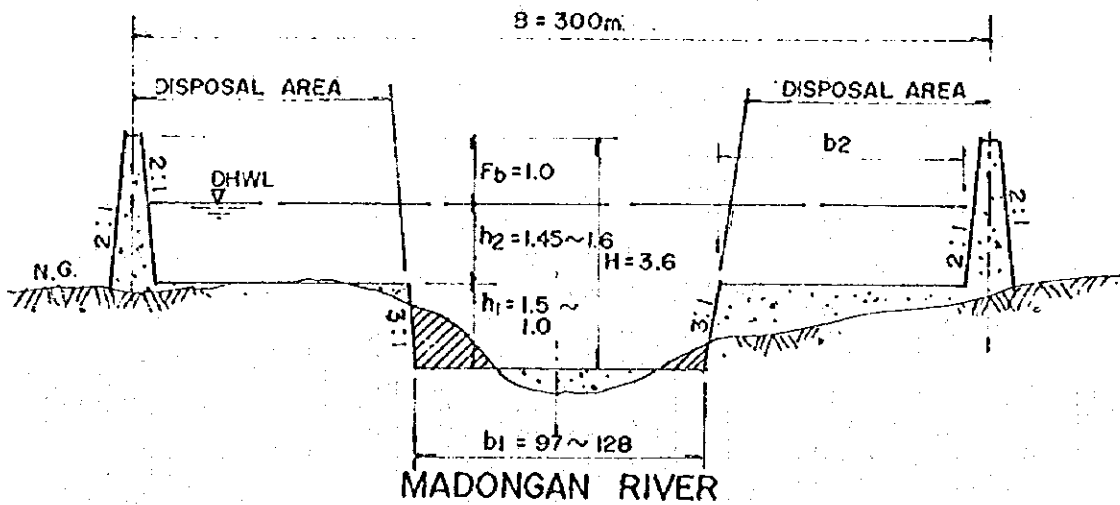
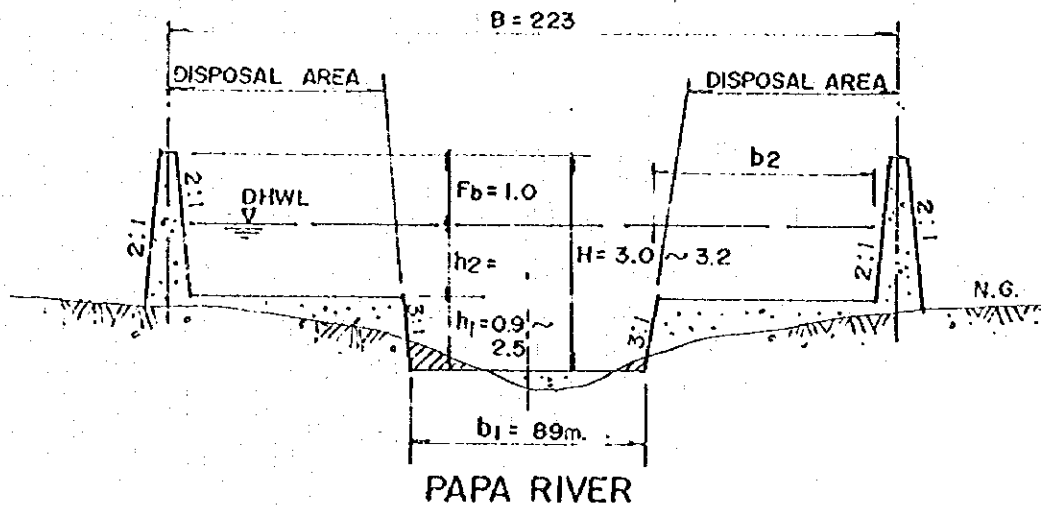
Fig. E.2.2

Standard Cross-Section of River Improvement
under UDPW

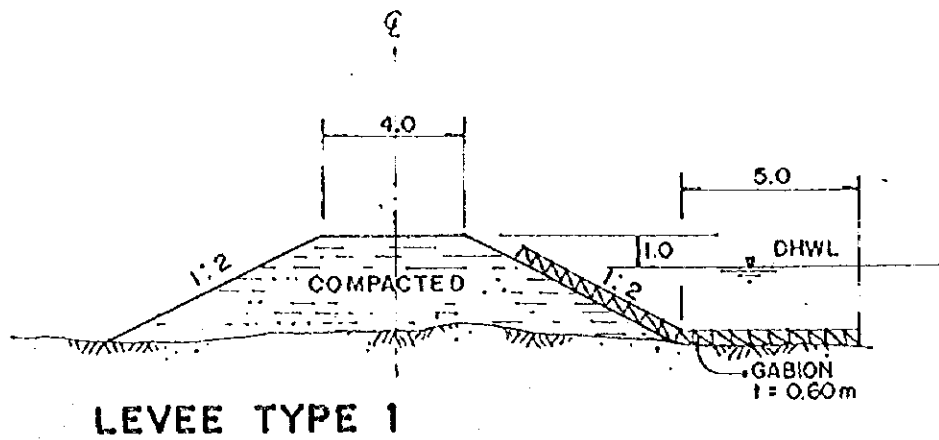
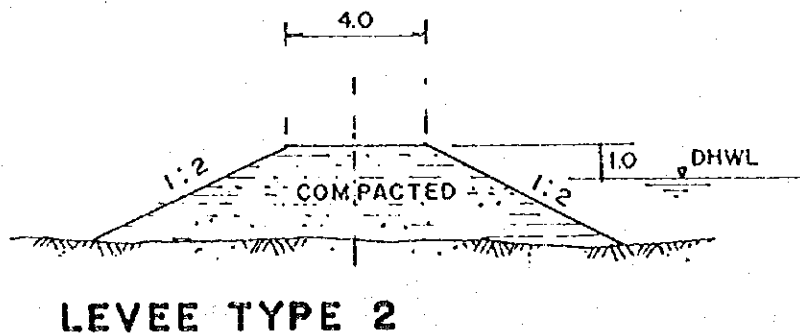
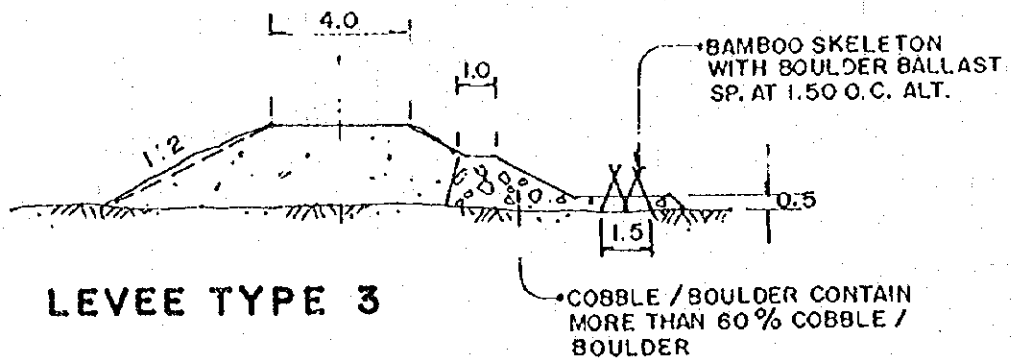
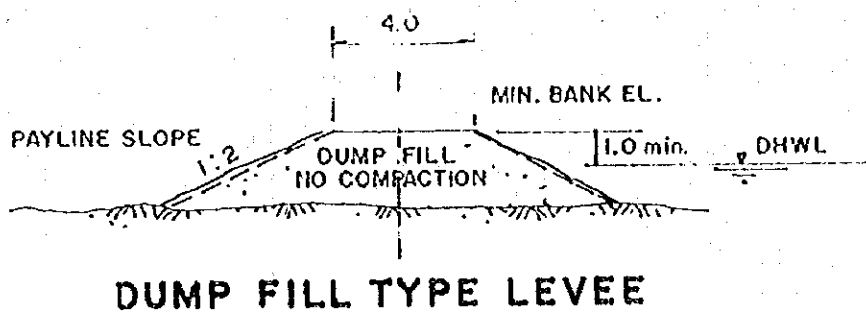
Fig. E.2.3

Existing Typical Dikes Constructed under UDPW

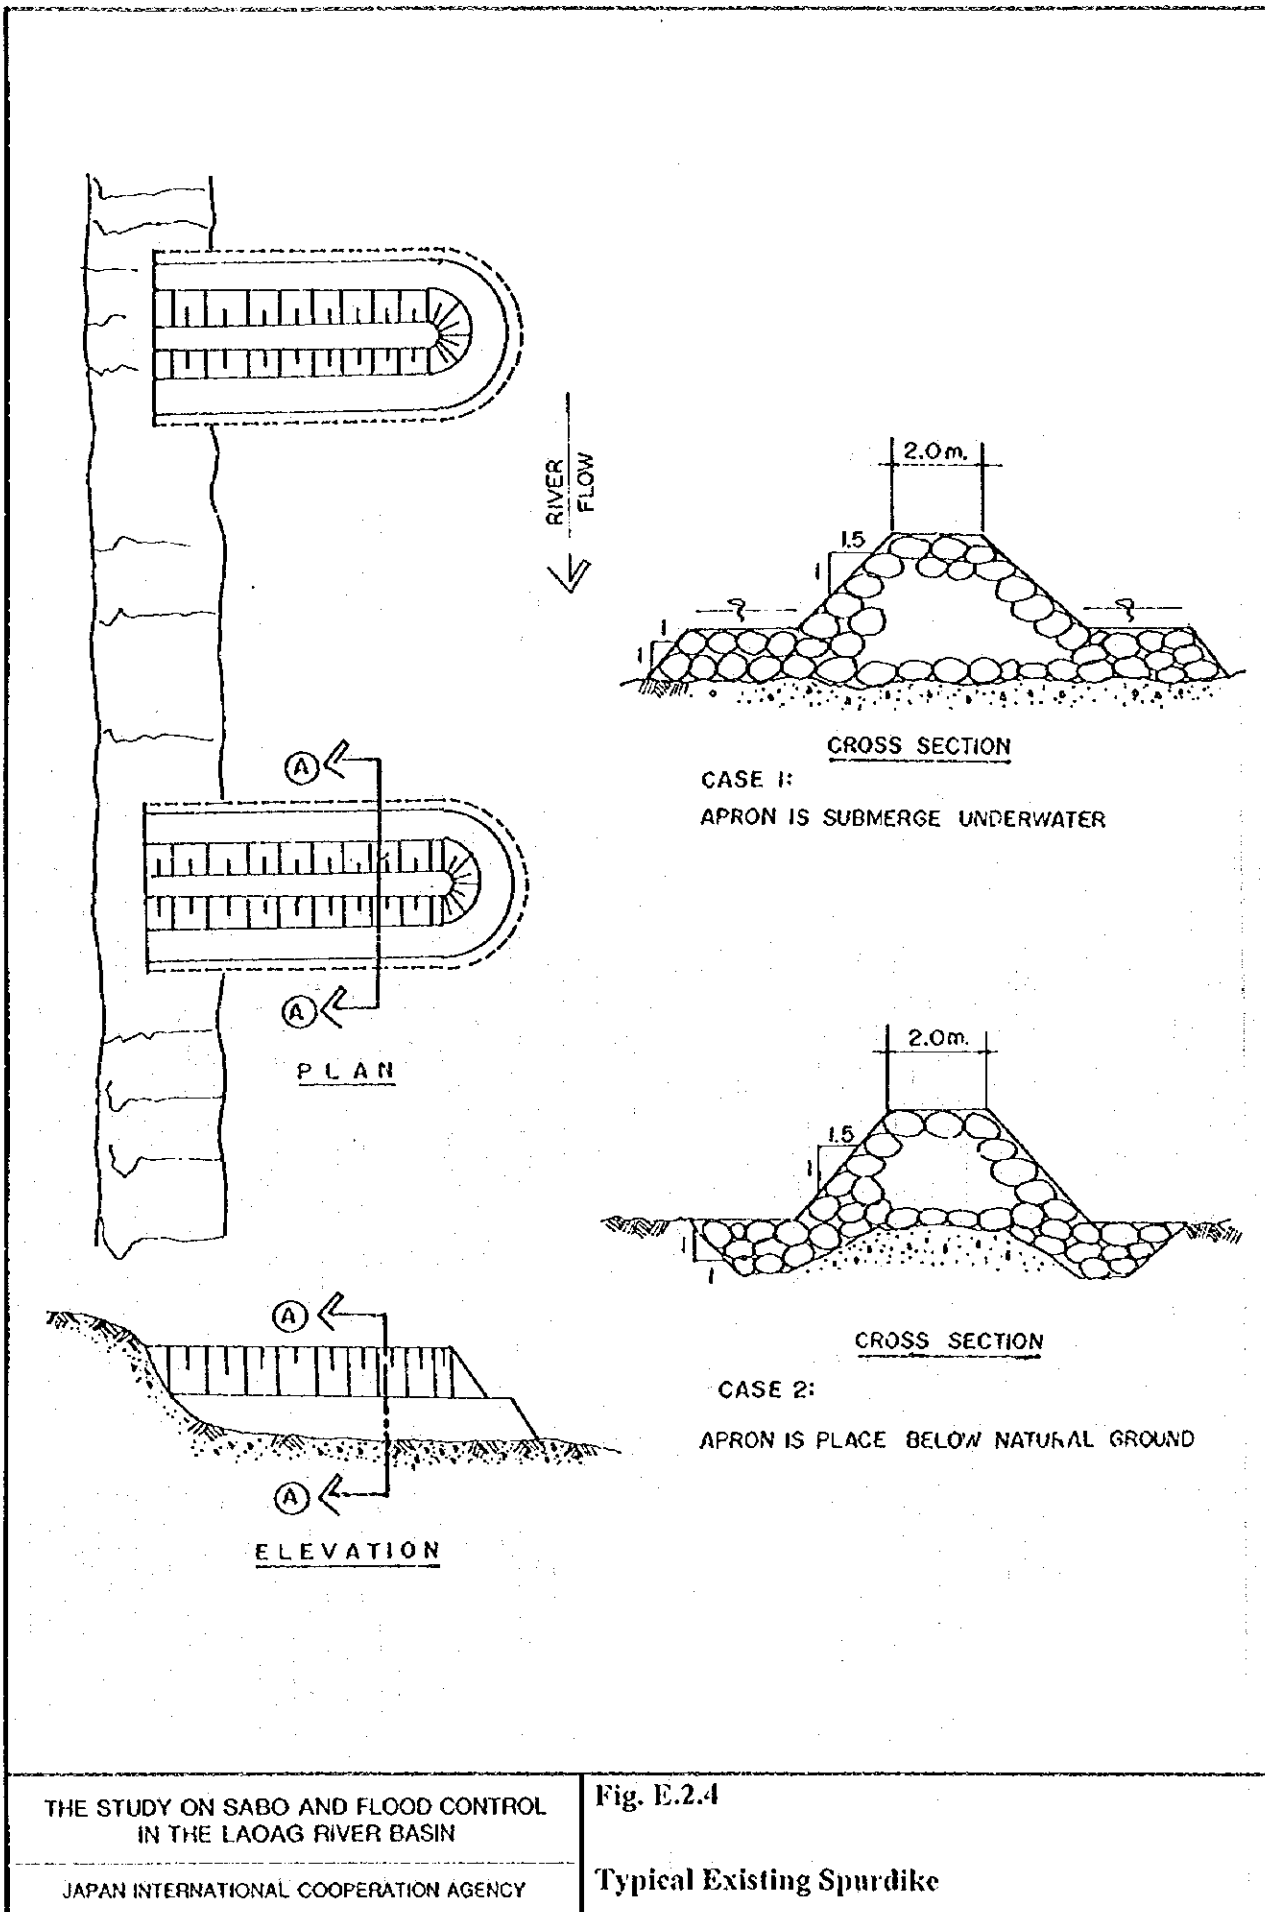
Fig. E.2.4

Typical Existing Spurdike

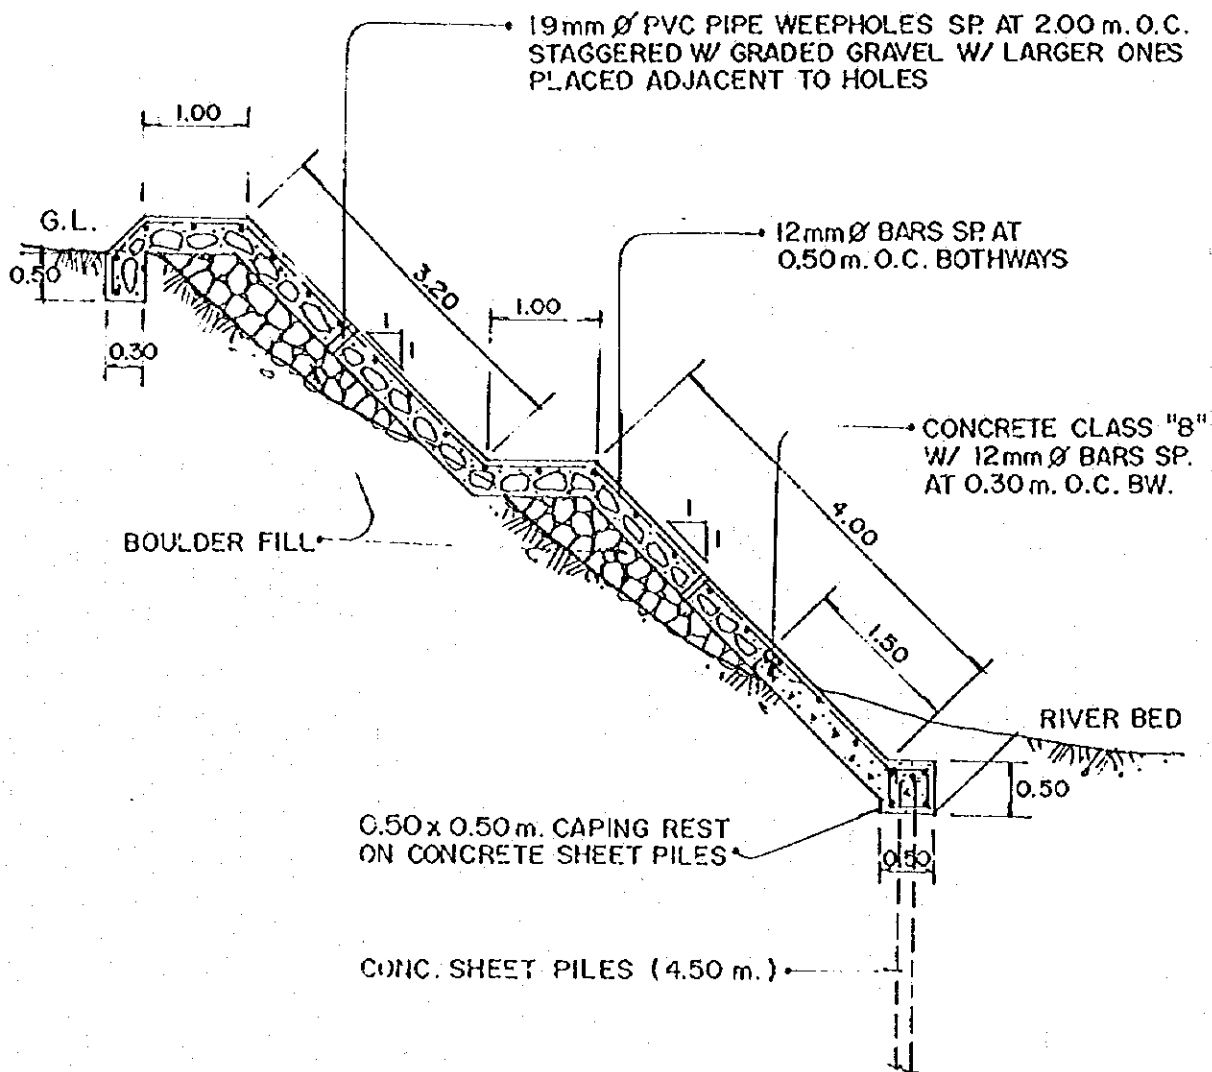
Fig. E.2.6

Existing Revetment at Laoag City

In the Laoag River System two types of revetment were constructed; stone concrete revetment and gabion mattress. Gabion type revetment can be found at the Papa, Madongan and Solsona rivers to protect the diking system. On the other hand, stone concrete revetment were provided at important locations such as the right bank of the Laoag city urban area and along the bridge approaches (refer to Fig. E.2.6; details of typical revetment).

At some sections stone concrete revetments were damaged. Observation shows that anchorage of slope protection into riverbed is not enough against toe scouring and structural strength of revetment is not sufficient to withstand itself in the absence of the toe protection; because concrete covers only the surface of stones for about 10 cm. The voids between stones should be filled with mortar to reinforce the structure.

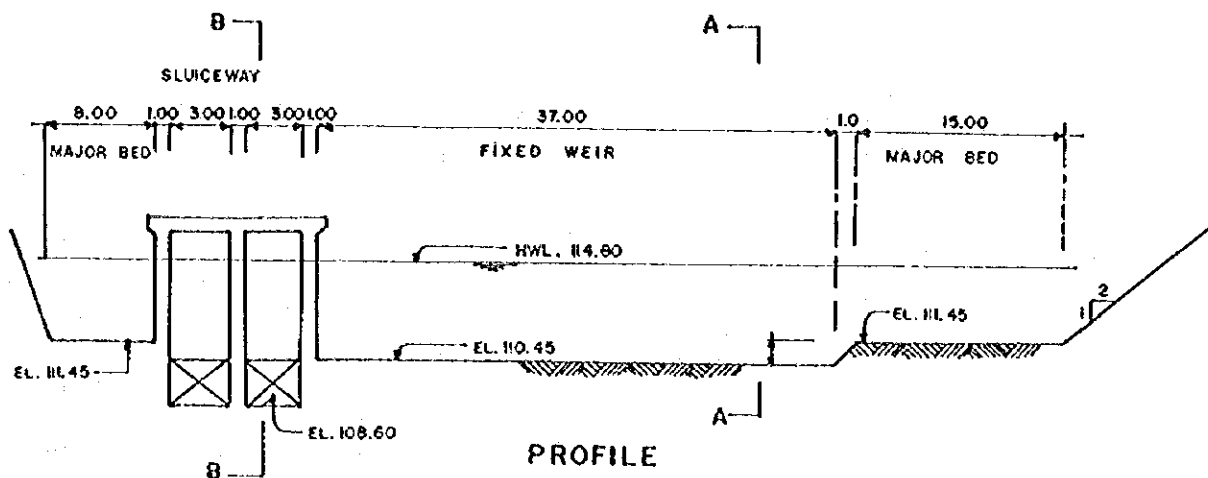
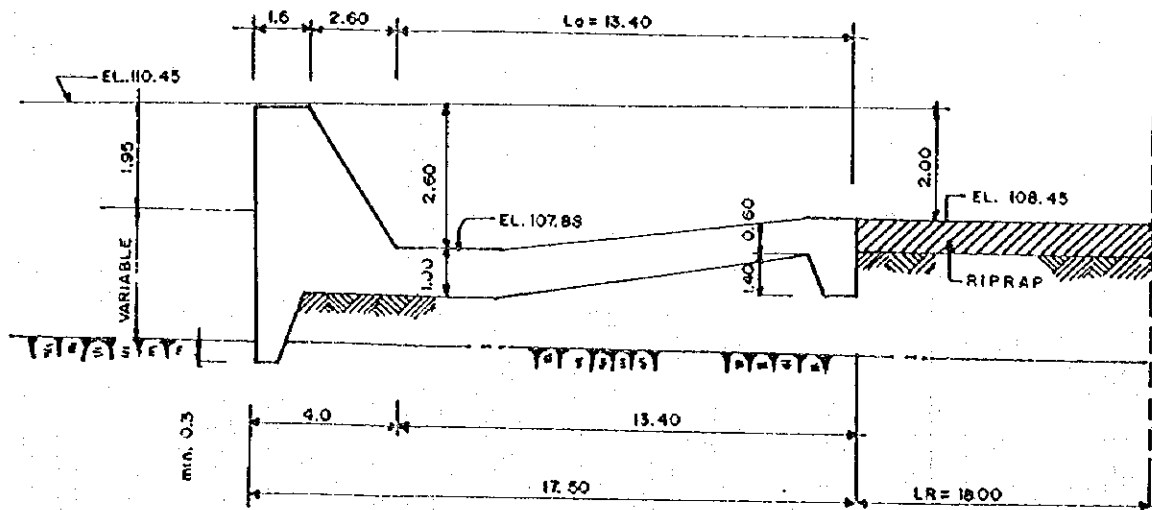
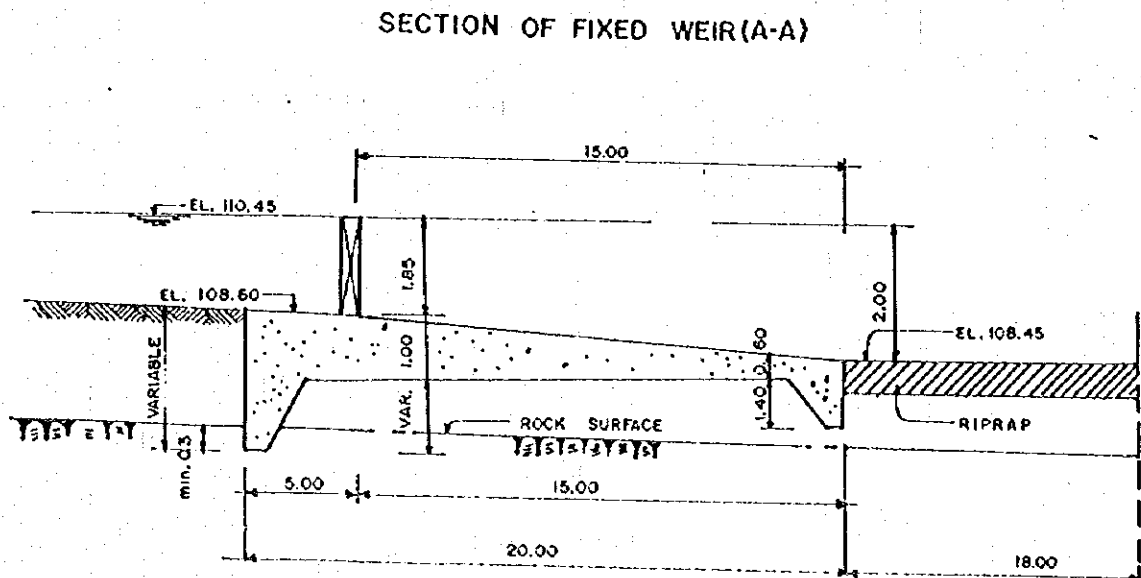
Fig. E.2.7

Existing Labugaon Diversion Dam

Diversion dams to take water for irrigation purpose were constructed as part of INIP (Phase I) in the middle 1980's. They are located at the top of alluvial fans of the Labugaon, Solsona, Madongan, Papa and Bongo rivers. Their major design features are listed in Table E.2.1 and Figs. E.2.7 to E.2.11. After the completion, these dams were repaired under the UDPW because they (especially aprons) were severely damaged by cascading boulders due to successive floods.

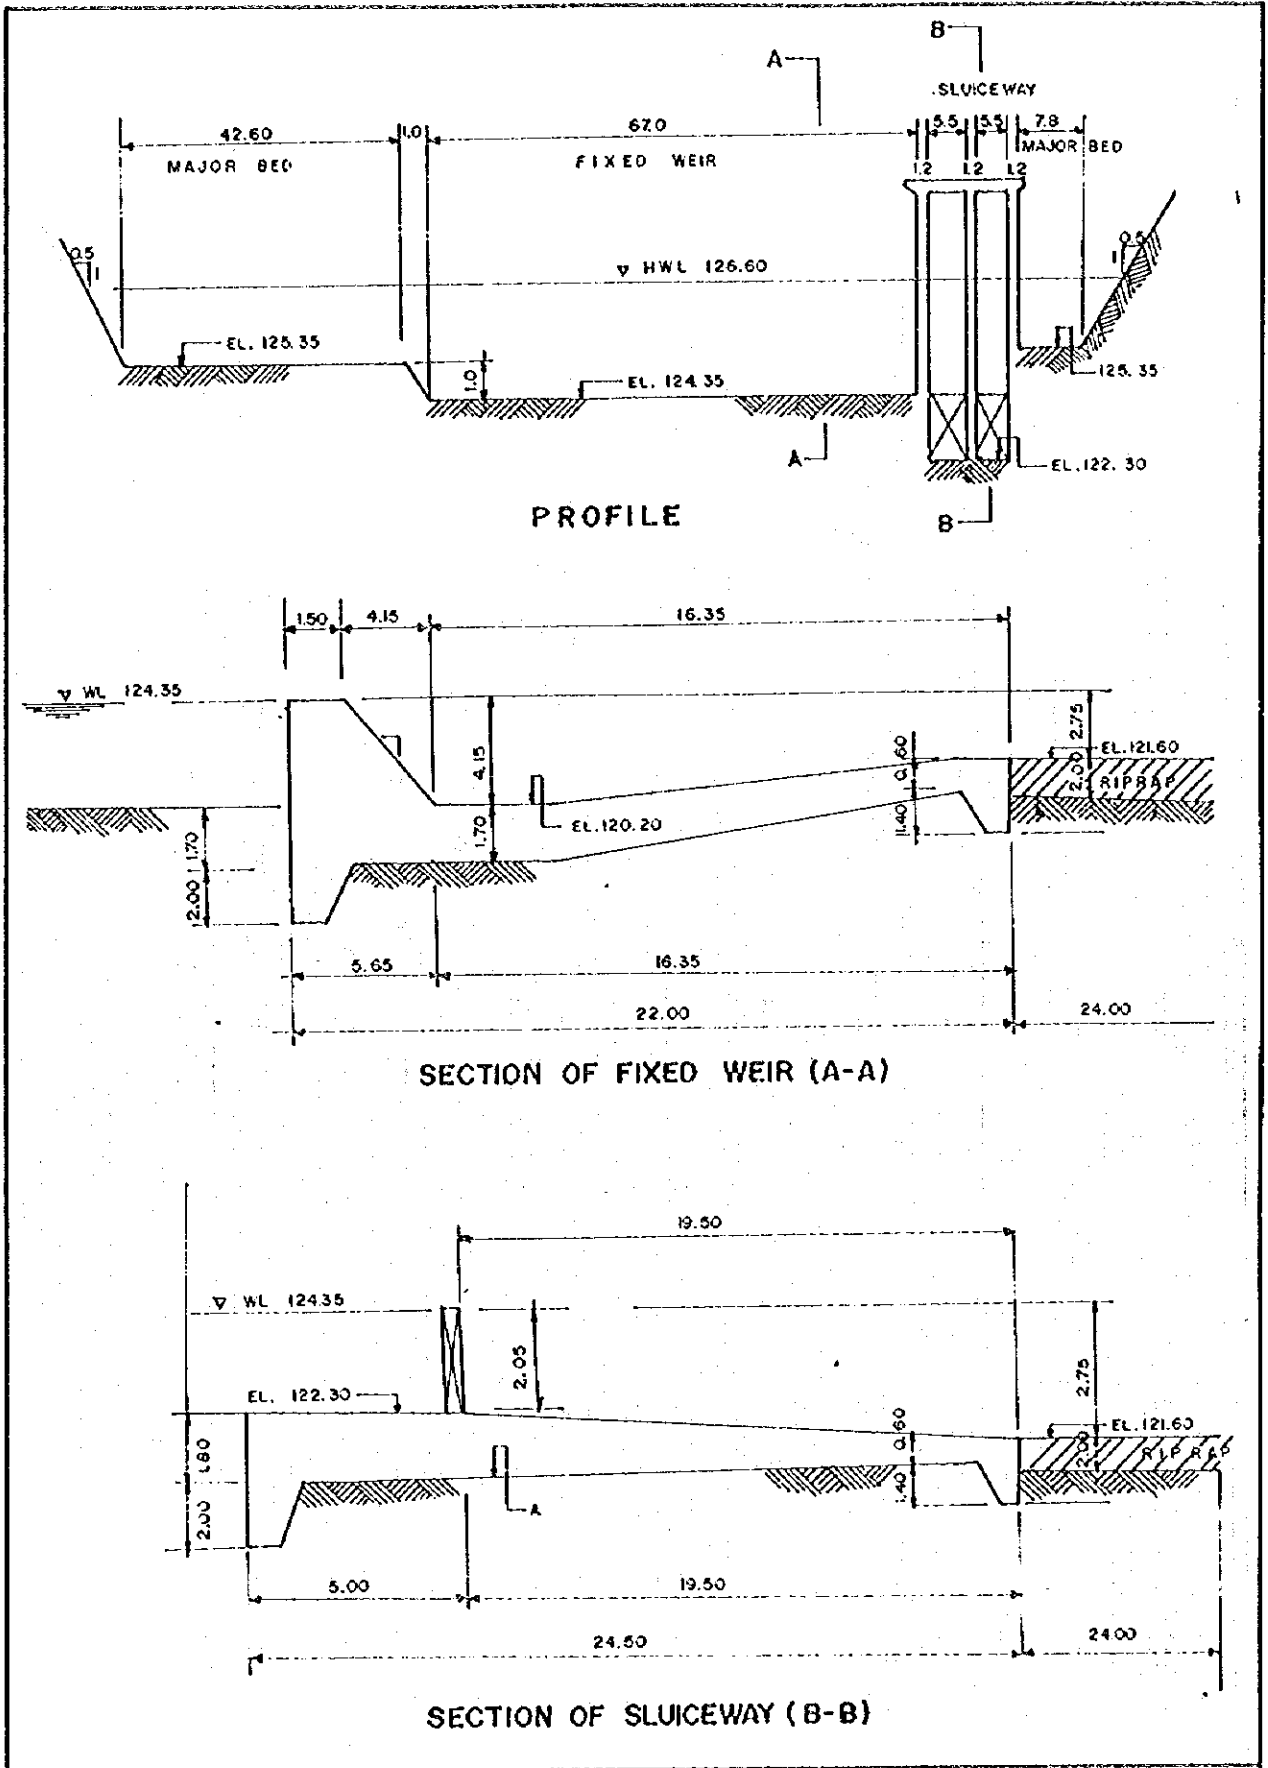
Fig. E.2.8

Existing Solsona Diversion Dam

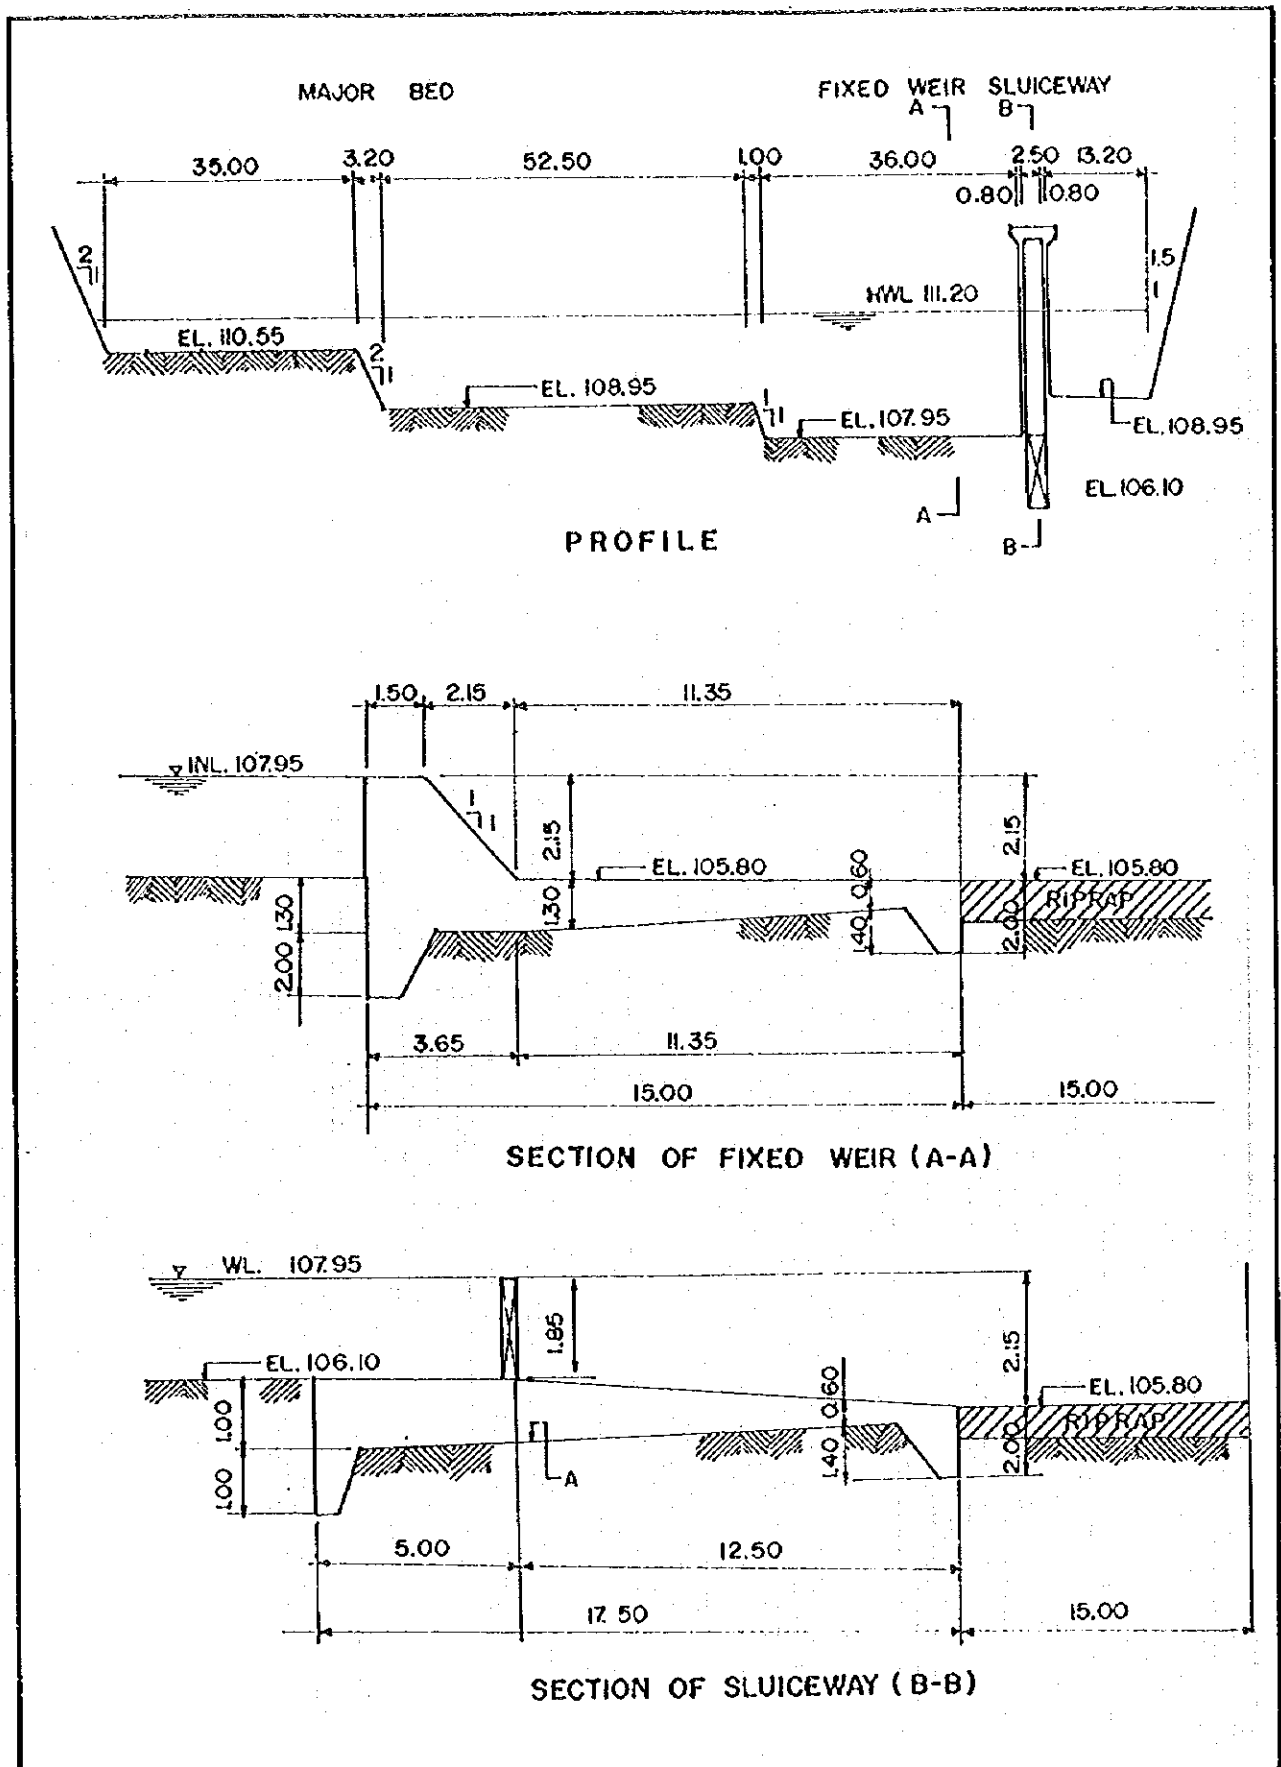
Fig. E.2.10

Existing Papa Diversion Dam
