APPENDIX E

**RIVER
CONDITIONS**

THE STUDY ON SABO AND FLOOD CONTROL
IN THE LAOAG RIVER BASIN

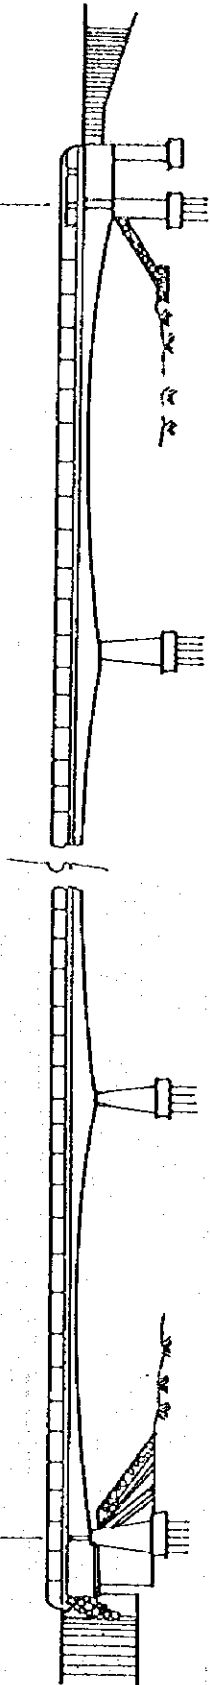
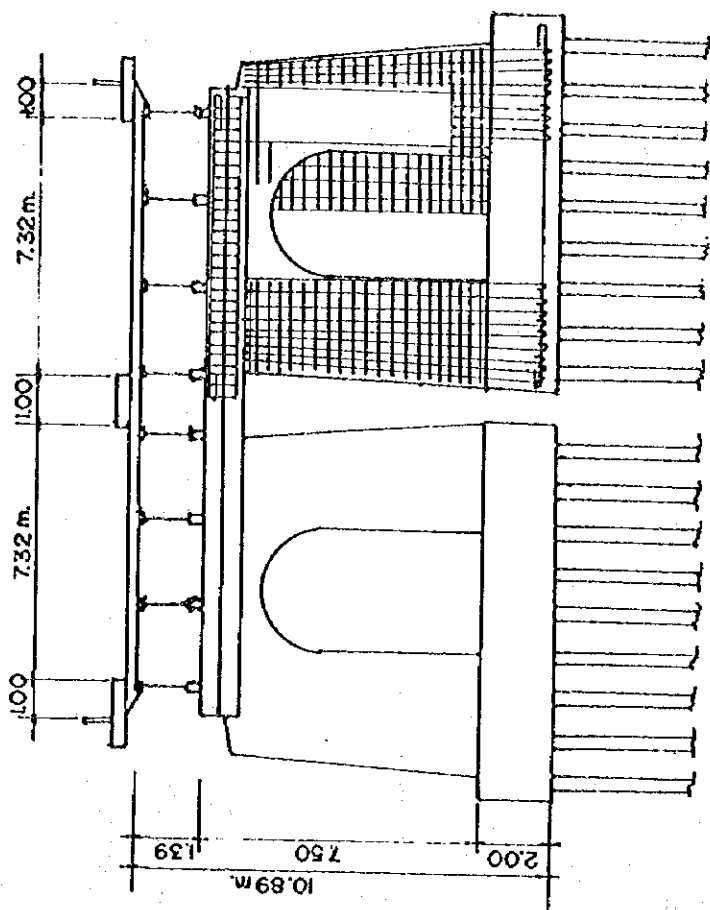
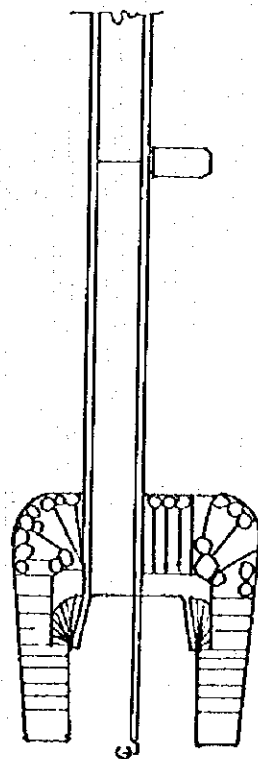
Existing Gilbert Bridge

GILBERT BRIDGE
LAOAG CITY

742.342m.
(15 SPANS)

ELEVATION

SECTION

P L A N

There are seven bridges crossing the major rivers; 5 bridges crossing the Laoag-Bongo River and 2 bridges crossing the Cura River. Gilbert Bridge crossing the Laoag River at Laoag City has the longest span of 748 m (4 lanes). The other bridges with 2 lanes were constructed in the middle 1980's as part of the Ilocos Norte Rural Road Development by DPWH with financial assistance from OECF. The bridges in the alluvial fan area are sometimes damaged by flood scouring between abutments and road approach due to insufficient revetment around the abutments. No remarkable scouring around bridge piers were observed. Major features of these existing bridges are listed in Table E.2.2 and shown in Fig. E.2.12 and Fig. E.2.13.

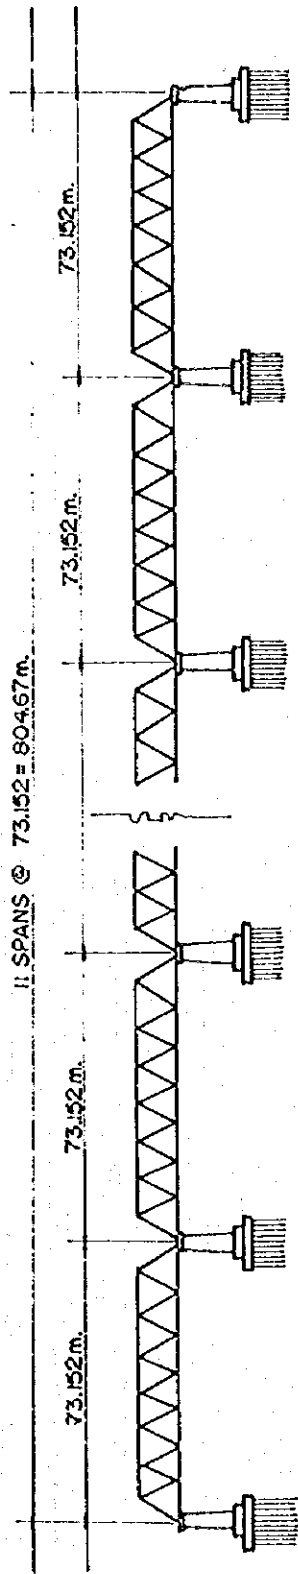
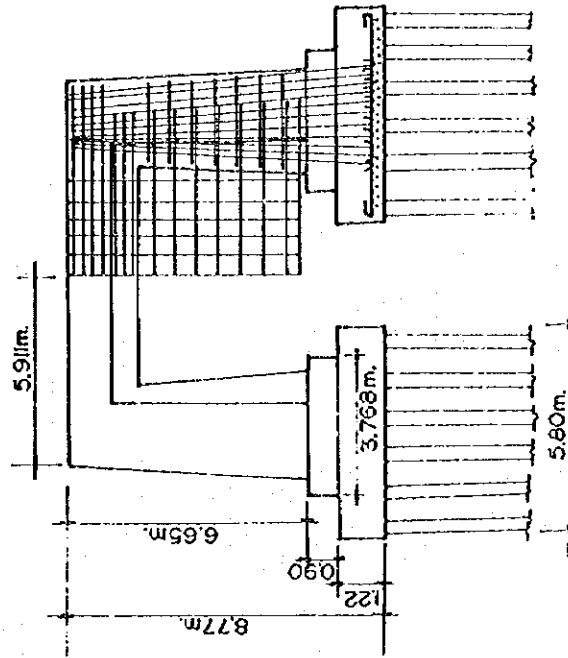
CAUPLASAN BRIDGE
DINGRAS, ILOCOS NORTE

ELEVATION

PLAN
