PLATE 2

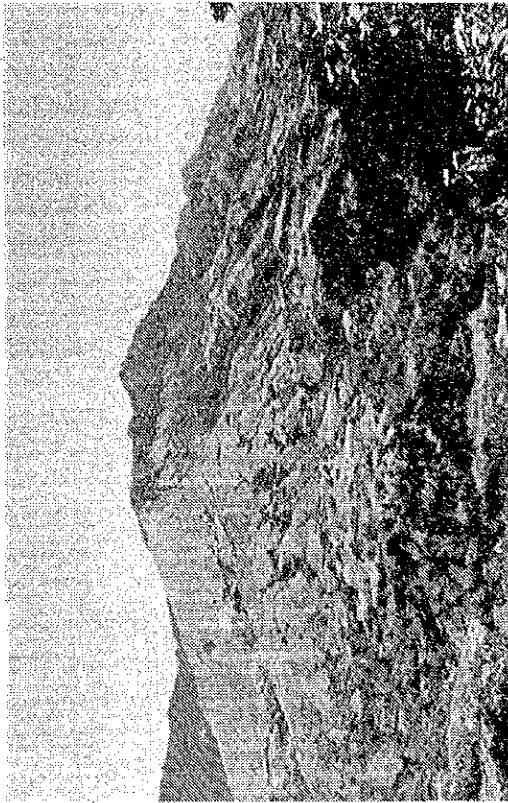
2. Limestone of the B<sub>1</sub> member composing the ridge line of Mount Aguaporonia.

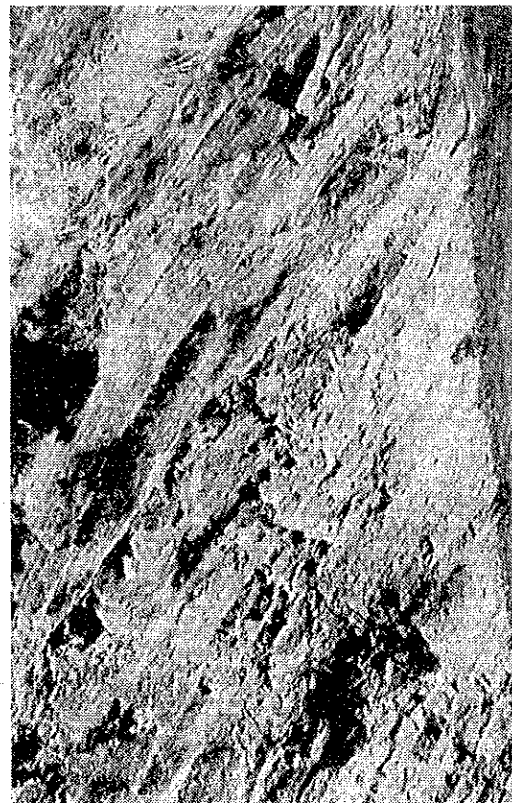
3. Mudstone interlaminated with sandstone, B<sub>2</sub> member, Aganan River, north to Tarug.

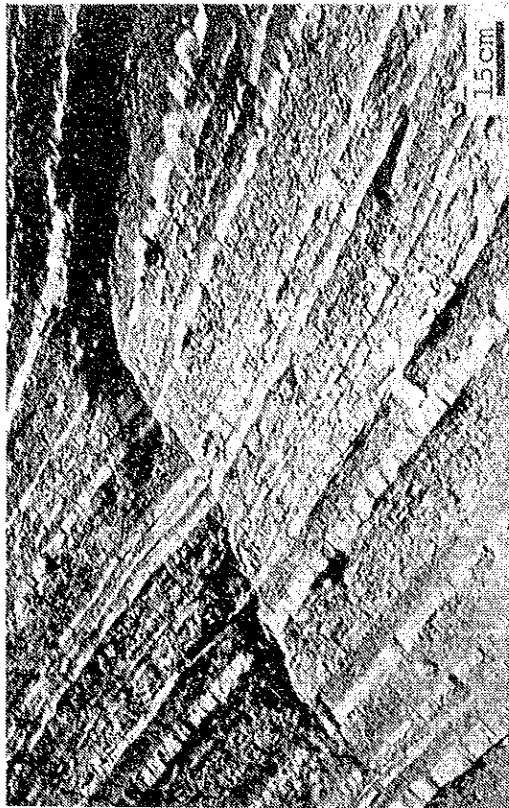
2. Interbedded mudstone and sandstone (mudstone being predominant), C<sub>2</sub> member, 3 km east of Bucari.

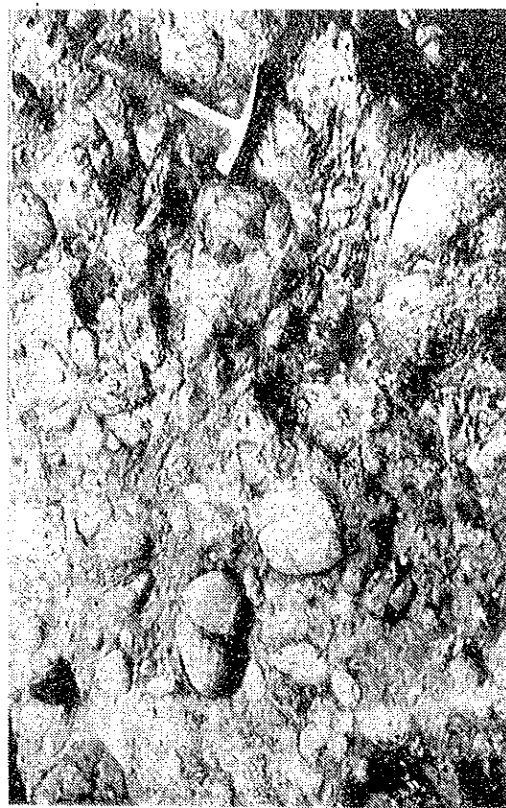
4. Cobble conglomerate, D<sub>1</sub> member, 1 km north of Maritang.

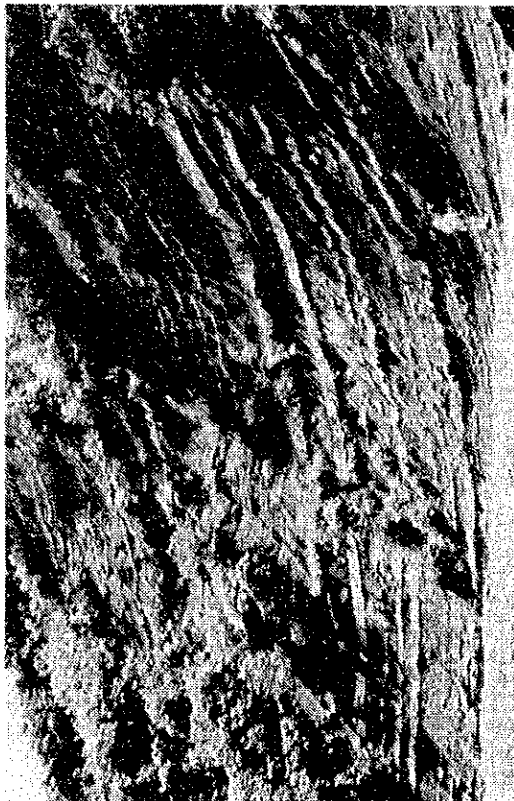
1. Alternating mudstone and sandstone, D<sub>3</sub> member, Sibalom River east of Tagasing.

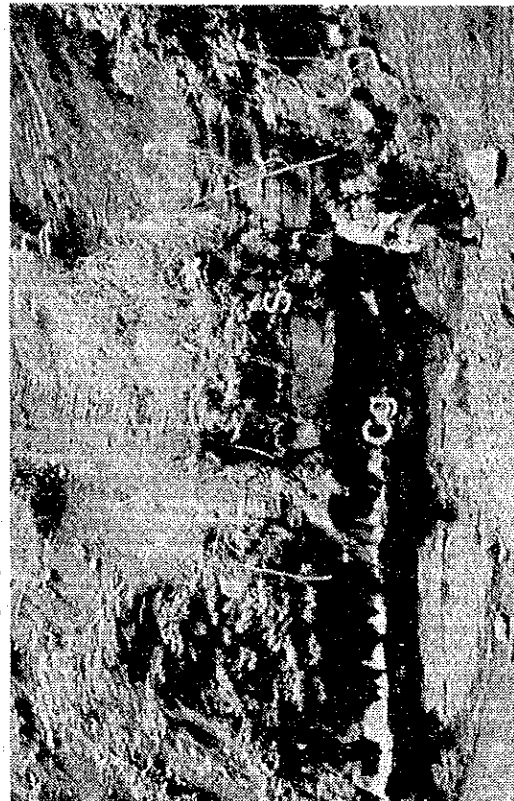
3. Conglomerate (Cg) and sandstone (S) beds in interbedded mudstone and sandstone, D<sub>3</sub> member, Sibalom River near Dorog. Note irregular erosional surface at the base of conglomerate bed.

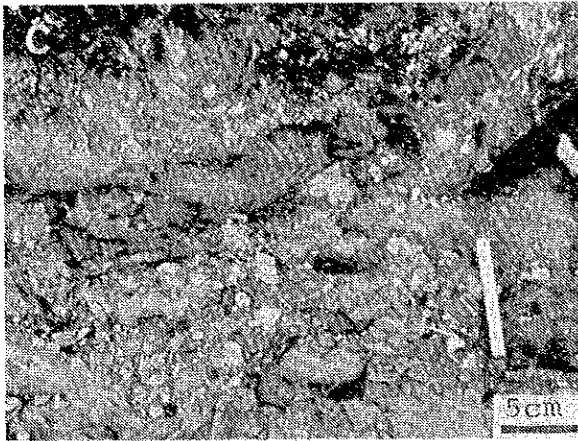
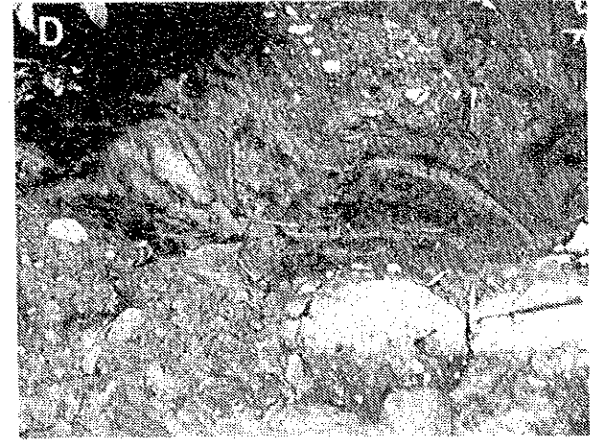
1. A. Slump fold of mudstone alternating with sandstone, D<sub>3</sub> member, Sibalom River, east of Tagsing.
- B. Discordance of mudstone beds due to slumping, E<sub>2</sub> member, 2 km northwest of Baguingin.
- C. Chaotic mixture of fragments of mudstone, sandstone and limestone, E<sub>1</sub> member, Sibalom River west of Buga.
- D. Pebbly mudstone including blocks of folded mudstone interbedded with sandstone, D<sub>2</sub> member, 1 km northwest of Tagsing.

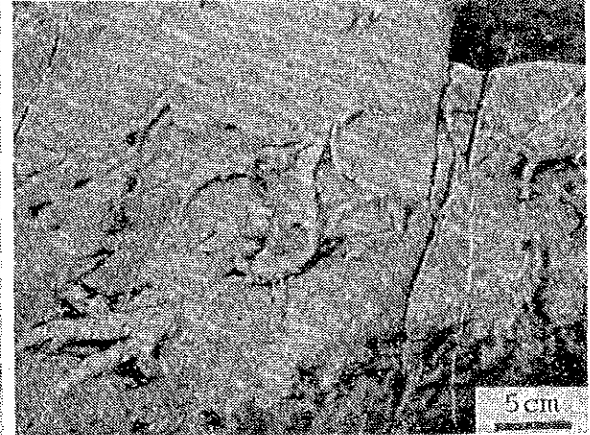
2. *Taphrohelminopsis* on sandstone sole, C<sub>2</sub> member, 3 km east of Bucari.
3. *Buthotrephis*-like burrows on sandstone top, B<sub>2</sub> member, Aganan River north of Tarug.

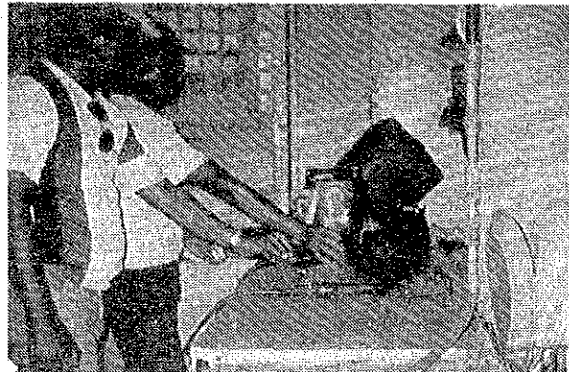
4. The kitchen of Zarraga Elementary School utilizing gas of PC-1 well.

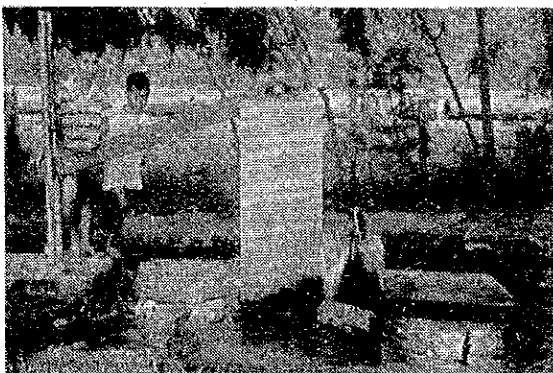
5. The hand pump of PC-2 well at Sigangao Elementary School (Zarraga).

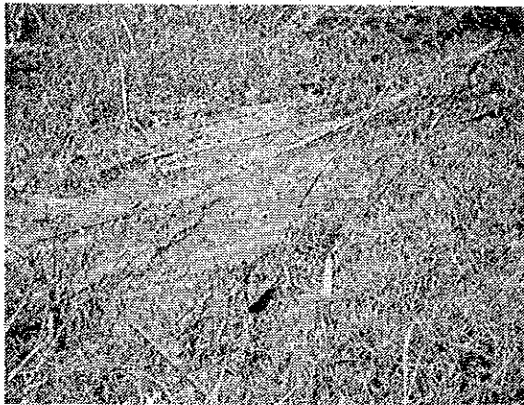
3. PC-6 mud volcano flowing out in the paddy of Naponglan (Lambunao).

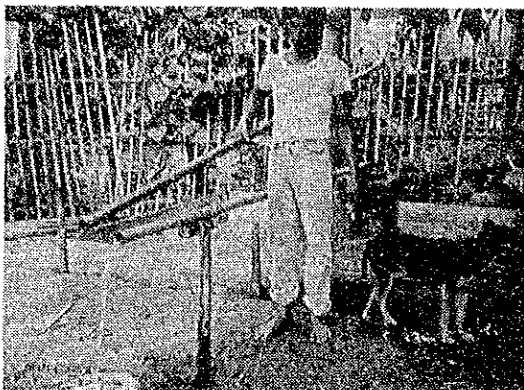
1. PC-10 saline water well of a village along the beach southwest of Pimolotan Hill (Dumangas).

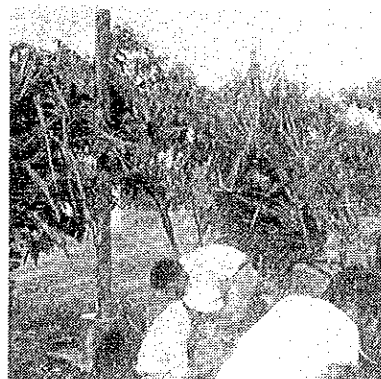
4. PC-14 gas-water free flowing well at Oton public plaza.

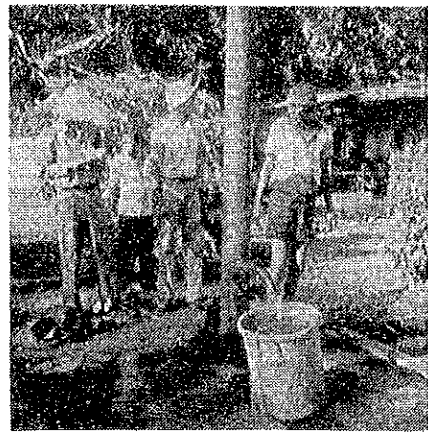
2. PC-18 saline water free flowing well at Arevalo plaza.

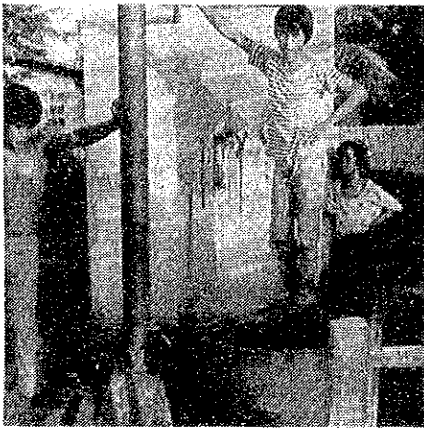
3. PC-19 free flowing water well at Oton Central Elementary School.

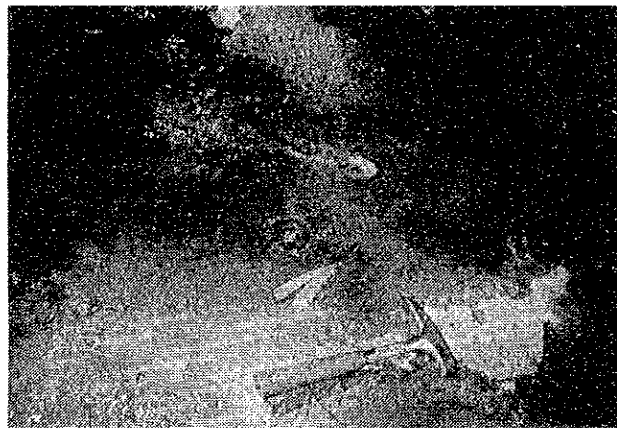
4. PC-20 gas outcrop of Captain Fernando (Leon).

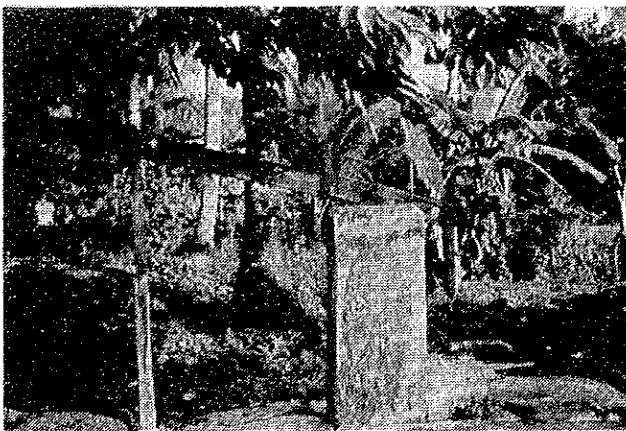
5. PC-21 in the residential area of Tubungan.

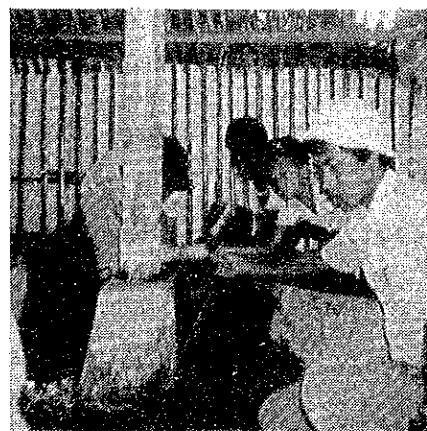
6. PC-22 saline water free flowing well of E. Yusay Elementary School.

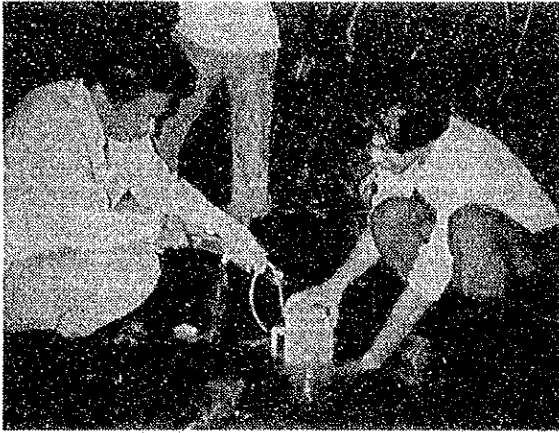
1. Collection of gas at PC-24 gas outcrop (Tampucao no. 1, Lambunao).

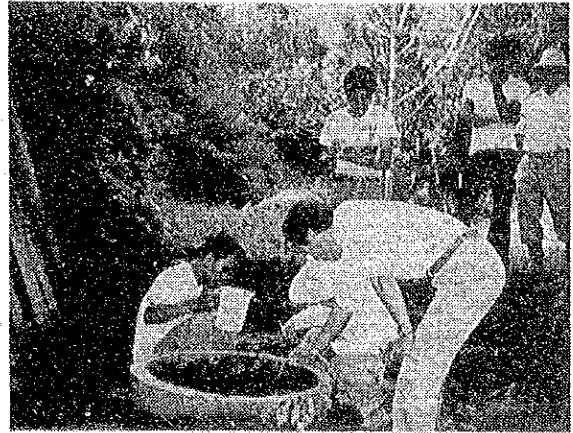
2. PC-26 manually bored saline water well (Magsaysay no. 1, Maasin).

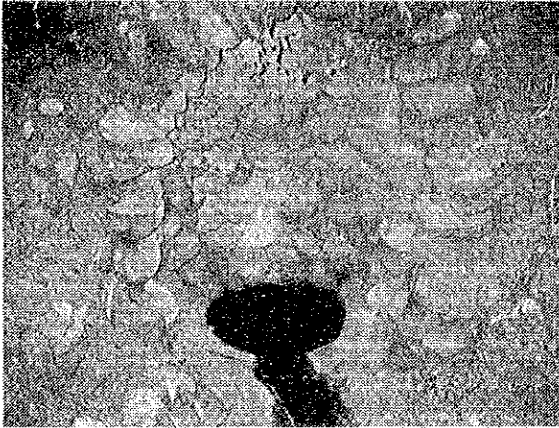
3. PC-27 saline water spring (Magsaysay no. 2, Maasin).

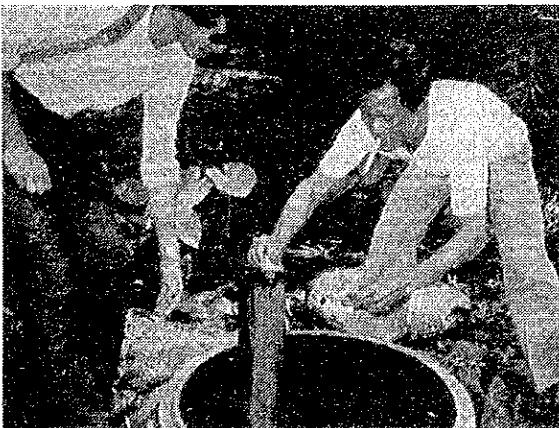
5. PC-29 fresh water well accompanied with gas indication (Pacuan no. 1, Maasin).

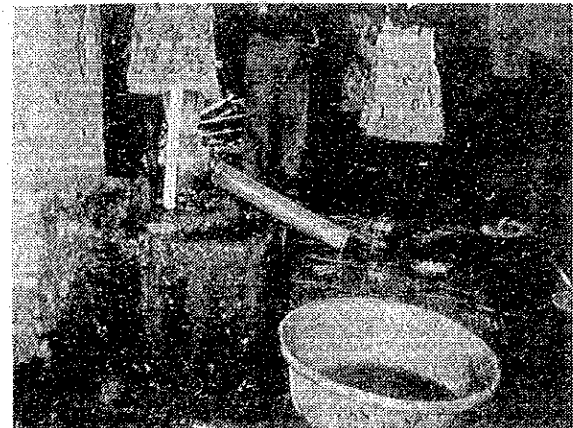
6. PC-30 water well freely flowing saline water accompanied with gas indication (Bagacay Ext. no. 1, Maasin).
