JAPAN INTERNATIONAL
COOPERATION AGENCY(JICA)

GENERAL DIRECTORATE OF HIGHWAYS
MINISTRY OF PUBLIC WORKS AND SETTLEMENT
THE REPUBLIC OF TURKEY(KGM)

THE STUDY ON ARTERIAL HIGHWAY MAINTENANCE IN THE REPUBLIC OF TURKEY

FINAL REPORT SUMMARY

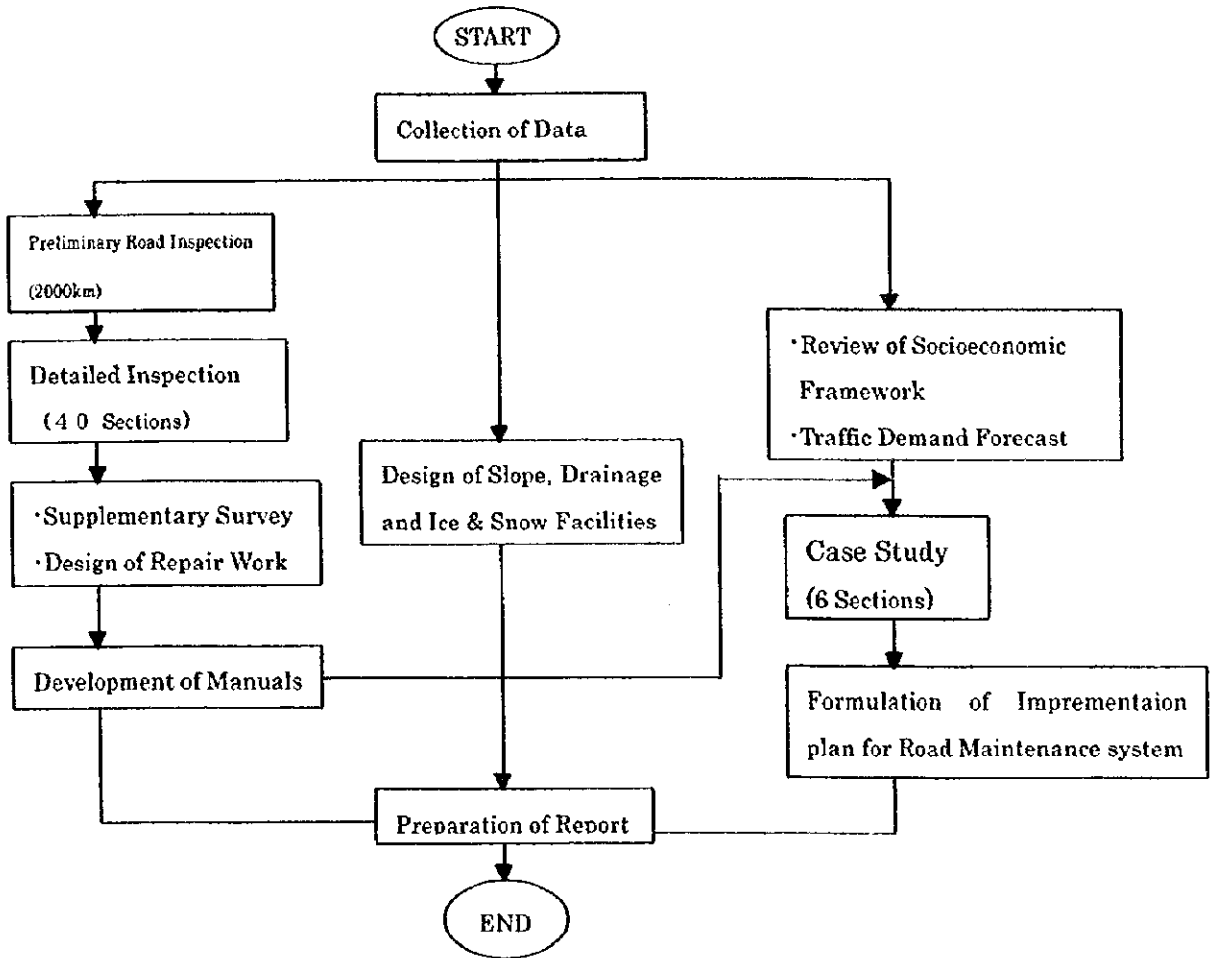
Fig. 1.1 Main Study Flow Chart

The study is comprised of two (2) stages. A general flow chart of the study is shown in Fig. 1.1.

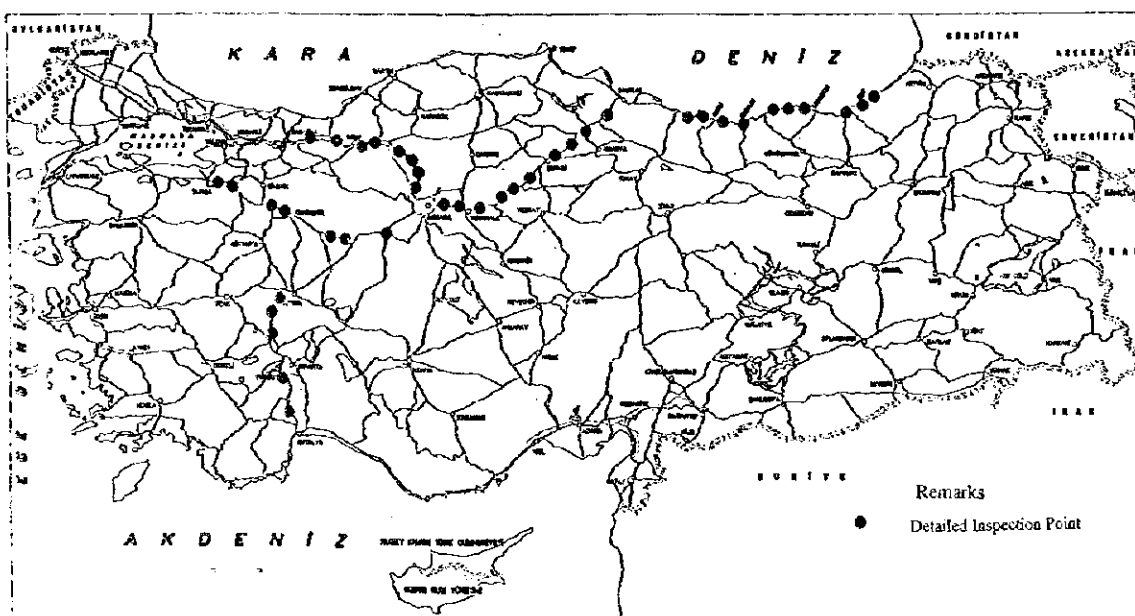
Table 3.1 Detailed Inspection Sections

40 sections (40km) have been selected for detailed inspection based on the results of the preliminary inspection as shown in Fig. 3.1.

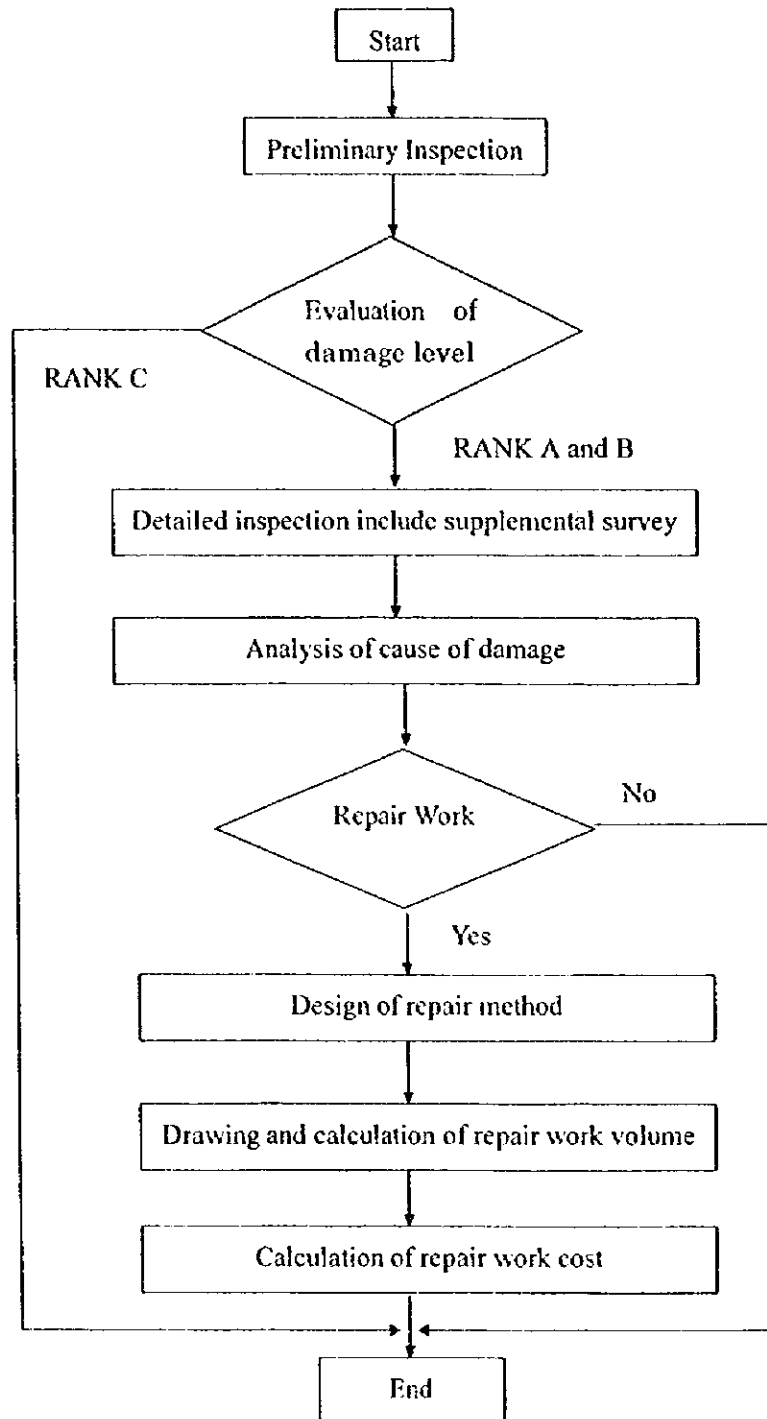
Fig. 4.1 The Flowchart for The Preliminary Design of Repair Work

The basic process of preliminary design of repair work is shown in Fig.4.1.

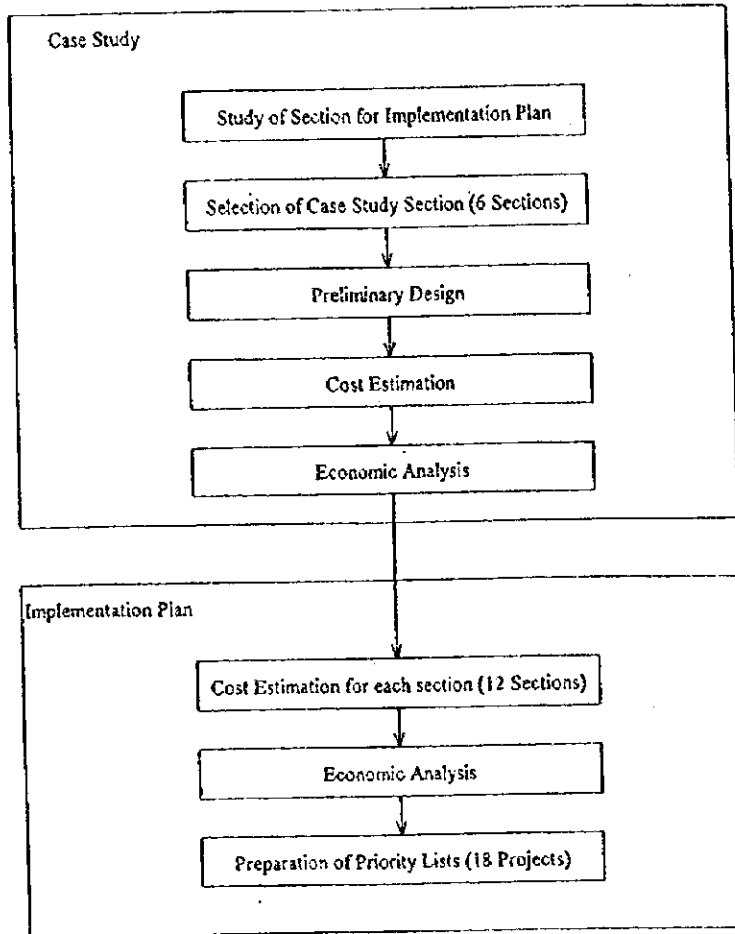
The basic process of implementation for the preliminary inspection section is as follows:
