Appendix E

Watershed Management and Flood Control

THE STUDY ON THE INTEGRATED WATER RESOURCES DEVELOPMENT AND MANAGEMENT MASTER PLAN IN THE FORMER YUGOSLAV REPUBLIC OF MACEDONIA
 JAPAN INTERNATIONAL COOPERATION AGENCY

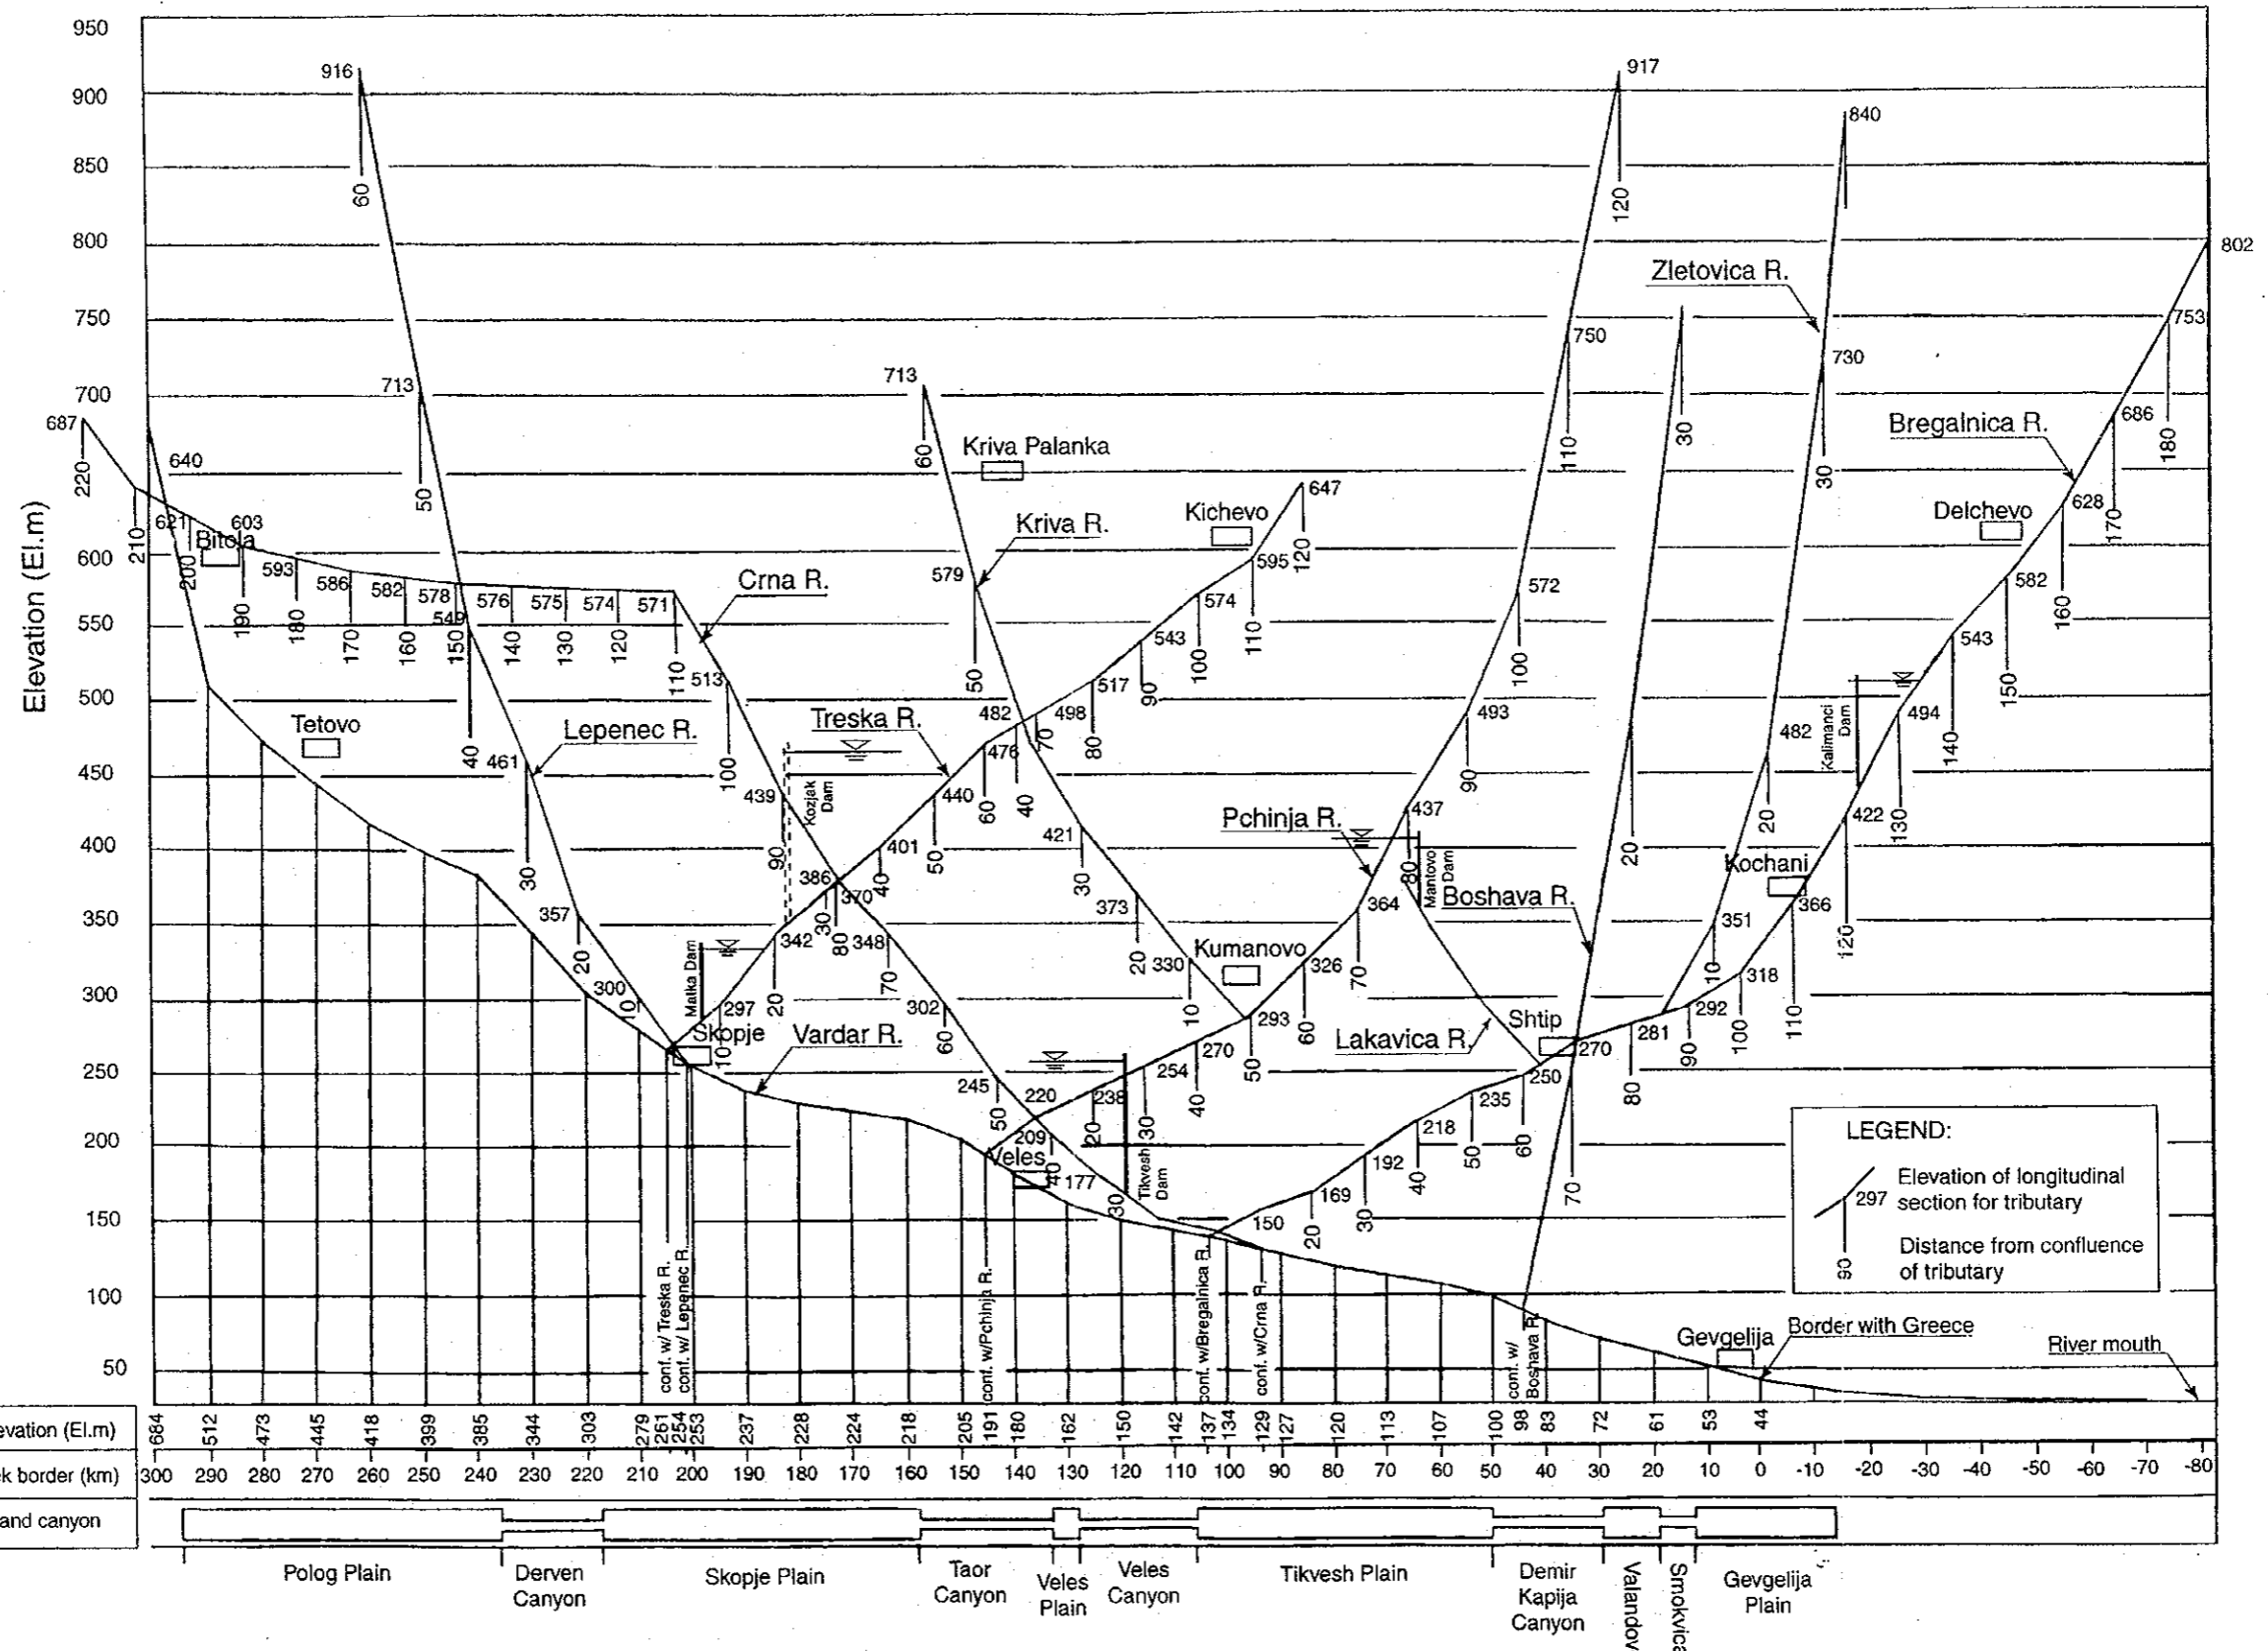
Lowest river bed elevation (El.m)	664	512	473	445	418	399	385	344	303	279	261	254	253	237	228	224	218	205	191	180	162	150	142	137	134	129	127	120	113	107	100	98	83	72	61	53	44		
Distance from Greek border (km)	300	290	280	270	260	250	240	230	220	210	200	190	180	170	160	150	140	130	120	110	100	90	80	70	60	50	40	30	20	10	0	-10	-20	-30	-40	-50	-60	-70	-80
Location of plain and canyon	Polog Plain			Derven Canyon		Skopje Plain				Taor Canyon		Veles Plain		Veles Canyon		Tikvesh Plain				Demir Kapija Canyon		Valandovo		Smokvica		Gevgelija Plain

Longitudinal Profile of Vardar River

(Note: This profile was prepared based on "Atlas Hydrological" Book, Hydrological Characteristics, 1954" with elaboration)

Figure E.1 Longitudinal Profile of Vardar River	E-15
Figure E.2 Location Map of Potential Erosion Area (Class I).....	E-16
Figure E.3 Check Dam (1/2).....	E-17
Figure E.3 Check Dam (2/2).....	E-18
Figure E.4 Screen Dam (1/2).....	E-19
Figure E.4 Screen Dam (2/2).....	E-20
Figure E.5 Tree Planting.....	E-21
Figure E.6 Location Map of Areas Requiring Countermeasures for Flood and Erosion Control.....	E-22
Figure E.7 Location Map of Flood Prone Area.....	E-23
Figure E.8 Flood Hydrograph of Vardar River in November 1962	E-24
Figure E.9 Flood Hydrograph of Vardar River in November 1979	E-25
Figure E.10 Inundated Area in Skopje due to 1962 Flood	E-26
Figure E.11 Inundated Area in Skopje due to 1979 Flood	E-27
Figure E.12 Inundated Area by Major Floods in Pelagonija Field	E-28
Figure E.13 Existing Drainage Canal in Pelagonija Field.....	E-29

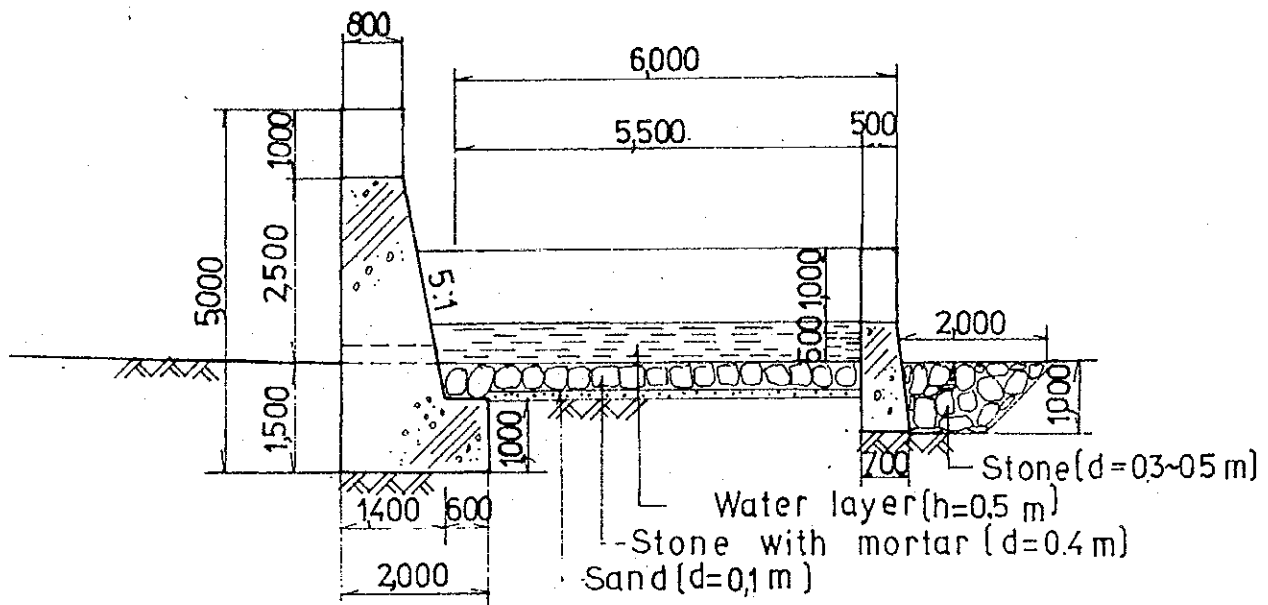
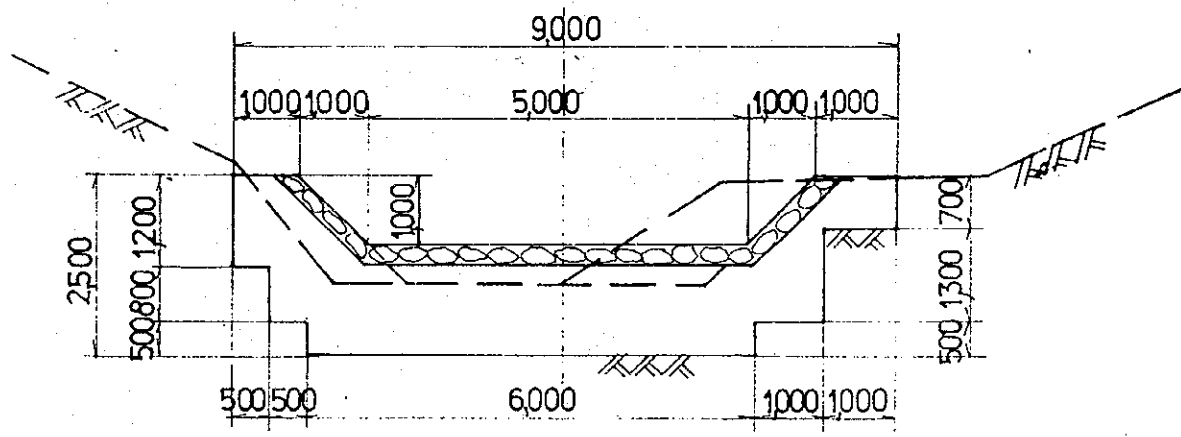
Figure E.3 Check Dam (2/2)

SECTION A-A

SECTION B-B

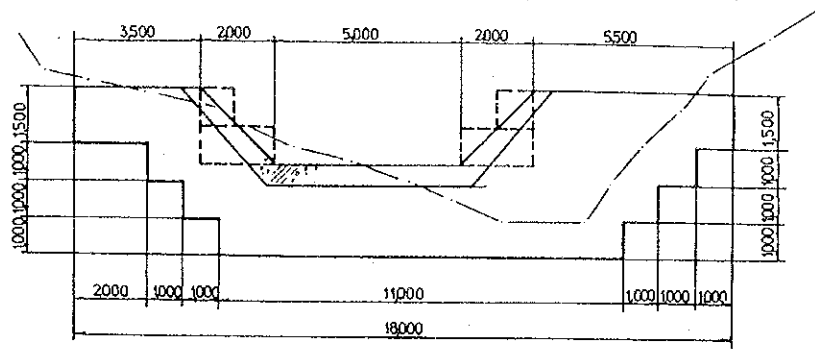
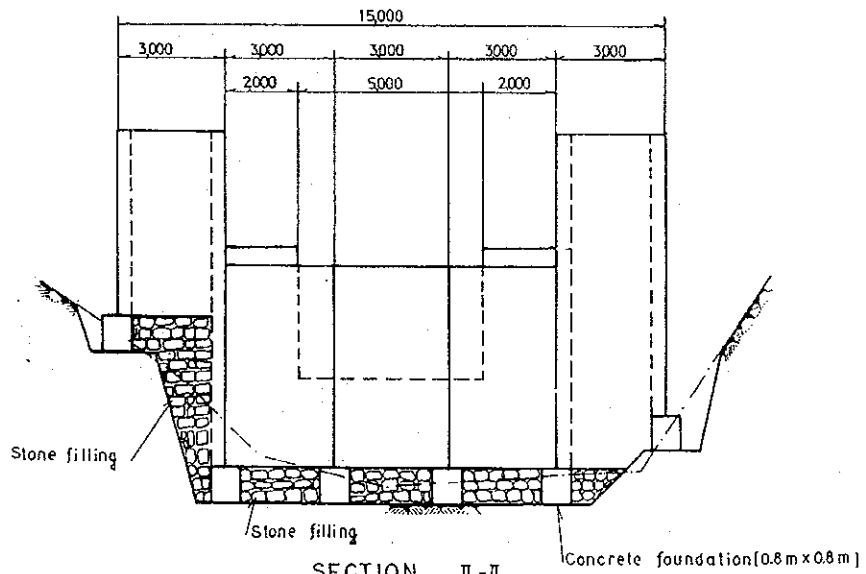
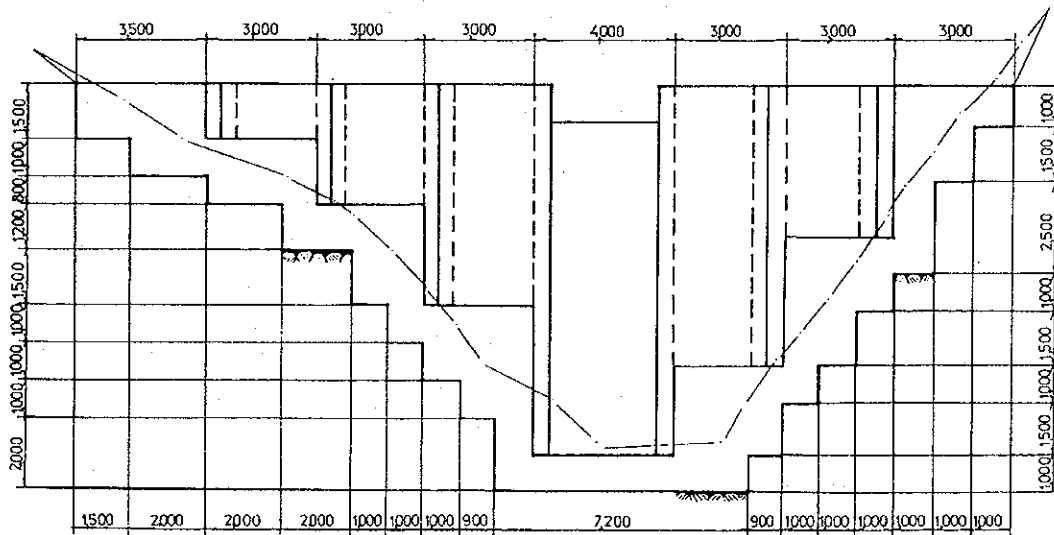
Figure E.4 Screen Dam (2/2)

SECTION I-I

SECTION II-II

SECTION III-III

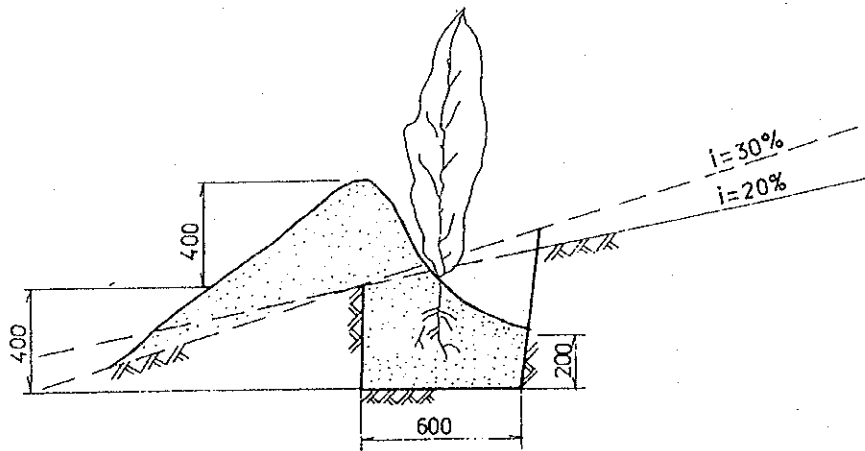
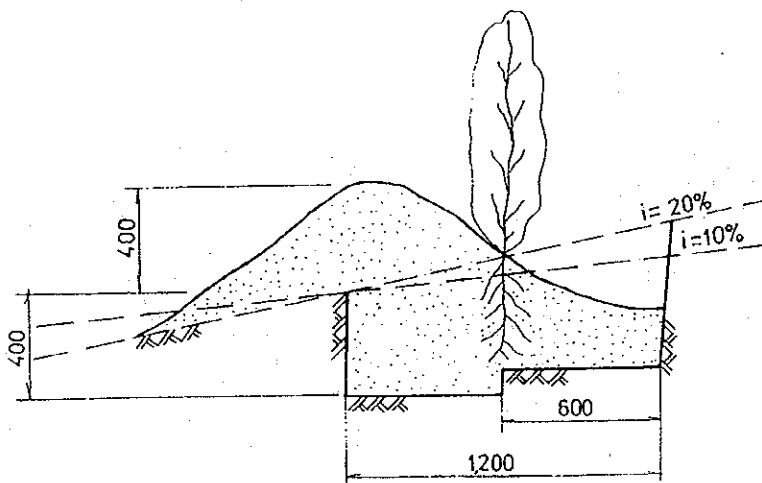
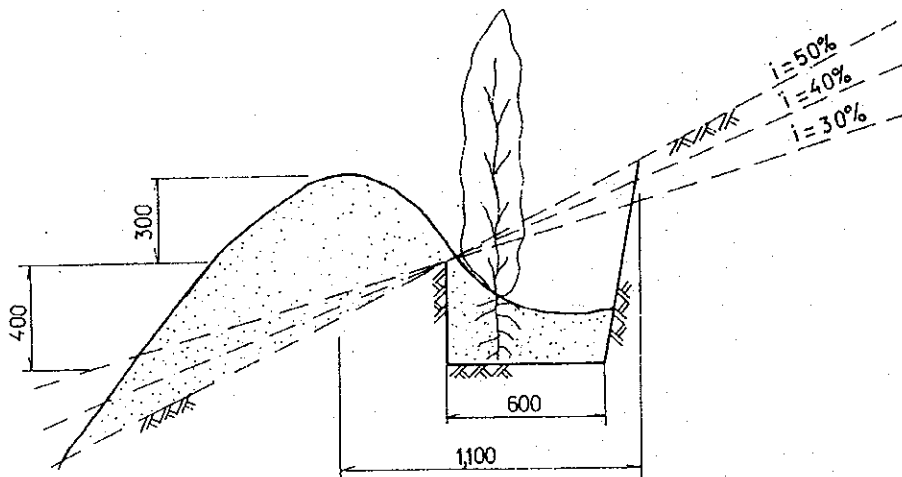
Figure E.5 Tree Planting

CROSS SECTION OF MECHANICAL PREPARED
CONTOUR TRENCH WITH ONE PLOW

CROSS SECTION OF MECHANICAL PREPARED
CONTOUR TRENCH WITH TWO PLOWS

CROSS SECTION OF HANDMADE CONTOUR TRENCH

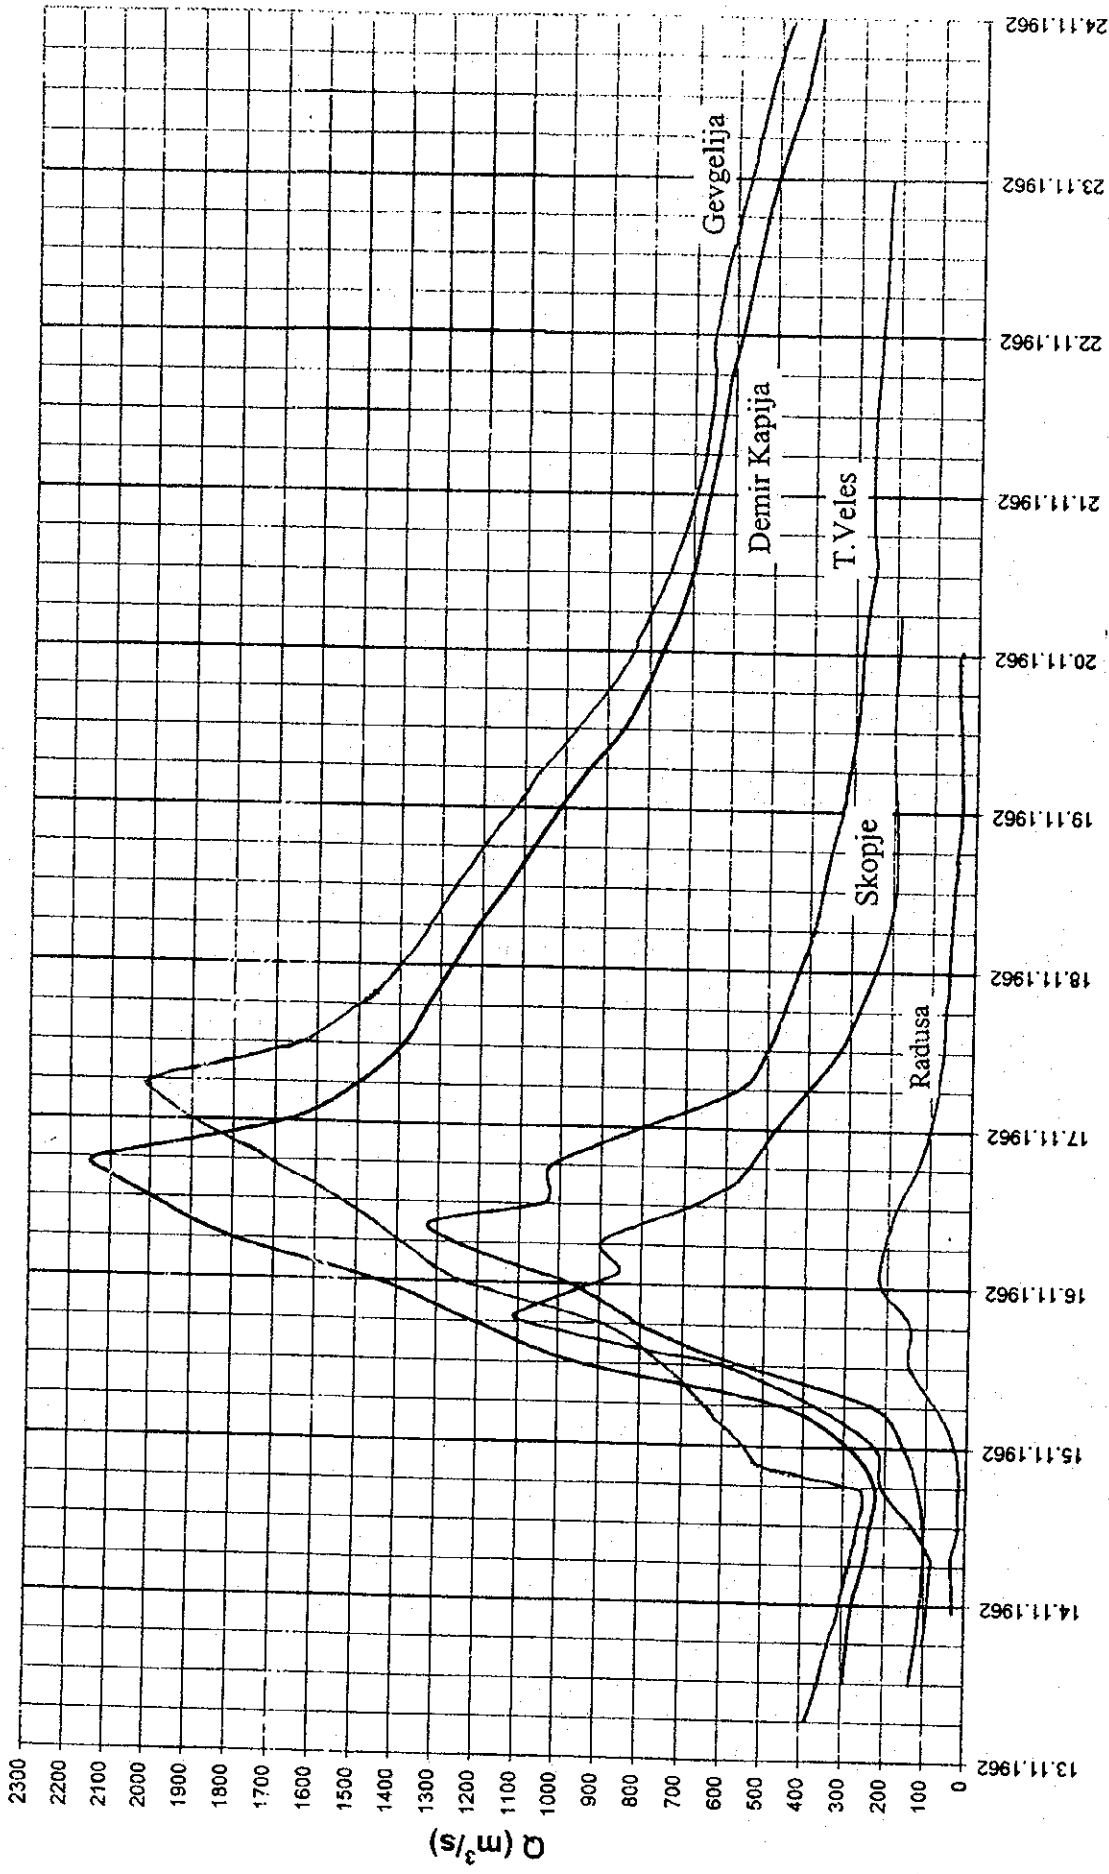
Figure E.8 Flood Hydrograph of Vardar River in November 1962

Source : "Climate and Hydrology of Macedonia" Volume Hydrology,
 Meteohydrological Institute, Feb.1998

Recently Hydrometeorological Institute prepared a report of *Climate and Hydrology of Macedonia*. Flood hydrographs of the two most serious floods in 1962 and 1979, which caused nation-wide disasters, are presented in the report as well as description on principal feature of flooding in Macedonia.

Items	November 1962	November 1979
1 Starting time of rising water level		
- Skopje	7:00 on 14 th	12:00 on 17th
- Gevgelija	18:00 on 14 th	6:00 on 18 th
2 Time of occurring peak		
- Skopje	18:00 on 15 th	15:00 on 19 th
- Gevgelija	6:00 on 17 th	11:00 on 21 th
3 Duration of flood		
- Skopje	102 hrs	118 hrs
- Gevgelija	216 hrs	222 hrs
4 Time lag between Skopje and Gevgelij	36 hrs	44 hrs
5 Accumulated discharge		
- Skopje	113 mil.m ³	118 mil.m ³
- Gevgelija	460 mil.m ³	465 mil.m ³
6 Runoff depth		
- Skopje	24.4 mm	25.5 mm
- Gevgelija	20.6 mm	20.9 mm

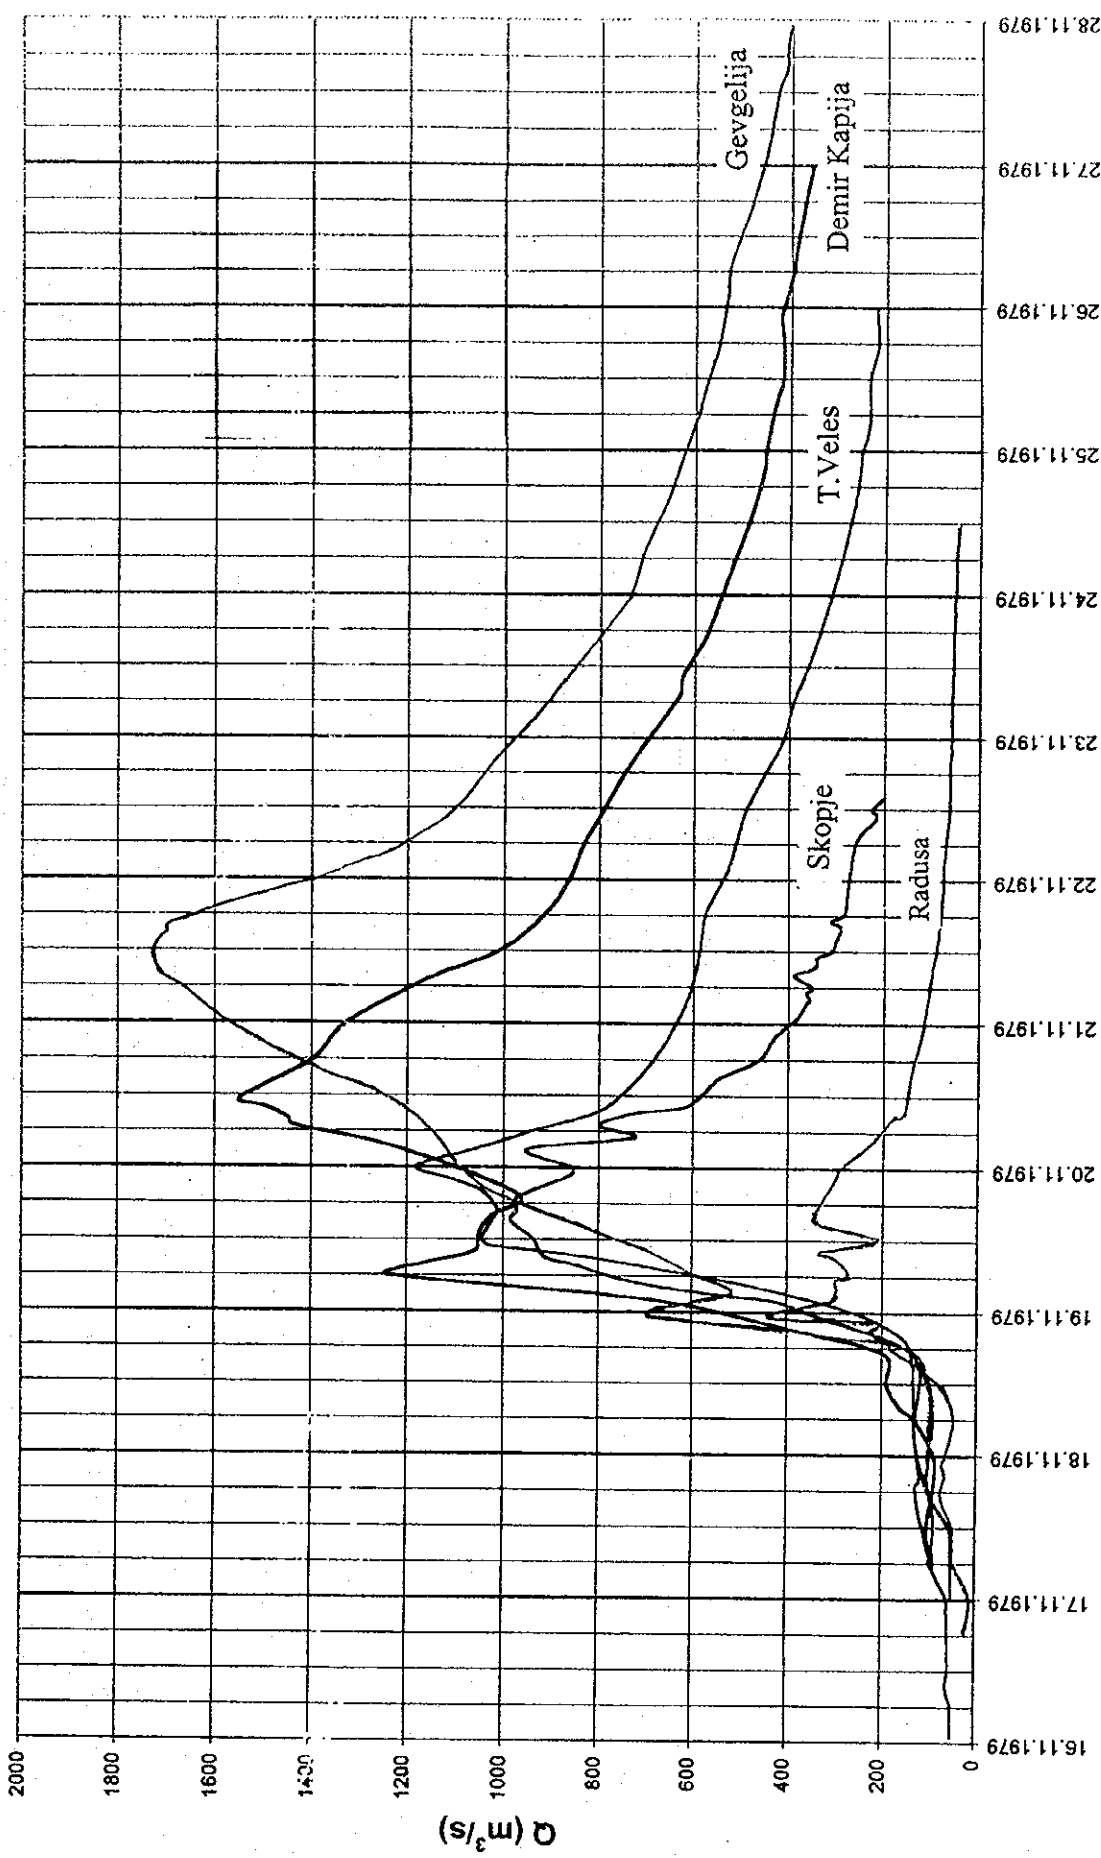
Figure E.9 Flood Hydrograph of Vardar River in November 1979

Source : "Climate and Hydrology of Macedonia" Volume Hydrology,
 Meteorological Institute, Feb.1998
