Figure 13-58: Photographs of Candidate Disposal Sites(1)

Figure 13-59: Photographs of Candidate Disposal Sites (2)

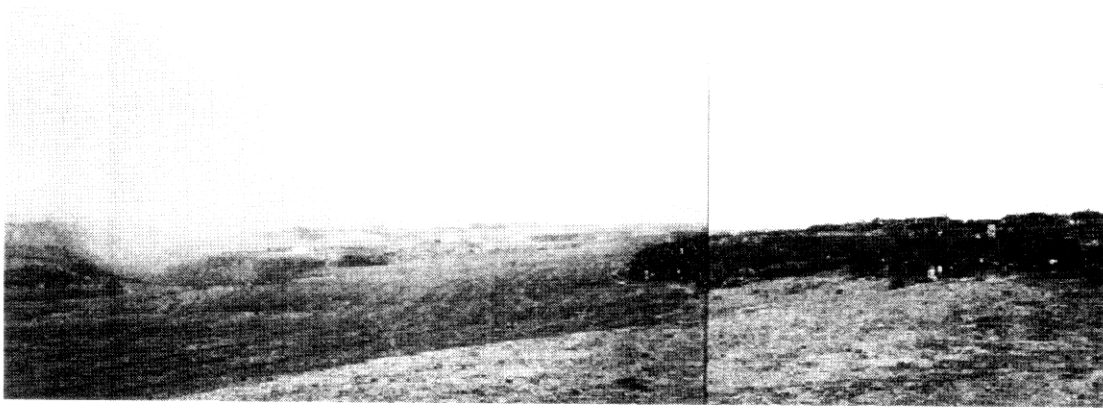
Present Landfill Site in Sofulu (Foreground is the site for extension)

**a. Present Landfill Site in Sofulu**

The situation is described in detail in this EIA report.

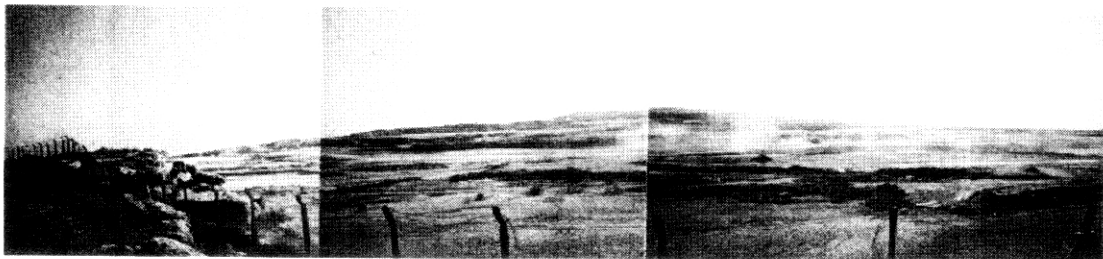
Adana Cimento Quarry

**b.1.3 Site Located in the Excavation Area at Adana Cimento**

The excavation area is huge and holds capacity for many years disposal from Adana. Soil for daily coverage of waste is easily available, and access to the bottom of the quarry is easily available. However, most of the excavation area is still operated by Adana Cimento.

The operation of a landfill in the excavation is considered very difficult, also because many blastings are carried out. The geological and hydrogeological conditions of the site have not yet been investigated.

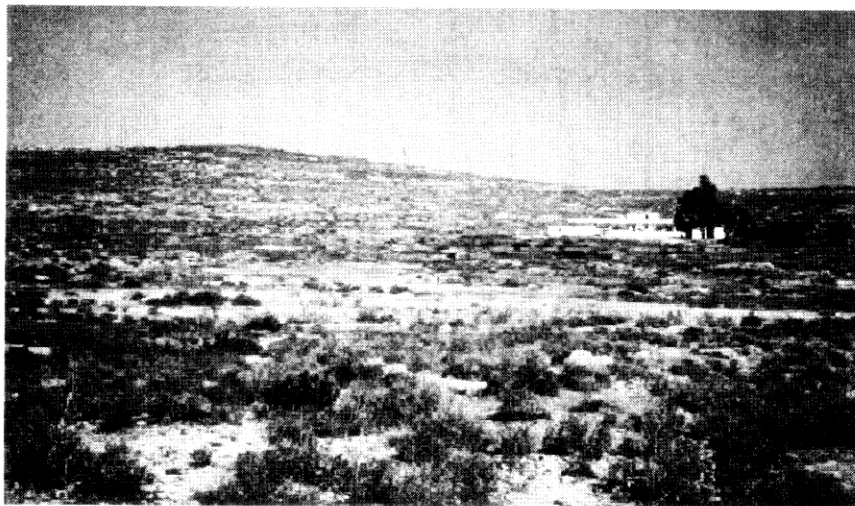
Adjacent Area of Adana Cimento

**b.1.1 Site South of Adana Cimento**

The site includes or is neighbouring an area with archaeological remains. Further, a village with mayor chicken farming is neighbour to the site. The site comprise a flat area that has a ground full of boulder rocks embed in clay. Earthworks would be expensive and soil for daily soil coverage would not be easily available, unless an agreement with Adana Cimento could be obtained regarding free delivery of soil that cannot be used in the production of cement. The site was recommended by a geologist due to the prevalence of clay, not considering other requirements to a landfill site.

**b.1.2 Site Southeast of Adana Cimento**

The proposed site is located immediately south-east of the premises of Adana Cimento. The site comprises a flat area full of boulder rocks. Earthworks would be expensive and soil for daily soil coverage would not be easily available, unless an agreement with Adana Cimento could be obtained regarding free delivery of soil that cannot be used in the production of cement. The site is neighbouring huge fields mainly cultivated with peanuts and cotton.

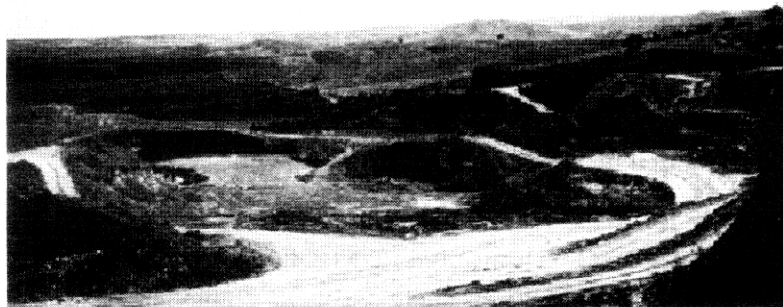
Quarries and Valleys at Karahan

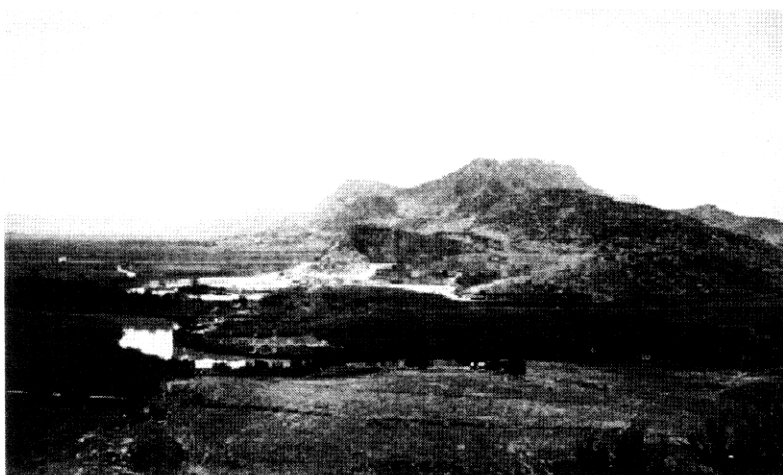
Quarries at Seyhan

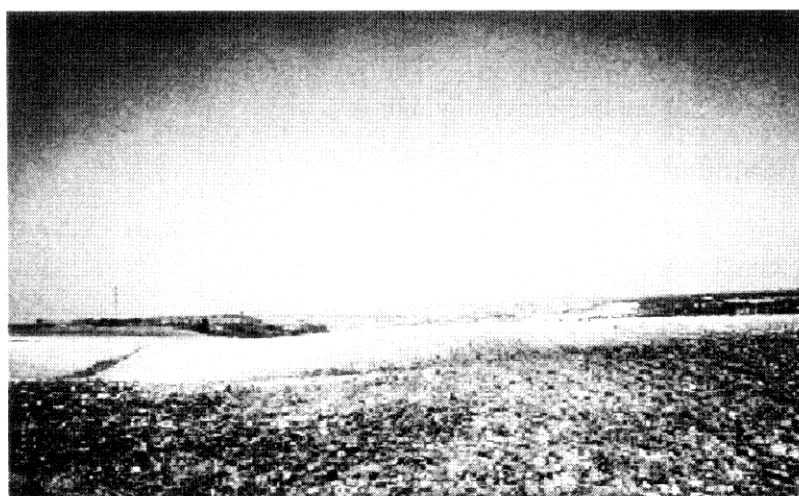
Site at Buruk
