THE STUDY ON THE KOK-ING-NAN WATER DIVERSION PROJECT
 Geological Map of Alternative Water Diversion Plan
 Map & Drawing No.
 JAPAN INTERNATIONAL COOPERATION AGENCY (JICA)
 SANYU CONSULTANTS INC. & NIPPON KOEI CO., LTD. Figure 11.1.4-1

THE STUDY ON THE KOK-ING-NAN WATER DIVERSION PROJECT
 ALTERNATIVE ROUTES IN KOK-ING DIVERSION CANAL
 JAPAN INTERNATIONAL COOPERATION AGENCY(JICA)
 SANYU CONSULTANTS INC. & NIPPON KOEI CO.,LTD.

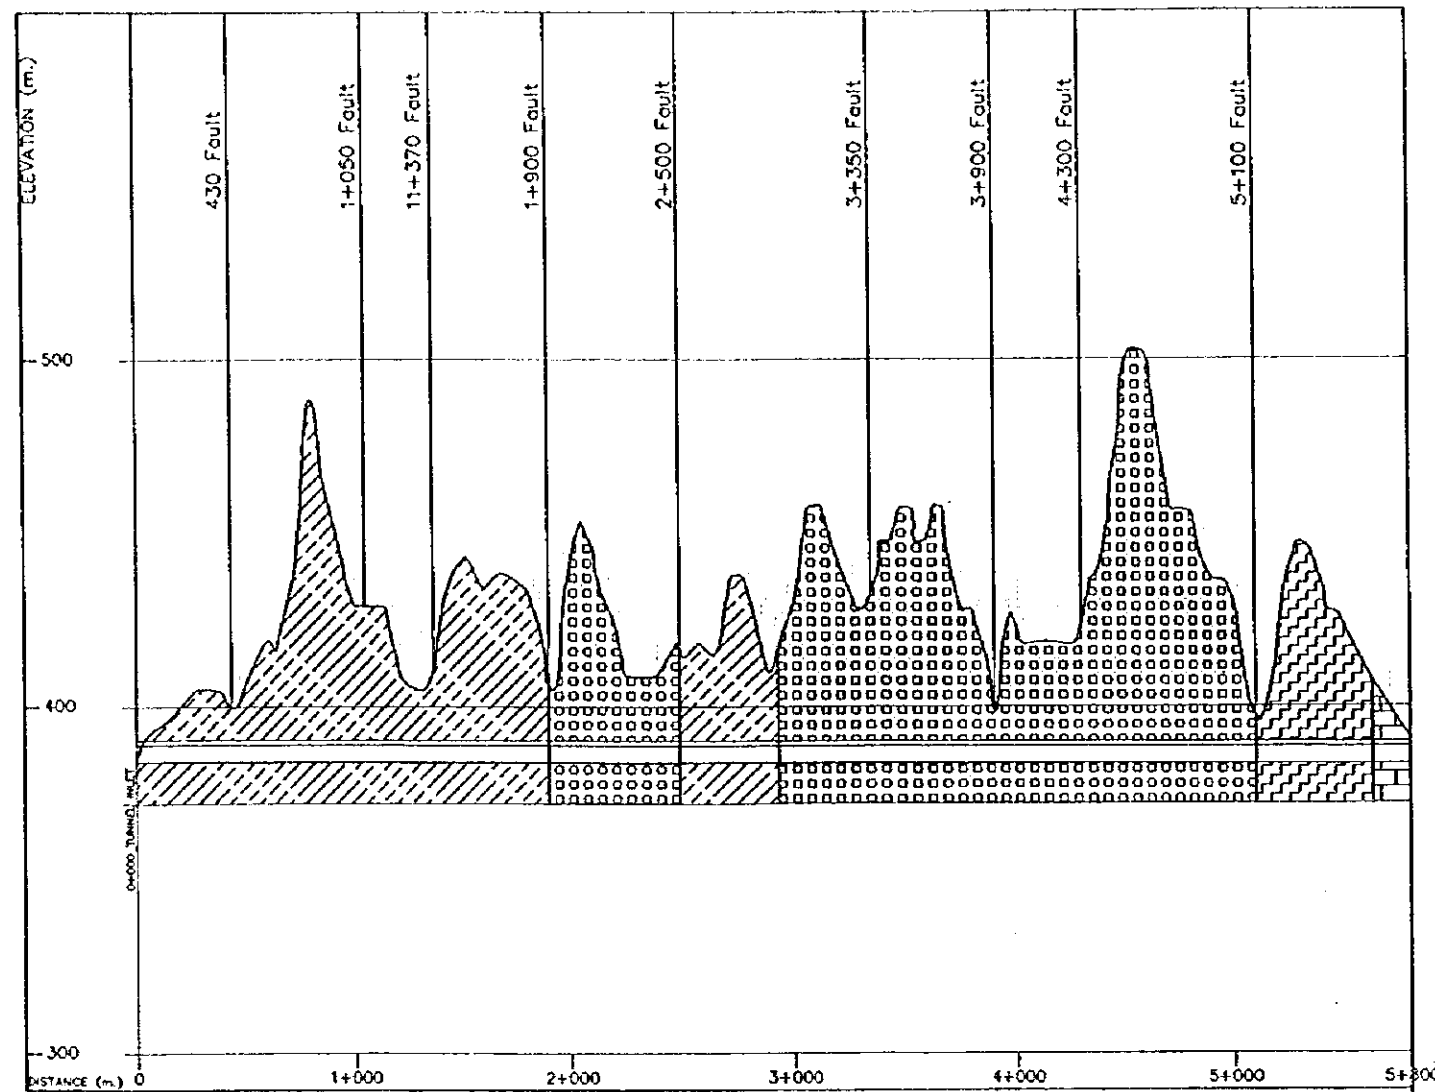
**GEOLOGICAL PROFILE OF ALTERNATIVE TUNNEL ROUTE
KOK-ING NO.1 TUNNEL (A ROUTE)**

Geological Condition	Shale, tuff highly weathered condition	Shale, tuff weathered, cracky and clayey along the fault zone	Rhyolitic tuff highly weathered	Shale, tuff highly weathered	Rhyolitic tuff, weathered breakable along bedding plane, cracky and clayey along the fault zone	Sandstone, shale highly weathered
Rock mass classification	D	D-CL, CL, O	D	E-CL	D	D-CL, D, CL, CM, CL, D, D-CL, D
Tunnel type	E2	E1, D2	E1(30%), E2(70%)			D2, D1, D2, E1(30%), E2(70%)

THE STUDY ON KOK-ING-NAN WATER DIVERSION PROJECT	
GEOLOGICAL PROFILE OF ALTERNATIVE TUNNEL ROUTE KOK-ING NO.1 TUNNEL (A ROUTE)	MAP & Drawing No.
JAPAN INTERNATIONAL COOPERATION AGENCY (JICA)	Figure 11.1.4.
SANYU CONSULTANTS INC. & NIPPON KOEI CO.,LTD.	(3)-3

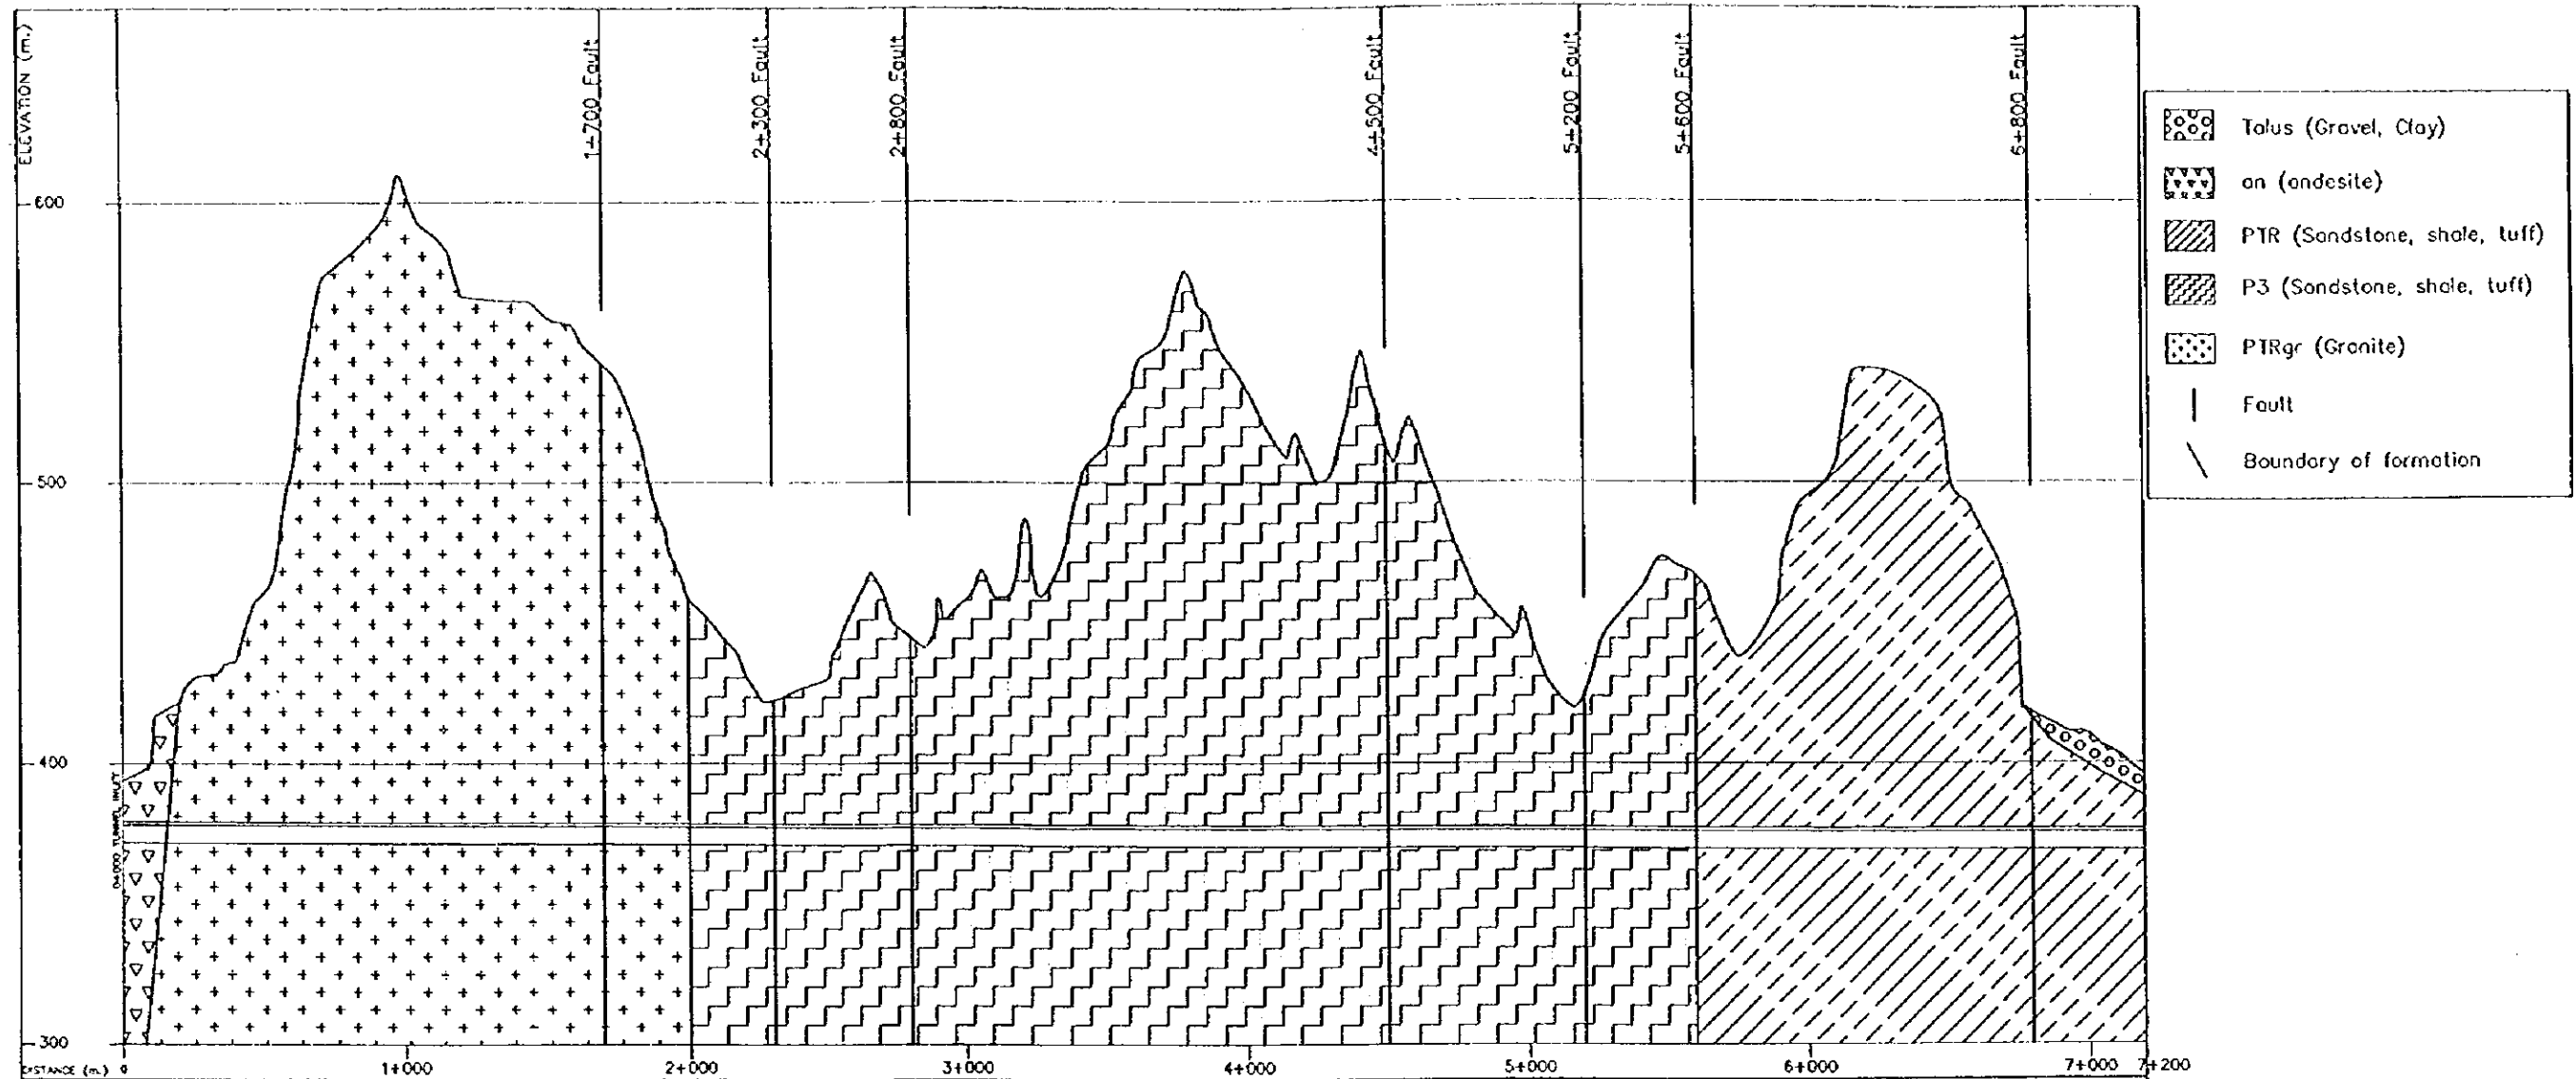
Geological Condition	Andesite highly weathered (clayey)				Granite, hard, cracky along joint highly weathered around inlet				Sandstone, shale, tuff fractured zone (fault zone) clayey				Sandstone, shale, tuff cracky, easily breakable along bedding plane				Sandstone, shale, tuff, cracky, easily breakable along fault			
Rock mass classification	D	CL	CM	CL	D	CL	D	CL	CM	CL	D	CL	D	CL	D	CL	CM	CL	D	
Tunnel type	E1(30%) E2(70%)	D2	C2(50%) D1(50%)	E1(50%) E2(50%)	E2	D2	C2(50%) D1(50%)	E1(70%) E2(30%)	D2(30%), E1(40%), E2(30%)	C2(50%) D1(50%)	D2	E1(30%) E2(70%)

THE STUDY ON KOK-ING-NAN WATER DIVERSION PROJECT	
GEOLOGICAL PROFILE OF ALTERNATIVE TUNNEL ROUTE KOK-ING NO.2 TUNNEL (A ROUTE)	MAP & Drawing No.
JAPAN INTERNATIONAL COOPERATION AGENCY (JICA)	Figure 11.1.4.
SANYU CONSULTANTS INC. & NIPPON KOEI CO.,LTD.	(3)-4

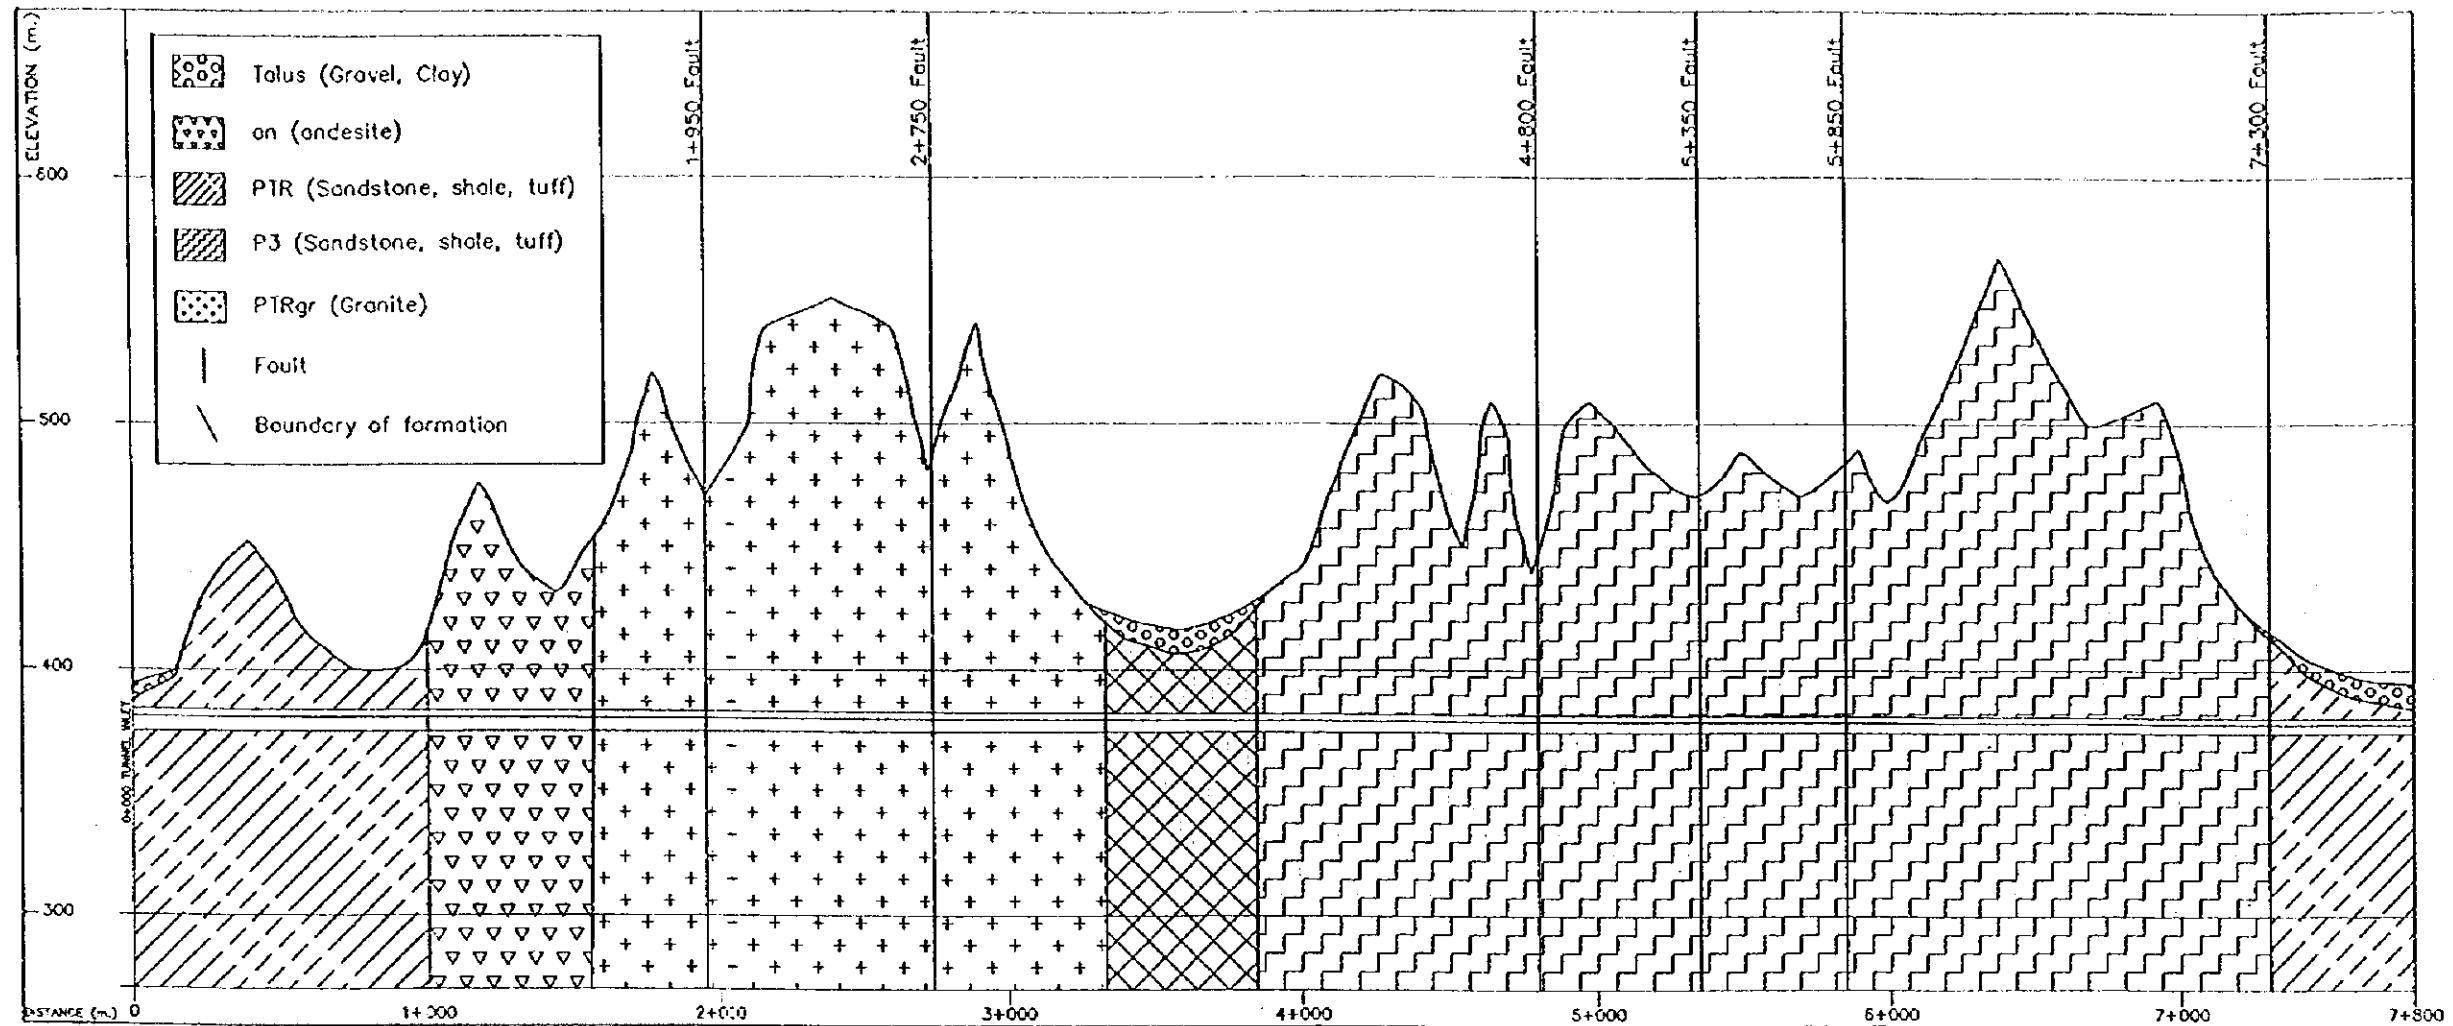
**GEOLOGICAL PROFILE OF ALTERNATIVE TUNNEL ROUTE
KOK-ING NO.2 TUNNEL (B-J ROUTE)**

Geological Condition	Sandstone, shale, tuff highly weathered (clayey)				Andesite highly weathered		Granite, hard, cracky along joint					Fractured zone (fault zone) clayey. Special attention should be paid to the occurrence of water discharge					Sandstone, shale, tuff cracky, easily breakable along bedding plane					Sandstone, shals, tuff cracky (clayey)			
	D	CL	D	CL	D	CL	D	CL	CM	CL	D	CL	D-CL	D	D-CL	CL	CM	D-CL	CM	CL	D	CL	CM	CL	D
Tunnel type	E2	D2(30%) E1(70%)	E2	D2(50%) E1(50%)	E2	D2(50%) E1(50%)	E2	D2(50%) E1(50%)	D1	D2(50%) E1(50%)	D-CL	E2	D	D-CL	CL	CM	D-CL	D1	D2(50%) E1(50%)	D1	D2(20%), E1(30%), E2(50%)	D1	D2	E1	E2

D2(50%), E1(50%)

THE STUDY ON KOK-ING-NAN WATER DIVERSION PROJECT	
GEOLOGICAL PROFILE OF ALTERNATIVE TUNNEL ROUTE KOK-ING NO.2 TUNNEL (B-J ROUTE)	MAP & Drawing No.
JAPAN INTERNATIONAL COOPERATION AGENCY (JICA)	
SANYU CONSULTANTS INC. & NIPPON KOEI CO.,LTD.	
Figure 11.1.4. (3)-5

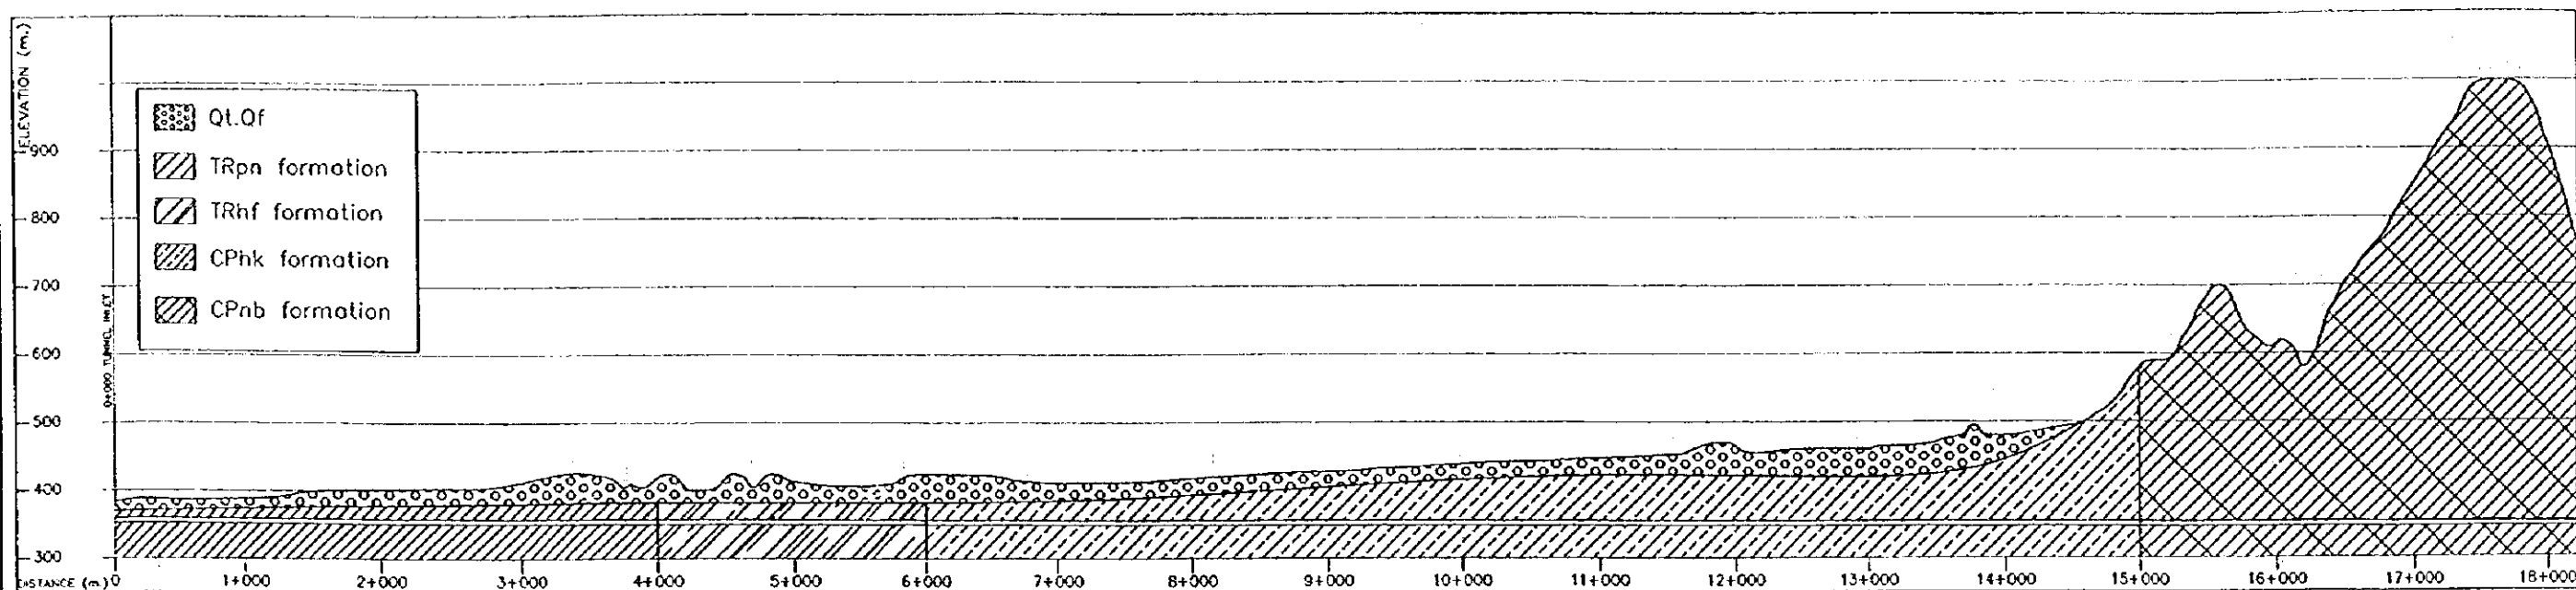
Alluvial deposits, unconsolidated gravel, sand, silt and clay	
Geological Condition	Slate, sandstone and conglomerate reddish brown, reddish purple, fine grained	Shale (slate) greenish-gray, grayish brown interbedded with sandstone and tuffaceous sandstone Meta-sandstone interbedded with meta-shale, brown and grayish brown Slate, quartzite, phyllite gray and grayish black, brown, folding, recrystalline limestone lens
	Basement rocks are associated with thick weathered rock zone at the surface part. It is noticed that the most significant problem in the tunnel construction is removal of groundwater which might be encountered at many places.

THE STUDY ON KOK-ING-NAN WATER DIVERSION PROJECT	
GEOLOGICAL PROFILE OF ALTERNATIVE TUNNEL ROUTE ING-YOT NO.2 TUNNEL (A ROUTE)	MAP & Drawing No.
JAPAN INTERNATIONAL COOPERATION AGENCY (JICA)	Figure 11.14.
SANYU CONSULTANTS INC. & NIPPON KOEI CO.,LTD.	(7)-1

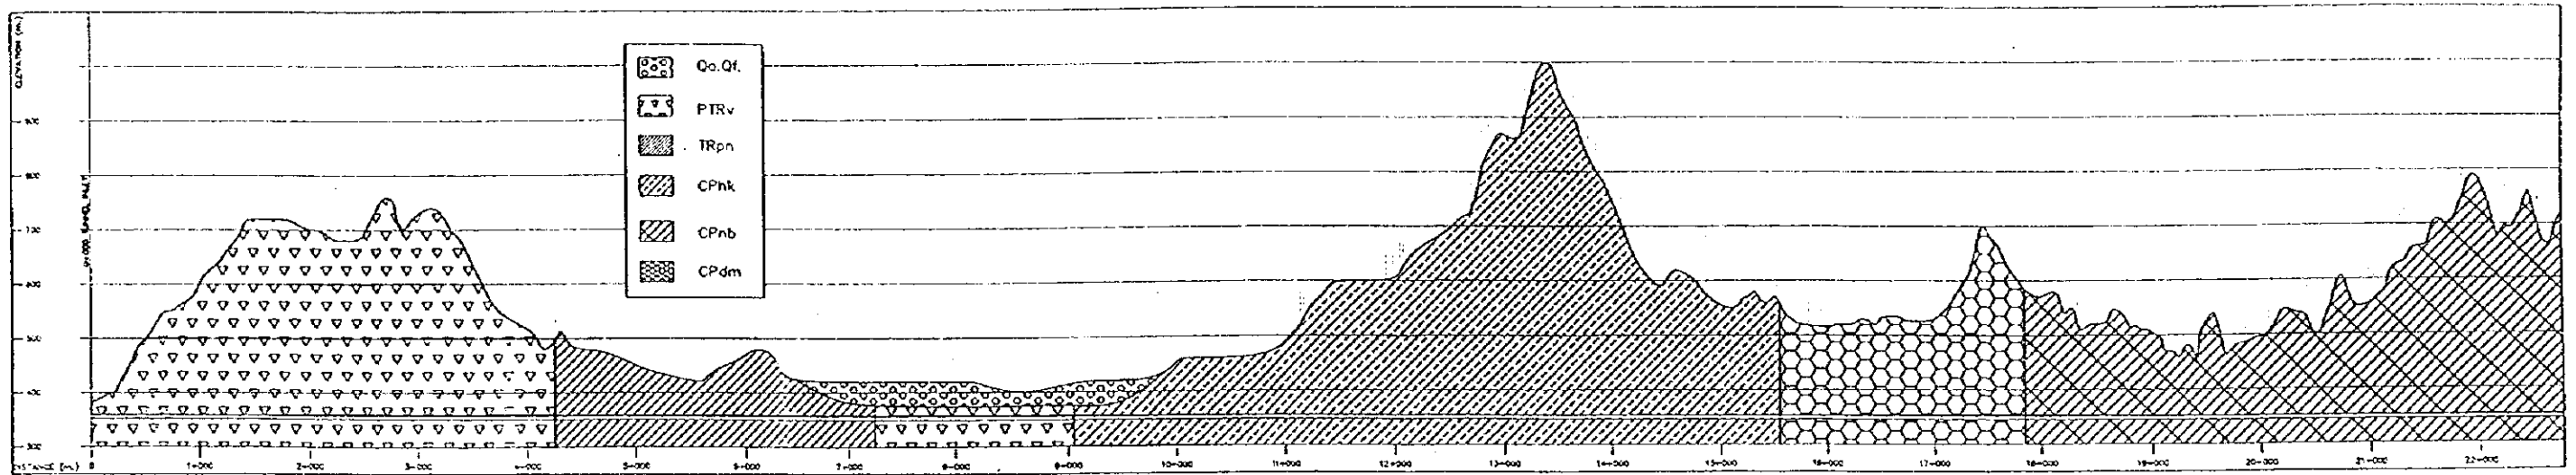
**GEOLOGICAL PROFILE OF ALTERNATIVE TUNNEL ROUTE
ING-YOT NO.2 TUNNEL (LOWER B ROUTE)**

Geological Condition	Volcanic rocks, rhyolite, andesite, tuff, agglomerate light purple to brownish-purple and white	Shale, sandstone and conglomerate reddish brown, reddish purple, fine grained	Alluvial deposits, unconsolidated gravel sand, silt and clay Tuff and agglomerate. There is a large possibility that this valley was eroded along the fault on a large scale. And it is judged that this area is rich in groundwater which is existing in a relatively shallow subsurface.	Meta-sandstone interbedded with meta-shale brown and grayish-brown	Schist, phyllite and meta-volcanic rocks	Slate, quartzite, phyllite, gray and grayish black, brown, folding, recrystalline limestone lens
----------------------	---	---	--	--	--	--

THE STUDY ON KOK-ING-NAN WATER DIVERSION PROJECT	
GEOLOGICAL PROFILE OF ALTERNATIVE TUNNEL ROUTE ING-YOT NO.2 TUNNEL (LOWER B ROUTE)	MAP & Drawing No.
JAPAN INTERNATIONAL COOPERATION AGENCY (JICA)	Figure 11.14.
SANYU CONSULTANTS INC. & NIPPON KOEI CO.,LTD.	(7)-2

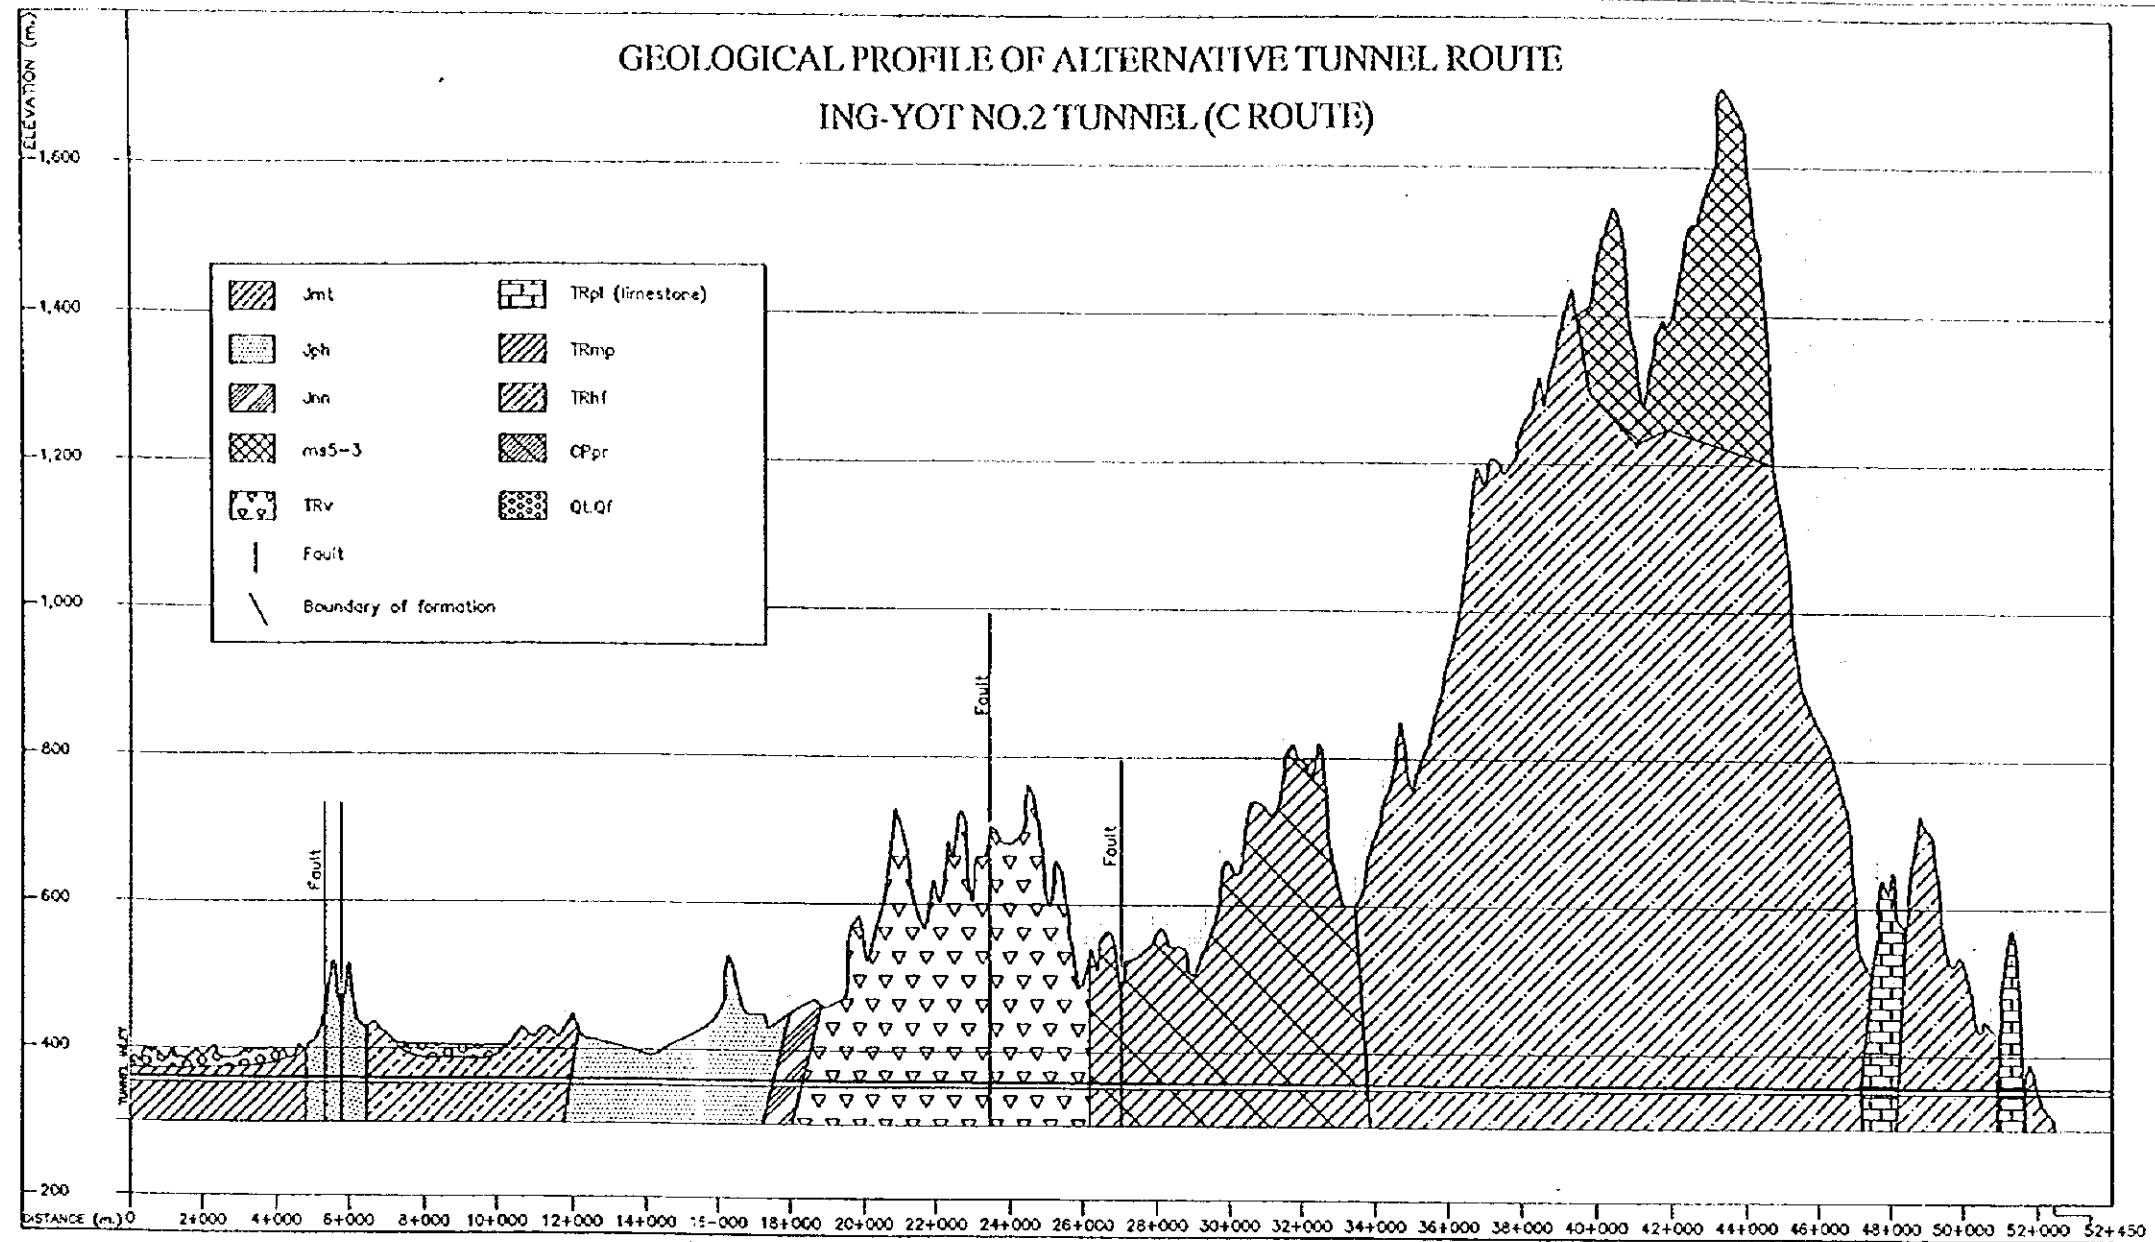
**GEOLOGICAL PROFILE OF ALTERNATIVE TUNNEL ROUTE
ING-YOT NO.2 TUNNEL (C ROUTE)**

Geological Condition	Pelitic shale interbedded with meta-sandstone weathered. (cracky)	Sandstone interbedded with shale and conglomerate cracky along fault	Slate (shale) interbedded with sandstone weathered (cracky)	Sandstone interbedded with shale and conglomerate weathered (cracky)	Rhyolitic and andesitic tuff, rhyolite, andesite hard and massive	Pelitic shale interbedded with meta-sandstone hard, breakable bedding plane	Sandstone, tuff, interbedded with shale hard and massive	Limestone, sandstone and tuff interbedded with shale hard, breakable, cracky along bedding plane
Rock mass classification	D	D-CL	D	D	CL-CM	CL-CM	CL-CM	CL-CM, CL, D
Tunnel type	E2	E1(30%), E2(70%)	E1(10%), E2(90%)	E2(10%), E1(30%), D2(60%)	E2(10%), E1(20%), D2(70%)	C2(50%), D1(50%)	B(10%), C1(40%), C2(50%)	E2(50%), D1(50%), C2(30%), D1(70%), C1(50%), E2

THE STUDY ON KOK-ING-NAN WATER DIVERSION PROJECT	
GEOLOGICAL PROFILE OF ALTERNATIVE TUNNEL ROUTE ING-YOT NO.2 TUNNEL (C ROUTE)	MAP & Drawing No.
JAPAN INTERNATIONAL COOPERATION AGENCY (JICA)	Figure 11.1.4
SANYU CONSULTANTS INC. & NIPPON KOEI CO., LTD.	(7)-3

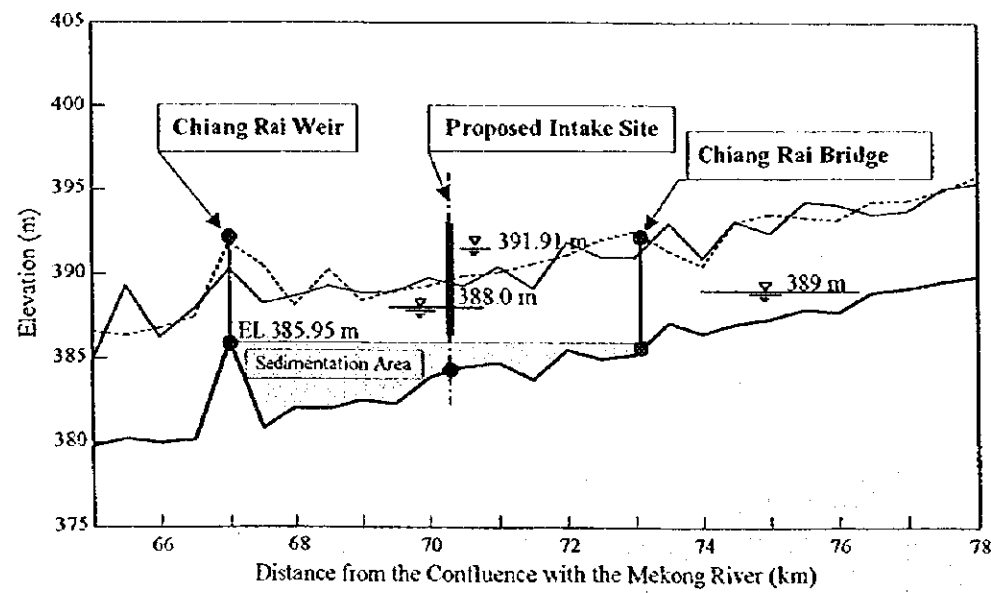
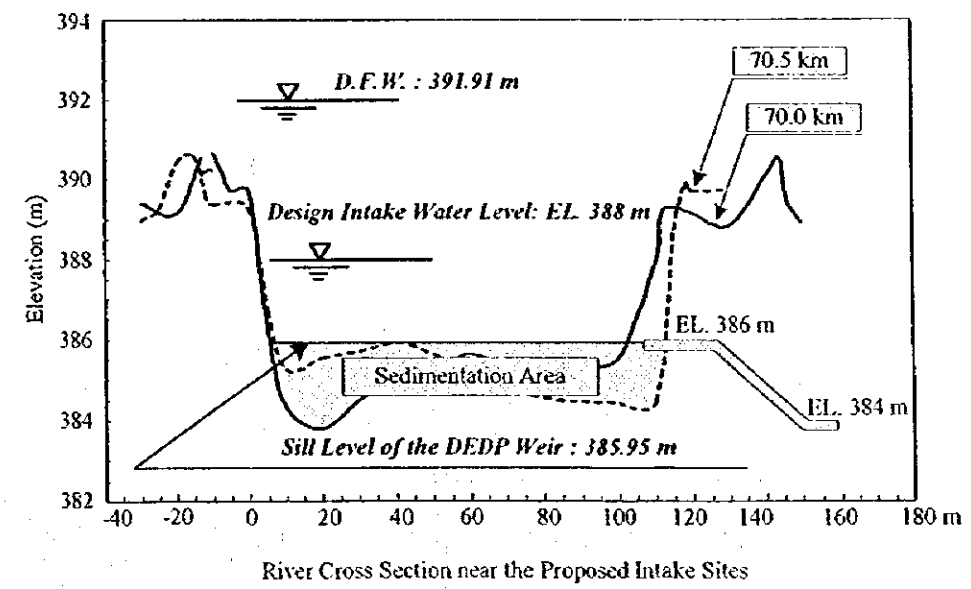
THE STUDY ON KOK-ING-NAN WATER DIVERSION PROJECT	
General Location Map of the Proposed Kok Diversion Weir and Intake	
JAPAN INTERNATIONAL COOPERATION AGENCY (JICA)	MGAP & Drawings No.
SANYU CONSULTANTS INC. & NIPPON KOEI CO., LTD.	Figure 11.2.1-2

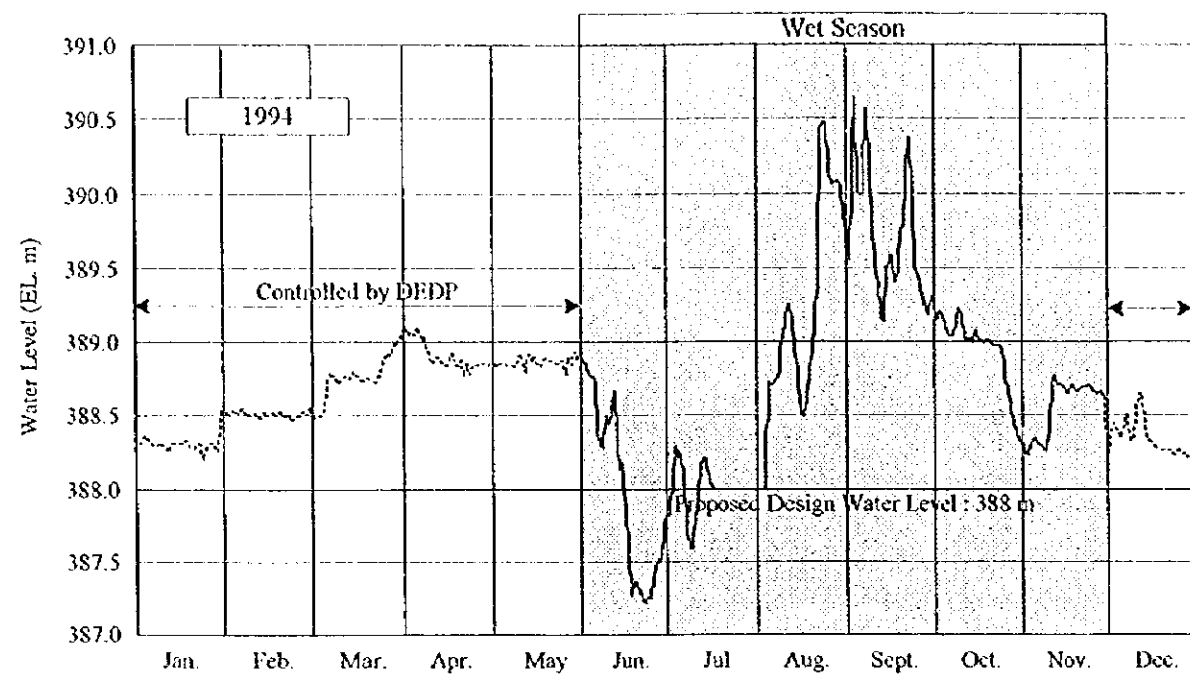
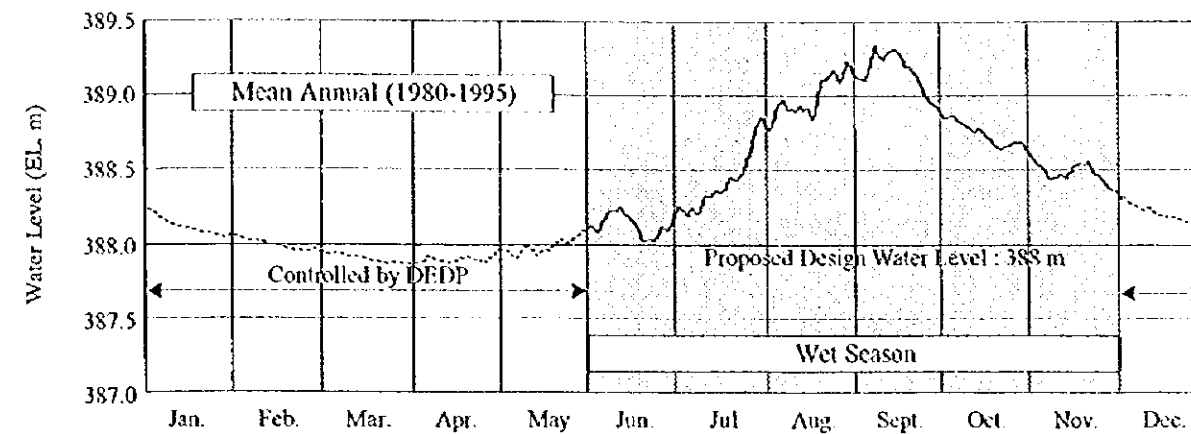
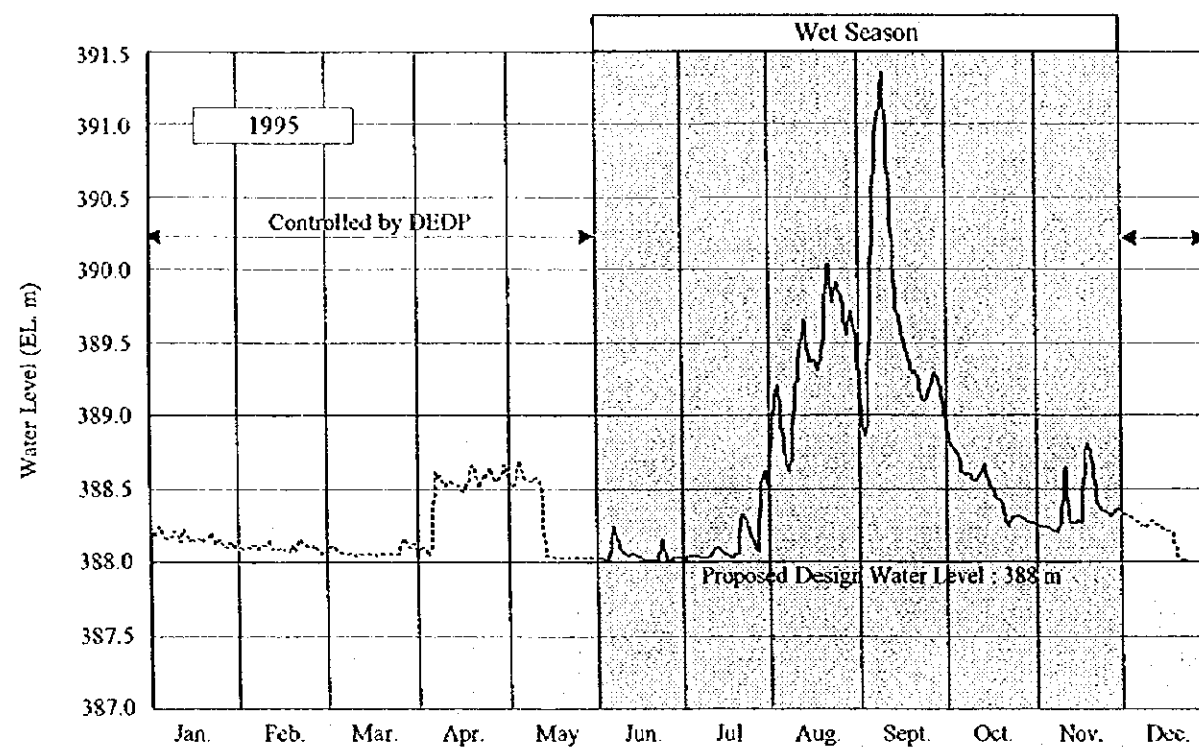
THE STUDY ON KOK-ING-NAN WATER DIVERSION PROJECT	
Water Level Hydrograph at Kok Intake Site	MAP & Drawings No.
JAPAN INTERNATIONAL COOPERATION AGENCY (JICA)	Figure
SANYU CONSULTANTS INC. & NIPPON KOEI CO., LTD.	11.2.1-3

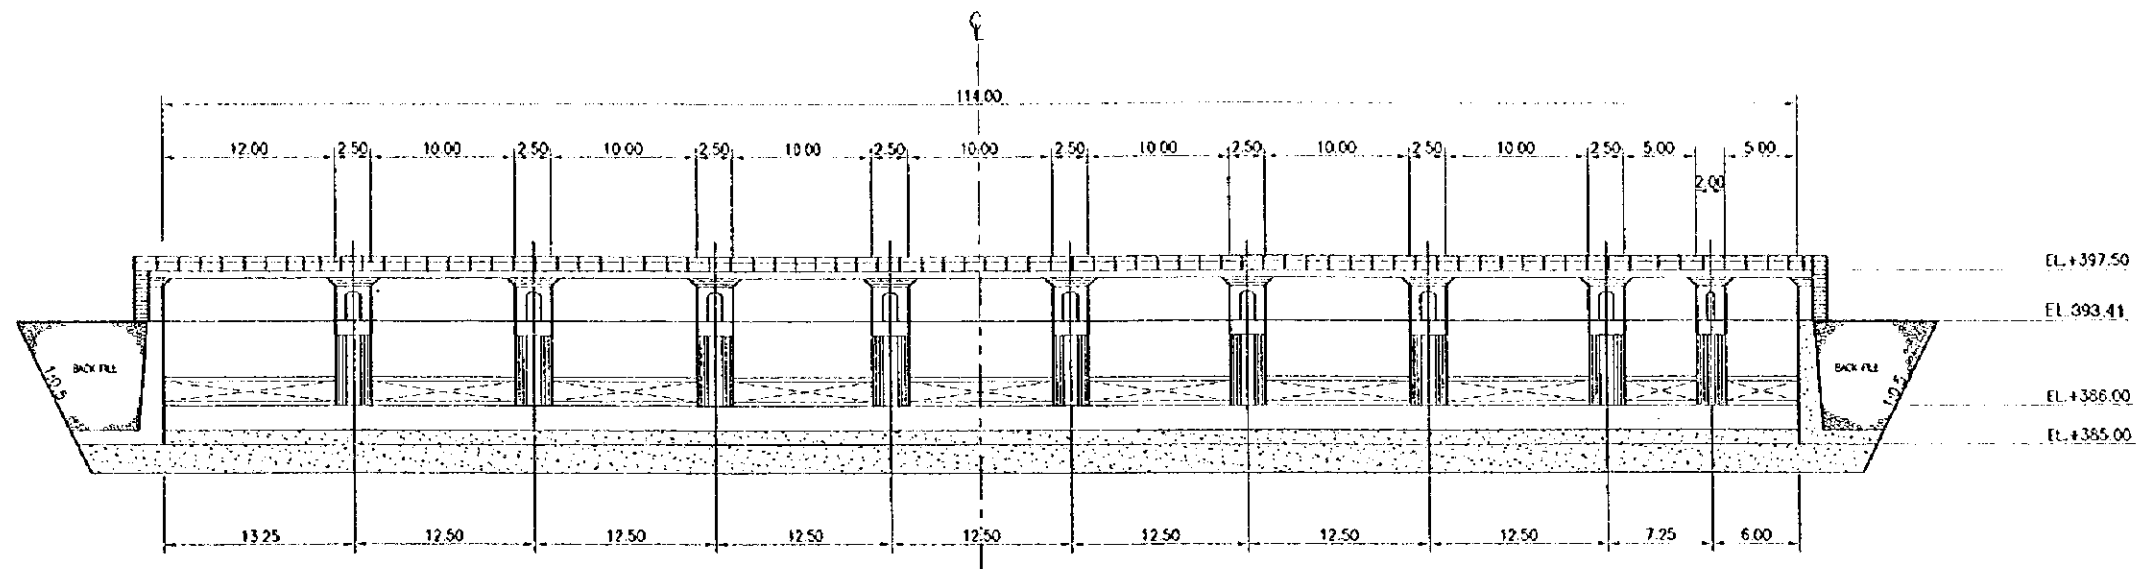
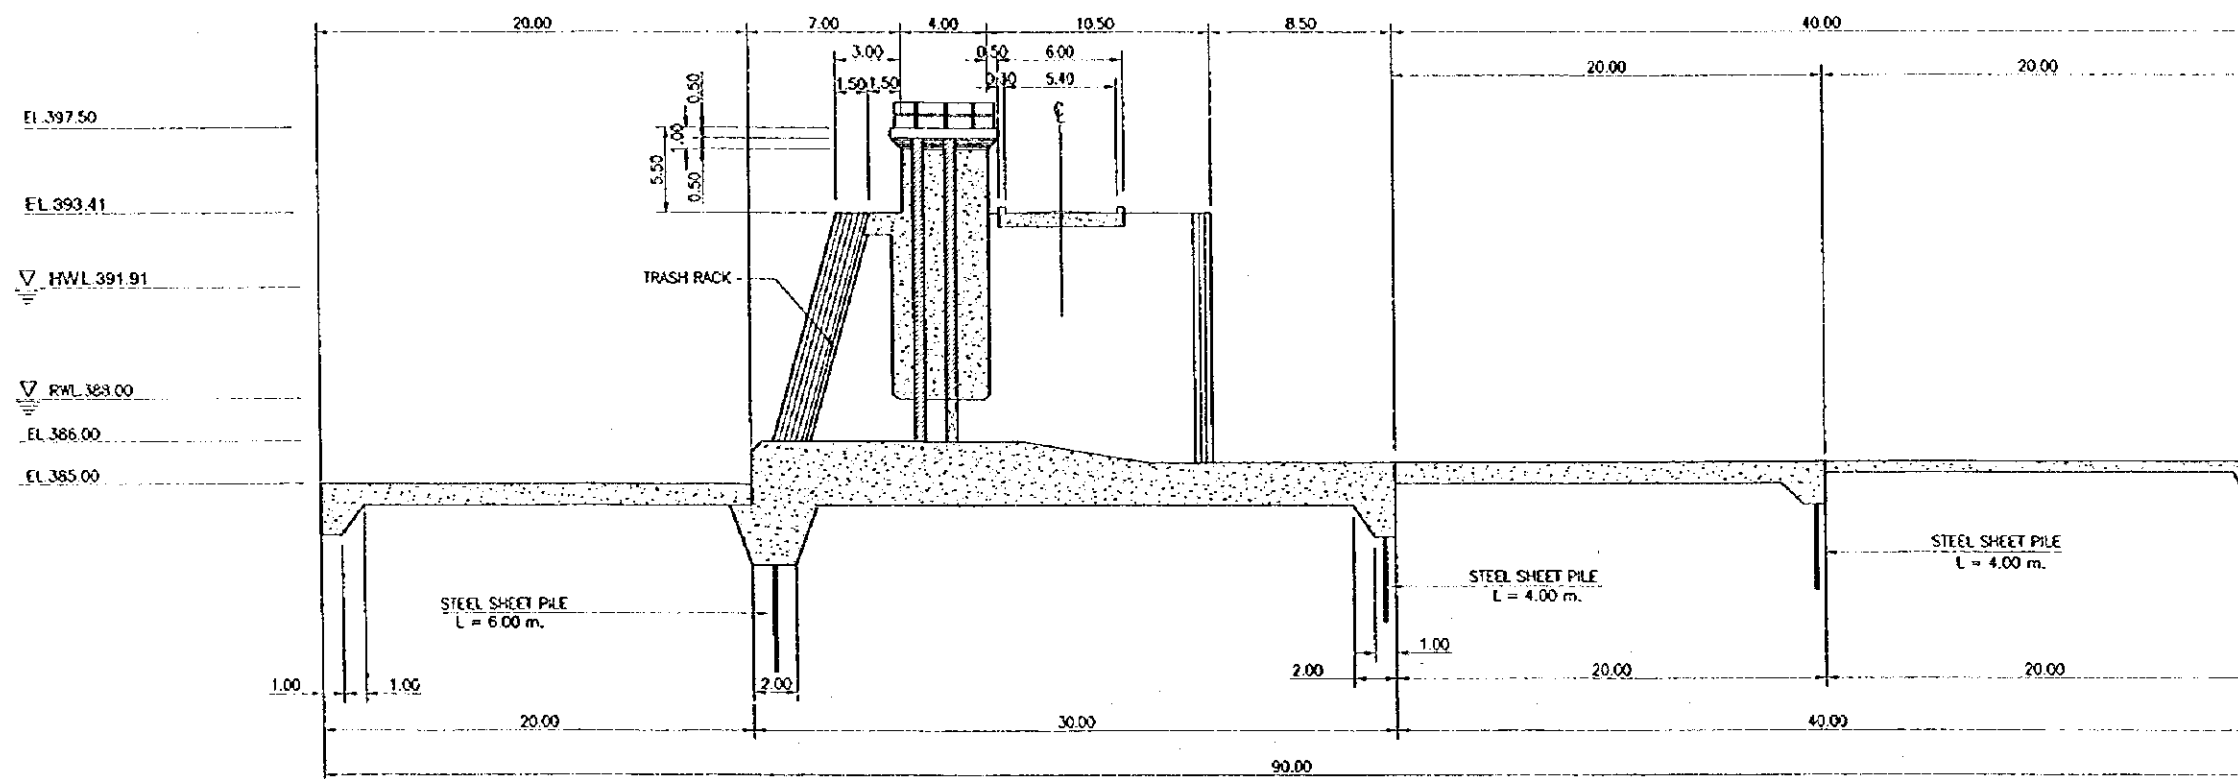
PROFILE KOK INTAKE

UPSTREAM VIEW

THE STUDY ON KOK-ING-NAN WATER DIVERSION PROJECT	
Profile of Kok Intake	MAP & Drawings No.
JAPAN INTERNATIONAL COOPERATION AGENCY (JICA)	Figure
SANYU CONSULTANTS INC. & NIPPON KOEI CO., LTD.	11.2.1-6
