Chapter 3. Present Situation of Water Supply Sector

3.2 Water Supply Condition in the Study Area

Chapter 5. Hydrogeology

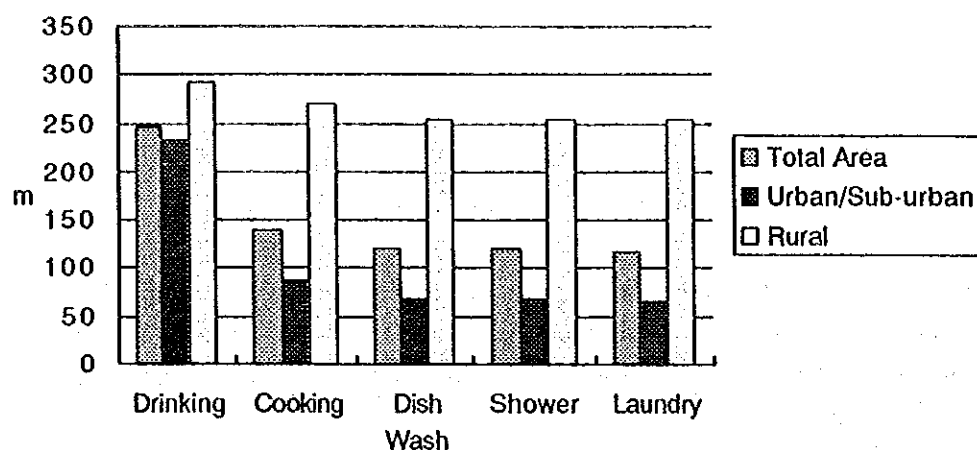
Fig.3.2.4 Average distance to Water Source

- The area where people can meet potable water supply, they go to the potable water resource between 150 m to 450 m for drinking water, but for shower and laundry about 100m. In rural area where is no potable water supply , the difference is much less.
- People go farther to get potable water for drinking and cooking than other purpose.

Fig.3.2.4 shows the average distance to water source by purpose

From these results, it is obvious that people are willing to pay more and consume more energy and time for primary drinking water and secondly cooking water.

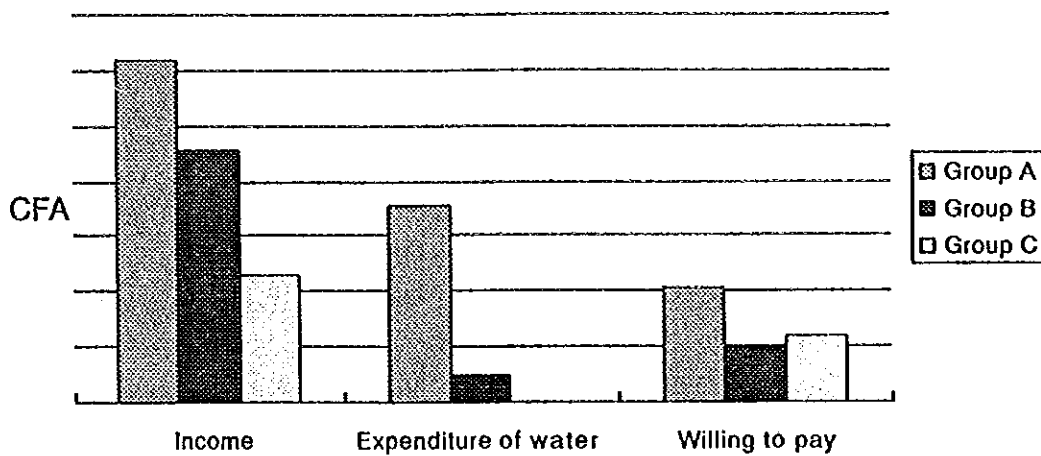
Fig.3.2.5 Income, expenditure of water and willingness to pay

Interestingly the price willing to pay for potable water of Group C people is about CFA 500 higher than its Group B, even through Group C people have lower income in general. These people live mostly too far away from Kiosque and have disparate need of potable water

therefore their willingness to pay becomes higher.

(*One unit for income is cfa20000, expenditure and willingness to pay cfa2000)
