*CHAPTER 2*  
*CONTENTS OF THE PROJECT*

### 2.1 Key Issues for the Project and Objectives

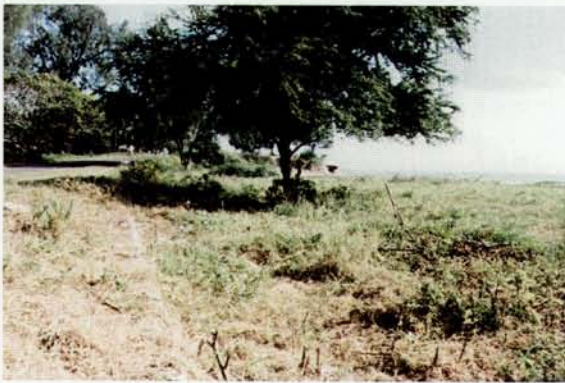
Photo 1: Point-A,  
Shoreline was moved.

Compared with aerial photos in 1975 and 1992, the shoreline in front of the State House has been shifted 70m offshore as shown in Photo-1. Sand drifts in this area.

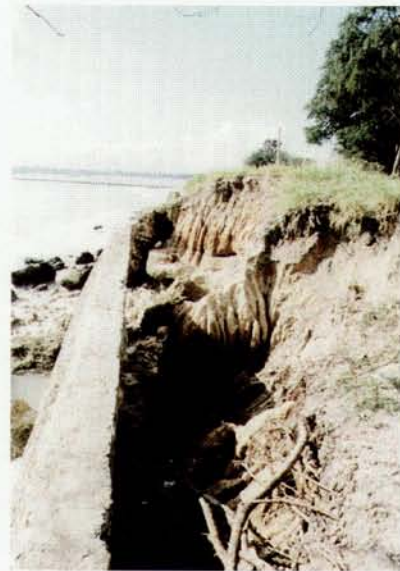
Photo 2: Revetment near Point-A  
Sand inside was scoured.

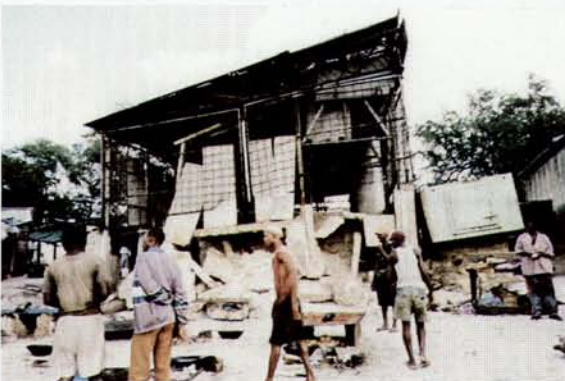
Photo 3: Old Ice Plant  
The foundation was scoured by waves.

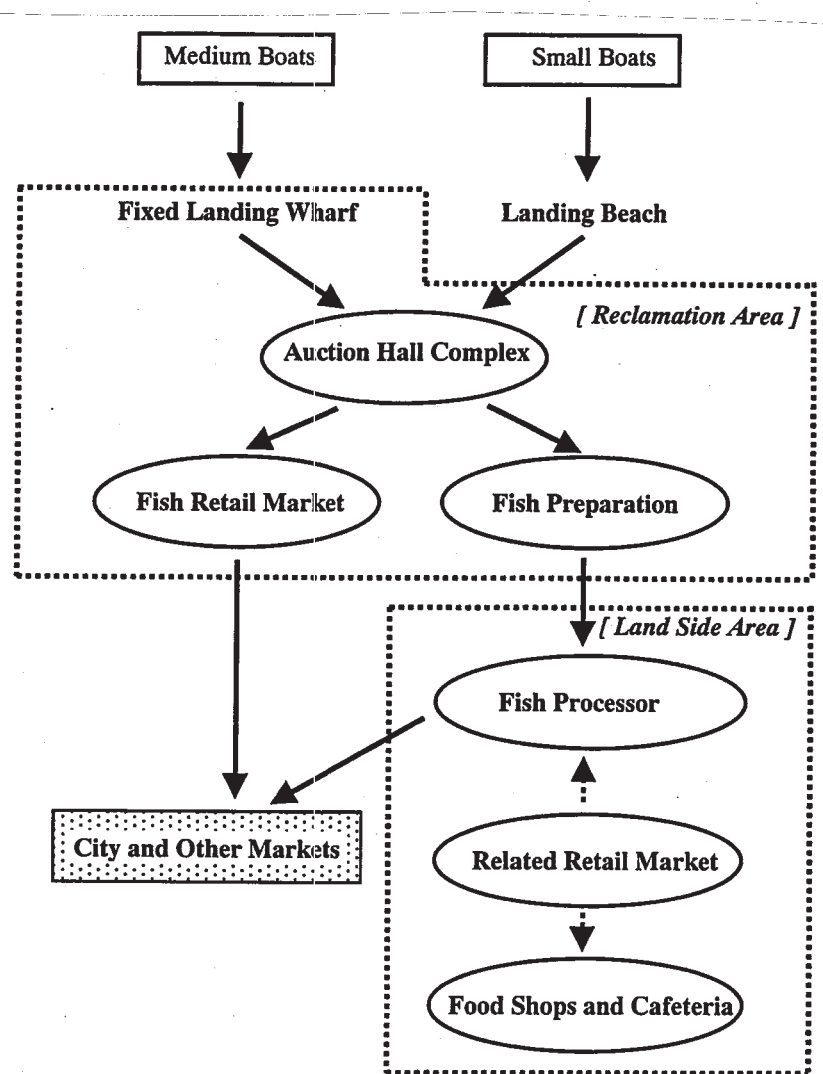
**Figure 2.5.1 General Flow of Fish and Commodity in Fish Market**

Figure 2.5.1 shows flow of fish and commodities in the market.
