Photo 1.1.24 Drilling Core Photograph of Bore Hole No. B - 27 (2 of 3)

ADDITIONAL GEOLOGICAL SURVEY
 FOR THE DETAILED DESIGN OF FLOOD CONTROL,
 URBAN DRAINAGE AND WATER RESOURCES DEVELOPMENT
 IN SEMARANG IN THE REPUBLIC OF INDONESIA

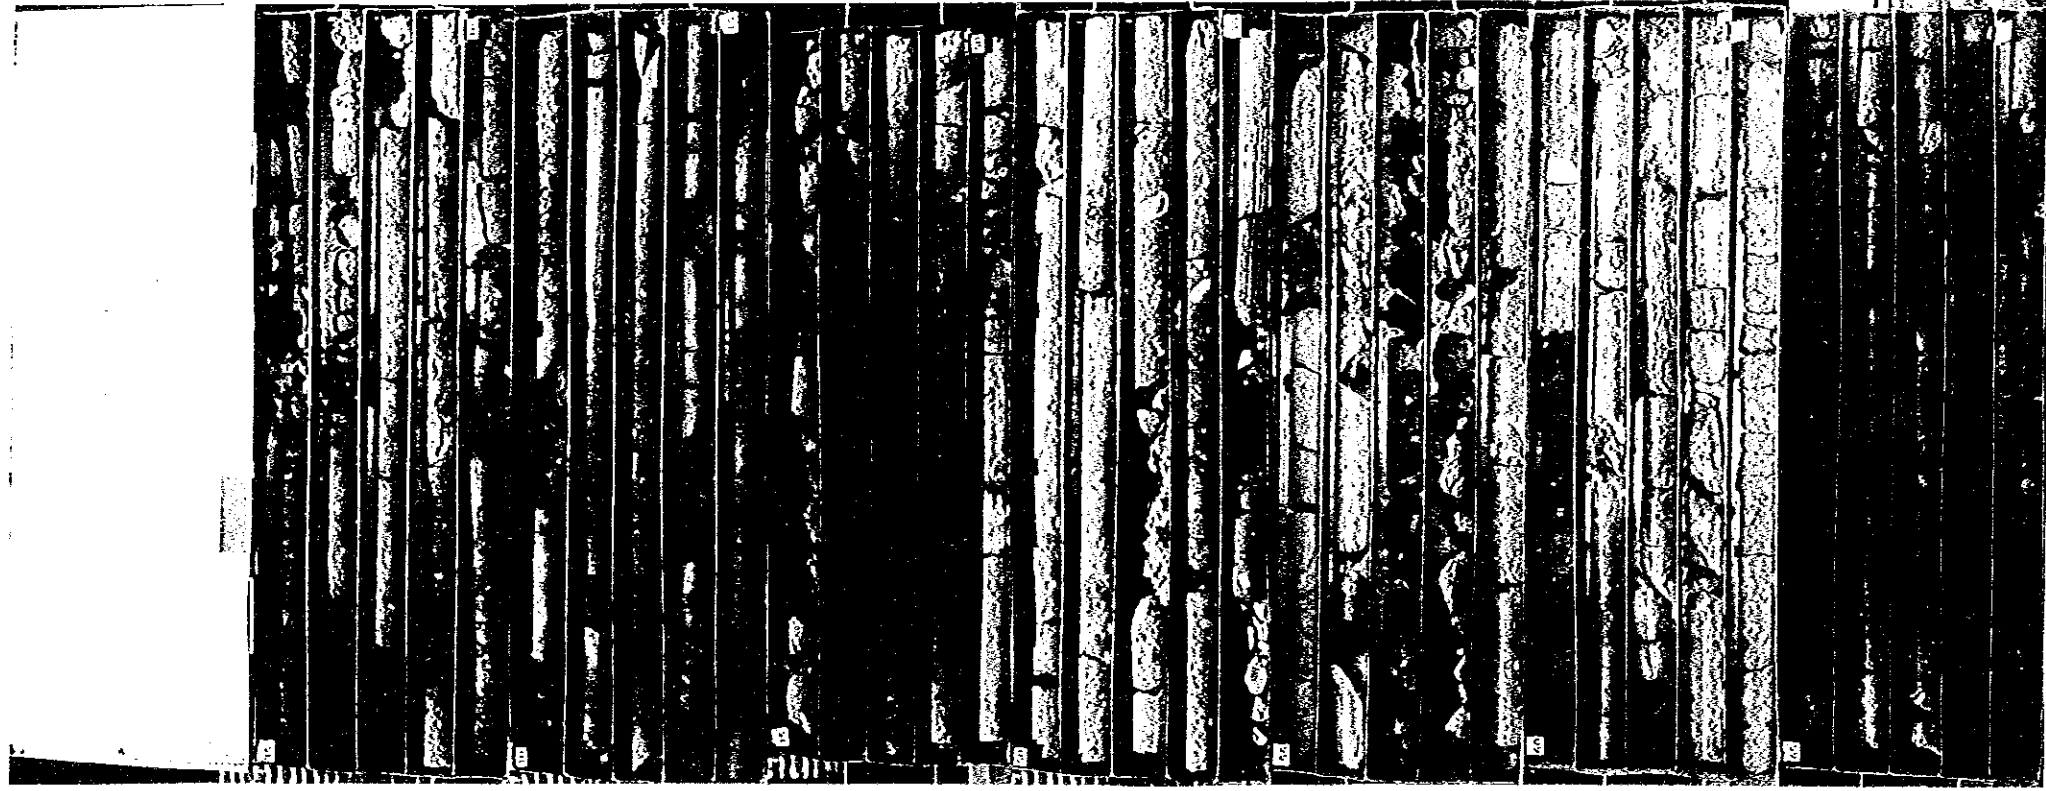
Bore Hole No. : B - 27
Location : Dam site
Ground Elevation : EL. 136.65 m
Total Depth : 88 m
Depth : 35 ~ 70 m

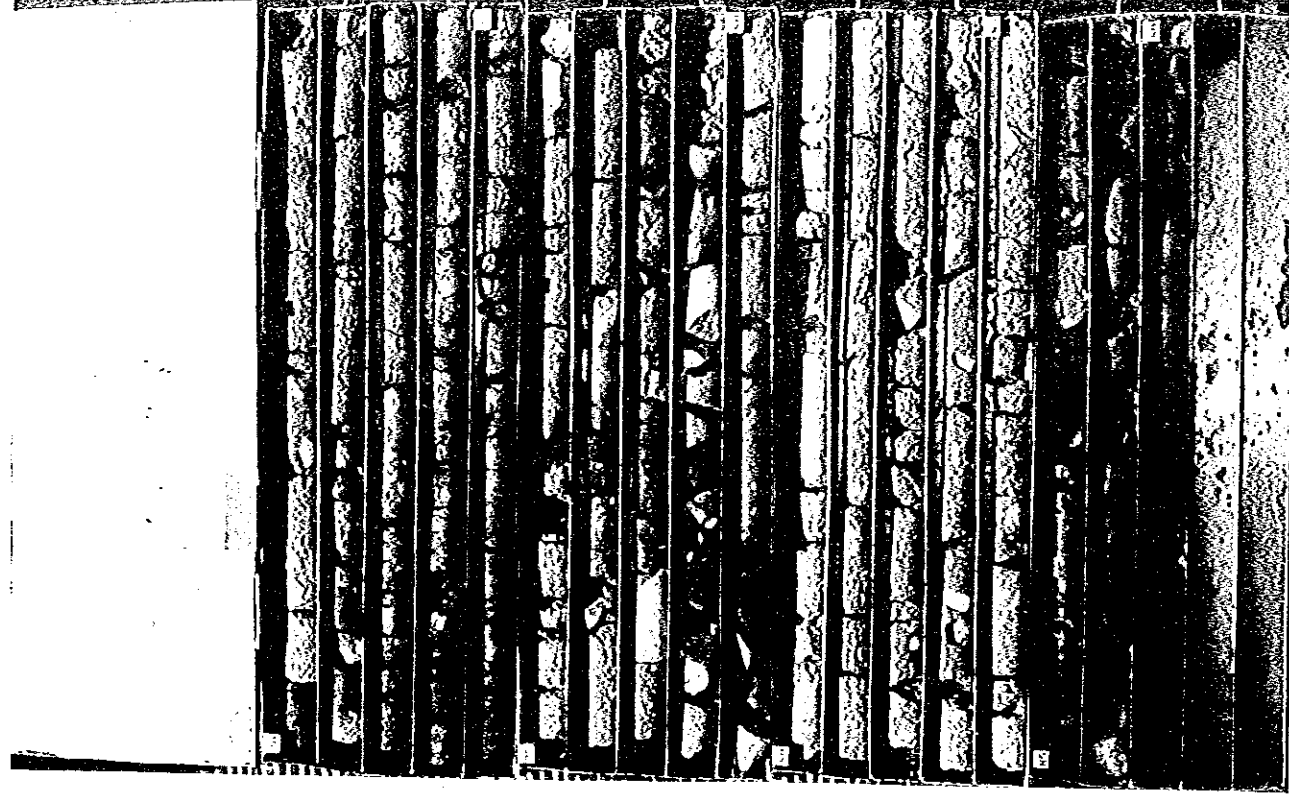
Photo 1.1.24 Drilling Core Photograph of Bore Hole No. B - 27 (3 of 3)

Bore Hole No. : B - 27
Location : Dam site
Ground Elevation : EL. 136.65 m
Total Depth : 88 m
Depth : 70 ~ 88 m

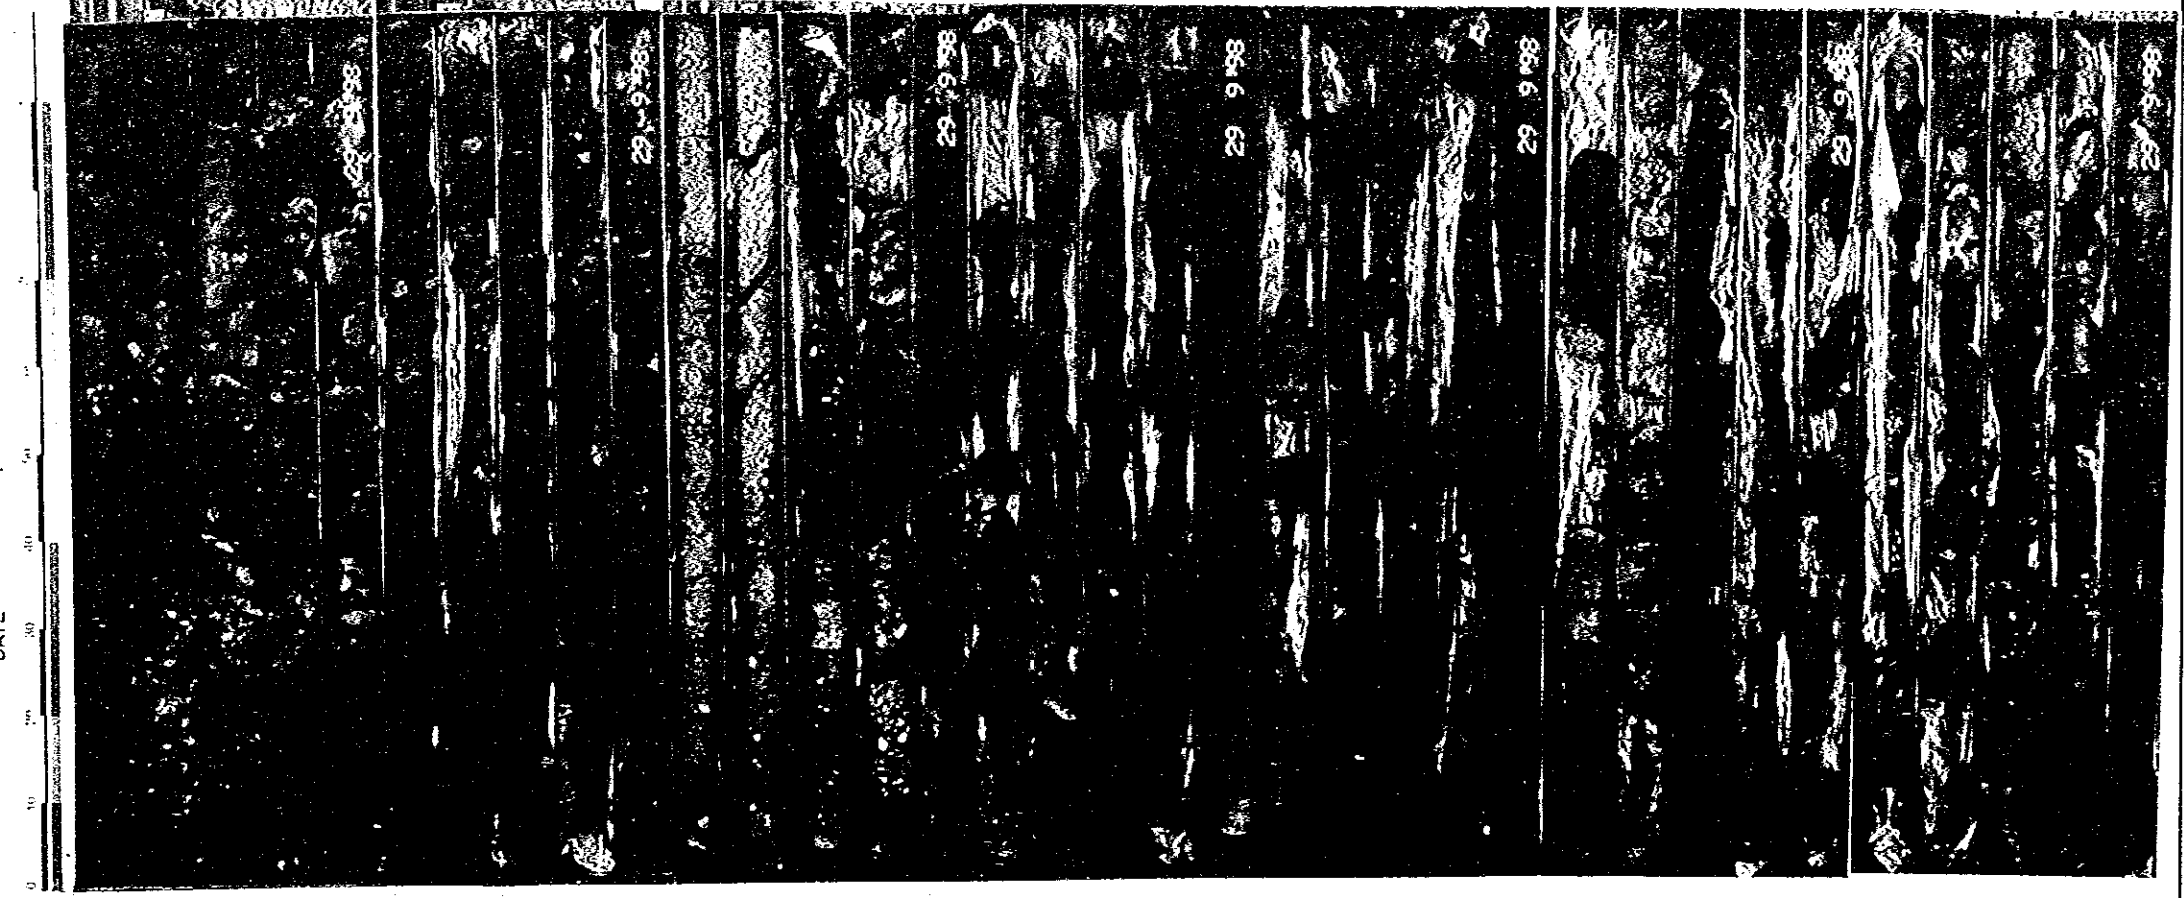
Photo 1.1.28 Drilling Core Photograph of Bore Hole No. B - 31 (1 of 2)

Bore Hole No. : B-31
 Location : Damsite
 Ground Elevation : EL. 147.380 m
 Total Depth : 65 m
 Depth : 0 ~ 35 m

BORE HOLE NO. : B-31
 LOCATION : DAM SITE
 TOTAL DEPTH : 65.00M
 DATE : 29 9 98

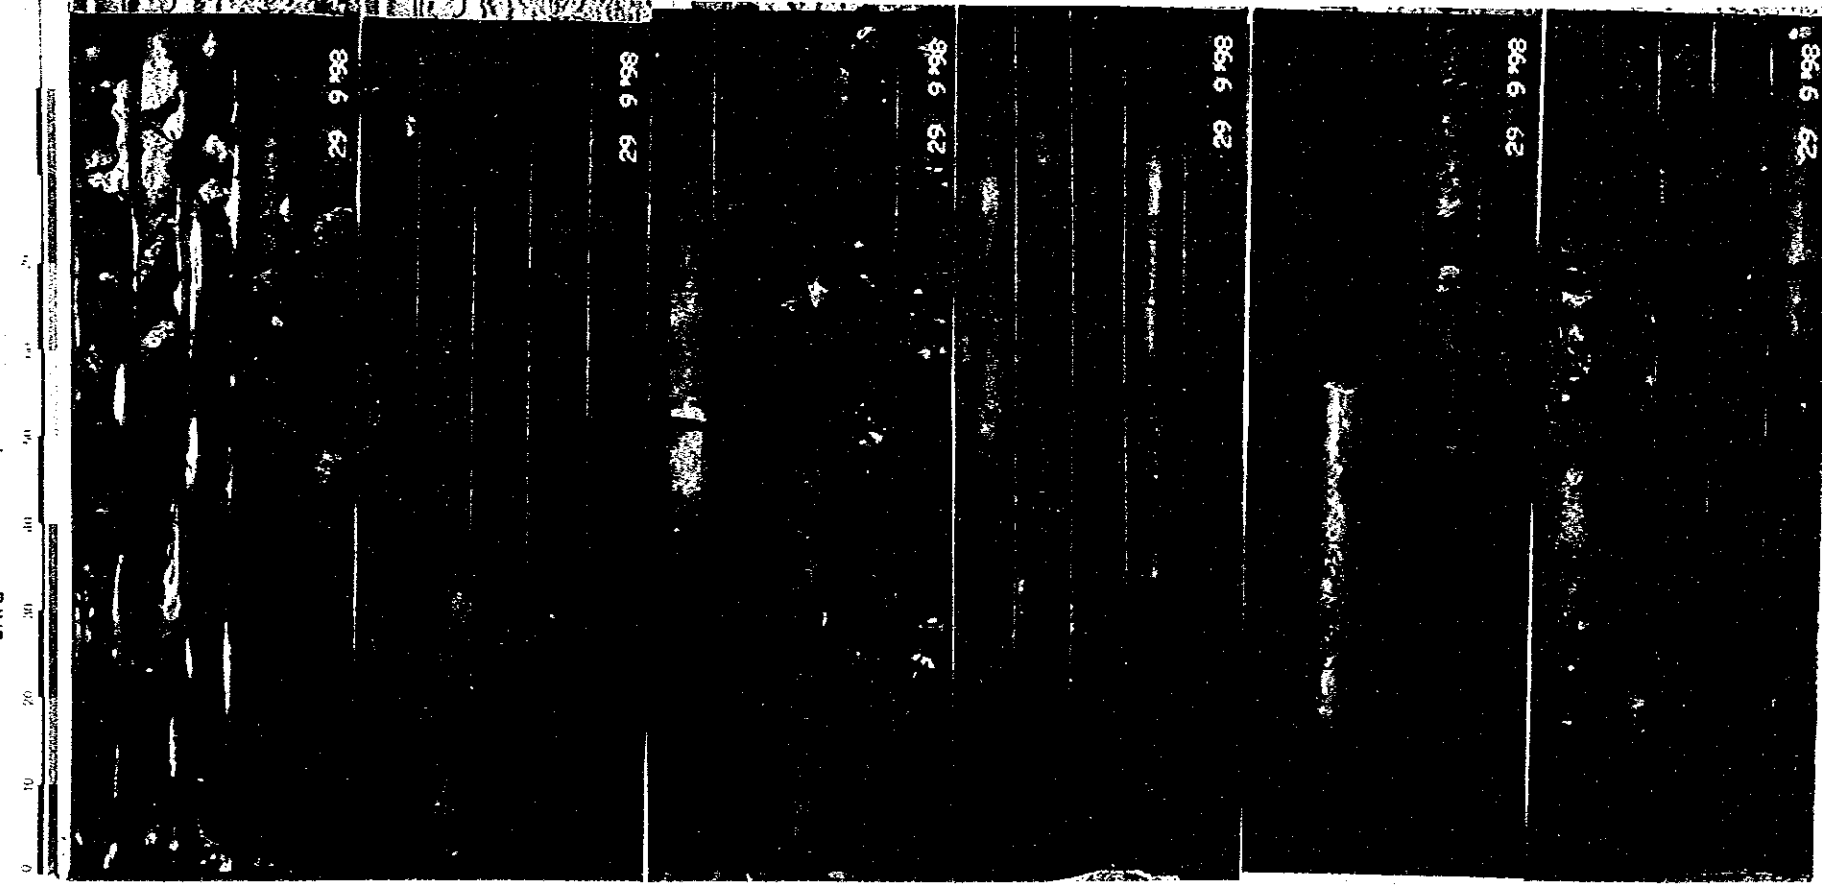
Photo 1.1.28 Drilling Core Photograph of Bore Hole No. B - 31 (2 of 2)

Bore Hole No. : B-31
 Location : Damsite
 Ground Elevation : EL. 147.380 m
 Total Depth : 65 m
 Depth : 35 ~ 65 m

JICA
 ADDITIONAL GEOLOGICAL SURVEY
 FOR THE DETAILED DESIGN OF FLOOD CONTROL,
 URBAN DRAINAGE AND WATER RESOURCES DEVELOPMENT
 IN SEMARANG IN THE REPUBLIC OF INDONESIA
 BORE HOLE NO. : B-31
 LOCATION : DAM SITE
 TOTAL DEPTH : 65.00m
 DATE : 29/9/98

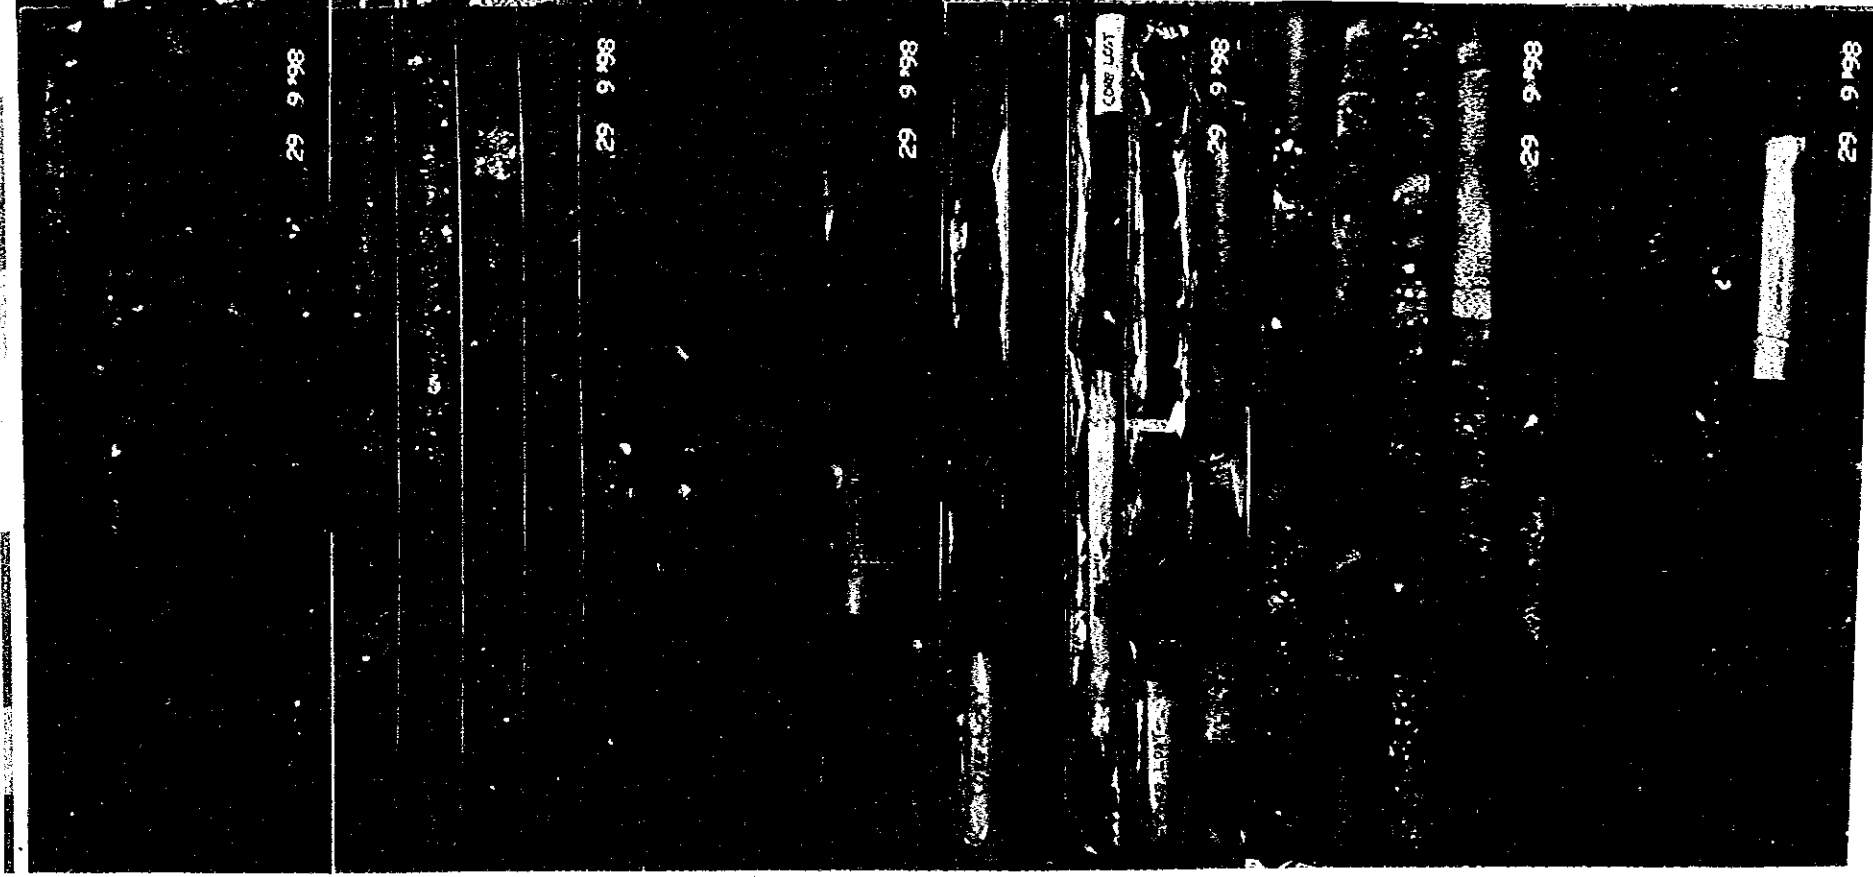
Photo 1.1.29 Drilling Core Photograph of Bore Hole No. B-32 (2 of 3)

Bore Hole No. : B-32
 Location : Dam site
 Ground Elevation : EL. 171.143 m
 Total Depth : 85 m
 Depth : 30 ~ 60 m

BORE HOLE NO. : B-32
 LOCATION : DAM SITE
 TOTAL DEPTH : 85.00 m
 DATE : 29 9 1988

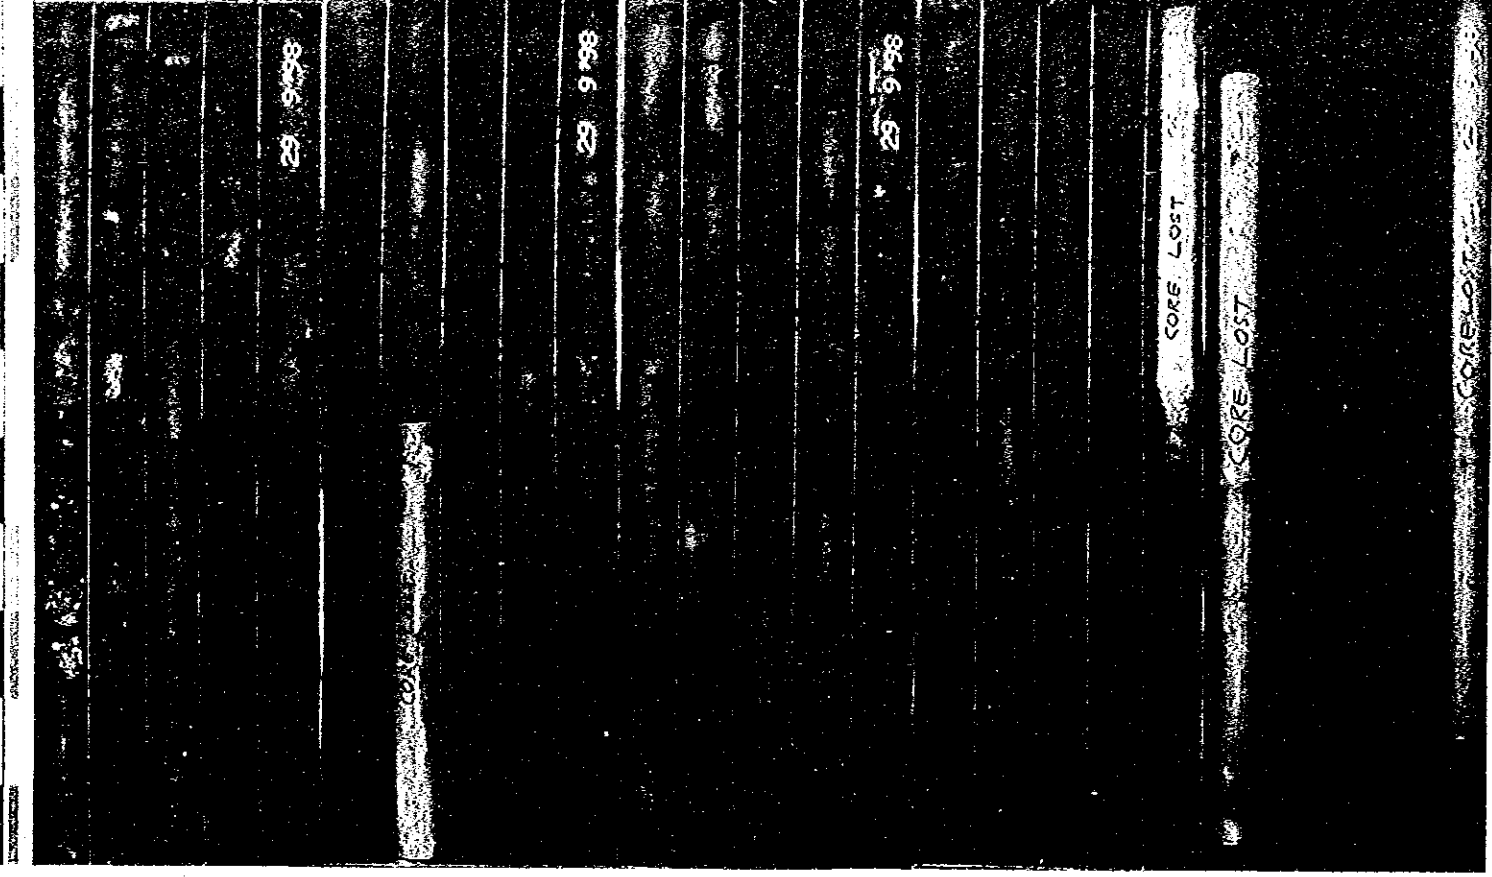
Photo 1.1.29 Drilling Core Photograph of Bore Hole No. B-32 (3 of 3)

Bore Hole No. : B-32
 Location : Dam site
 Ground Elevation : EL. 171.143 m
 Total Depth : 85 m
 Depth : 60 ~ 85 m

BORE HOLE NO. : B-32
 LOCATION : DAM SITE
 TOTAL DEPTH : 85.00 m
 DATE : 29 9 1988

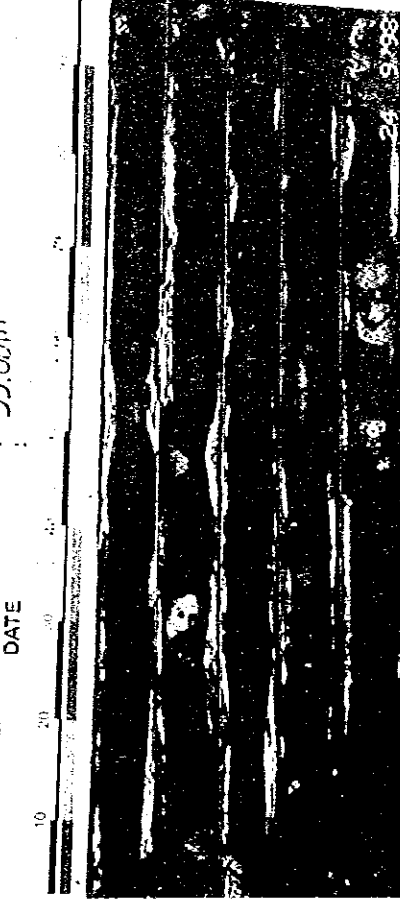
Photo 1.1.30 Drilling Core Photograph of Bore Hole No. B - 33 (2 of 2)

Bore Hole No. : B-33
 Location : Damsite
 Ground Elevation : EL. 88.096 m
 Total Depth : 35 m
 Depth : 30 ~ 35 m

BORE HOLE NO. : B-33
 LOCATION : DAM SITE
 TOTAL DEPTH : 35.00m
 DATE : 24 9 1988

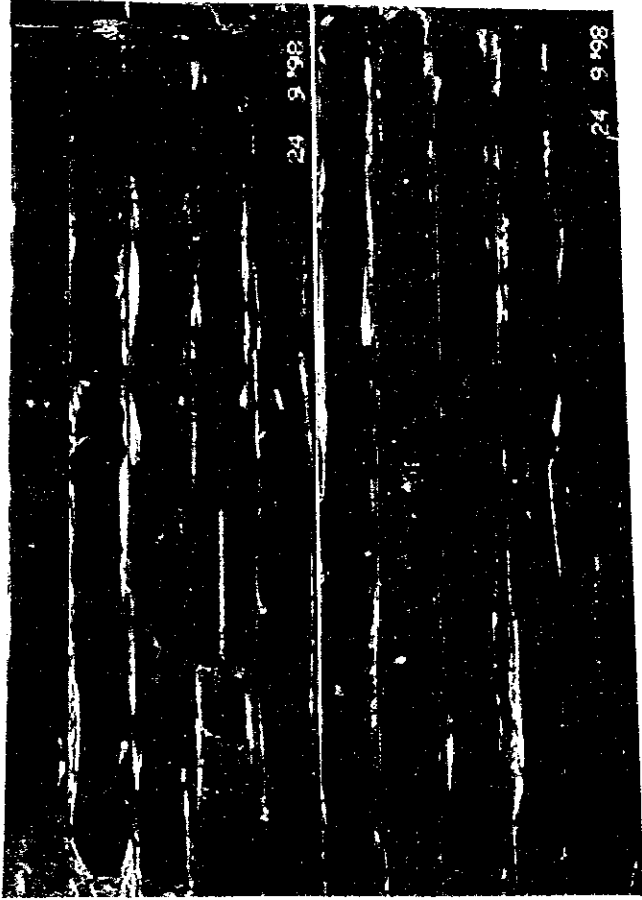
Photo 1.1.31 Drilling Core Photograph of Bore Hole No. B - 34 (1 of 1)

Bore Hole No. : B-34
 Location : Damsite
 Ground Elevation : EL. 100.958 m
 Total Depth : 10 m
 Depth : 0 ~ 10 m

BORE HOLE NO. : B-34
 LOCATION : DAM SITE
 TOTAL DEPTH : 10.00 m
 DATE :

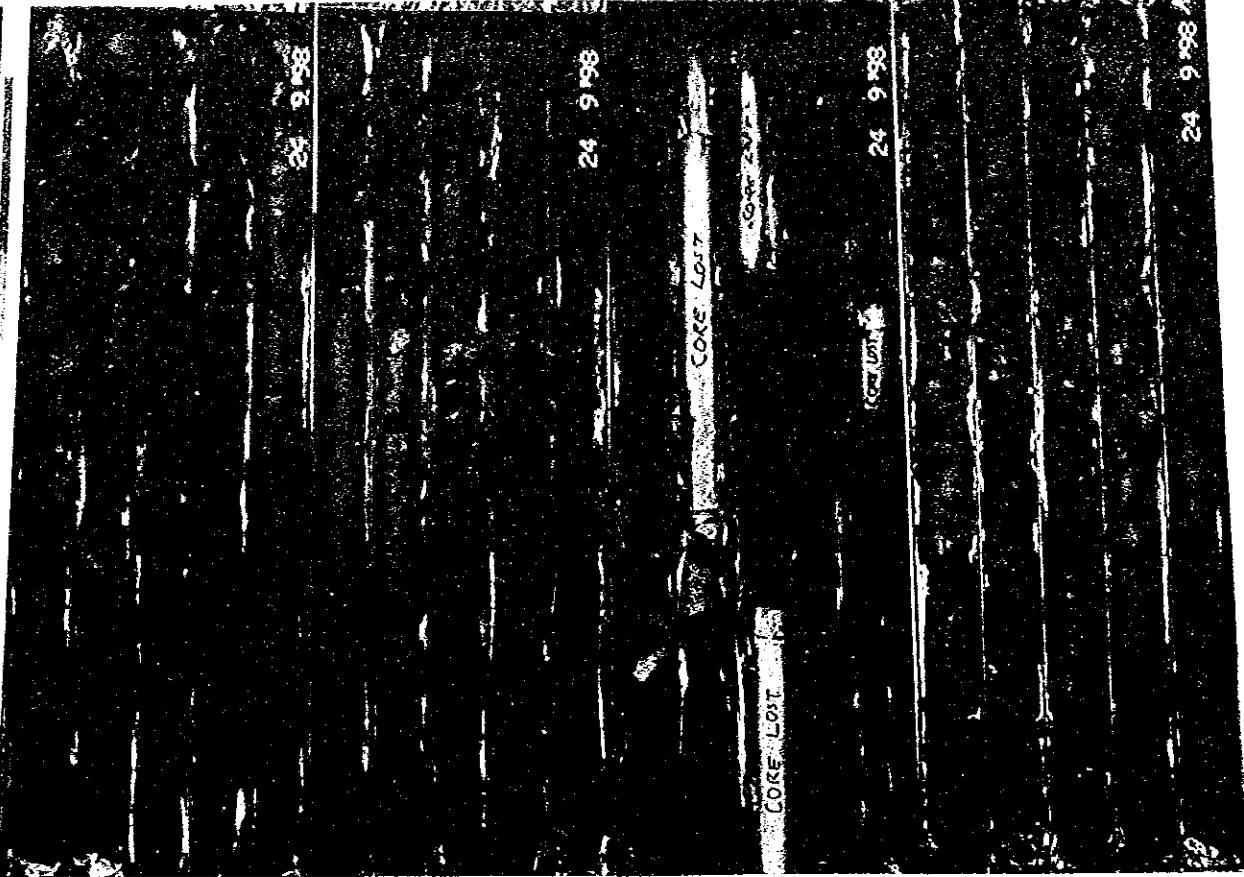
Photo 1.1.32 Drilling Core Photograph of Bore Hole No. B - 35 (1 of 1)

Bore Hole No. : B-35
 Location : Damsite
 Ground Elevation : EL. 150.163 m
 Total Depth : 20 m
 Depth : 0 ~ 20 m

BORE HOLE NO. : B-35
 LOCATION : DAM SITE
 TOTAL DEPTH : 20.00 m
 DATE : SEPTEMBER '98

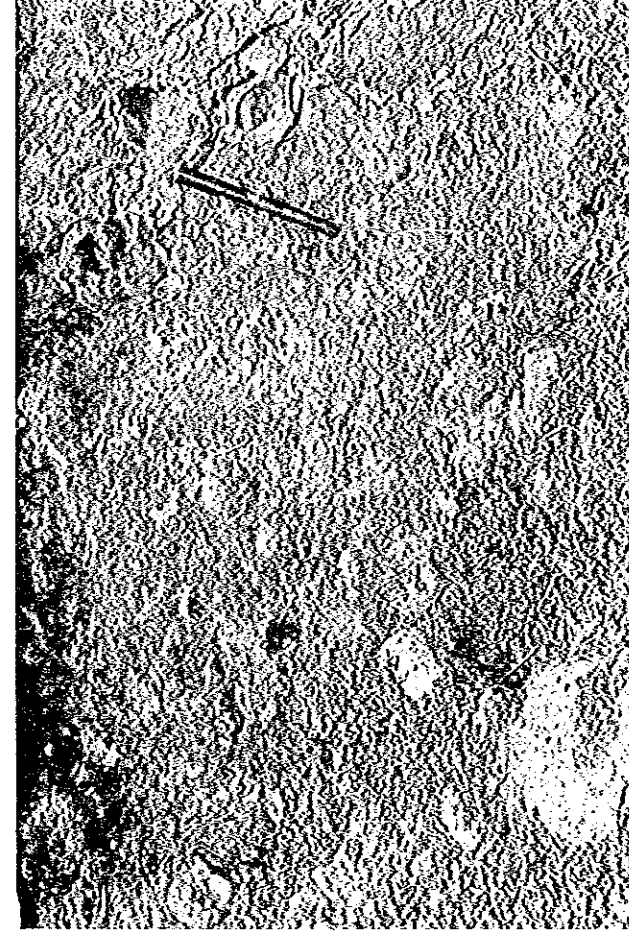
Volcanic Conglomerate, poor cemented, greyish brown (CL - L)
on the Axis Dam

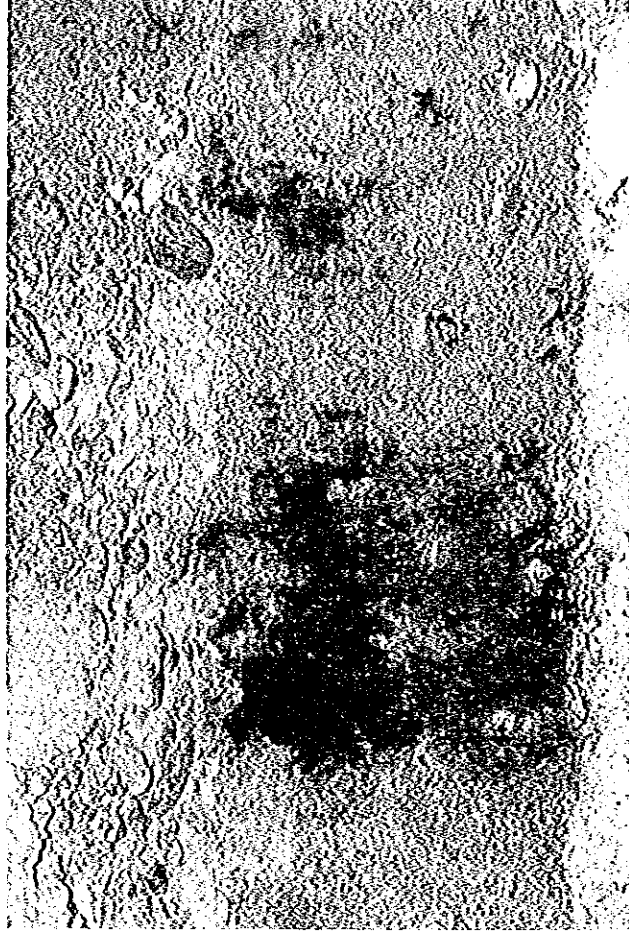
Conglomerate, poor cemented, greyish brown (CL - L) and Sand loose, Coarse grained, blackish (D) on the T - 2.
