6. MASTER PLAN FOR CHANNEL IMPROVEMENT

6.1 General

This chapter describes the channel improvement plan for the vessel navigation, in viewpoint of efficient operation and maintenance including minimization of dredging activities. The technical aspects of master planning such as basis of channel improvement, methods of channel improvement, dredging improvement and preliminary cost estimates for the proposed project are discussed in sections from 6.2 to 6.5. The institutional and organizational studies, and environmental impacts are explained in sections 6.6 and 6.7. Moreover, economic and financial evaluation of the project from the standpoint of national economy and selection of priority projects are discussed in sections 6.8 and 6.9.

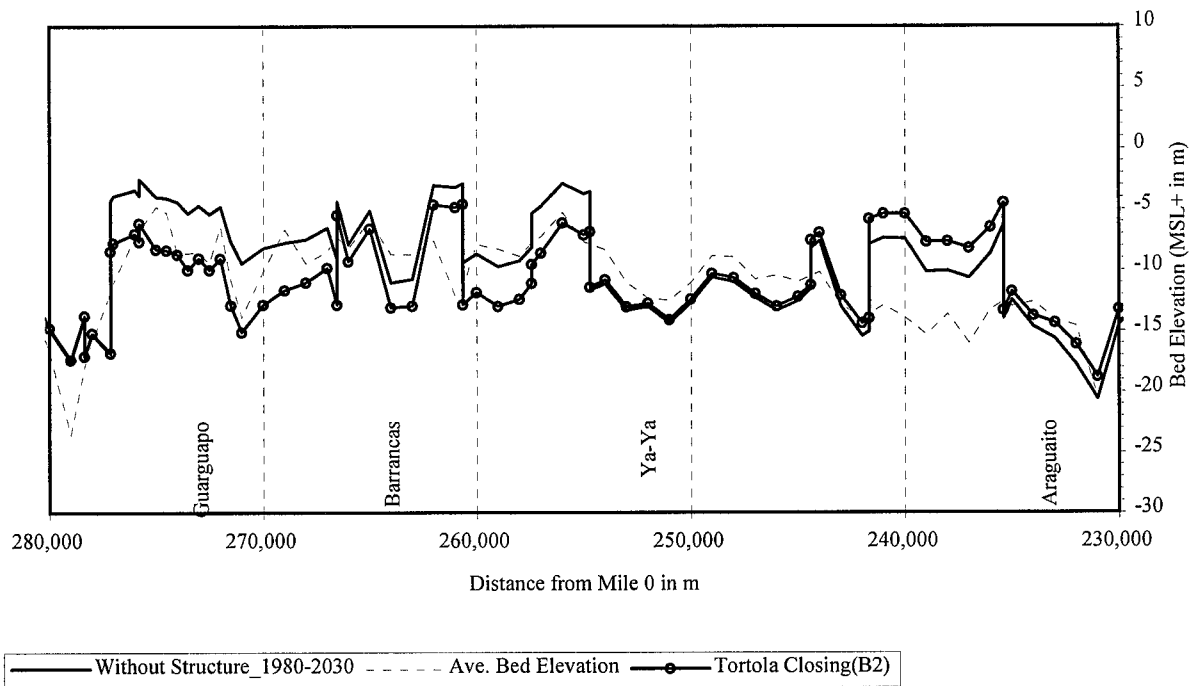
LONGITUDINAL PROFILE OF BED ELEVATION IN RIO GRANDE CHANNEL
Alt.B2: Discharge Control at Tortola Channel

Fig.6-3-6 CHANGE OF BED ELEVATION AND DISCHARGE DISTRIBUTION BY ALT.B2

It should be noted, however, that the expected results with implementation of B2 scheme are evaluated hydraulically utilizing purely 1-dimensional numerical analysis. The adverse effects of river bank erosion by increase of discharge in the navigation channel, could not be clearly studied yet, especially in terms of extent and intensity of erosion, due to lack of information in this stage. The risk is still existed due to unclear phenomenon and the estimated construction cost for bank protection structure is also tentative.
