**THE DETAILED DESIGN STUDY
ON
THE PROJECT FOR REDUCTION
OF NON-REVENUE WATER
IN THE GREATER COLOMBO AREA
IN
THE DEMOCRATIC SOCIALIST REPUBLIC OF SRI LANKA**

FINAL REPORT

**DESIGN REPORT ON THE CONTRACT
FOR LEAK REPAIR WORKS**

MARCH 2001

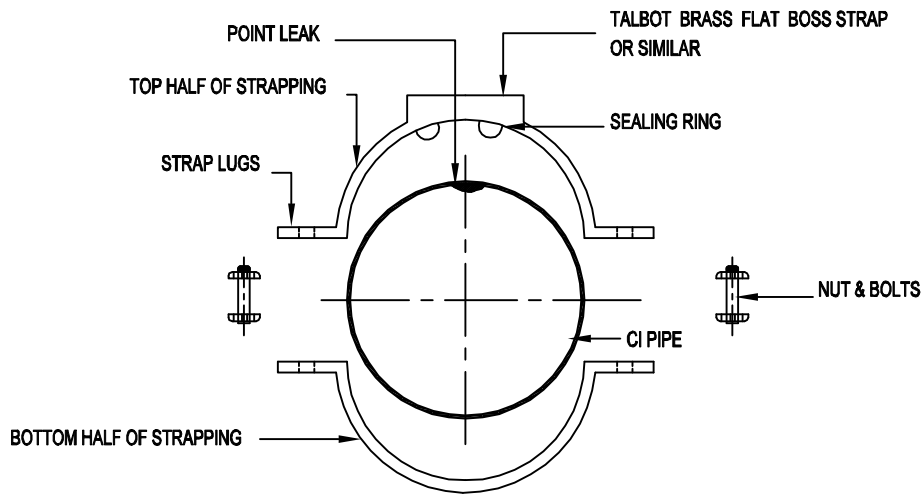
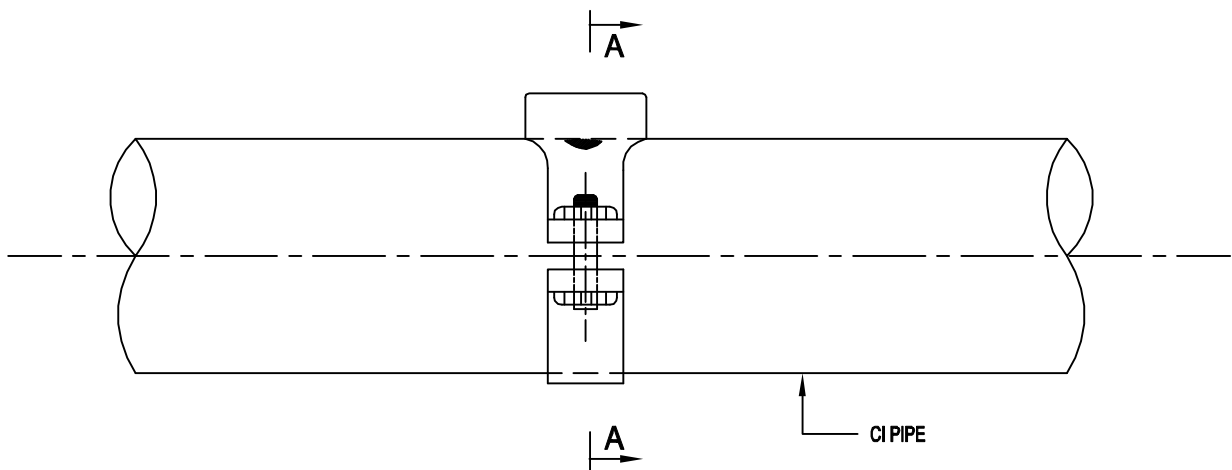
LR/SD/01	Leak Type - A
SCALE	Not to Scale
JICA STUDY TEAM THE DETAILED DESIGN STUDY ON THE PROJECT FOR REDUCTION OF NON-REVENUE WATER IN THE GREATER COLOMBO AREA IN THE DEMOCRATIC SOCIALIST REPUBLIC OF SRI LANKA

SECTION A - A

ELEVATION

LEAK TYPE A

SMALL POINT LEAK THAT CAN BE REPAIRED WITH BRASS SADDLE STRAP

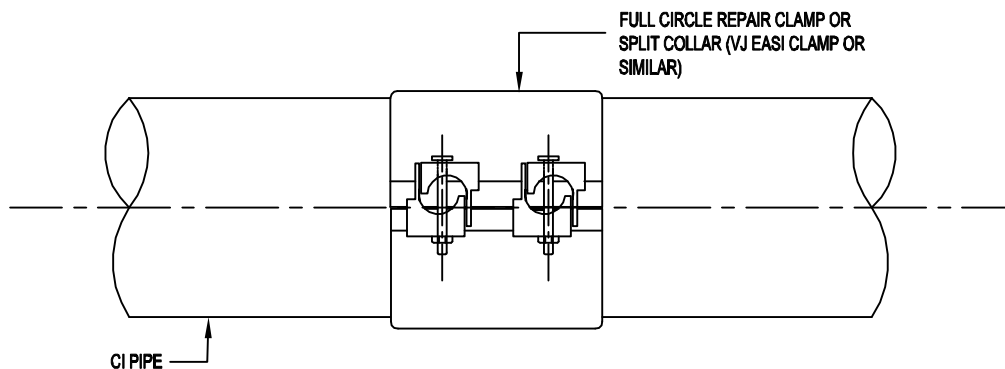
LR/SD/02	Leak Type - B
SCALE	Not to Scale
JICA STUDY TEAM THE DETAILED DESIGN STUDY ON THE PROJECT FOR REDUCTION OF NON-REVENUE WATER IN THE GREATER COLOMBO AREA IN THE DEMOCRATIC SOCIALIST REPUBLIC OF SRI LANKA

CORROSION HOLES

IMPACT DAMAGE

LONGITUDINAL CRACKS

LEAK TYPE B

CORROSION HOLES, LONGITUDINAL CRACKS, IMPACT DAMAGES AND CIRCUMFERENTIAL BREAKS WITH THE AFFECTED WIDTH OF THE PIPE NOT GREATER THAN 200 mm (FOR THE DIAMETER RANGE OF 3" - 8") THAT CAN BE REPAIRED WITH A MALLEABLE IRON / DUCTILE IRON FULL CIRCLE REPAIR CLAMP SIMILAR TO VJ EASICLAMP. (SPLIT COLLARS)

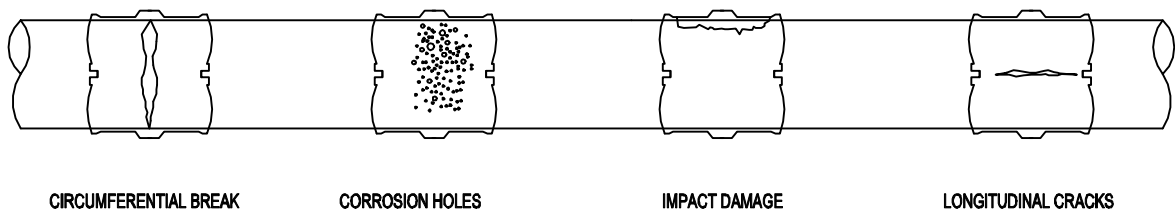
LR/SD/03	Leak Type - B1
SCALE	Not to Scale
JICA STUDY TEAM THE DETAILED DESIGN STUDY ON THE PROJECT FOR REDUCTION OF NON-REVENUE WATER IN THE GREATER COLOMBO AREA IN THE DEMOCRATIC SOCIALIST REPUBLIC OF SRI LANKA

CIRCUMFERENTIAL BREAK

CORROSION HOLES

IMPACT DAMAGE

LONGITUDINAL CRACKS

LEAK TYPE B1

LEAK TYPE AS IN TYPE B BUT ASSOCIATED WITH A SERVICE CONNECTION THAT CAN BE REPAIRED WITH A MALLEABLE IRON / DUCTILE IRON, FULL CIRCLE REPAIR SADDLE SIMILAR TO VJ EASITAP. (SPLIT COLLAR WITH THREADED OUTLET FOR SERVICE PIPE)

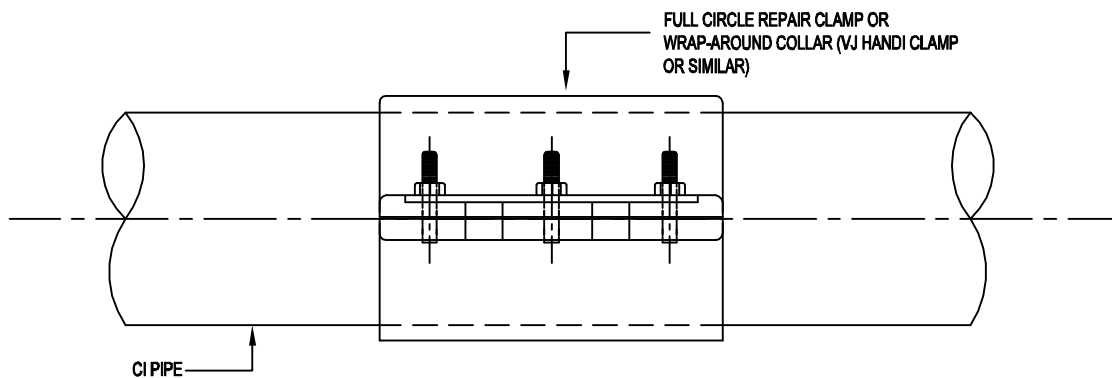
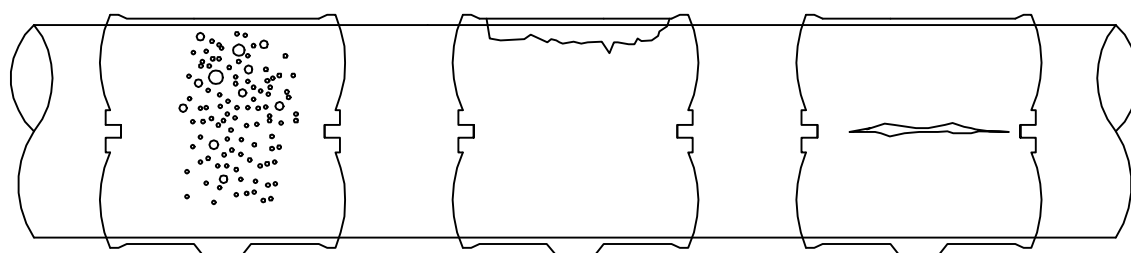
LR/SD/04	Leak Type - C
SCALE	Not to Scale
JICA STUDY TEAM THE DETAILED DESIGN STUDY ON THE PROJECT FOR REDUCTION OF NON-REVENUE WATER IN THE GREATER COLOMBO AREA IN THE DEMOCRATIC SOCIALIST REPUBLIC OF SRI LANKA

CIRCUMFERENTIAL BREAK

IMPACT DAMAGE

LOGITUDINAL CRACKS

LEAK TYPE C

CORROSION HOLES, LONGITUDINAL CRACKS AND IMPACT DAMAGES WITH THE AFFECTED WITH OF THE PIPE BETWEEN 300 - 400 mm (DIAMETER OF 3" - 8") THAT CAN BE REPAIRED WITH A STAINLESS STEEL FULL CIRCLE REPAIR CLAMP SIMILAR TO VJ HANDI CLAMP. (WRAP - AROUND COLLAR)

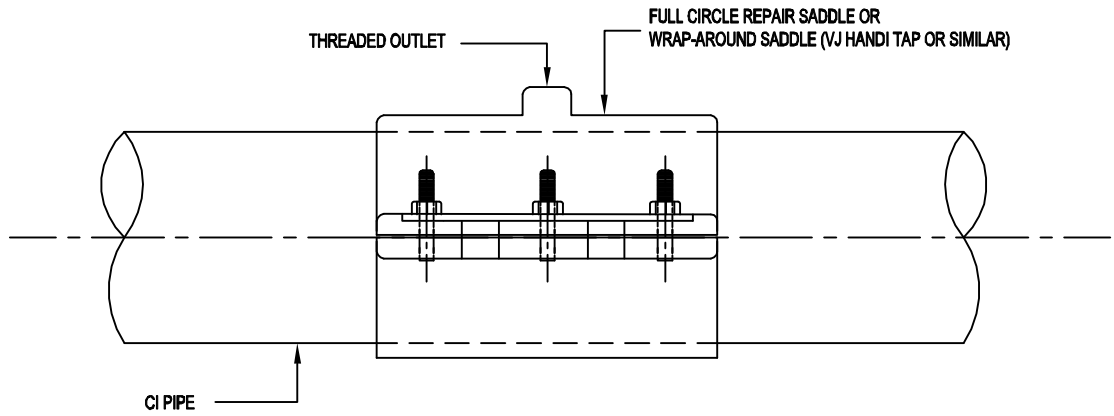
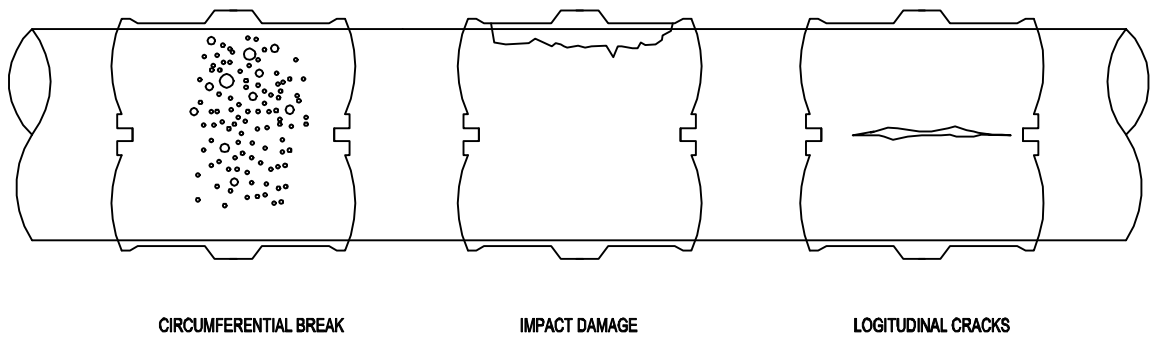
LR/SD/05	Leak Type - C1
SCALE	Not to Scale
JICA STUDY TEAM THE DETAILED DESIGN STUDY ON THE PROJECT FOR REDUCTION OF NON-REVENUE WATER IN THE GREATER COLOMBO AREA IN THE DEMOCRATIC SOCIALIST REPUBLIC OF SRI LANKA

LEAK TYPE C1

LEAK TYPE AS IN TYPE C BUT ASSOCIATED WITH A SERVICE CONNECTION THAT CAN BE REPAIRED WITH A STAINLESS STEEL FULL CIRCLE REPAIR SADDLE SIMILAR TO VJ HANDI TAP. (WRAP - AROUND COLLAR WITH THREADED OUTLET FOR SERVICE PIPE)

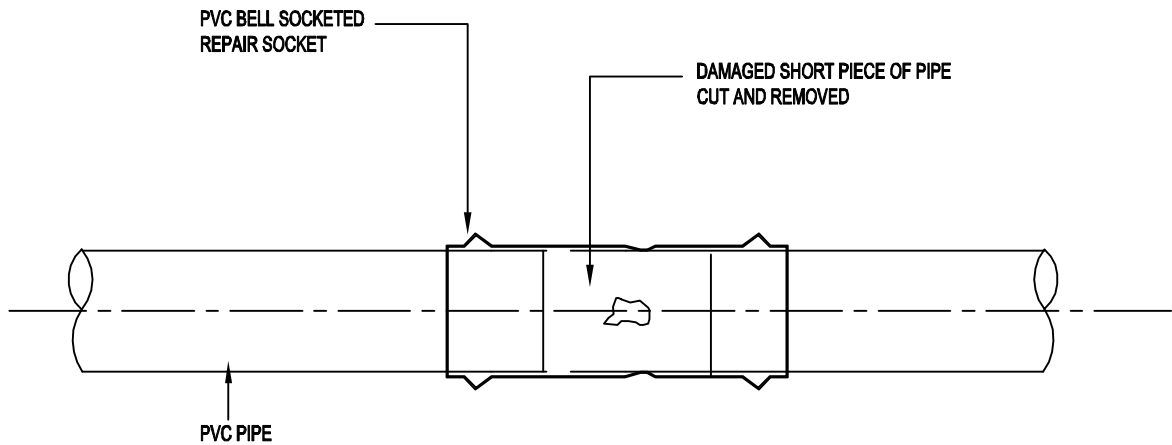
LR/SD/06	Leak Type - D
SCALE	Not to Scale
JICA STUDY TEAM THE DETAILED DESIGN STUDY ON THE PROJECT FOR REDUCTION OF NON-REVENUE WATER IN THE GREATER COLOMBO AREA IN THE DEMOCRATIC SOCIALIST REPUBLIC OF SRI LANKA

LEAK TYPE D

POINT DAMAGE OR LOCALIZED DAMAGE IN PVC PIPE THAT CAN BE REPAIRED WITH A PVC BELL SOCKETED REPAIR SOCKET

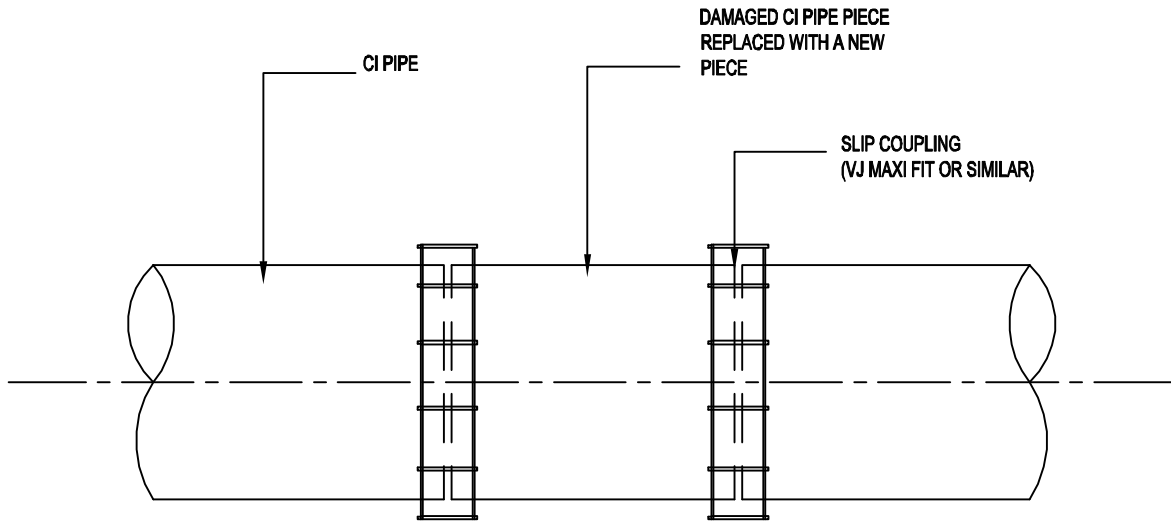
LR/SD/07	Leak Type - E
SCALE	Not to Scale
JICA STUDY TEAM THE DETAILED DESIGN STUDY ON THE PROJECT FOR REDUCTION OF NON-REVENUE WATER IN THE GREATER COLOMBO AREA IN THE DEMOCRATIC SOCIALIST REPUBLIC OF SRI LANKA

LEAK TYPE E

EXTENSIVE DAMAGE WHICH REQUIRES THE REPLACEMENT OF THE AFFECTED LENGTH OF THE CI PIPE WITH TWO SLIP COUPLINGS SIMILAR TO VJ MAXI FIT ON BOTH SIDES.

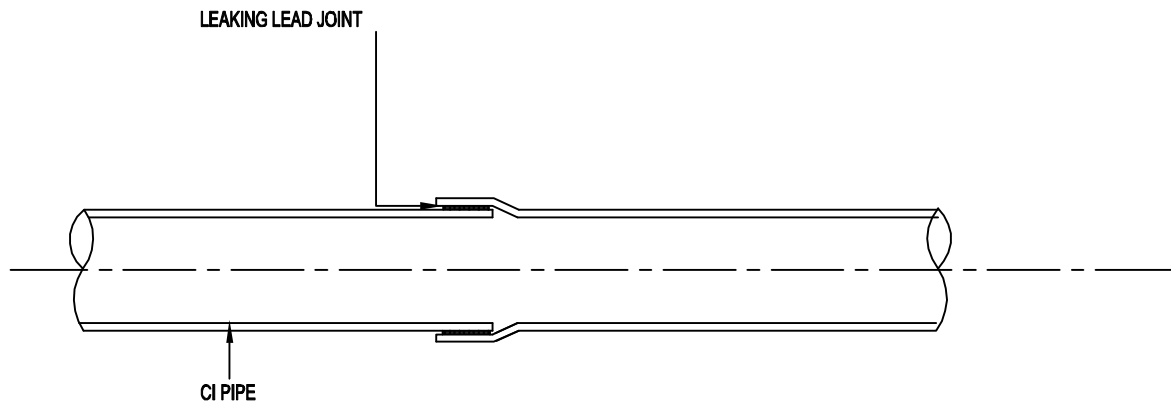
LR/SD/09	Leak Type - F
SCALE	Not to Scale
JICA STUDY TEAM THE DETAILED DESIGN STUDY ON THE PROJECT FOR REDUCTION OF NON-REVENUE WATER IN THE GREATER COLOMBO AREA IN THE DEMOCRATIC SOCIALIST REPUBLIC OF SRI LANKA

LEAK TYPE F

JOINT LEAKS IN CAST IRON PIPES WHICH CAN BE REPAIRED BY RE-CAULKING WITH OR WITHOUT ADDITIONAL LEAD WITH A VARIETY OF SMALL TO LARGE PNEUMATIC OR HAND CAULKING IRONS, FORCING THE LEAD BACK INTO THE BELLS.

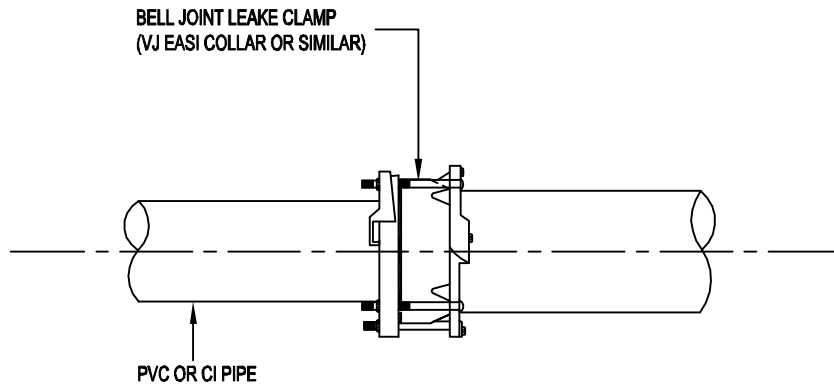
LR/SD/10	Leak Type - F1
SCALE	Not to Scale
JICA STUDY TEAM THE DETAILED DESIGN STUDY ON THE PROJECT FOR REDUCTION OF NON-REVENUE WATER IN THE GREATER COLOMBO AREA IN THE DEMOCRATIC SOCIALIST REPUBLIC OF SRI LANKA

LEAK TYPE F1

JOINT LEAKS IN CAST IRON OR PVC PIPES WHICH REQUIRE BELL JOINT LEAKE CLAMP SIMILAR TO VJ EASI COLLAR.

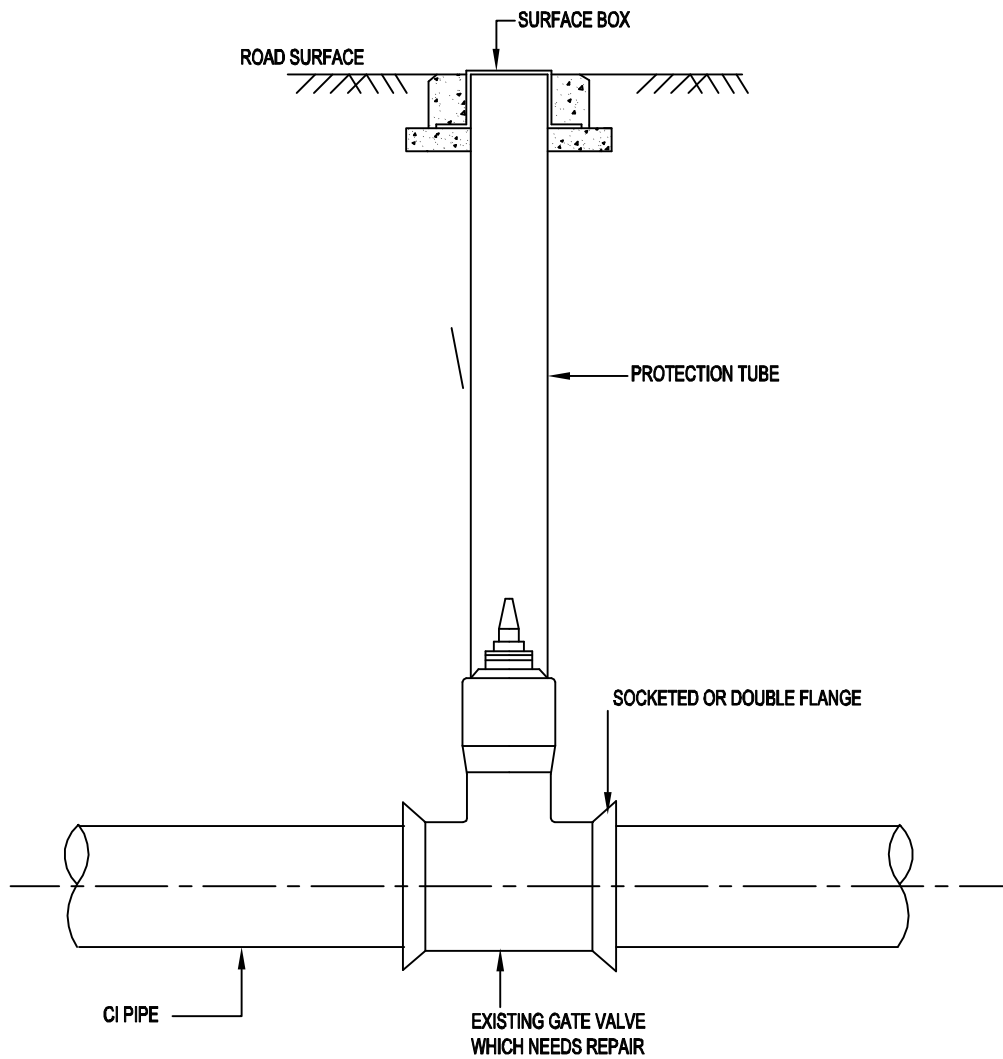
LR/SD/12	Leak Types - J
SCALE	Not to Scale
JICA STUDY TEAM THE DETAILED DESIGN STUDY ON THE PROJECT FOR REDUCTION OF NON-REVENUE WATER IN THE GREATER COLOMBO AREA IN THE DEMOCRATIC SOCIALIST REPUBLIC OF SRI LANKA

EXISTING LEAKING GATE VALVE

LEAK TYPE J

GATE VALVE LEAK WHICH CAN BE REPAIRED BY REPLACING THE GASKETS/ O-RINGS OR SIMILAR REPLACEABLE ITEMS

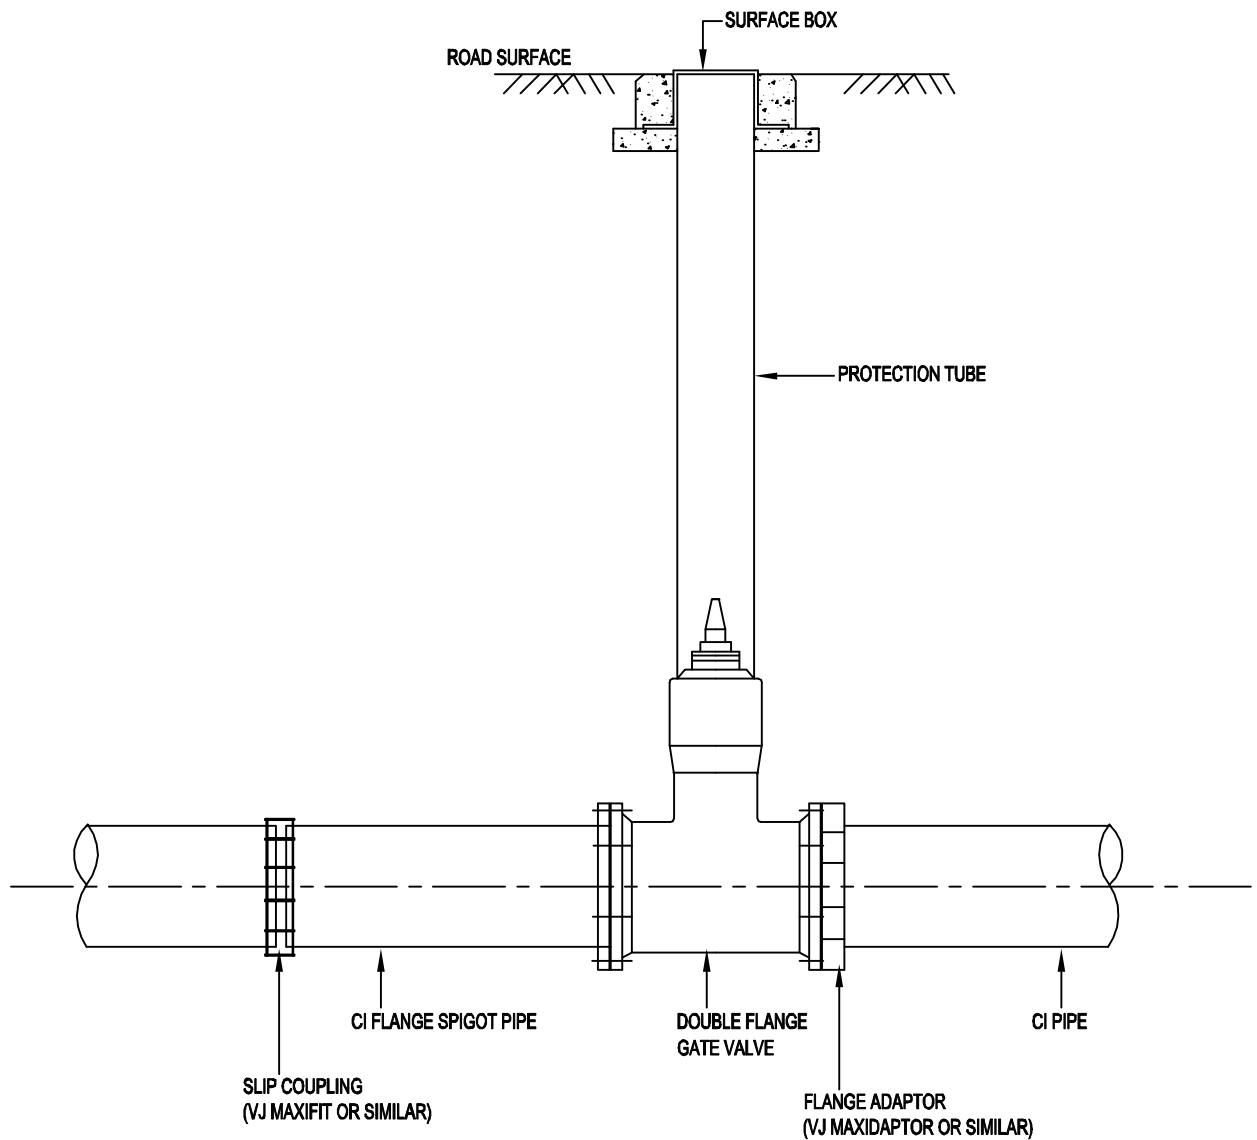
LR/SD/13	Leak Types - J1
SCALE	Not to Scale
JICA STUDY TEAM THE DETAILED DESIGN STUDY ON THE PROJECT FOR REDUCTION OF NON-REVENUE WATER IN THE GREATER COLOMBO AREA IN THE DEMOCRATIC SOCIALIST REPUBLIC OF SRI LANKA

**LEAKING GATE VALVE REPLACED WITH A
DOUBLE FLANGED GATE VALVE**

LEAK TYPE J1

**GATE VALVE LEAKS WHICH NEEDS REPLACEMENT OF THE LEAKING VALVE WITH
A NEW DOUBLE FLANGE VALVE**

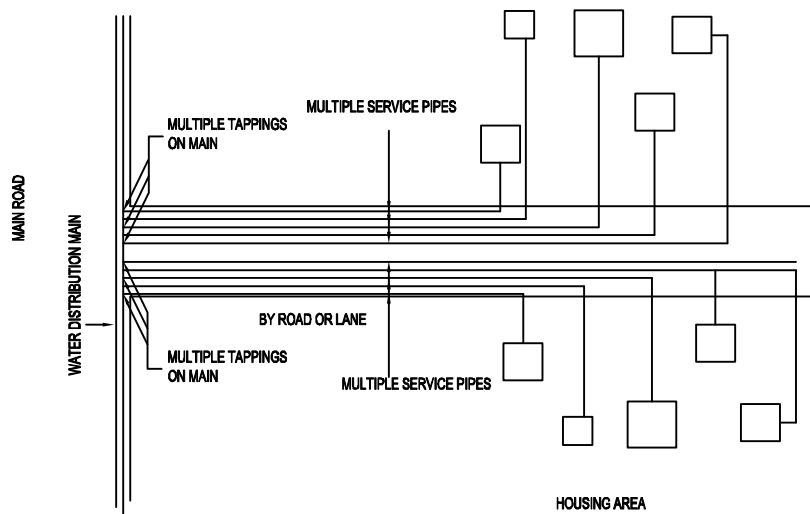
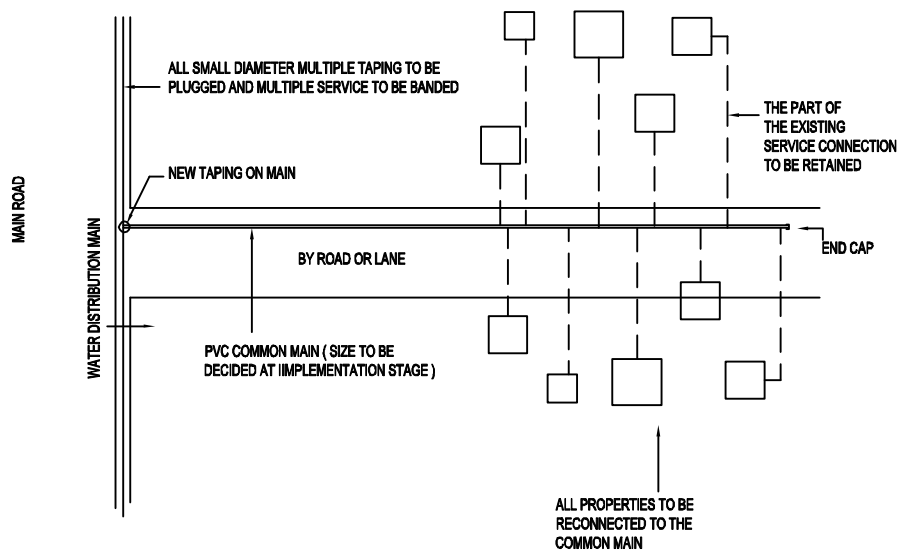
LR/SD/17	Laying of Common Water Mains of Byroads
SCALE	Not to Scale
JICA STUDY TEAM THE DETAILED DESIGN STUDY ON THE PROJECT FOR REDUCTION OF NON-REVENUE WATER IN THE GREATER COLOMBO AREA IN THE DEMOCRATIC SOCIALIST REPUBLIC OF SRI LANKA

EXISTING MULTIPLE SERVICE CONNECTIONS ON BY ROADS

PROPOSED COMMON MAIN AND TRANSFERRING OF SERVICE CONNECTIONS ON TO THE COMMON MAIN

LAYING OF COMMON WATER MAINS ON BYROADS

It is suggested to eliminate approximately 1,000 leaking PVC service pipes, which have been laid along by-roads over a long distance and without a sufficient cover. This problem can be rectified by laying a new common main along the road and by transferring the services on to the new main. All of the existing multiple tapping connections on the distribution main should be plugged and the leaking spaghetti pipes should be abandoned.

It is assumed that there are 10 service pipes on average on each by-road for replacement and the size of common main as 2". Therefore, common mains will be laid on 100 by-roads to eliminate 1,000 service pipes. The assumed quantities are as follows.

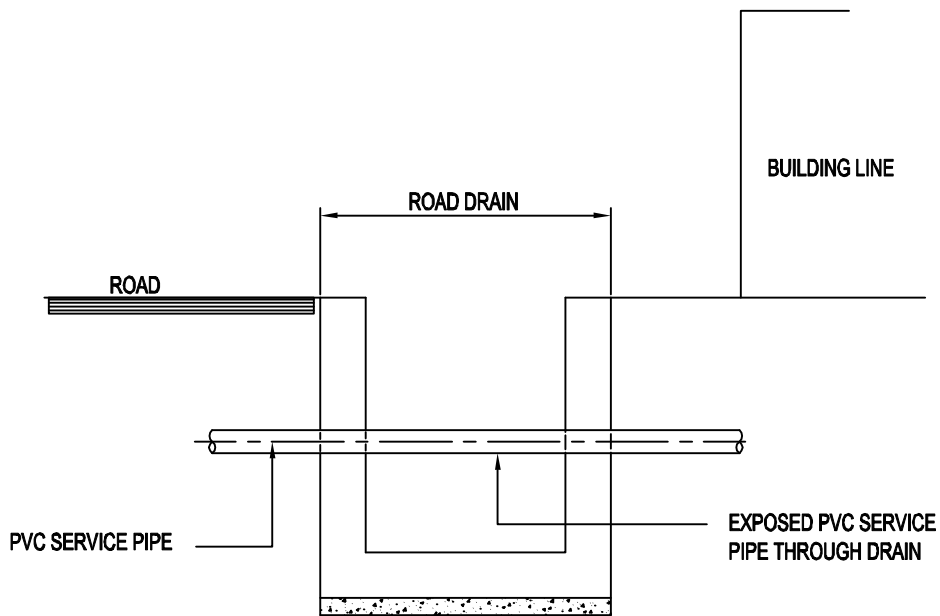
LR/SD/18	GI Pipe Encasement
SCALE	Not to Scale
JICA STUDY TEAM THE DETAILED DESIGN STUDY ON THE PROJECT FOR REDUCTION OF NON-REVENUE WATER IN THE GREATER COLOMBO AREA IN THE DEMOCRATIC SOCIALIST REPUBLIC OF SRI LANKA

PROVISION OF GI PIPE ENCASEMENTS TO EXISTING PVC SERVICE PIPES EXPOSED AT ROAD DRAINS

It is assumed that 1,000 Nos. of leaking PVC service pipes will be repaired and encased at drain crossings.
