#### CHAPTER 4 METHOD OF SLOPE INSPECTION

# The Study on Slope Disaster Management for Federal Roads in Malaysia

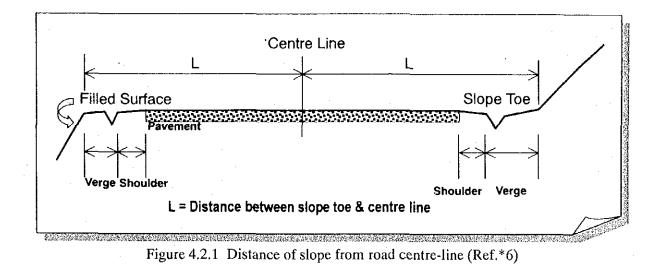
Distance from Road Centre-Line to Slope Toe
 Distance from the centre of road to the toc of slope shown in Figure 4.2.1.

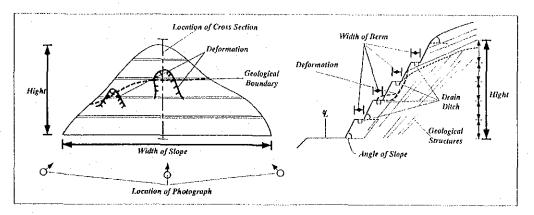
Figure 4.2.2 Basic slope information to be on the Form B (Sketch of Slope)

In Form B (sheet of sketch), the condition of the slope surface under observation and measurements for recording purpose are required. The following data shall be recorded in Form B.

- (1) Basic Structure of slope
  - Distance from road centre to the toe of slope
  - Geometry of the slope
  - Facilities on the slope
  - Countermeasure work on the slope
- (2) Topography
  - Topographic features
  - Up- slope condition
  - Down- slope condition
  - Natural drainage
- (3) Slope hazard condition
  - Occurrence of collapse
  - Deformation of slope
  - Rock mass stability condition
  - Boulder stability
  - Gully erosion
- (4) Countermeasure
  - Features of countermeasure
  - General layout of countermeasure
- (5) Geological data
  - Rock type
  - Condition of surface soil
  - Dip/strike of bed
  - Condition and structure of discontinuity
  - Weathering grade
  - Pattern of rock discontinuity
- (6) Location of photograph

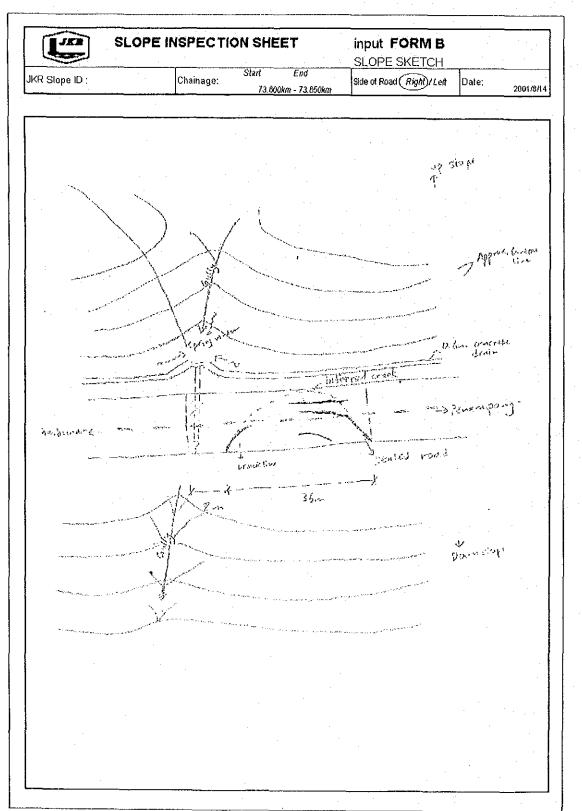
Figure 4.2.3 Example of Sketch (Penanpang-Tambunan Road, Sabah)

If a sketch is drawn using a pencil, it should be traced again on a new sheet or the drawing highlighted using a black pen without any dirt on the sheet.

An example of sketch is shown in the Figure 4.2.3.

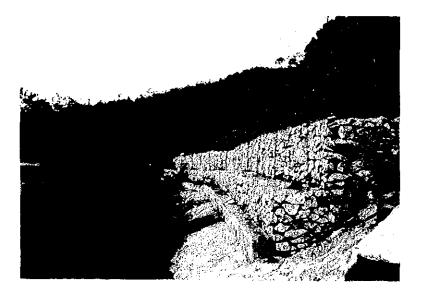
Figure 4.2.6 Example of Photograph(CH27.0km East- West Highway)

One or two photographs of general view required and two or three photographs of features of slope condition are required. A total of three to five shots is recommended as an adequate number of photographs.

An example of photograph is shown in Figure 4.2.6.

### (a) General View

### (b) Feature of Slope Condition

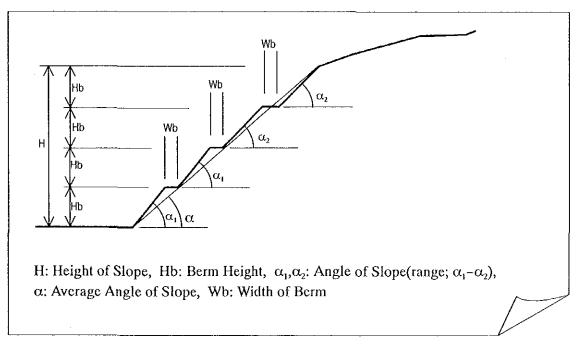
Figure 4.2.7 Basic Element of Slope

As shown in Figure 4.2.7, the Basic Elements of Slope, following fundamental data of slope shall be entered in the table. Maximum and minimum berm height (Hb) and width shall be entered.

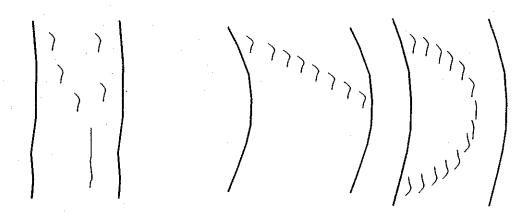
Figure 4.2.8 Pavement Cracks and Cracks caused by Slope Failure

Evaluation on Cause of Cracks (c) is most important procedure. When cracks are due to fatigue, they have no continuous relationship and depression. When a slope failure is taking place, cracks are continuous and some depression is found. (Figure 4.2.8)

(a) **Pavement cracks** (Random fabric) (b) Cracks caused by slope failure (Linear structure)

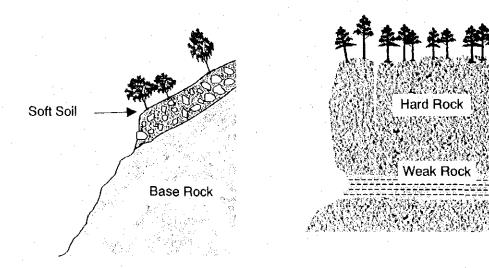
Figure 4.2.10 Soft Soil over Base Rock

Figure 4.2.11 Hard Rock over Weak Rock

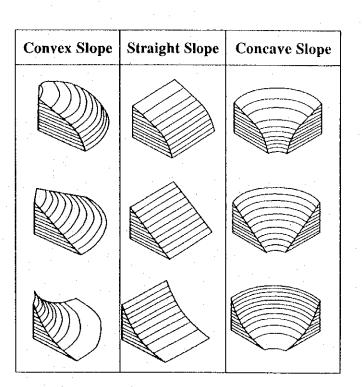
Figure 4.2.12 Schematic Classification of Slope Shape (Rcf. \*1)

- (i) Convex Slope;
- (ii) Debris Sediment;
- (iii) Concave Slope and
- (iv) Others

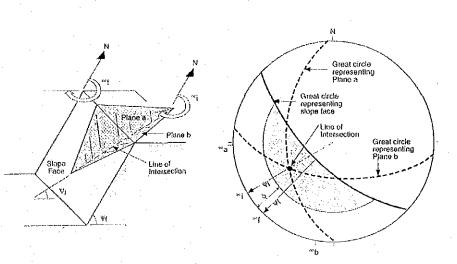
Figure 4.2.18 Probability of Rock Mass Failure by Daylight Wedge (Ref. \*9)

- (i) Daylight: Line of intersection of two rock joint plane is gentler than the slope angle, including planar structure.
- (ii) Non-daylight: Not daylight structure
- (iii) No plane: Large scale fault, joint, crack, bedding are not developed

Schematic diagram of daylight structure is shown in the Figure 4.2.18.

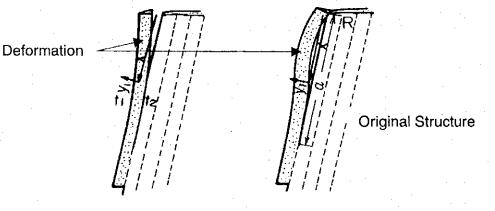
Figure 4.2.20 Schematic diagram shows the deformation of the original structure.(Ref. \*10)

(c) Deformation or bending of original structure (Figure 4.2.20)

Deformation or bending of original structure also implies future rock mass failure. When this phenomenon is found, the condition of the rock mass shall be observed carefully.

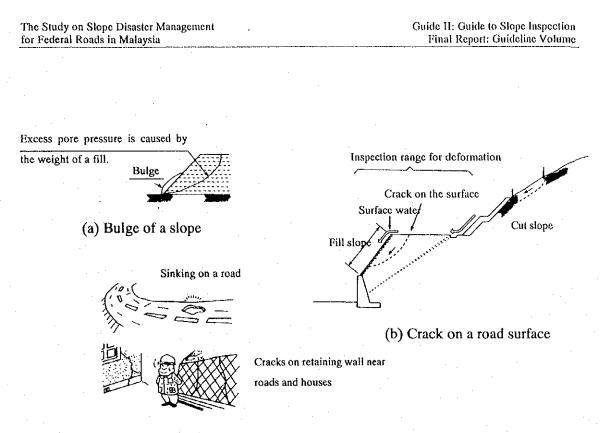
Figure 4.2.21 Examples of Embankment Deformation

In general, deformation occurring at the surface of an embankment implies the presence of potentially unstable factors in the embankment or adjacent ground. Therefore, stability of embankment is evaluated by those deformations occurring at embankments.

Example of deformation of embankment in the Figure 4.2.21

(c) Depressions on a road surface and cracks on a retaining wall

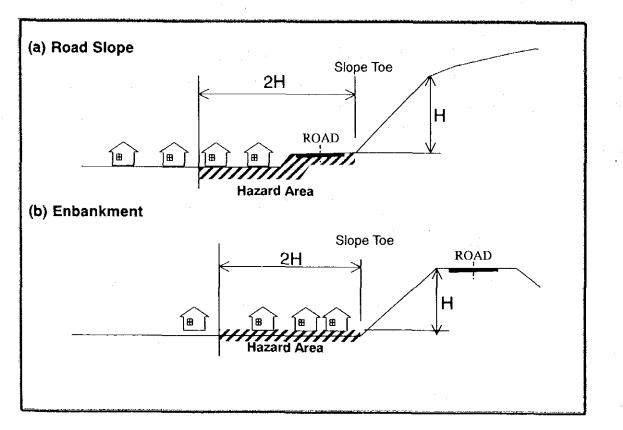
Figure 4.3.1 Distance of Services, Public Utilities and Building

If gas, oil, telecommunications, electric, or water pipe line installations are within a distance of 2 H (H: height of slope), mark "Yes". (Figure 4.3.1)

Distance from the toe of slope to the building shall be measured. When the distance is less than two times of slope height, there is danger to the building. (Figure 4.3.1)
