2. Master Plan

2.1 Natural Condition at the New Cebu Port

This chapter describes as to the following survey result, i.e., Current, Tide, Bathymetric and Topographic Survey which has been carried out in the New Cebu Port Site (Consolacion Area).

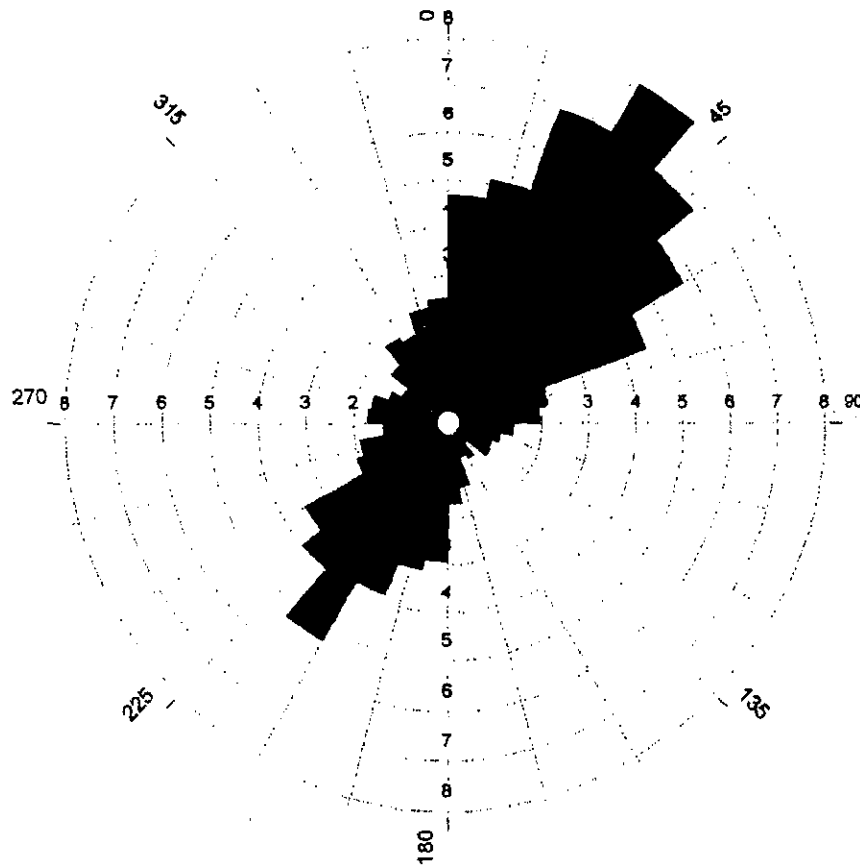
Fig. 2.1.1-3 Current Flow Direction Sea Surface

Calculation Method Frequency
Class Interval 10 Degrees
Length Filtering Activated
Minimum Length 0
Maximum Length 0
Azimuth Filtering Deactivated
Data Type Unidirectional
Population 1,946
Maximum Percentage 8.1 Percent
Mean Percentage 2.8 Percent
Standard Deviation 1.96 Percent
Vector Mean 19.7 Degrees
Confidence Interval ... 8.98 Degrees
R-mag 0.2

CURRENT FLOW DIRECTION AT CEBU
LOCATION2,NEAR SURFACE CURRENTS

These observation data are obtained at the near sea surface (Refer to Fig. 2.1.1-3) and middle depth (Fig. 2.1.1-4). While at the sea bottom, the current is scattered in disorderly direction NE (bearing 320° to 180°) and conspicuous direction cannot be found out (Refer to Fig. 2.1.1-5).

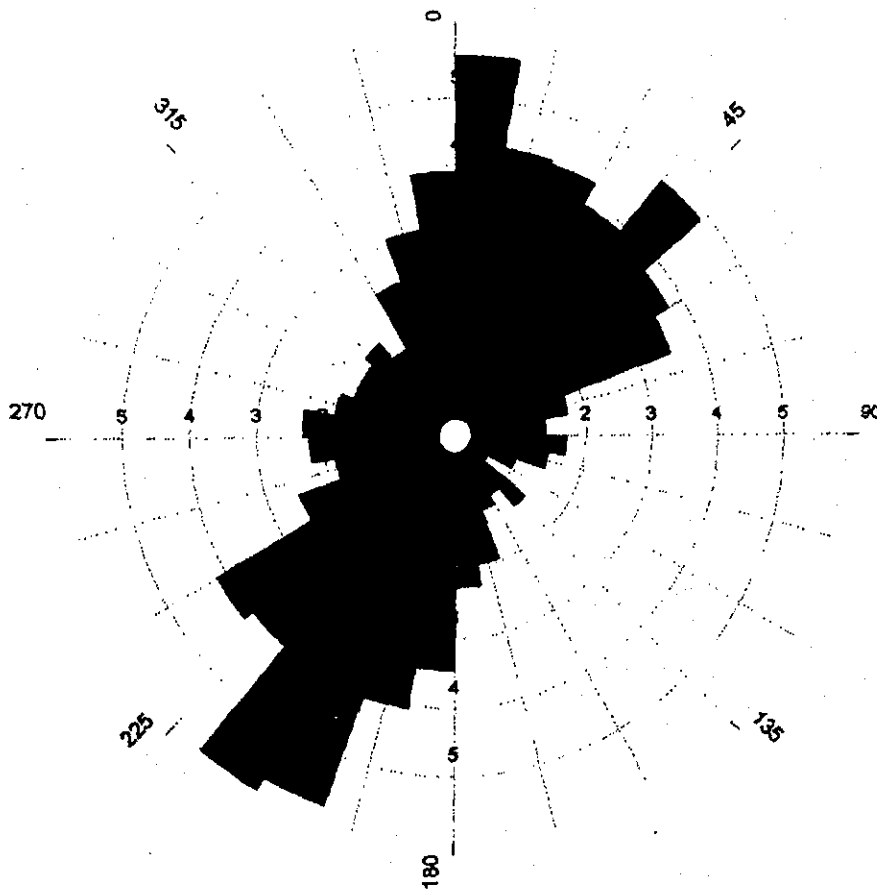
Fig. 2.1.1-4 Current Flow Direction Middle Depth

Calculation Method Frequency
Class Interval 10 Degrees
Length Filtering Activated
Minimum Length 0
Maximum Length 0
Azimuth Filtering Deactivated
Data Type Unidirectional
Population 1,946
Maximum Percentage 6 Percent
Mean Percentage 2.8 Percent
Standard Deviation 1.47 Percent
Vector Mean 315.54 Degrees
Confidence Interval ... 22.66 Degrees
R-mag 0.08

CURRENT FLOW DIRECTION AT CEBU.
LOCATION2.MID DEPTHCURRENTS

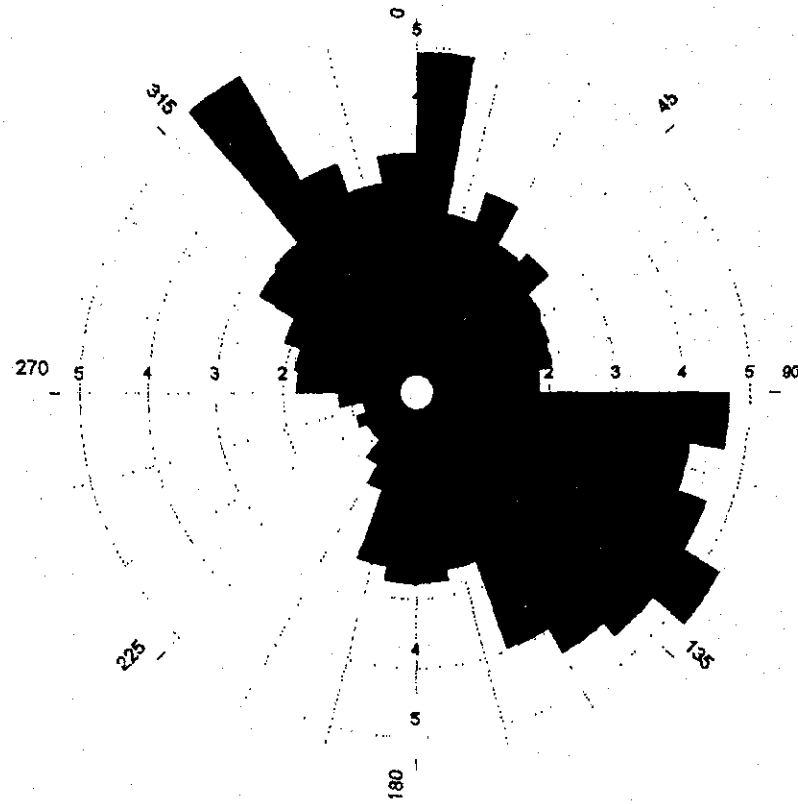
Fig. 2.1.1-5 Current Flow Direction Sea Bottom

Calculation Method Frequency
Class Interval 10 Degrees
Length Filtering Activated
Minimum Length 0
Maximum Length 0
Azimuth Filtering Deactivated
Data Type Unidirectional
Population 1,946
Maximum Percentage 5.3 Percent
Mean Percentage 2.8 Percent
Standard Deviation 1.31 Percent
Vector Mean 75.05 Degrees
Confidence Interval ... 10.38 Degrees
R-mag 0.17

CURRENT FLOW DIRECTION AT CEBU
LOCATION2, NEAR BOTTOM CURRENTS

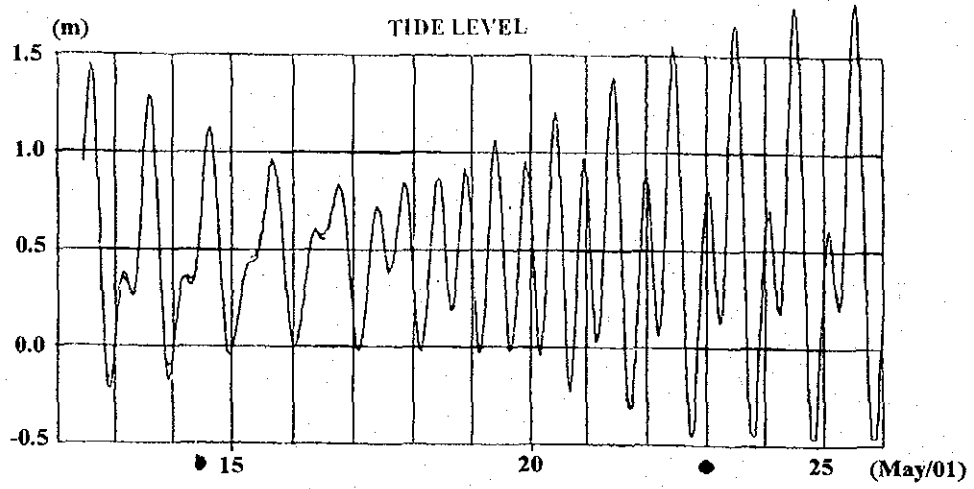
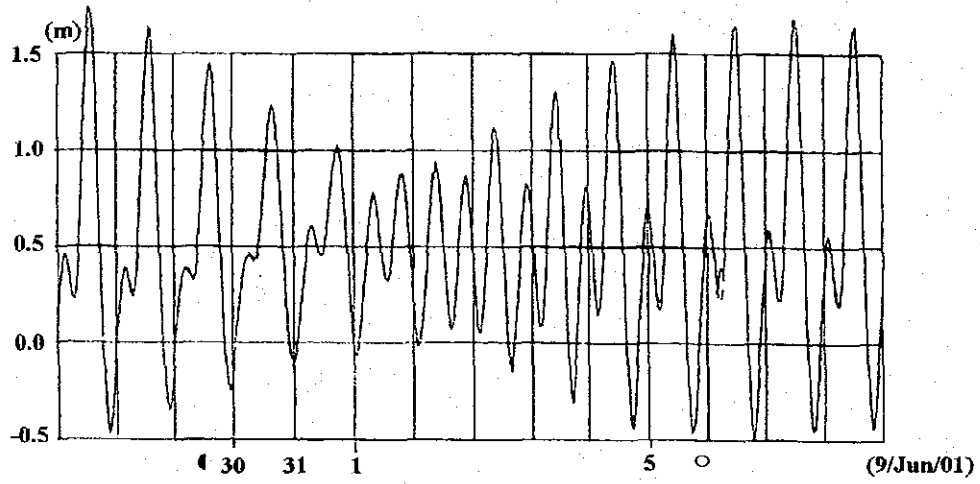
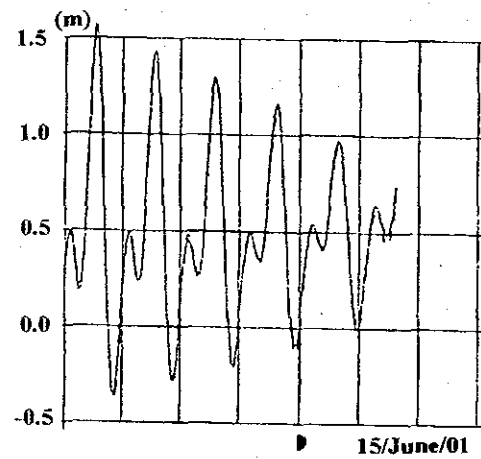
Fig. 2.1.1-6 Tide Level Change Graph

1. Datum-line (0.00m) : MLLW (Mean Lower Low Water) is applied.
2. HWL = 1.90 m
3. MSL = 0.58 m
4. LWL = -0.35 m

In the Tide and Current Tables Philippines 2001, the lowest tide level is recorded daily between -0.20 to -0.37 m of long period (1 year). The value of LWL in the present tide observation (30 days) is -0.4 m. Although there is slight difference (20 cm) between 2 figures mentioned above, consequently, the Cebu baseport is set LWL at -0.35 m and it is expected that long period data of -0.20 to -0.37 m is more reliable than short period data of -0.4 m, the low water level at new Cebu port is set at -0.35 m.

In addition to current meter survey, tide level is simultaneously measured during 30 days.

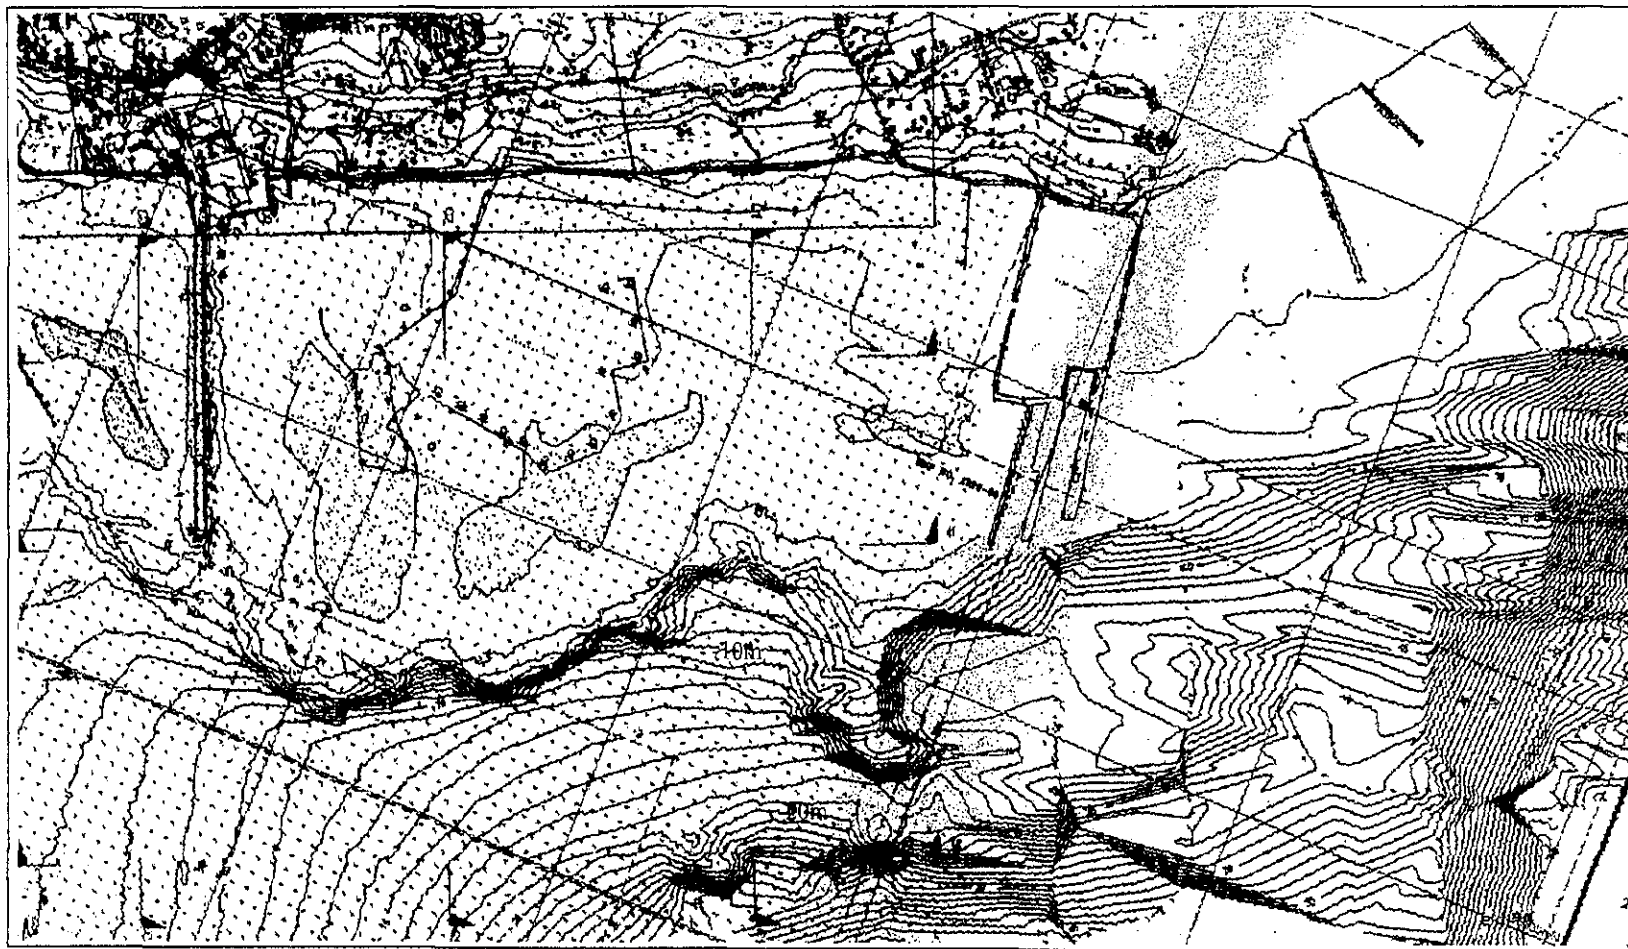
Fig. 2.1.2-2 Bathymetric Map

5) Depth Contour Map (Refer to Fig. 2.1.2-2)

Result of bathymetric survey is shown on the depth contour map (Refer to Fig. 2.1.2-2), in which water depth is presented together with main land/sea marks.

From geological/topographical view point, this region was originally coral reefs and through process of earth crust upheaval together with marine regression, present topographic form have been settled. It is classified into following 2 types i.e. (1) Tidal Flat Zone and (2) Deep Channel.

It spreads widely in front of the shore and about 600 m toward offshore and its area is estimated approximately 60 ha. It appears a relic of old lagoon of coral reef.

At the offshore side of the tidal flat zone, deep channel is formed where main navigation route is set up. Water depth becomes sharply large toward offshore, which is a common bathymetric feature of coral reef. As a consequence, it is measured over 50 m deep around central part of the channel, although nearly 10 m at the boarder of tidal flat zone. According to the chart of Cebu Harbour and Approaches, depth shows over 150 m in the deeper place.

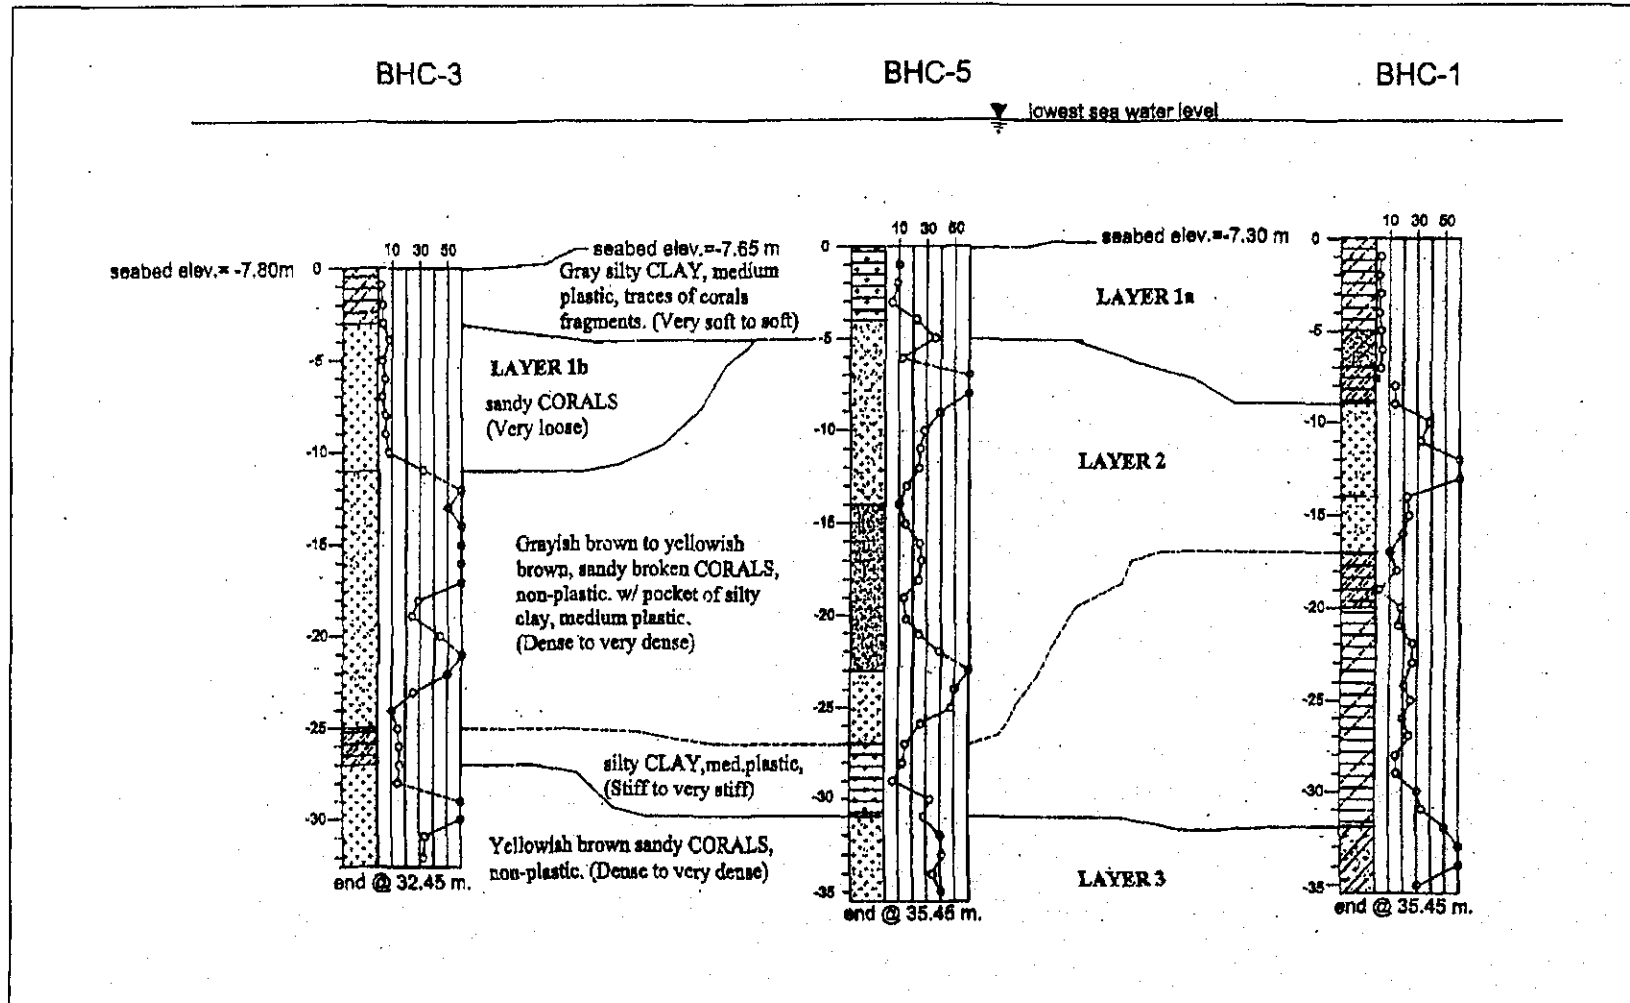
Fig. 2.1.2-5 Soil Profile (deep area)

Geological type in this area is composed of sand/gravel of coral fossils. In addition limestone boulders are scattered in some places. From Engineering view point, soft soil is scarcely contained, therefore it is regarded to be sufficiently firm for structure foundation.
