Minutes of Discussions
on
the Basic Design Study on the Project for Reconstruction
of Thaajuddeen School, Republic of Maldives

- 1. ORIGIN**
- 2. SCOPE**
- 3. LOCATION**
- 4. WORK CARRIED OUT**
 - 4.1 GENERAL**
 - 4.2 STANDARD PENETRATION TEST (SPT)**
 - 4.3 SAMPLING AND CLASSIFICATION**
 - 4.4 WATER TABLE**
 - 4.5 LABORATORY TESTING**
 - 4.6 SOIL PROFILE**
- 5. DISCUSSION**
- 6. RECOMMENDATIONS**

The Ministry of Education of the Republic of Maldives (MoE) has envisaged a Project to reconstruct the Thaajuddeen School of Male and Messes Mohri Architect and Associates Inc. (MAAI) of 2-4-13, Chuo-ku, Tokyo, Japan has been appointed as the Consulting Engineers for the Project. The MAAI has required to investigate the sub soil conditions of the Site earmarked for the Project in order to evaluate the parameters involved with designing the foundation system of the new buildings. Under the above circumstances Messes Ground Engineering Consultants (Pvt) Ltd. of No. 24, Station Road, Wattala, Sri Lanka, (GECL) has been entrusted by MAAI with the sub soil investigation after accepting their Financial Proposal of 21st November 2001.

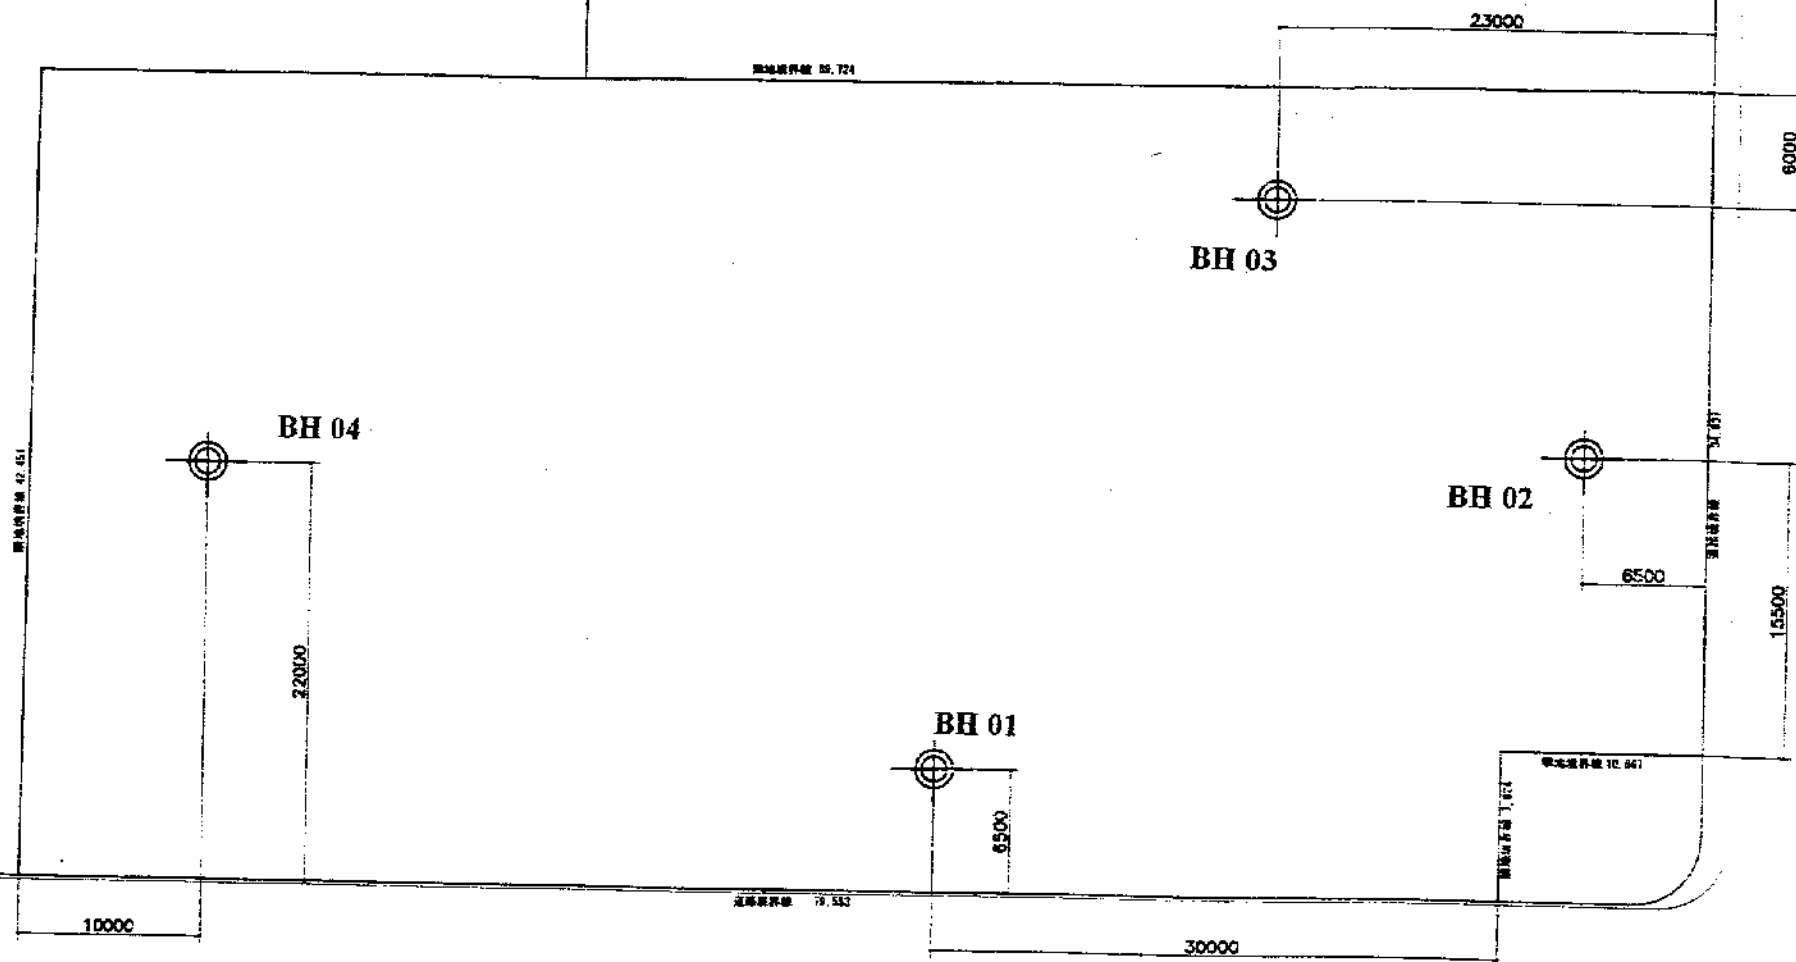
Figure I

Location Plans of the Site and the Bore Holes

Location Plan of the Bore Holes
(not to scale)

The Report should include the location plan of the bore holes, soil profiles, bore hole log data, results of the laboratory tests carried out and suggestions of supporting layer and building foundation.

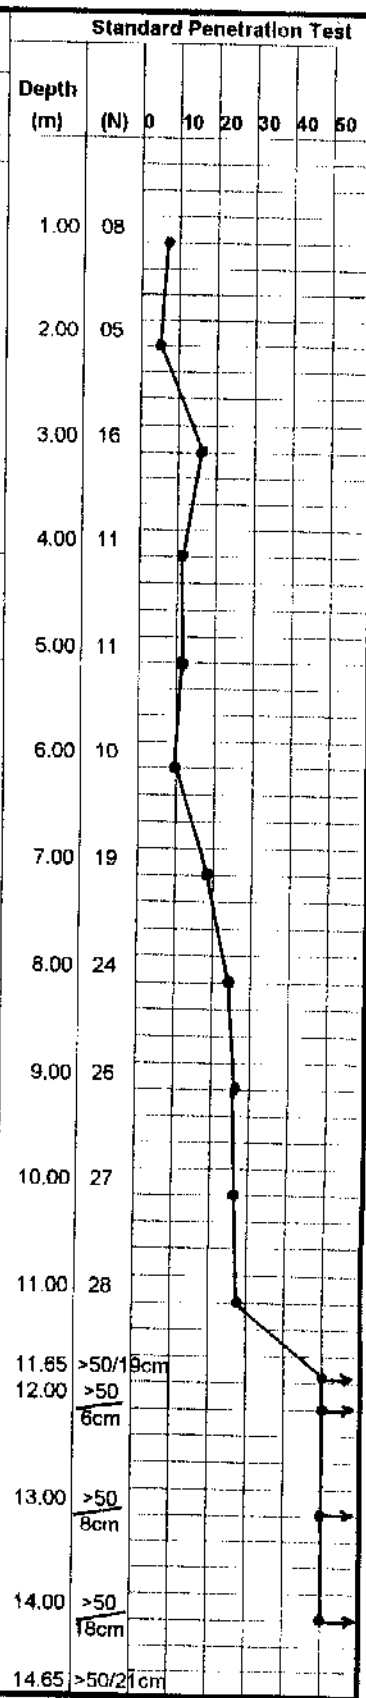
GEOLOGICAL RECORD OF BORING

Project	: Reconstruction of Thajudeen Sch	Date of Drilling:	21/12/2001
Client	: Mohri Architects	Angle from the vertical:	0
Bore Hole Number	: BH 02	Depth of Hole (m):	10.45
Ground Elevation	: Assumed as 0.00	Depth to the ground water level:	0.84m from the EGL
Dia. of the hole (mm)	: 100	Logged By:	BSY

The water levels of the ground water table with respect to the existing ground level at the bore hole locations have been observed and are reported in the vertical soil profiles under Annexure B to this Report.

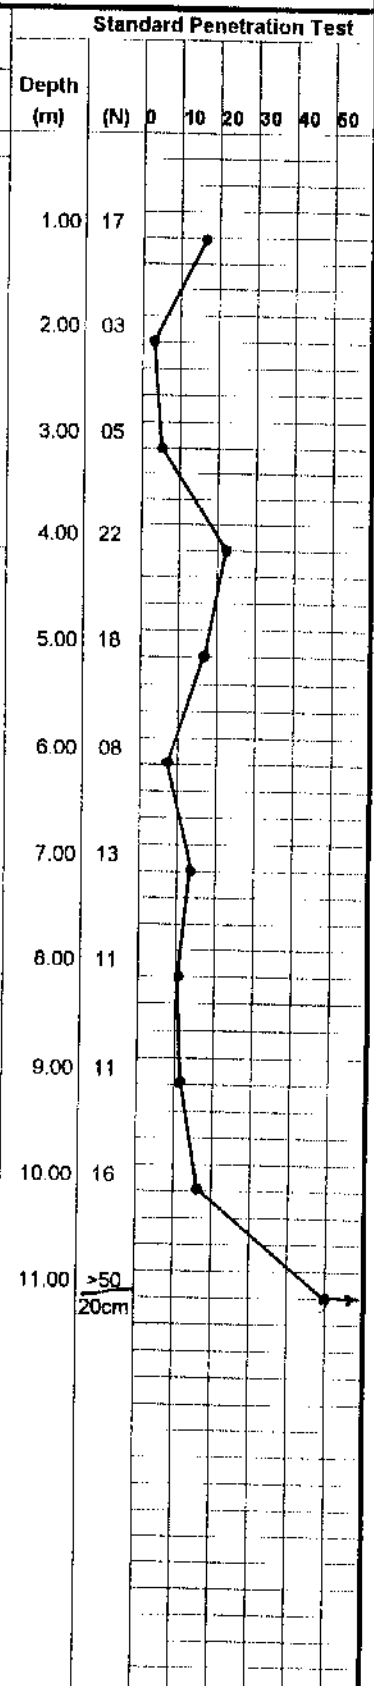
Bore hole terminated at 11.45m below the existing ground level on hard coral bed.

GEOLOGICAL RECORD OF BORING

The highly weathered to slightly weathered coral rock bed has been encountered at the depth of 11.65m in BH 01 and at the depth of 11.10m in BH 04. But according to our experience in the Male Island this coral bed is again followed by depositional soils in many of the places. Since the thickness of the coral bed is not known consideration of pile foundations is not advisable. If pile foundations are considered further investigations should be carried out in order to establish the thickness of the coral bed and the compressive strength of the rock.

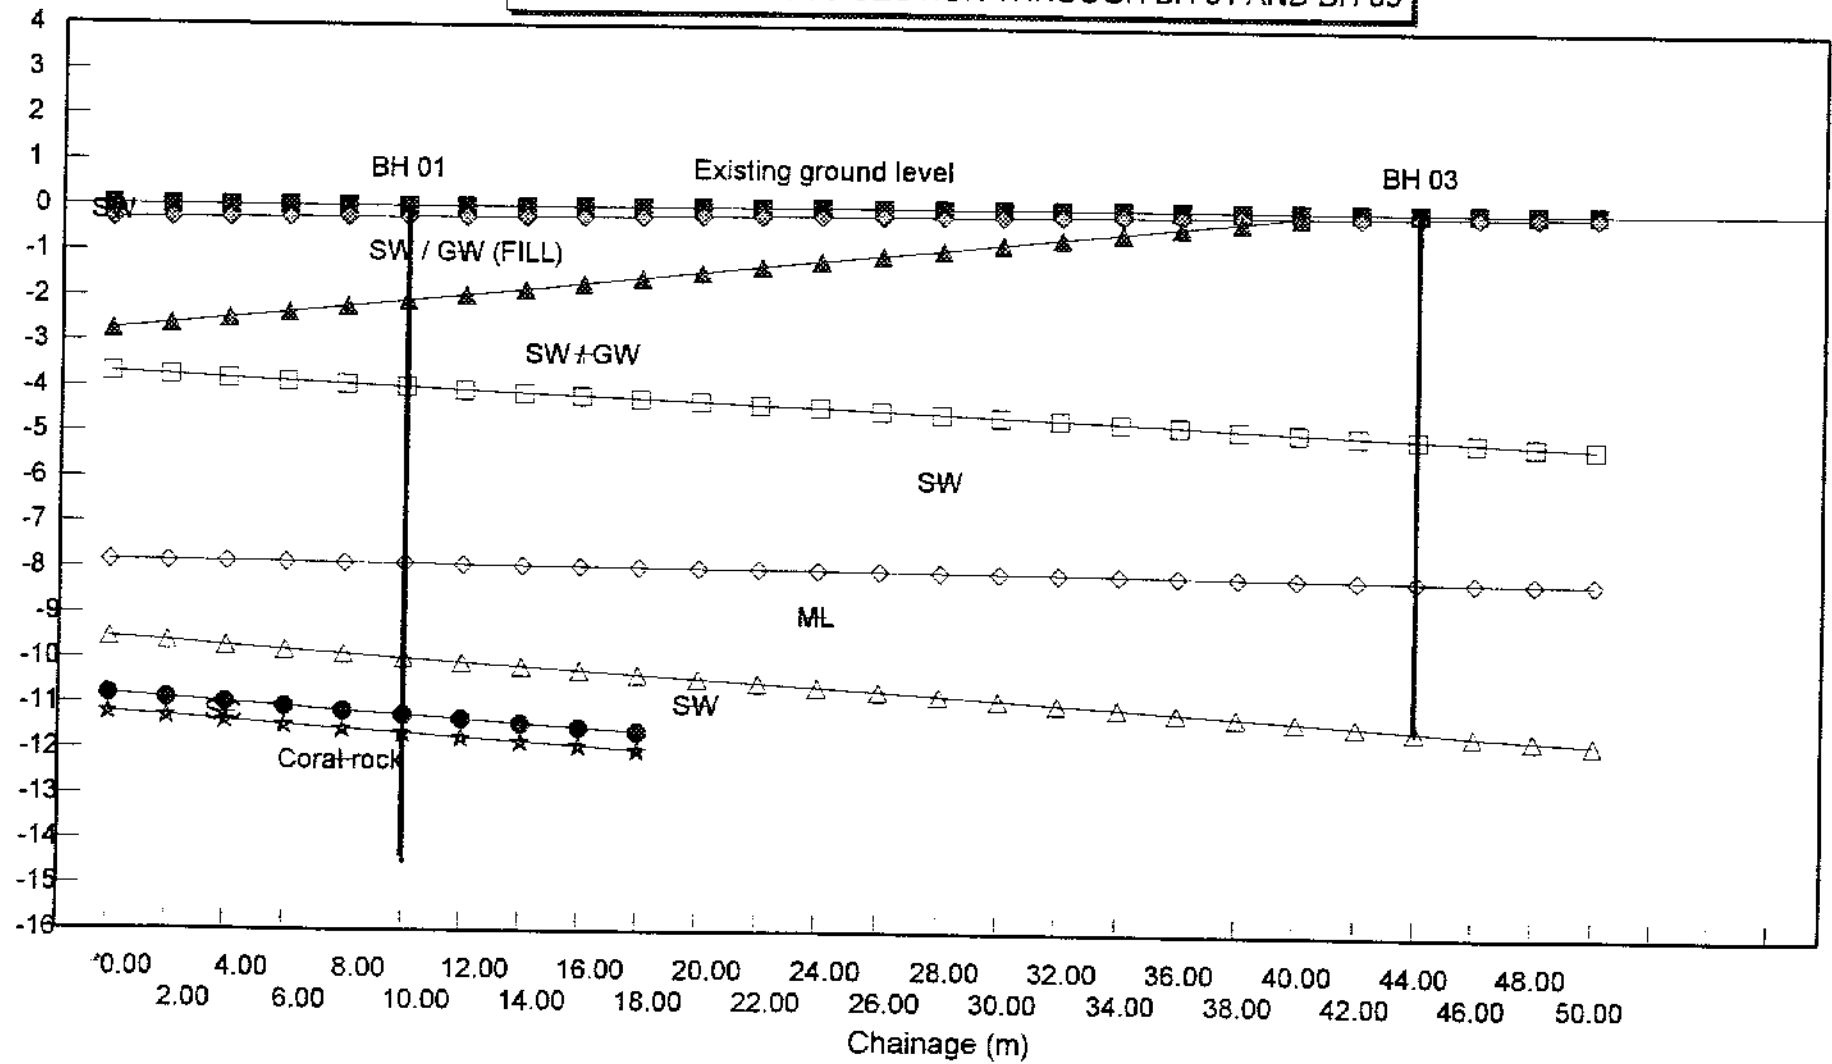
FIGURE II - A

GENERALISED CROSS SECTION THROUGH BH 01 AND BH 03

| ■ Elev. of existing Ground | ◇ Elev. of bot. of first SW laye | ▲ Elev. of bot. of FILL layer | ◻ Elev. of bot. of SW/GW lay |

The top most soil stratum is a 0.10m (BH 03) to 0.30m (BH 04) thick grayish brown coloured Top soil layer which contains partially decayed parts of vegetation, which is common all over the Site.

The reclaimed portion is restricted to the area of BH 01 and BH 04. The reclamation has been done by using waste material mixed with sea sand. The thickness of the filled layer varies from 1.85m in BH 01 to 2.95m in BH 04. In BH 01 the filled material is dominantly sea sand with little waste material and in BH 04 it vise versa. The inorganic portion of the filled material could be classified as loose, fine to coarse sand with some gravel.

The top soil stratum of BH 02 and BH 03 area is a 1.85m (BH 02) to 4.90m (BH 03) thick loose to dense, fine to coarse sand with some gravel and cobbles. This stratum continues into the BH 01 and BH 04 area underneath the filled layer.

The above sand layer is followed by a layer of loose to dense, very fine to coarse sand layer whose thickness varies from 3.15m (BH 03) to 5.90m (BH 02).

Subsequent to the above stratum a very loose to extremely dense / very stiff very fine sand / silt layer has been encountered. The particle size of this silty sand layer becomes very fine towards silt in the BH 04 area. A 1.05m cavity has been encountered on the top of this silty sand layer in the BH 04. No water losses have been encountered while penetrating this cavity. The lateral extension of the cavity can not be quantified with the available data.

Again another loose to dense very fine to coarse sand layer has been come across below the silty stratum in BH 01 and BH 04. This layer has not been found in BH 03.

The final soil stratum found in the area is a very thin, extremely dense, slightly plastic clayey sand layer deposited on the highly weathered coral bed rock. This was found only in the BH 01.

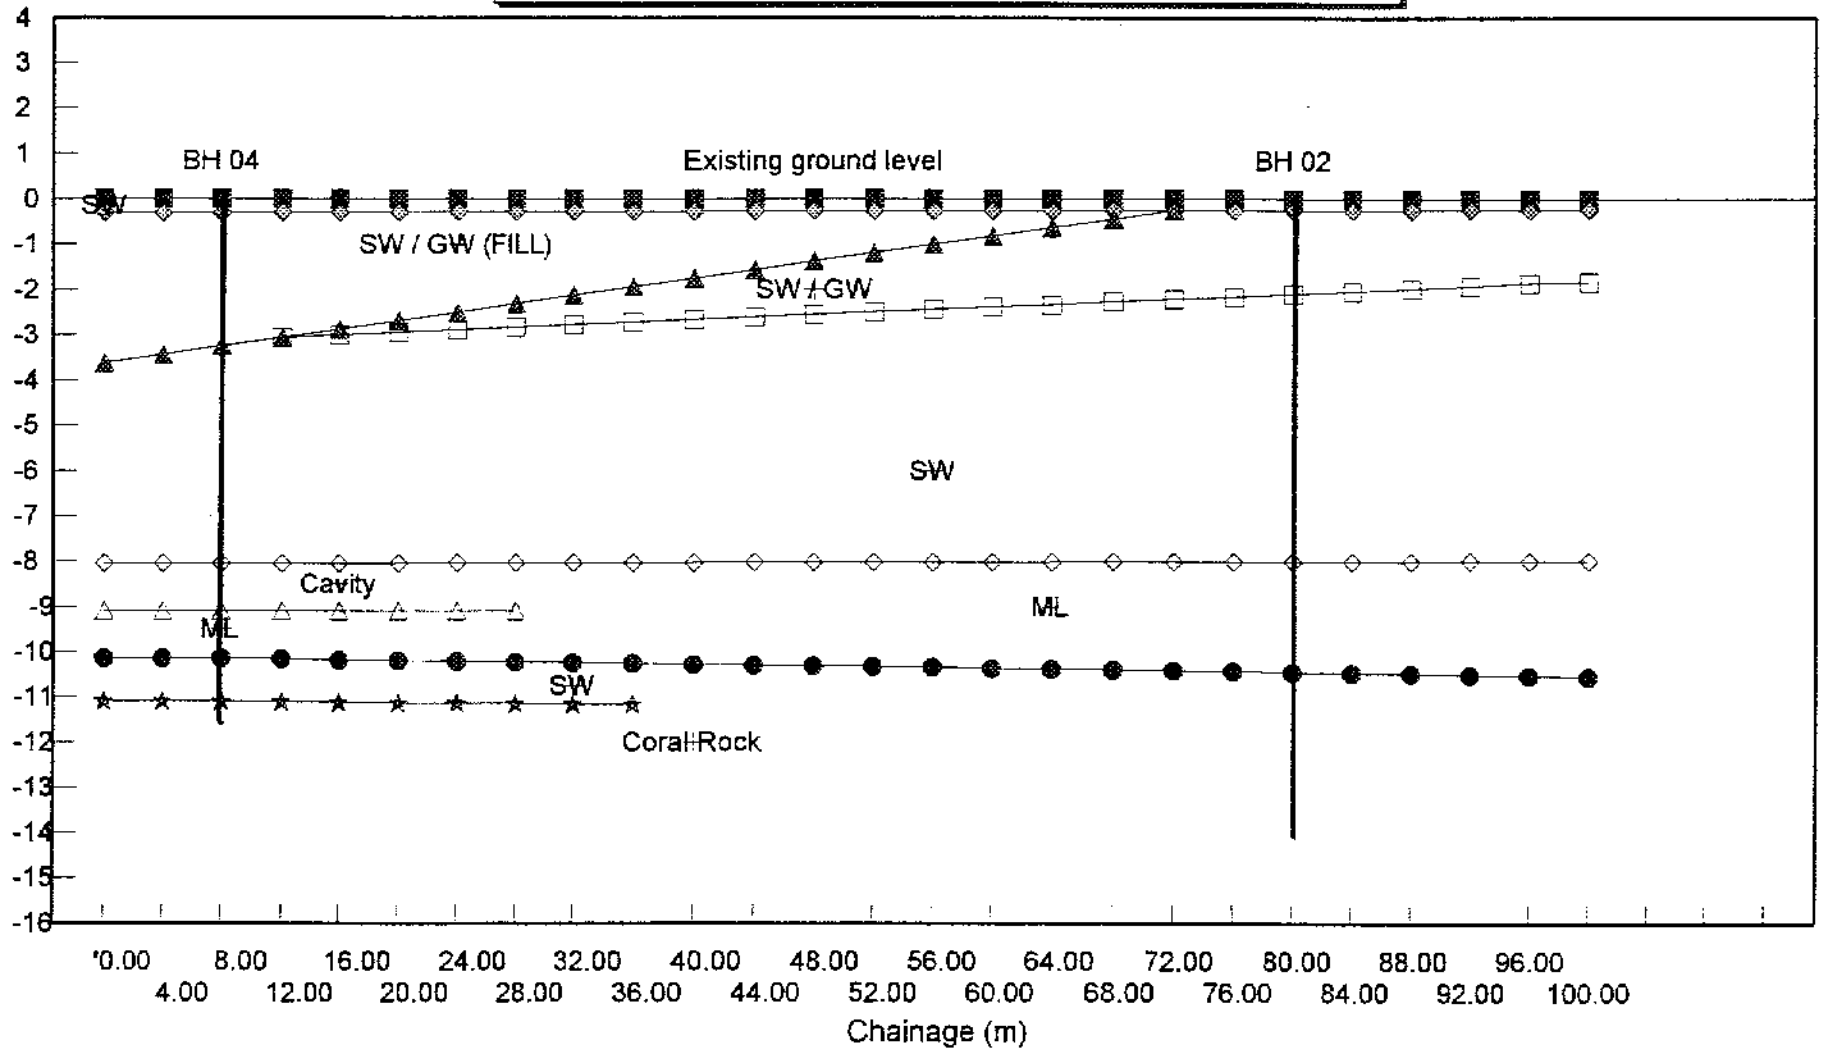
FIGURE II - B

GENERALISED CROSS SECTION THROUGH BH 04 AND BH 02

■ Elev. of existing Ground	◇ Elev. of bot. of first SW laye	▲ Elev. of bot. of FILL layer	□ Elev. of bot. of SW/GW lay
◊ Elev. of bot. of second SW I	△ Elev. of bot. of Cavity	● Elev. of bot. of ML layer	★ Elev. of bot. of third SW lay

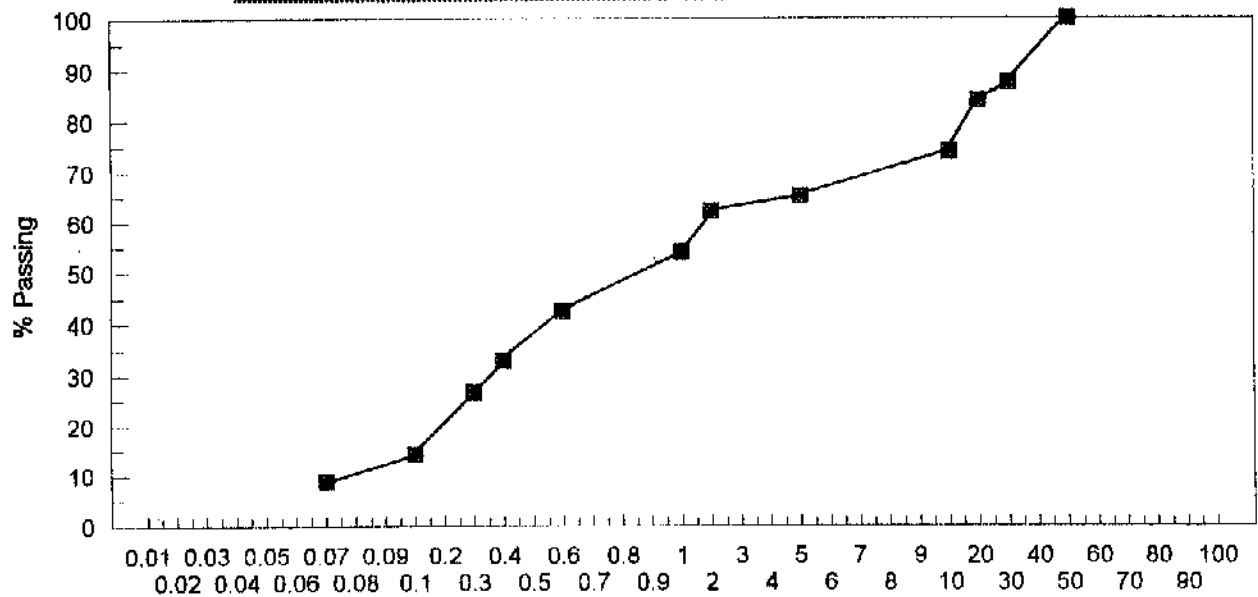
Sieve Size/ Partical Size mm	Weight g	Retained %	Cum. Retained %	% Passing %	Remarks
50.00		0.00	0.00	100.00	
28.00	11.20	12.33	12.33	87.67	
20.00	3.31	3.65	15.98	84.02	
14.00		0.00	15.98	84.02	
10.00	9.10	10.02	26.00	74.00	
5.00	7.90	8.70	34.70	65.30	
2.00	2.83	3.12	37.82	62.18	
1.18	7.33	8.07	45.89	54.11	
0.60	10.61	11.69	57.58	42.42	
0.425	8.61	9.48	67.06	32.94	
0.300	5.61	6.18	73.24	26.76	
0.150	11.30	12.44	85.68	14.32	
0.075	5.01	5.52	91.20	8.80

PARTICLE SIZE DISTRIBUTION CURVE

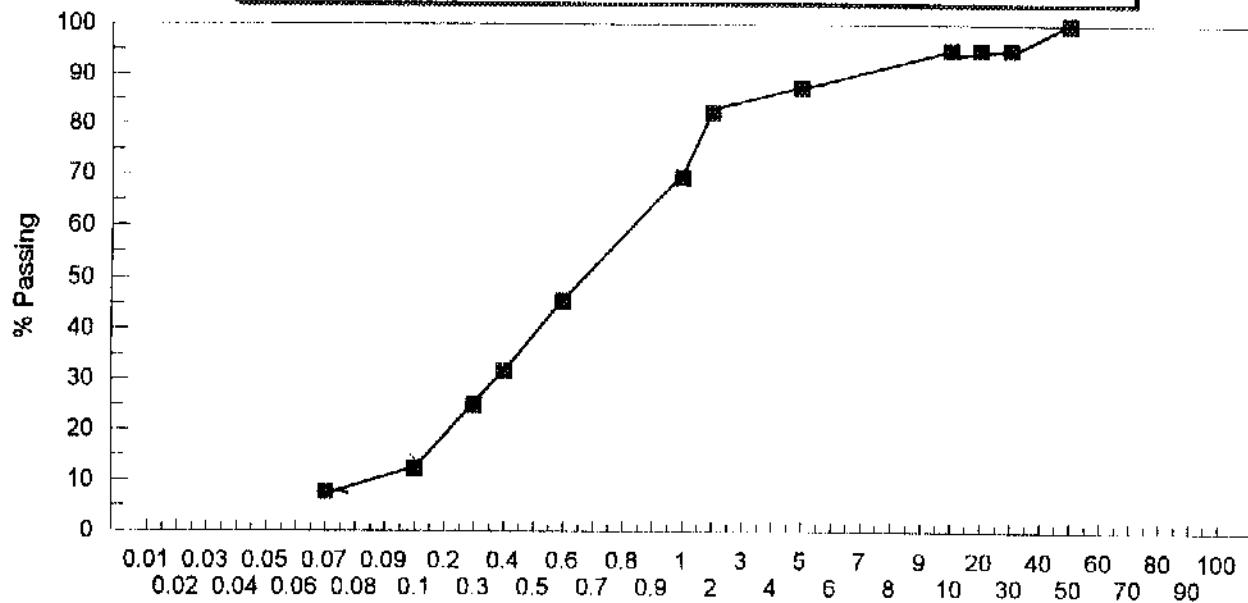
Sieve Size/ Partical Size mm	Weight g	Retained %	Cum. Retained %	% Passing %	Remarks
50.00		0.00	0.00	100.00	
28.00	5.41	5.00	5.00	95.00	
20.00		0.00	5.00	95.00	
14.00		0.00	5.00	95.00	
10.00		0.00	5.00	95.00	
5.00	8.21	7.59	12.60	87.40	
2.00	5.42	5.01	17.61	82.39	
1.18	14.01	12.96	30.57	69.43	
0.60	25.92	23.98	54.55	45.45	
0.425	14.90	13.78	68.33	31.67	
0.300	7.20	6.66	75.00	25.00	
0.150	13.91	12.87	87.86	12.14	
0.075	4.80	4.44	92.30	7.70

PARTICLE SIZE DISTRIBUTION CURVE

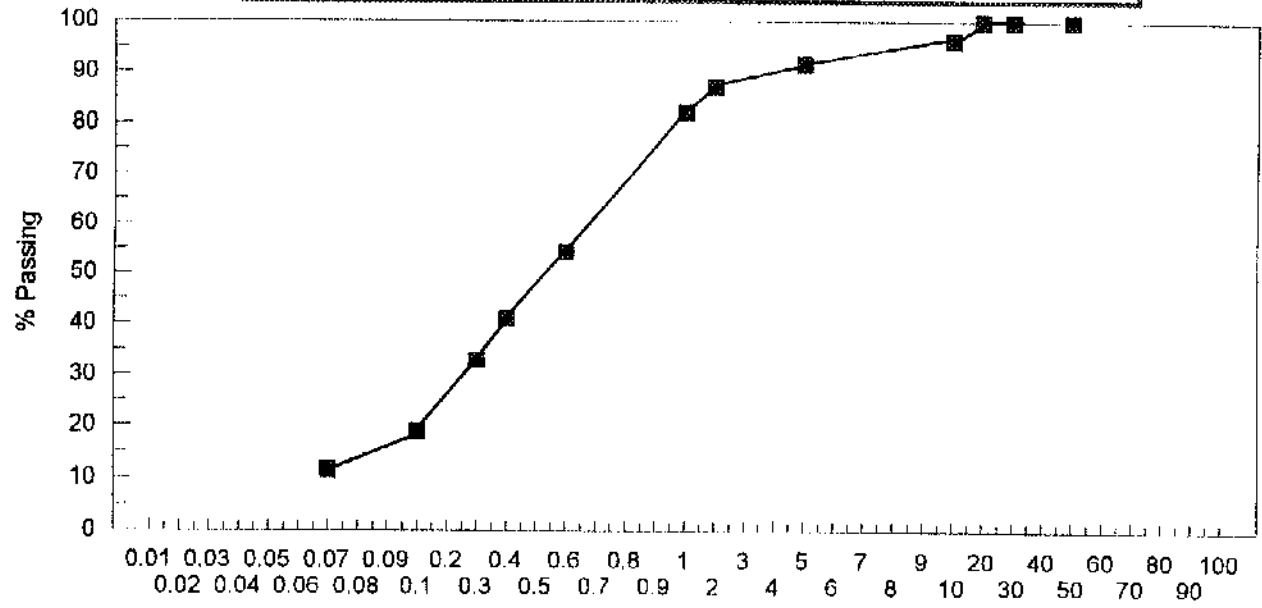
Sieve Size/ Partical Size mm	Weight g	Retained %	Cum. Retained %	% Passing %	Remarks
50.00		0.00	0.00	100.00	
28.00		0.00	0.00	100.00	
20.00		0.00	0.00	100.00	
14.00	3.40	3.62	3.62	96.38	
10.00		0.00	3.62	96.38	
5.00	4.40	4.69	8.31	91.69	
2.00	4.31	4.59	12.90	87.10	
1.18	4.69	4.99	17.89	82.11	
0.60	26.10	27.79	45.68	54.32	
0.425	12.62	13.44	59.12	40.88	
0.300	7.61	8.10	67.22	32.78	
0.150	13.20	14.06	81.28	18.72	
0.075	6.83	7.27	88.55	11.45

PARTICLE SIZE DISTRIBUTION CURVE

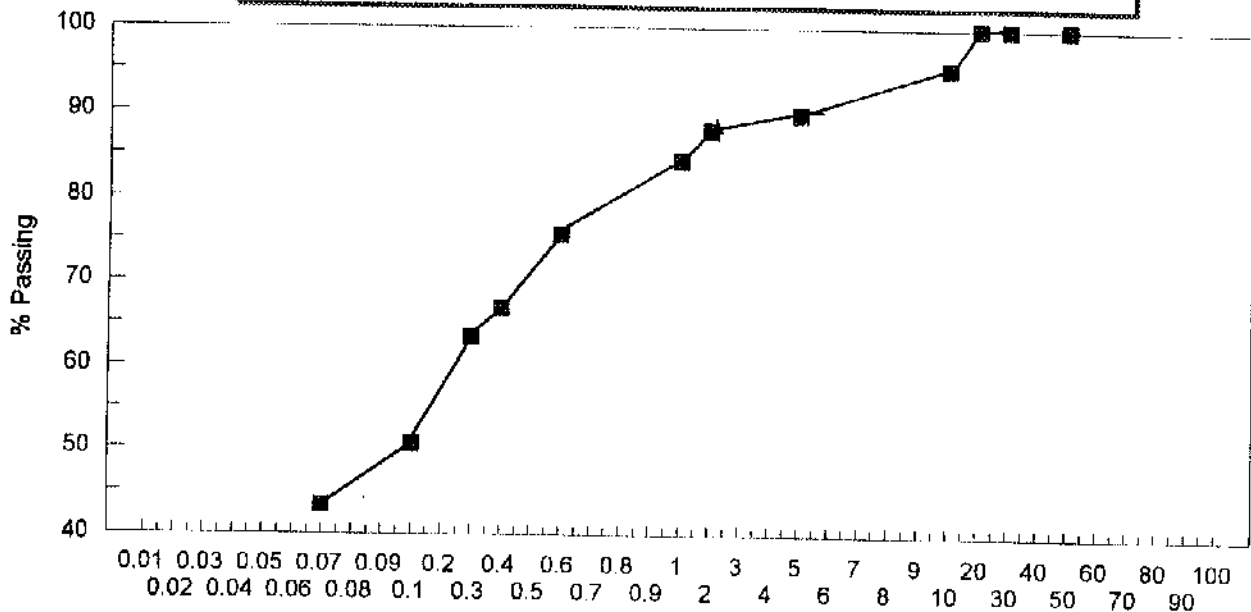
Sieve Size/ Partical Size mm	Weight g	Retained %	Cum. Retained %	% Passing %	Remarks
50.00		0.00	0.00	100.00	
28.00		0.00	0.00	100.00	
20.00		0.00	0.00	100.00	
14.00		0.00	0.00	100.00	
10.00	2.81	4.72	4.72	95.28	
5.00	3.30	5.55	10.27	89.73	
2.00	1.11	1.87	12.13	87.87	
1.18	2.12	3.56	15.69	84.31	
0.60	5.20	8.74	24.43	75.57	
0.425	5.22	8.77	33.20	66.80	
0.300	2.01	3.38	36.58	63.42	
0.150	7.65	12.85	49.44	50.56	
0.075	4.33	7.28	56.71	43.29

PARTICLE SIZE DISTRIBUTION CURVE

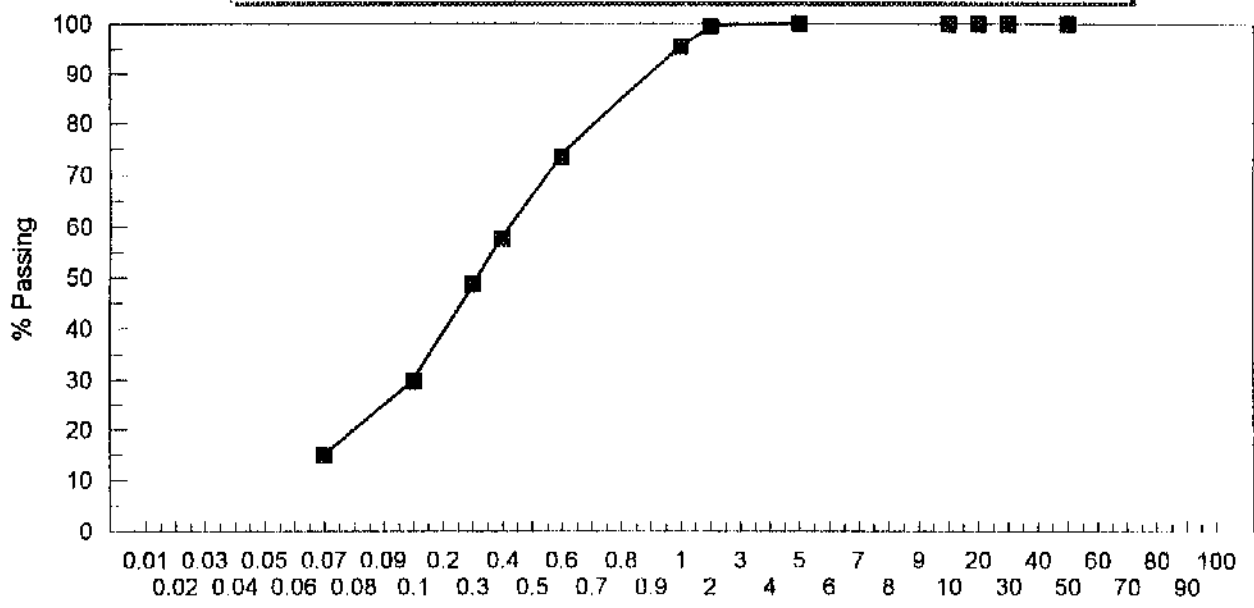
Sieve Size/ Partical Size mm	Weight g	Retained %	Cum. Retained %	% Passing %	Remarks
50.00		0.00	0.00	100.00	
28.00		0.00	0.00	100.00	
20.00		0.00	0.00	100.00	
14.00		0.00	0.00	100.00	
10.00		0.00	0.00	100.00	
5.00		0.00	0.00	100.00	
2.00	0.82	0.55	0.55	99.45	
1.18	5.92	3.96	4.51	95.49	
0.60	33.02	22.08	26.59	73.41	
0.425	23.72	15.86	42.46	57.54	
0.300	13.22	8.84	51.30	48.70	
0.150	28.32	18.94	70.24	29.76	
0.075	22.22	14.86	85.10	14.90

PARTICLE SIZE DISTRIBUTION CURVE

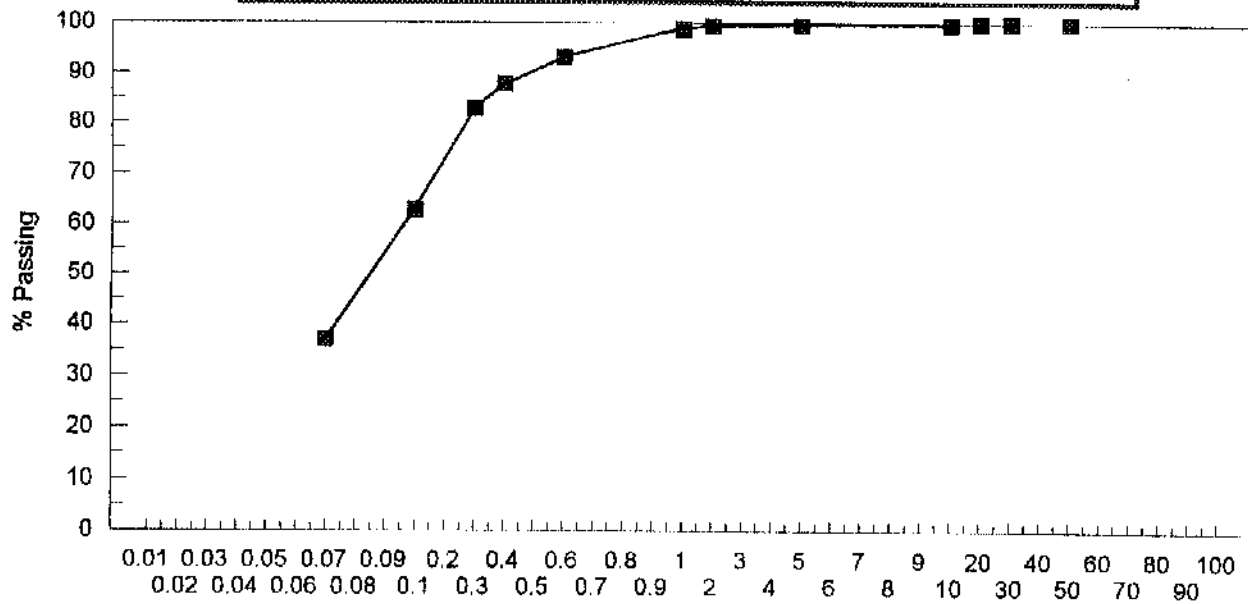
Sieve Size/ Partical Size mm	Weight g	Retained %	Cum. Retained %	% Passing %	Remarks
50.00		0.00	0.00	100.00	
28.00		0.00	0.00	100.00	
20.00		0.00	0.00	100.00	
14.00		0.00	0.00	100.00	
10.00	0.61	0.34	0.34	99.66	
5.00	0.30	0.17	0.51	99.49	
2.00	0.21	0.12	0.63	99.37	
1.18	1.01	0.57	1.20	98.80	
0.60	9.90	5.56	6.75	93.25	
0.425	9.52	5.35	12.10	87.90	
0.300	9.11	5.11	17.21	82.79	
0.150	35.71	20.05	37.26	62.74	
0.075	45.91	25.78	63.04	36.96

PARTICLE SIZE DISTRIBUTION CURVE

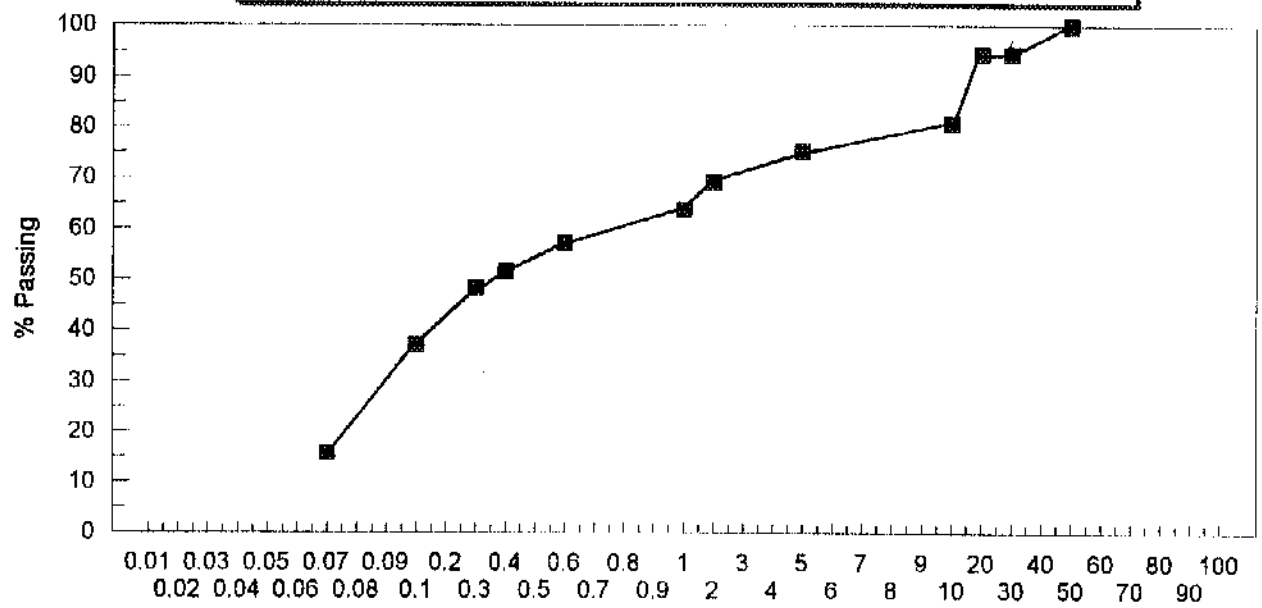
Sieve Size/ Partical Size mm	Weight g	Retained %	Cum. Retained %	% Passing %	Remarks
50.00		0.00	0.00	100.00	
28.00	11.01	5.51	5.51	94.49	
20.00		0.00	5.51	94.49	
14.00		0.00	5.51	94.49	
10.00	27.10	13.56	19.07	80.93	
5.00	11.20	5.61	24.68	75.32	
2.00	12.11	6.06	30.74	69.26	
1.18	11.11	5.56	36.30	63.70	
0.60	13.10	6.56	42.86	57.14	
0.425	10.82	5.42	48.27	51.73	
0.300	6.90	3.45	51.73	48.27	
0.150	22.20	11.11	62.84	37.16	
0.075	43.00	21.52	84.36	15.64

PARTICLE SIZE DISTRIBUTION CURVE

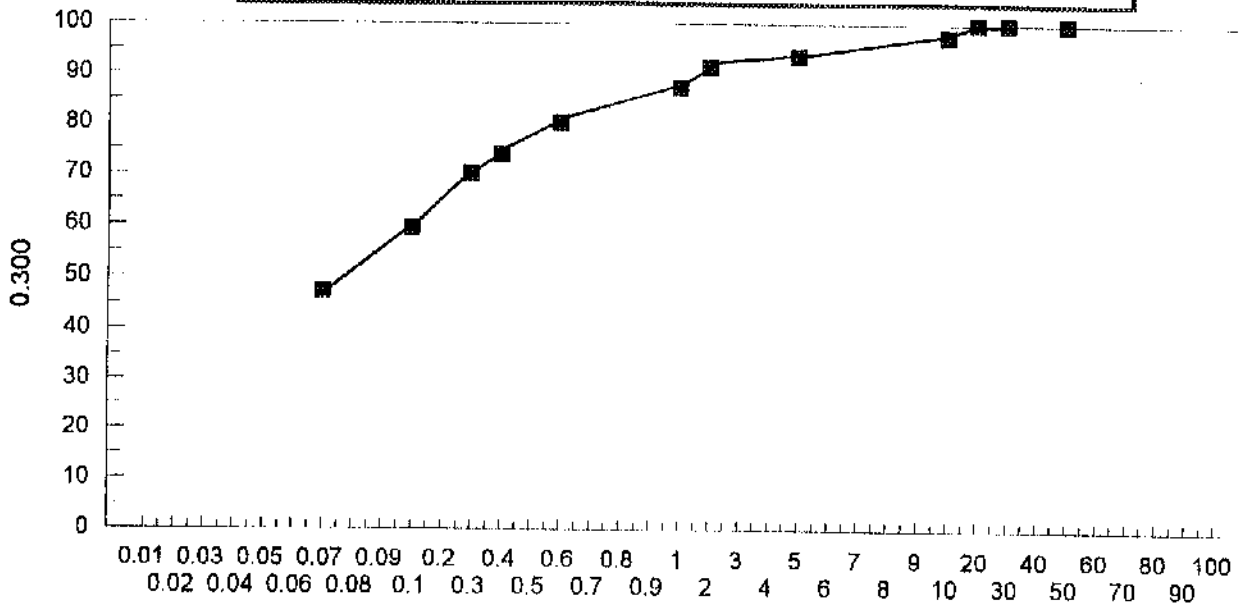
Sieve Size/ Partical Size mm	Weight g	Retained %	Cum. Retained %	% Passing %	Remarks
50.00		0.00	0.00	100.00	
28.00		0.00	0.00	100.00	
20.00		0.00	0.00	100.00	
14.00		0.00	0.00	100.00	
10.00	5.11	2.48	2.48	97.52	
5.00	7.80	3.79	6.27	93.73	
2.00	4.71	2.29	8.56	91.44	
1.18	8.51	4.14	12.70	87.30	
0.60	14.42	7.01	19.70	80.30	
0.425	13.11	6.37	26.07	73.93	
0.300	7.82	3.80	29.87	70.13	
0.150	22.20	10.79	40.66	59.34	
0.075	24.51	11.91	52.57	47.43

PARTICLE SIZE DISTRIBUTION CURVE

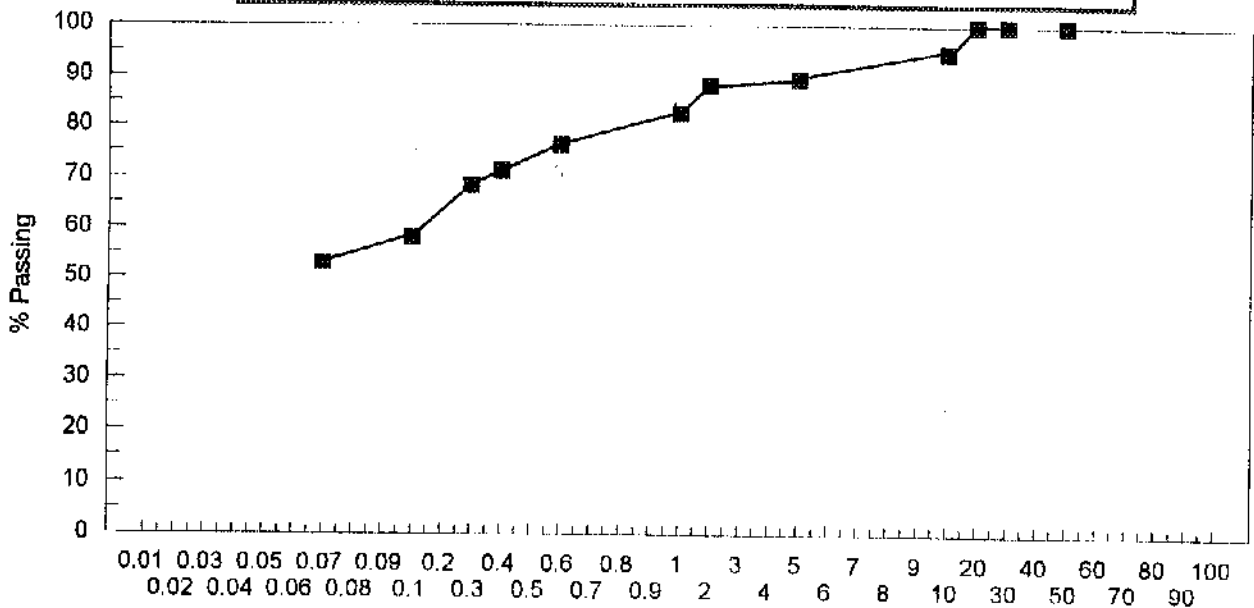
Sieve Size/ Partical Size mm	Weight g	Retained %	Cum. Retained %	% Passing %	Remarks
50.00		0.00	0.00	100.00	
28.00		0.00	0.00	100.00	
20.00		0.00	0.00	100.00	
14.00		0.00	0.00	100.00	
10.00	5.32	5.14	5.14	94.86	
5.00	5.52	5.33	10.47	89.53	
2.00	1.41	1.36	11.83	88.17	
1.18	5.71	5.52	17.35	82.65	
0.60	6.52	6.30	23.65	76.35	
0.425	5.31	5.13	28.78	71.22	
0.300	3.01	2.91	31.69	68.31	
0.150	10.63	10.27	41.96	58.04	
0.075	5.30	5.12	47.08	52.92

PARTICLE SIZE DISTRIBUTION CURVE

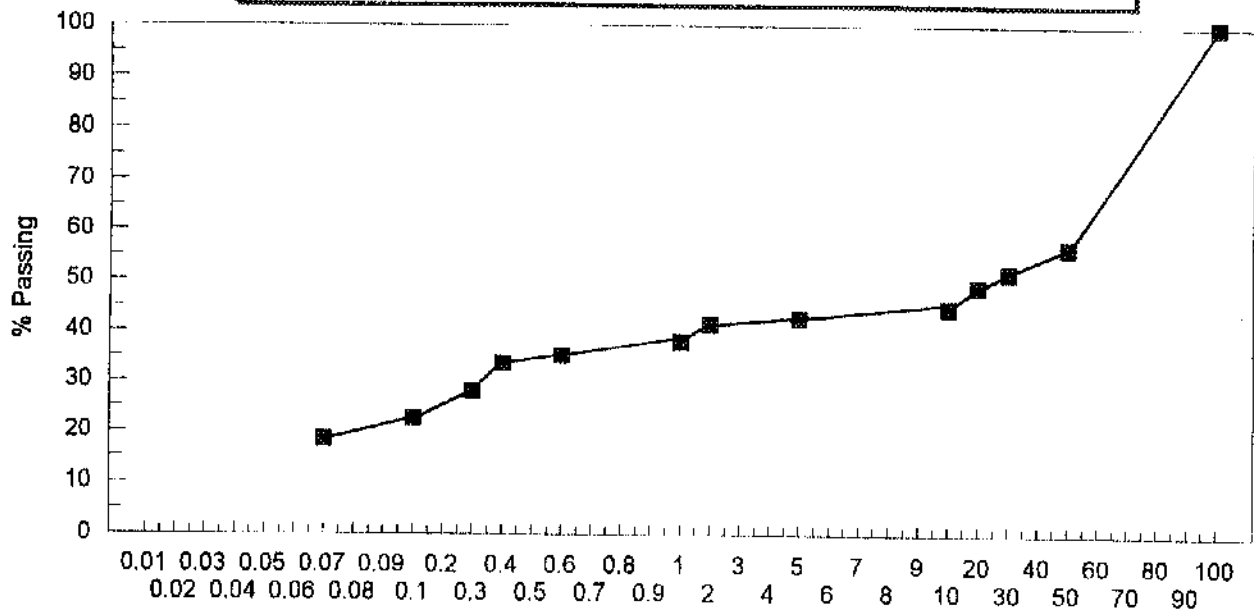
Sieve Size/ Partical Size mm	Weight g	Retained %	Cum. Retained %	% Passing %	Remarks
50.00	60.22	43.51	43.51	56.49	
28.00	6.71	4.85	48.36	51.64	
20.00	3.70	2.67	51.03	48.97	
14.00		0.00	51.03	48.97	
10.00	5.82	4.21	55.24	44.76	
5.00	2.81	2.03	57.27	42.73	
2.00	1.71	1.24	58.50	41.50	
1.18	4.83	3.49	61.99	38.01	
0.60	4.06	2.93	64.93	35.07	
0.425	2.11	1.52	66.45	33.55	
0.300	7.64	5.52	71.97	28.03	
0.150	7.62	5.51	77.48	22.52	
0.075	5.83	4.21	81.69	18.31

PARTICLE SIZE DISTRIBUTION CURVE
