The Study on Flood Control and Landslide Prevention in Tegucigalpa Metropolitan Area

Hazard Map of Slope Failures

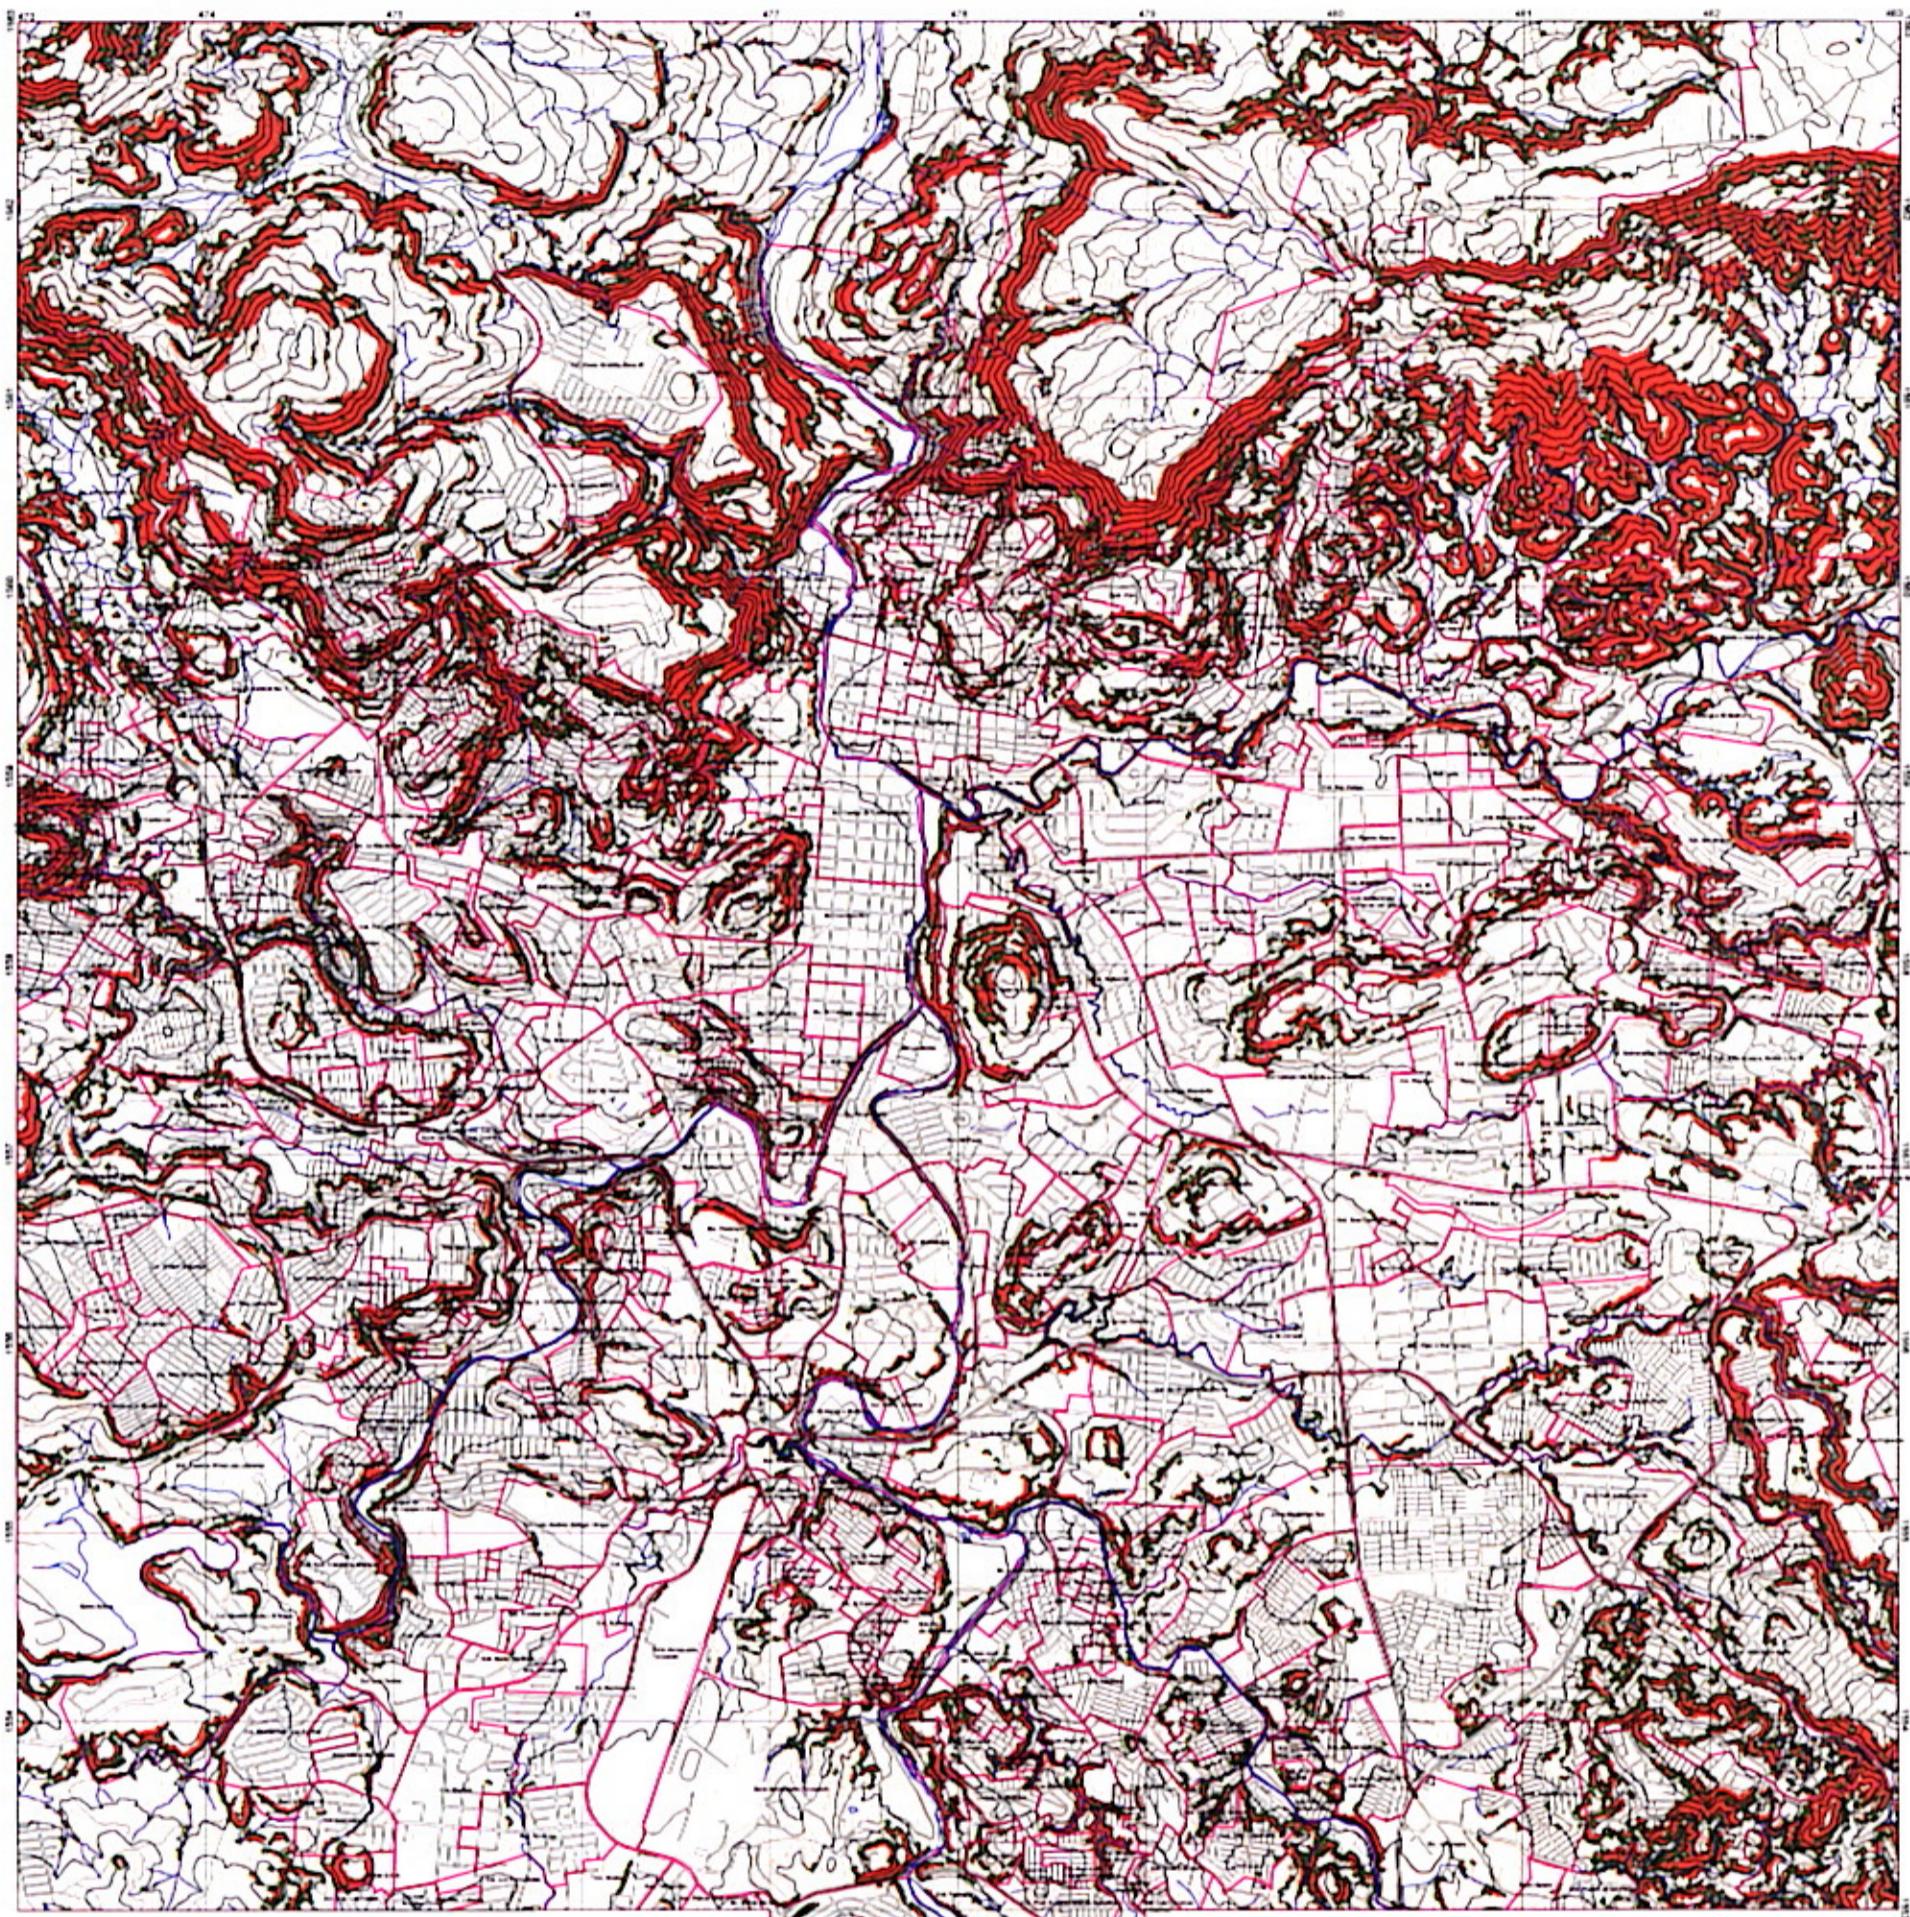
1:40000
1000 Meters

This Hazard Map was created by the joint venture of PACIFIC CONSULTANTS INTERNATIONAL and NIKKEN CONSULTANTS INC. ("THE STUDY ON FLOOD CONTROL AND LANDSLIDE PREVENTION IN TEGUCIGALPA METROPOLITAN AREA OF THE REPUBLIC OF HONDURAS") placed an order by JICA (JAPAN INTERNATIONAL COOPERATION AGENCY).
The field survey and analysis were performed by Katsu Nakada from April, 2001 through November, 2001.
The distribution of the existing slope failures referred to the result which USGS investigated after Mitch (1998).

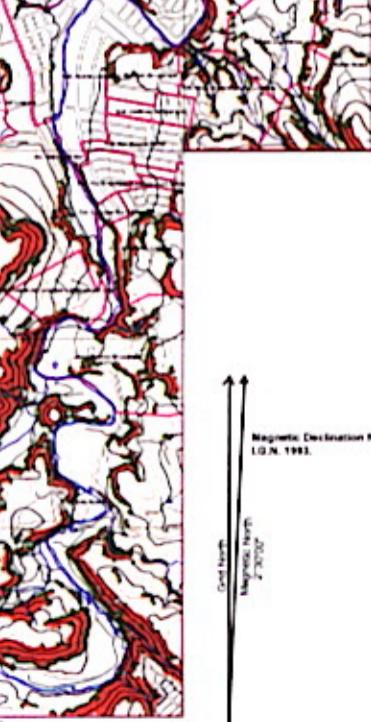
Slope Failure Dangerous Area

Item	Report
Existing Slope Failure	The slope failure part checked by USGS after Mitch, and the slope failure part checked by this investigation. However, landslides remove. The present of these parts is also unstable and a slope failure may also generate them from now on.
Dangerous Slope	A slope with a possibility that a slope failure will occur in 10% or more of probability from now on.
Affected Area by Slope Failure	When either of the two above-mentioned person's slopes collapses, the range which the colluvium reaches is shown. The range which is in the distance of nearly 20m from the lower end of a dangerous slope is displayed.
