Appendix F

Intersection Safety Improvement Plans

This appendix contains information for 20 junctions, where existing physical and traffic conditions are gathered, traffic problems are analyzed and improvement plan is formulated and cost is estimated. Information was gathered through site visit and field observation, traffic volume count survey, queue length survey, and pedestrian count survey. In addition, some information was gathered through interview with persons who are familiar with the junction.

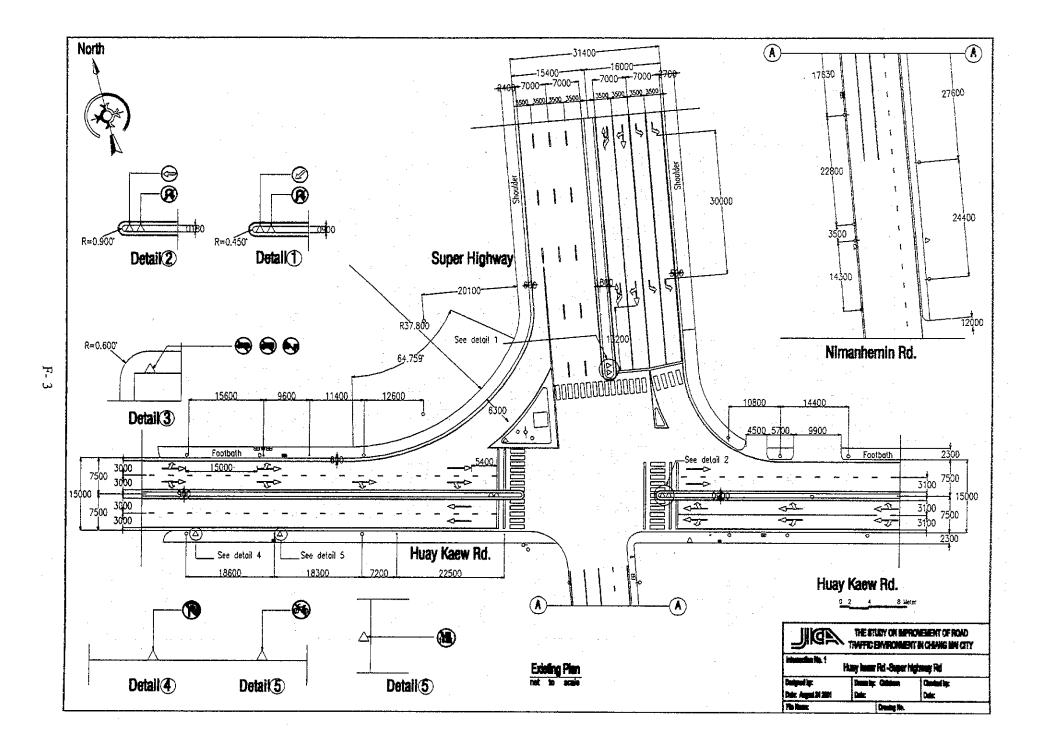
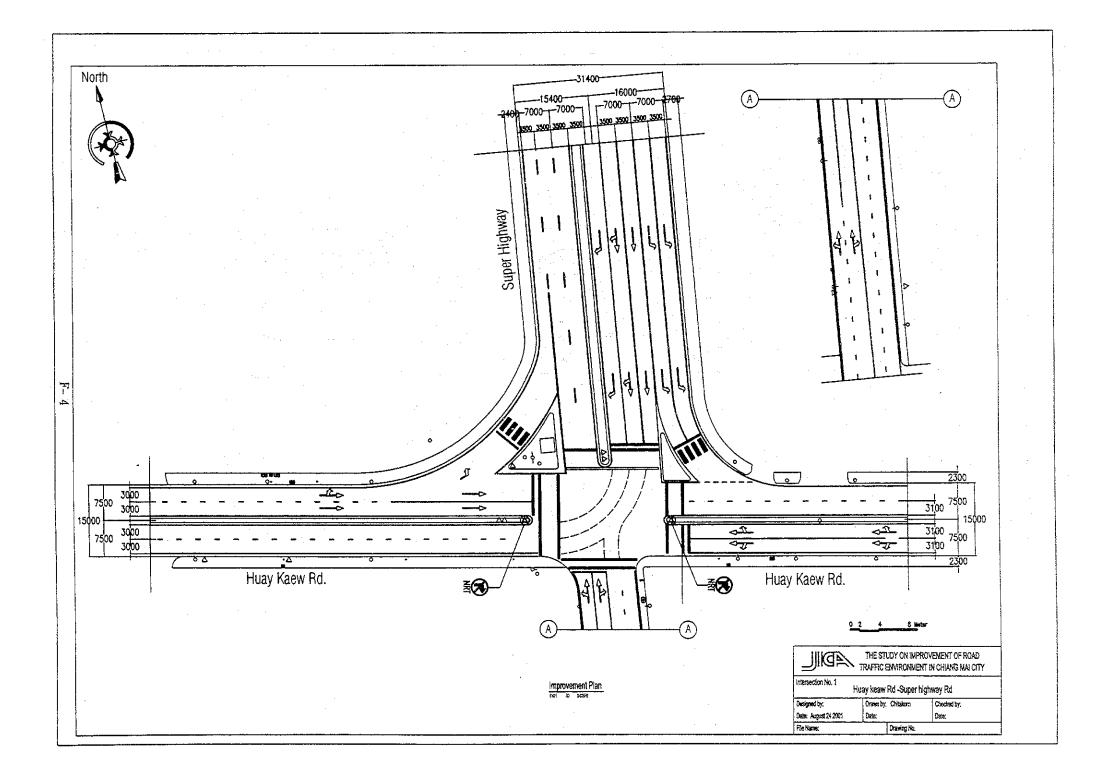
Code	J-1 Signalization	Signalized
Name	Super Highway, Nimmanhamin Road and Huay Kae	
Physical	1. 4-leg junction at the west end of Super Highway.	Main junction in the west side
conditions	of the city.	e de la

3. Re-adjustment of signal timing.	
	4. Addition of pedestrian signal.	
	5. Modification of signal phase.	
·		<u> </u>
Cost (thousand	Geometric improvement and pavement marking:	1,470
Baht)	Signal installation/improvement:	1,151

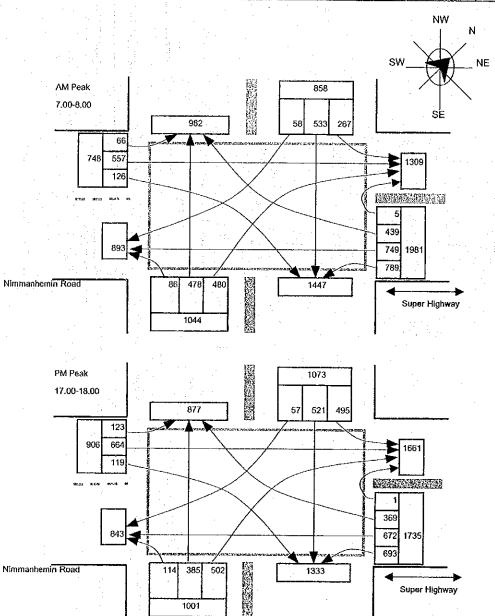
Peak Flow	in PC	U			Juncti	ion No	. J1		Inters	ecting	Stree	ets	Hua	/ Kae	w Roa	ad-Su	per H	ighway
	from N	lorthea	ast apr	roach		from S	Souther	ast app	roach	from S	Southw	est ap	proach	from h				
			********		Total				Total				Total				Total	Total
Peak Periods	То	То	То	То	From	То	То	To	From	То	To	То	From	To	To.	To	From	inbound
	sw	SE	NW	U-Turn	NE	NW	sw	NE	SE	NE	NW	SE	sw	SE	NE	sw	ИW	
AM: 7.00-8.0	749	789	439	5	1981	478	86	480	1044	657	66	126	748	533	267	58	858	4631
РМ: 17.00-18	672	693	369	1	1735	385	114	502	1001	664	123	119	906	521	495	57	1073	4715

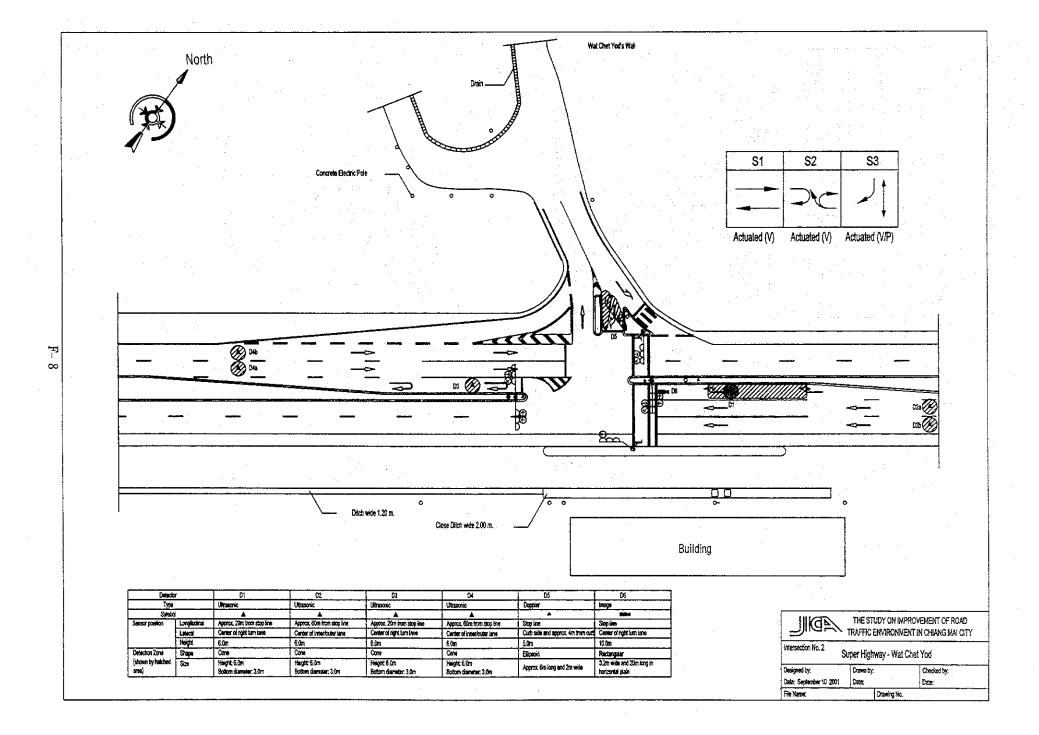
Code	J-2	Signalization	Not signalized
Name	Super Highway and Soi Wat Ch		
	 Super Highway and Soi Wat Ch T-junction of high grade Supand a local collector road of Another collector road which Super Highway about 80 m in the super Highway about 80 m in the super Highway about 9 m in the super Highway about 10%. Sodium type lightings are in the super Highway and Super Highway about 10%. 	et Yod ler Highway (4-lane of 10 meter wide. It is a continuation of from the junction. In it is provided along the space is used as provided and connects with a lower than Super Histalled on median of the stalled on t	Hivided road with wide shoulder) Wat Chet Yod connects with Super Highway for both Super Highway in front of the barking lot. with Super Highway. ighway and the grade of the highway.

Improvements	Chet Yod approach, extension Highway and sidewalk along	egulate movement of nstruction of corner is on of median on the n g southeast side of Su	slands and a center island on Wat tortheast approach of Super tiper Highway.
Cost	Cost is not estimated as the imp project.

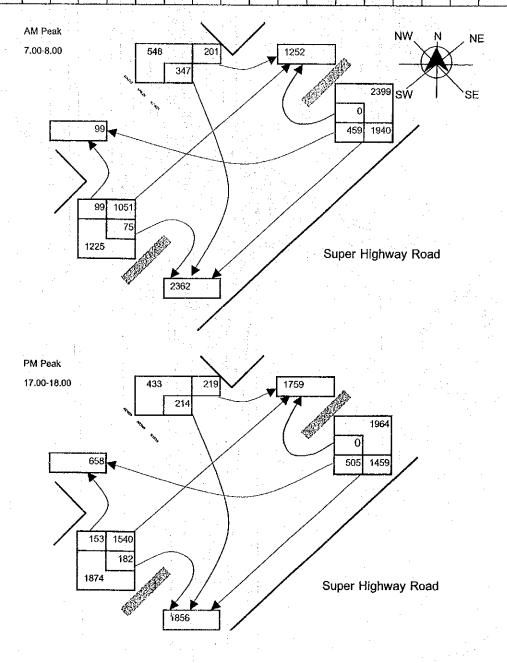
Peak Flow In	PCU				Junct	ion No	o. J2		Supe	r High	way-S	oi Wa	at Che	t Yod			•
	from i	lortheas	st appi	oach	from S	outhea	st app	roach	from S	outhwe	est app	roach	from N				
				Total				Total				Total				Total	Total
Peak Periods	То	То	То	From	То	То	То	From	То	То	То	From	То	То	То	From	inbound
	SW	U-Turn	NW	NE	NW	SW	NE	SE	NE	NW	U-Turn	sw	SE	NE	sw	NW	
AM: 7.00-8.00	1940	0	459	2399	-	-	- T	-	1051	99	75	1225	-	201	347	548	4172
PM: 17.00-18.0	1459	0	505	1964	-	-	-	÷	1540	153	182	1874	-	219	214	433	4272

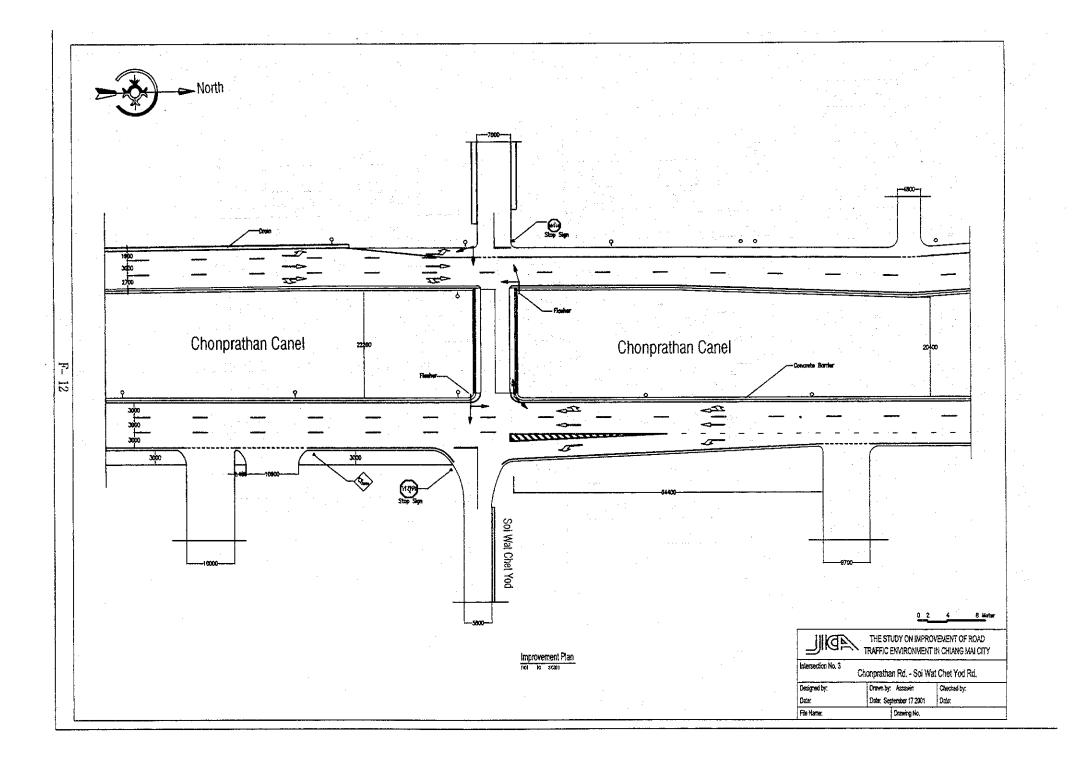
Code	J-3 Signalization Not signalized
Name	Canal Road and Soi Chet Yod Khlan
Physical	1. Canal road being divided by the canal with a two lanes narrow bridge as crossing
conditions	section and sharp curve section from canal road.
$\{ e_{k} \mid k \in \mathbb{N} \mid k \in \mathbb{N} \}$	2. Soi Chet Yod Khlan slants uphill to Canal Road at junction.

2. Application of pavement markings.
	3. Removal of no through traffic sign and installation of stop sign.
C-+ (1)1	100
Cost (thousand	Geometric improvement and pavement marking: 149
Baht)	Signal installation/improvement: 1,322 Engineering services: 294

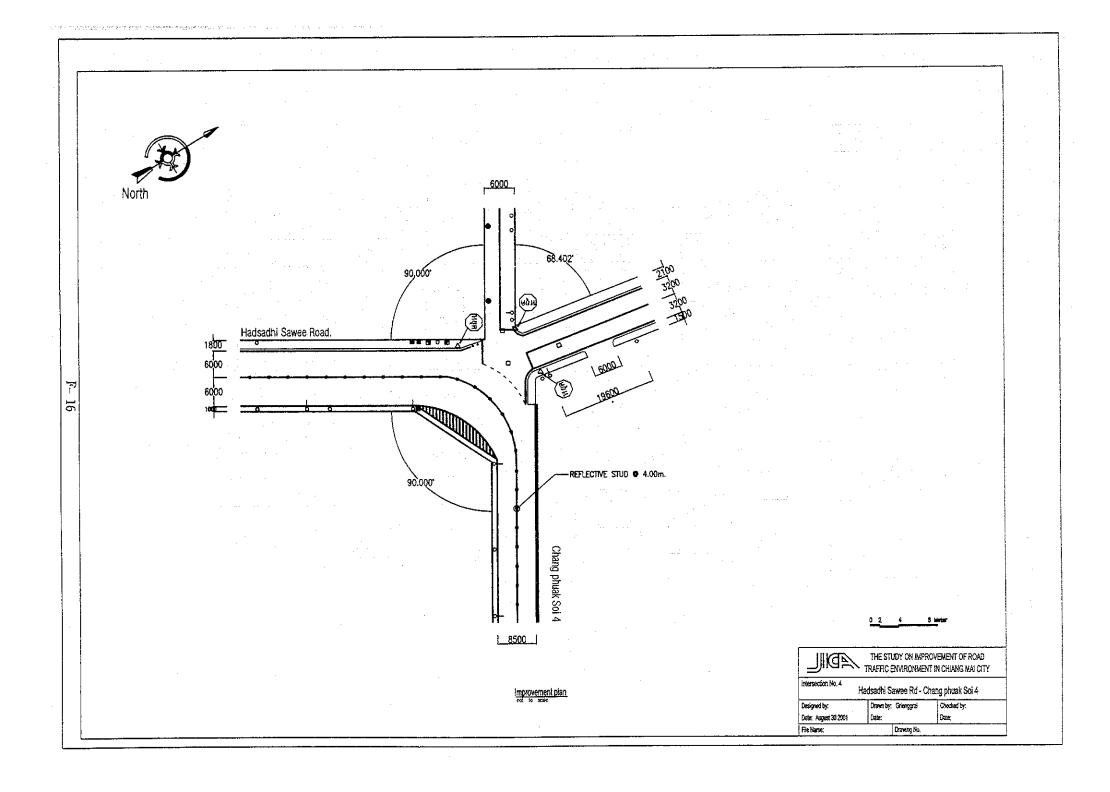
Code	J-4 Signalization	Not signalized
Name	Hadsadhi Sawee Road and Chang Phuak Soi 4	
Physical	1. 4-leg junction in the west area of Chang Phua	k Road.
conditions	2. Hadsadhi Sawee is a 2-lane undivided road w	ith carriageway width of 12 meter
	plus 1.5 meter wide side walk on one side. The	he carriageway becomes 6.4 meter
	north of junction.

3. Installation of STOP sign.	
	J. Mistalian di Di Ci digin	
Cost (thousand	Geometric improvement and pavement marking:	162
Baht)	Signal installation/improvement:	
	Engineering services:	32
4	Total project cost:	194 thousand Baht
	1

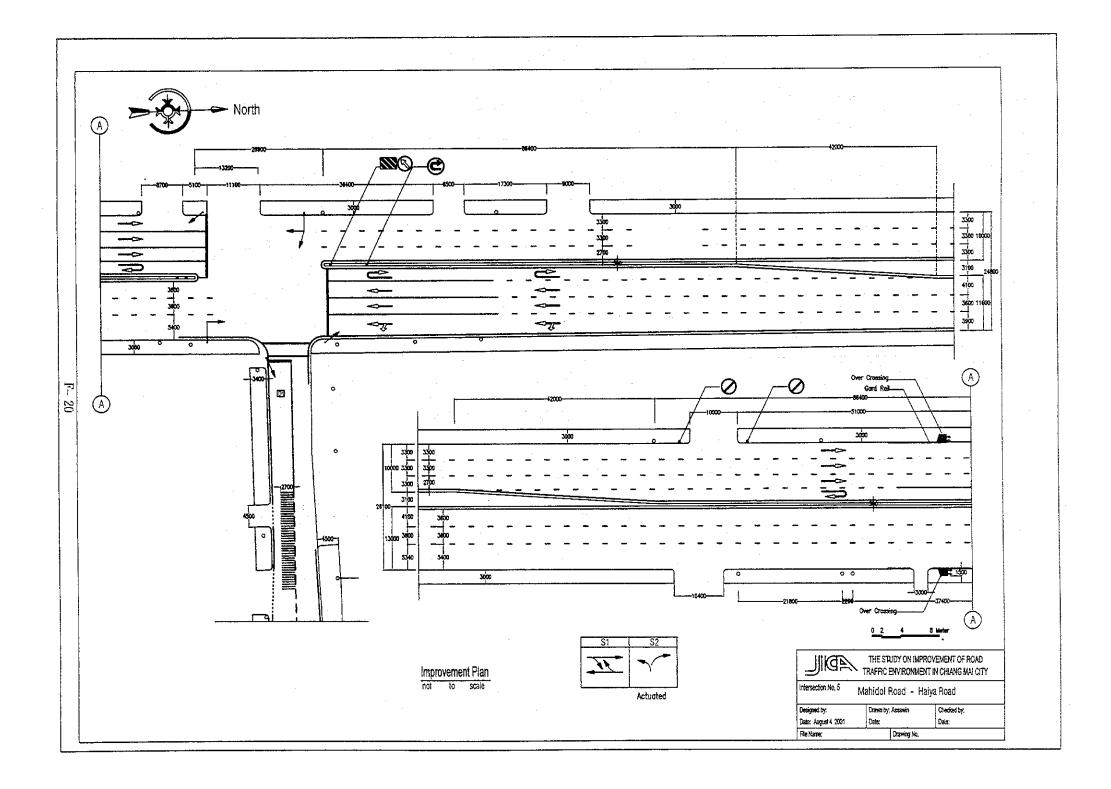
Code	J-5 Signalization Not signalized
Name	Mahidol Road and Haiya Road
Physical	1. T-type junction where an access road of 9.3 meter wide connects to Mahidol
conditions	Road, a 6-lane divided high grade highway.

2. Removal of no right turn sign.
	3. Application of pavement marking.
	4. Installation of no pedestrian crossing sign.
Burney Burney	
Cost (thousand	Geometric improvement and pavement marking: 232
Baht)	Signal installation/improvement: 2,218
	Engineering services: 489

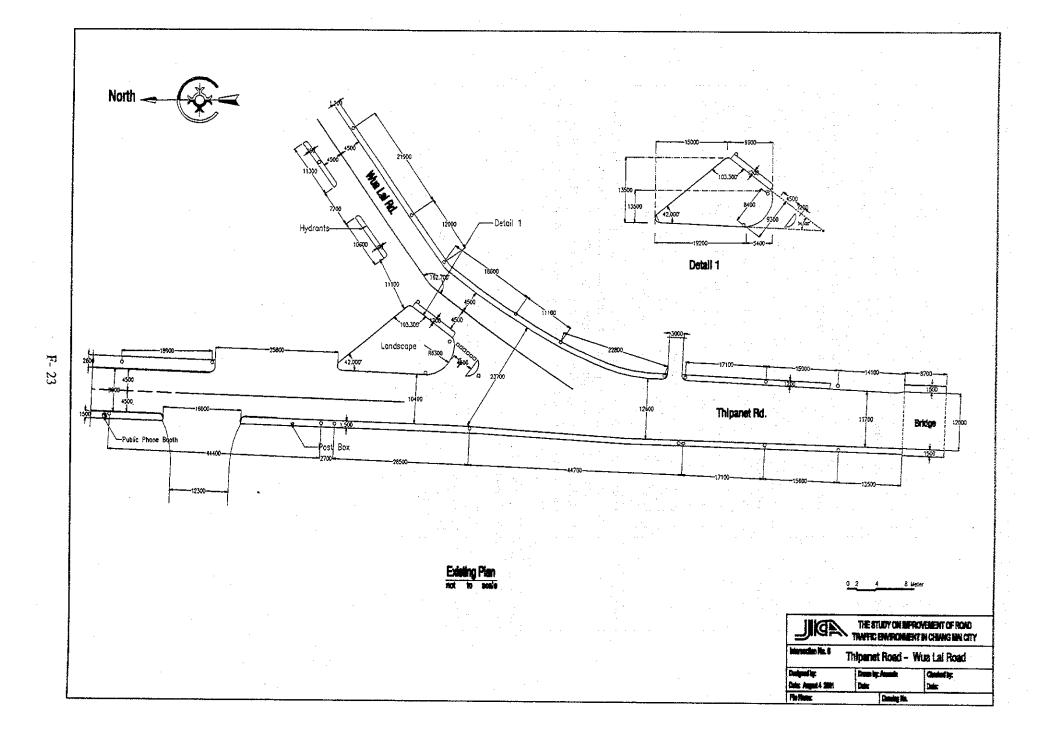
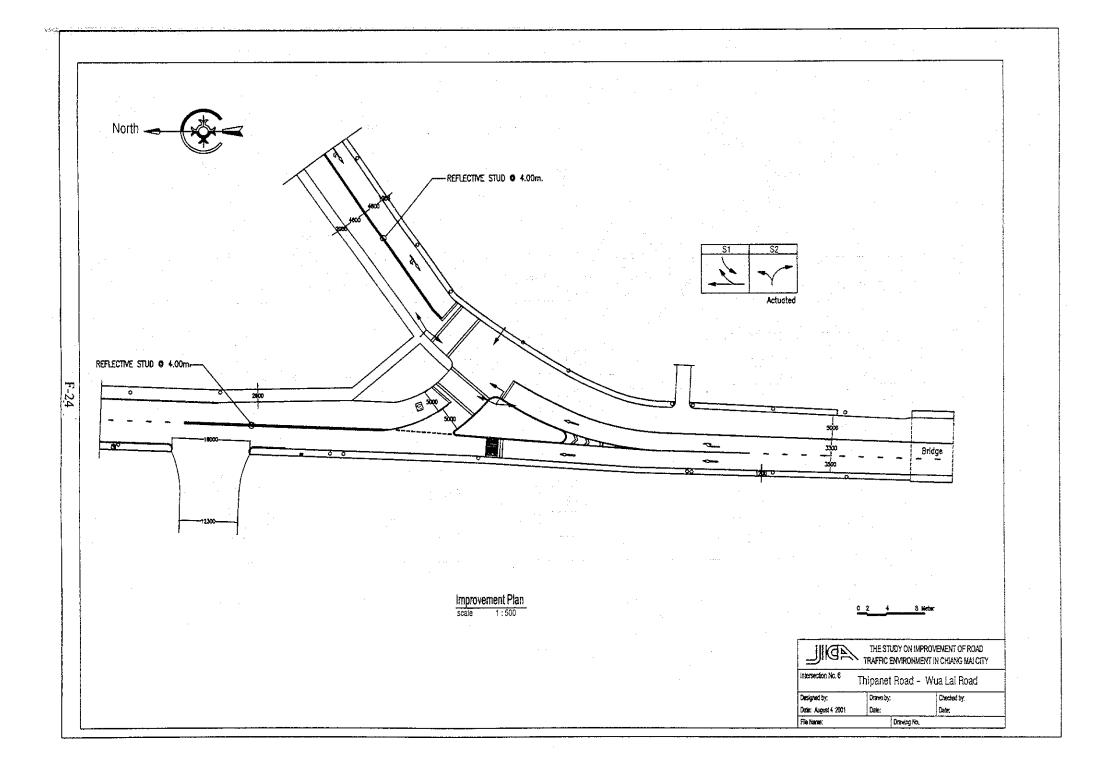
Code	J-6 Signalization Not signalized
Name	Wua Lai Road and Thipanet Road
Physical conditions	 Y-type junction of an arterial of 12 meter wide (Thipanet) with anther arterial of 9 meter wide (Wua Lai). Two branches merge with small angle. A signalized junction is located about 150 meters south of the junction. No pedestrian crossing facility. No markings visible. A small island is constructed at the nose for left turn from Thipanet to Wua Lai. A steel pipe barrier is placed on the island to make it more conspicuous. Lightings are installed.
Traffic conditions	 Traffic is moderately high (total volume of more than 2000 PCU per hour) from morning till night. 60 % to 65 % of north bound traffic makes right turn to Wua Lai road. Crossing south bound traffic. Right turn from Wua Lai toward north is very small but exists. Occasionally queue of more than 100 meters develops along Wua Lai Road during afternoon peak. Priority of the movements is not clear. Parked cars constrict traffic flow from south to north on Thipanet road. Food stalls occupy the site of closed fuel station at the nose.

Analysis	 Wua Lai and Thipanet are a major route connecting south moat with Hang Don Road. Because of one-way system around moat, there is 1.6 times more southbound traffic than northbound passing this junction. North and northeast approaches connect at a small angle. In addition, lack of guidance as to the priority flow makes maneuvering through this junction difficult and hazardous.
Improvements	Signalization. Geometric improvement.
Cost (thousand Baht)	Geometric improvement and pavement marking: 303 Signal installation/improvement: 1,689 Engineering services: 398 Total project cost: 2,390 thousand Baht

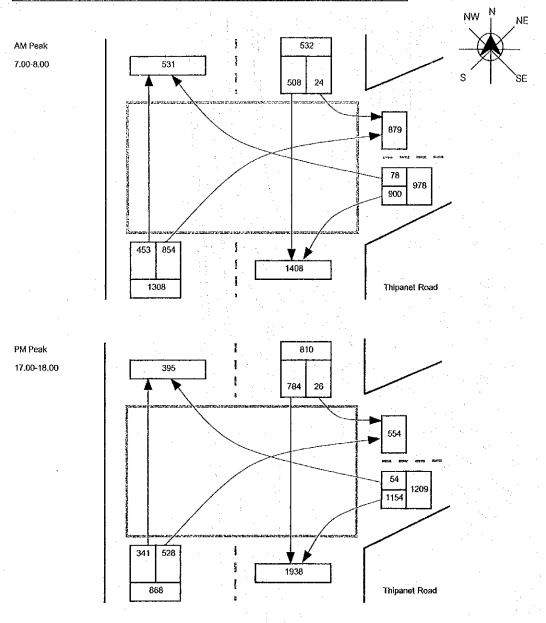
Junction No. J6

from N	lorth a	pproac	h į	from N	lorthea	st app	roach	from S				
				Total		Γ		Total				Total	pun
Peak Periods	То	То	To	From	То	То	То	From	То	То	То	From	inbound
	South	NE	West	North	NW	South	North	NE	North.	West	NE	South	Total
AM: 7.00-8.00	508	24	-	532	-	900	78	978	453	-	854	1308	2817
PM: 17.00-18.00	784	26	-	810	-	1154	54	1209	341		528	868	2887

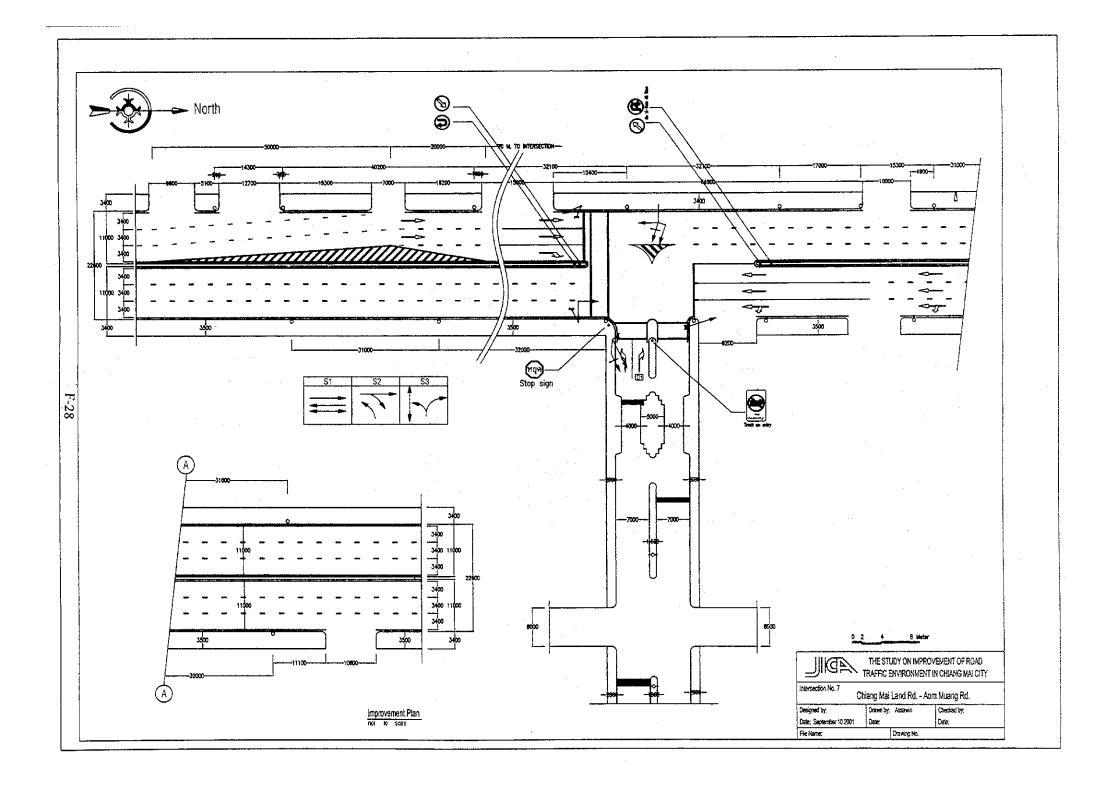
Code	J-7 Signalization Not signalized								
Name	Super Highway (Aom Muang Road) and Chiang Mai Land Road								
Physical	1. T-Type junction of a 6-lane divided high grade arterial (Super Highway) with a								
conditions	minor collector road.

4. Removal of gate miniming road which of Chiang ivial Land.								
Cost (thousand	Geometric improvement and payement marking: 280								
Cost (thousand	Geometric improvement and pavement marking: 280 Signal installation/improvement: 2,647								
Baht)	Engineering services: 585								
	Total project cost: 3,512 thousand Baht

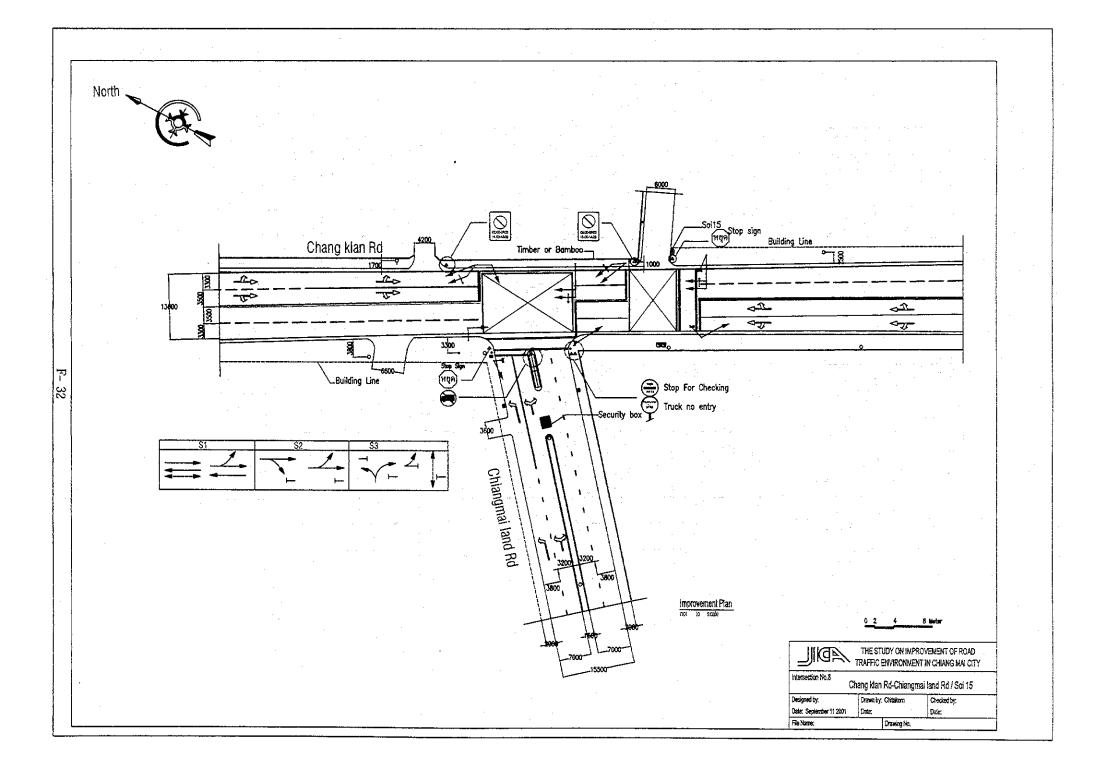
Code	J-8 Signalization Not signalized								
Name	Chang Khlan Road and Chiang Mai Land Road (Soi 15)								
Physical	1. T-type junction with a 2-lane Soi connected at offset position.								
conditions	2. Poor and faded markings (lane line and yellow box) on main road.

2. Application of pavement marking.								
Cost (thousand	Geometric improvement and pavement marking: 291								
Baht)	Signal installation/improvement: 3,432								
	Engineering services: 745								
	Total project cost: 4,468 thousand Baht

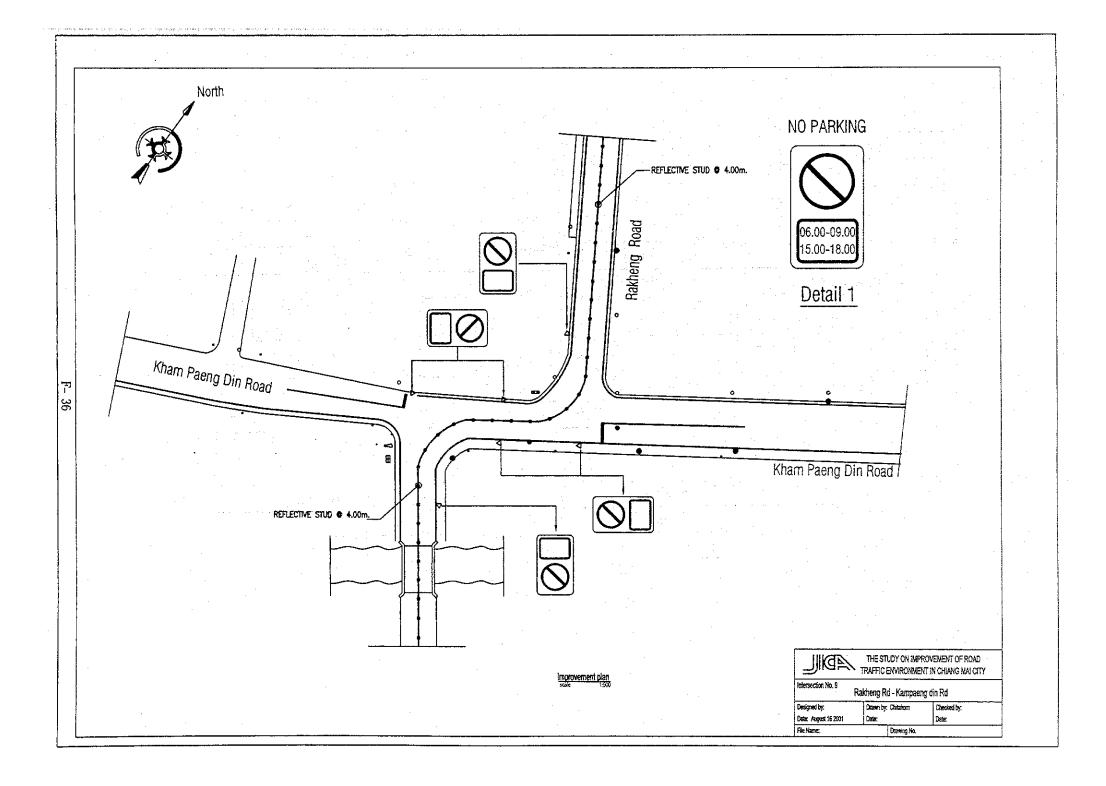
Code	J-9 (Signalization	Not signalized						
			110t Bigitarizot						
Name	Rakheng Road and Kampheng Din Road								
Physical	1. Poorly shaped junction with offset approaches.								
conditions	2. No visible markings except yellow color center line and no stop signs.

2. Installation of reflective stud al	ong center line.							
	3. Center line will be drawn along	g Rakheng Road., w	hich carries main flow.						
•	4. Installation of stop lines and sto	op signs for minor n	novements.						
Cost (thousand	Geometric improvement and paver	ment marking:	83						
Baht)	Signal installation/improvement:								
/		and the second of the second	17						
	Engineering services:	and the second s	17

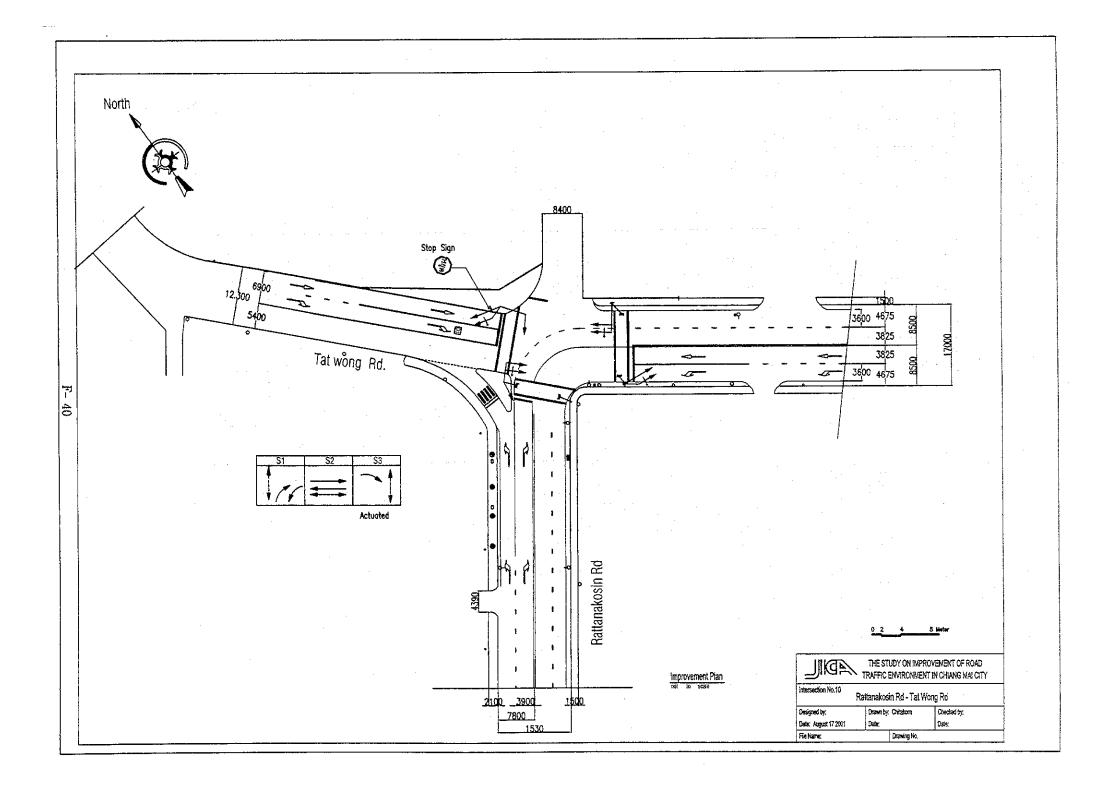
Code	J-10 Signalization Not signalized
Name	Rattanakosin Road and Tat Wong Road
Physical conditions	 T-junction with a small dead-end road connected to junction. Tat Wong Road is slightly slanted from T-shape. Turning movement markings are provided within junction without priority sign (stop sign) creating confusion on priority. Two flashers, one for Rattanakosin and another for Thung Hotel Road are installed but they are not working. The visibility of the latter is blocked by the tree. Poor visibility for left turn traffic from Thung Hotel Road due to obstructions on carriageway and tree. Wade lane width along Thung Hotel Road and Rattanakosin Road but trees and utility poles exist at the fringe of carriageway. Effective lane width is still sufficient. No pedestrian crossing provided.
Traffic conditions	 Major flow is between Rattanakosin Road and Thung Hotel Road. High left turn from Thung Hotel to Rattanakosin; 78 % and 75 % for morning peak (7:00 - 8:00) and afternoon peak (17:00 - 18:00), respectively. Likewise, right turn from Rattanakosin to Thung Hotel is 66 % and 76 % for morning and afternoon, respectively. Traffic volume of Tat Wong Road is small at the level of 70 - 130 PCU per hour except morning peak during which volume is 374 PCU per hour. Queue of up to 150 meter is observed along Rattanakosin during afternoon peak.

Analysis	 Rattanakosin and Thung Hotel serve as a route between east part of the Municipality and the area north of moat. It is also an alternative route for Kaew Nawarat Road, which is congested during school hours.
	 Although volume is not large, Tat Wong Road is a short cut from Chiang Mai Prao Road to CBD, particularly for commuting in the morning. Wide space inside junction and major flow turning at right angle render the junction difficult to maneuver and hazardous
Improvements	 Construction of corner island. Widening of sidewalk along Rattanakosin and Thung Hotel. Installation of signal. Application of pavement markings (pedestrian crossing, stop line, etc.)
Cost (thousand Baht)	Geometric improvement and pavement marking: Signal installation/improvement: Engineering services: Total project cost: 2,630 570 3,421 thousand Baht

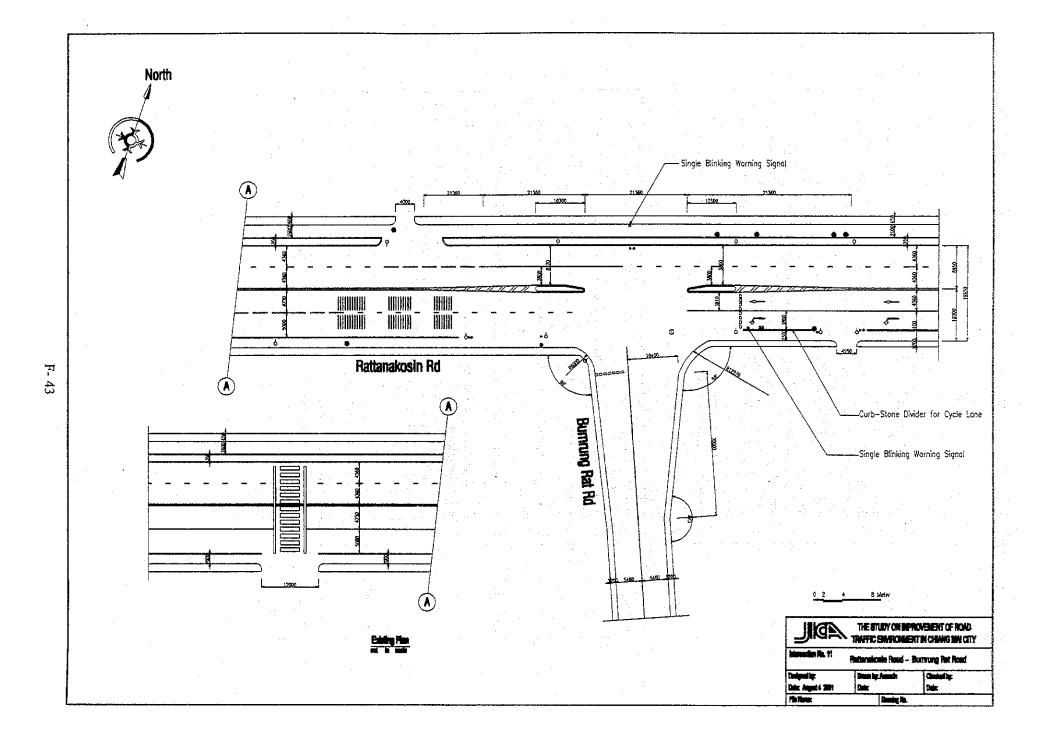
Code	J-11 Signalization Not signalized
Name	Rattanakosin Road and Bumrung Rat Road
Physical conditions	1. T-junction of a 4-lane arterial (Rattanakosin) with a 2-lane collector (Bumrung Rat).

4. High speed of vehicles along Rattanakosin makes the junction a hazardous
	location.
Improvements	1. Installation of signal.
	2. Application of pavement marking including pedestrian crossing.
Cost (thousand	Geometric improvement and pavement marking: 231
Baht)	Signal installation/improvement: 2,847
	Engineering services: 615
	Total project cost: 3,693 thousand Baht

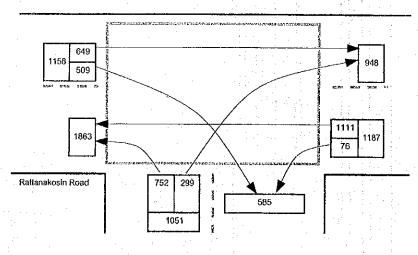
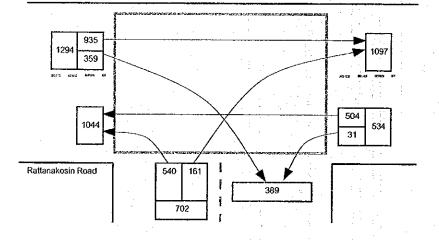
Junction No. J11

Peak Flow in PCU

AM Peak

7.00-8.00

PM Peak

17.00-18.00

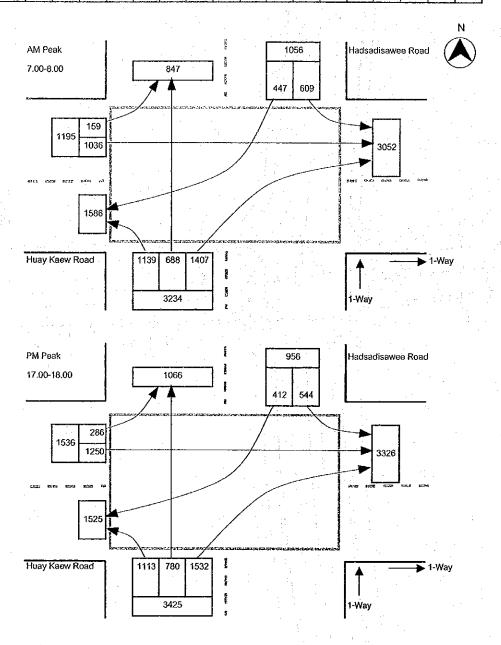
Peak Flow in PCU Intersecting Streets....Huay Kaew Road - Hadsadisawee Road Junction No. J12 from North approach from East approach from South approach from West approach punoqui Total Total Total Total Peak Periods То To То Τo From To То From To To То From To To To From Total South West East West South East West North South North North East East North West South AM: 7.00-8.00 609 1056 688 1407 447 1139 3234 1036 159 1195 5486 PM: 17.00-18.00 544 412 956 780 1113 1532 3425 1250 286 1536 5917

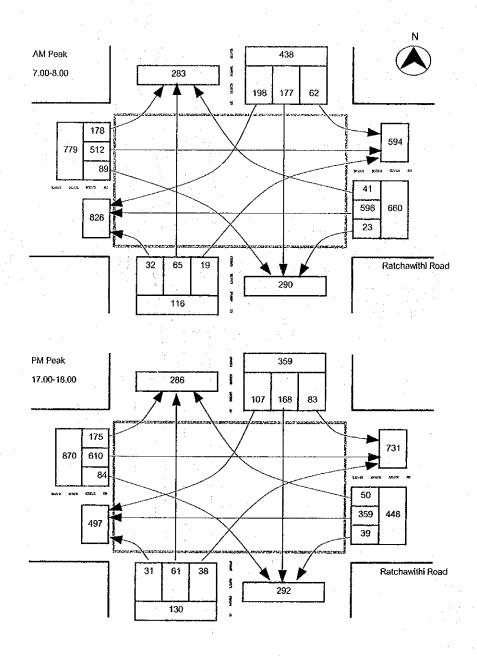
Peak Flow in F	Peak Flow in PCU				Junction No. J14				Ratchawithi Road-Ratchaphakhinai Road									
	from N	orth a	proacl	ch from East approach				from South approach					from V	<u> </u>				
	************			Total				Total				Total				Total	p F	
Peak Periods	То	То	To	From	То	То	То	From	To :	Ťο	То	From	То	То	То	From	Q i.	
	South	East	West	North	West	South	North	East	North	West	East	South	East	North	South	West	Total	
AM: 7.00-8.00	177	62	198	438	596	23	41	660	65	32	19	116	512	178	89	779	1993	
PM: 17.00-18.00	168	83	107	359	359	39	50	448	61	31	38	130	610	175	84	870	1807

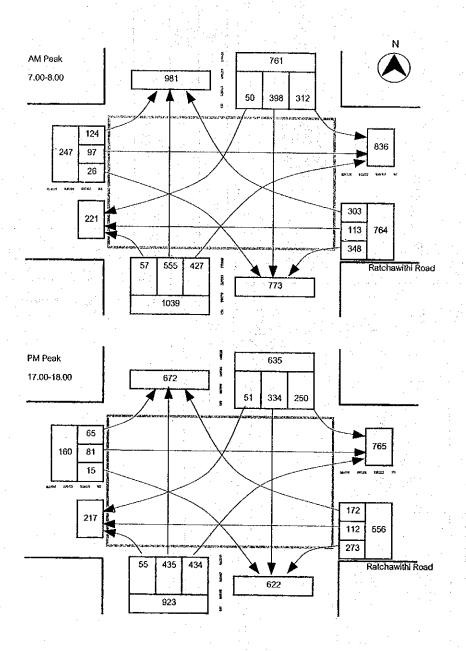
<u></u>	from N	lorth ap	proact	1	from E	ast app	oroach	100	from S	outh ap	proac	h	from V	Vest ap	proach		
			,	Total				Total				Total				Total	g
Peak Periods	То	То	То	From	То	То	То	From	То	To	To	From	То	То	То	From	inbo
	South	East	West	North	West	South	North	East	North	West	East	South	East	North	South	West	igi jg
AM: 7.00-8.00	398	312	50	761	113	348	303	764	555	57	427	1039	97	124	26	247	2810
PM: 17.00-18.00	334	250	51	635	112	273	172	556	435	55	434	923	81	65	15	160	2275

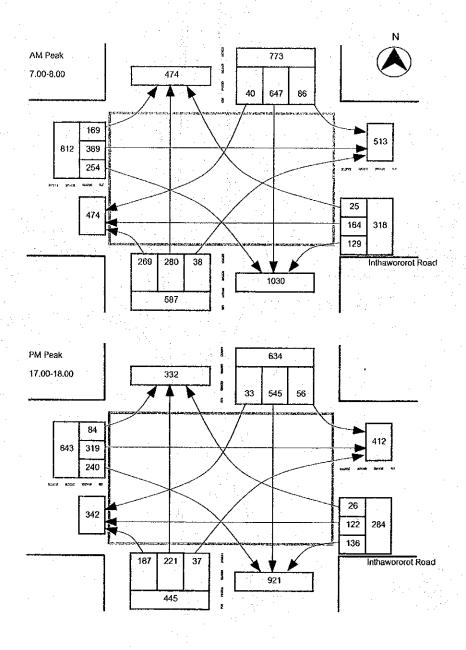
Peak Flow in F	Junct	Intersecting StreetsInthawororot Road - Singharat Ro									Road						
	from North approach				from East approach				from S	from South approach			from V	Vest ap	proach		
				Total				Total		******		Total		<u> </u>		Total	Ę
Peak Periods	То	То	Τo	From	Τo	То	То	From	To	To	To	From	То	То	To	From	inbour
	South	East	West	North	West	South	North	East	North	West	East	South	East	North	South	West	l ≂
AM: 7.00-8.00	647	86	40	773	164	129	25	318	280	269	38	587	389	169	254	812	2490
PM: 17.00-18.00	545	56	33	634	122	136	26	284	221	187	37	445	319	84	240	643	2007

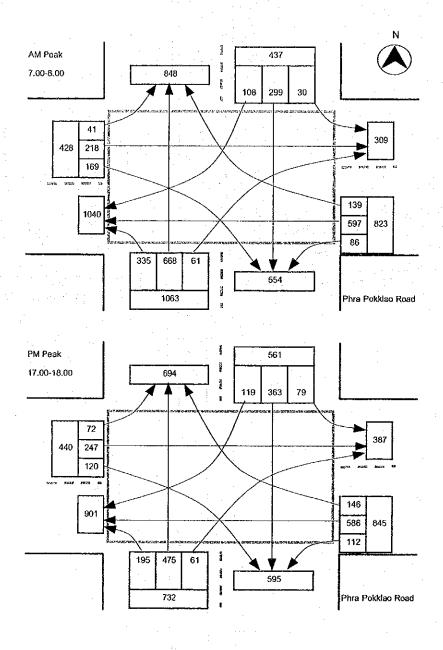
Peak Flow in PCU Junction No. J17 Intersecting Streets...Phra Sing Road - Phra Pokklao Road from North approach from East approach from South approach from West approach Total Tota! Total Total Peak Periods То From To From To From To To To То То From To To To To Total South East West North West West South North East North East South East North South West AM: 7,00-8.00 299 30 108 437 597 86 139 668 335 61 1063 823 218 169 428 41 2751 PM: 17.00-18.00 363 561 79 **1**19 586 112. 146 845 475 195 732 61 247 440 72 120 2577

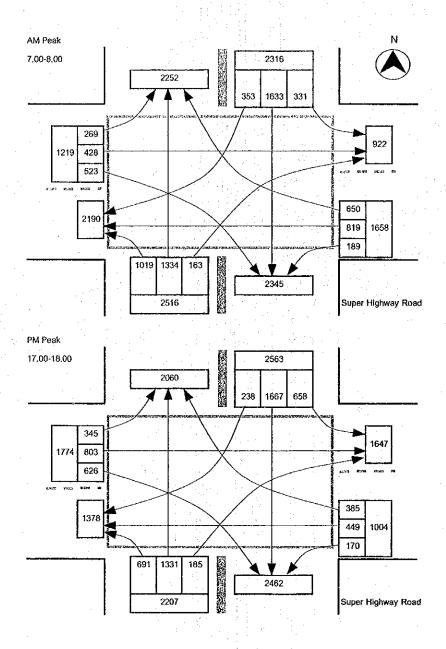
Peak Flow in PCU June					Junct	ion No. J18			Inters	ecting	Stree	lsS	uper l	lighw	ay - C	haroe	n Mua	ng R
	from North approach)	from East approach				from South approach				from West approach					
ľ					Total		<u> </u>		Total		1.		Total				Total	ğ
ĺ	Peak Periods	ĩο	Τo	То	From	То	То	To	From	То	То	To	From	To	To	To	From	inoqui
		South	East	West	North	West	South	North	East	North	West	East	South	East	North	South	West	Total Etal
,	AM: 7.00-8.00	1633	331	353	2316	819	189	650	1658	1334	1019	163	2516	428	269	523	1219	7709
1	PM: 17.00-18,00	1667	658	238	2563	449	170	385	1004	1331	691	185	2207	803	345	626	1774	7547

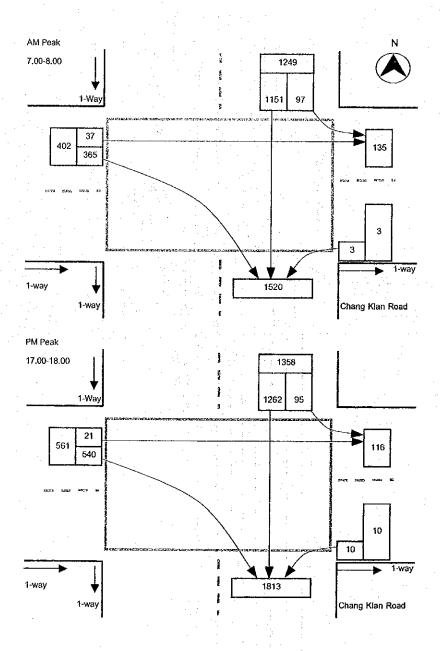
I GOV I TOW HILL	***************************************				r	,,,,,,,,,,,,,,,,,,,,,,,,,,,,,,,,,,,,,				secting StreetsChar							on Ro
···					from East approach				from South approach				from West approach				
				Totat				Total		: "		Total				Total	Ę
Peak Periods	То	То	То	From	То	Τo	To	From	То	То	То	From	To	То	То	From	inbo
4.	South	East	West	North	West	South	North	East	North	West	East	South	East	North	South	West	To Jan
AM: 7.00-8.00	1151	97	-	1249	-	3	-	3	-		-	-	37	-	365	402	1655
PM: 17.00-18.00	1262	95	-	1358	-	10	-	10			-	-	21	-	540	561	1929
