Chapter 6. Quick Reconstruction Support Project for Educational Facilities

6.1 Design Aims of Educational Facilities

6.2 Primary School Plans at Each Site

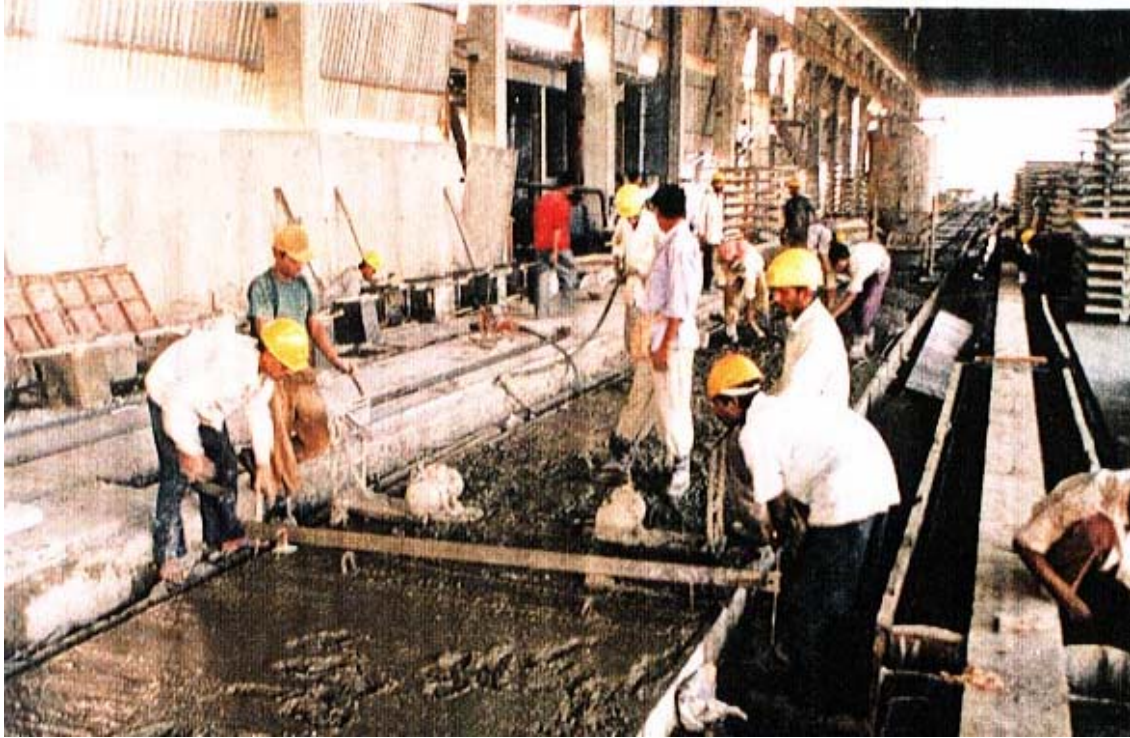
Vibrating In Progress Of Wall Panels as on 17/12/01

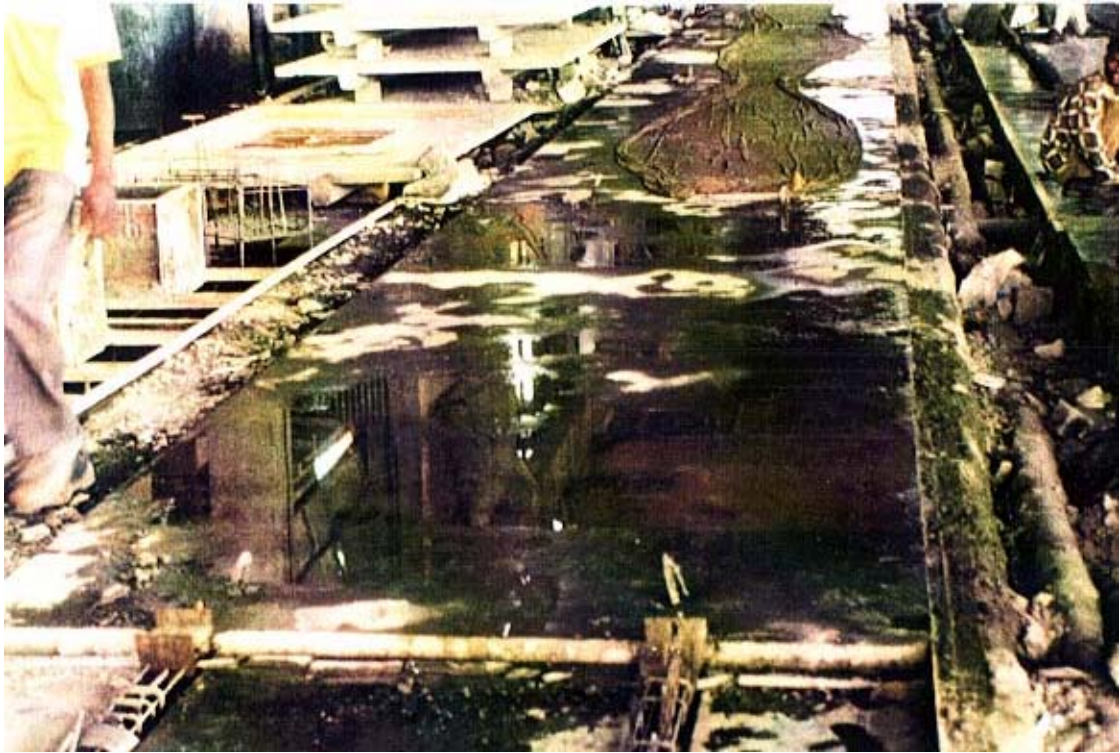
Curing In Progress Of Wall Panels as on 18/12/01

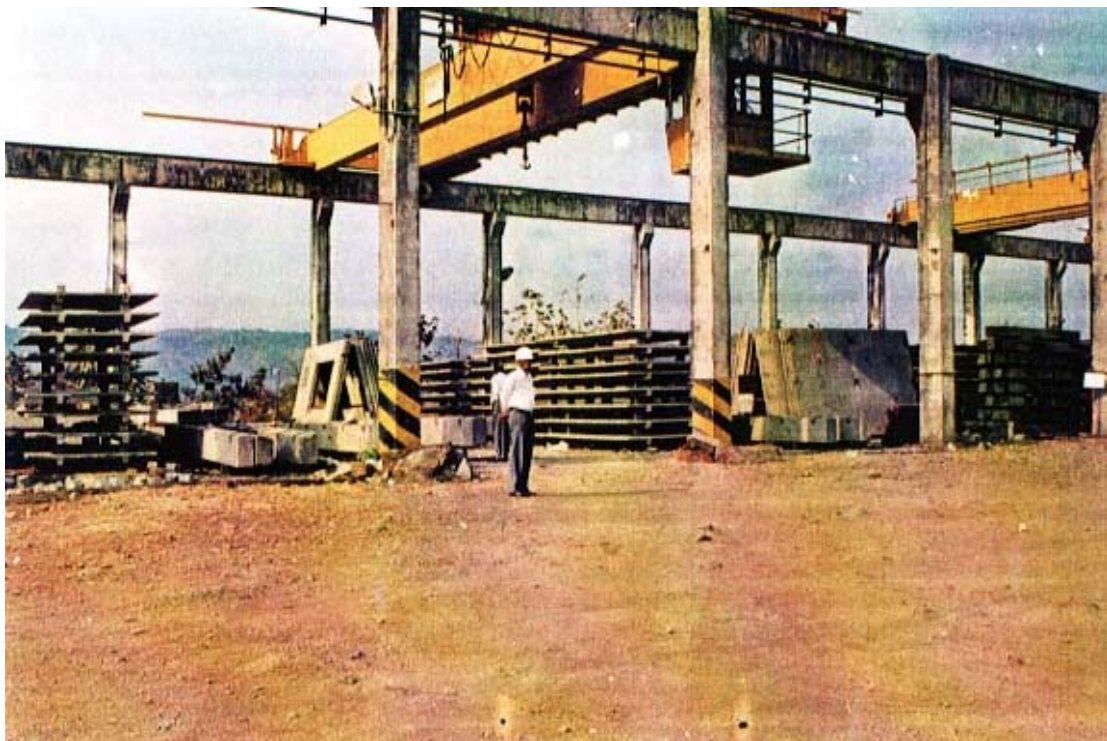
Stacking & Delivering Of Wall Panels as on 20/12/01

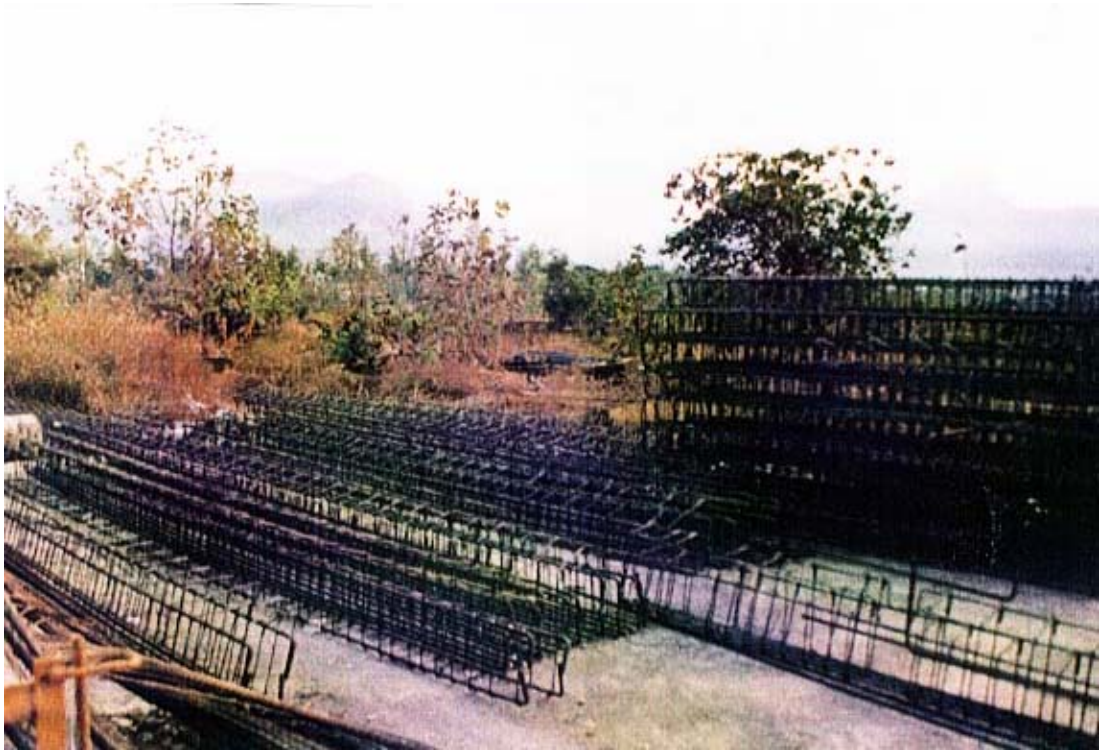
Beam Reinforcements as on 26/12/01

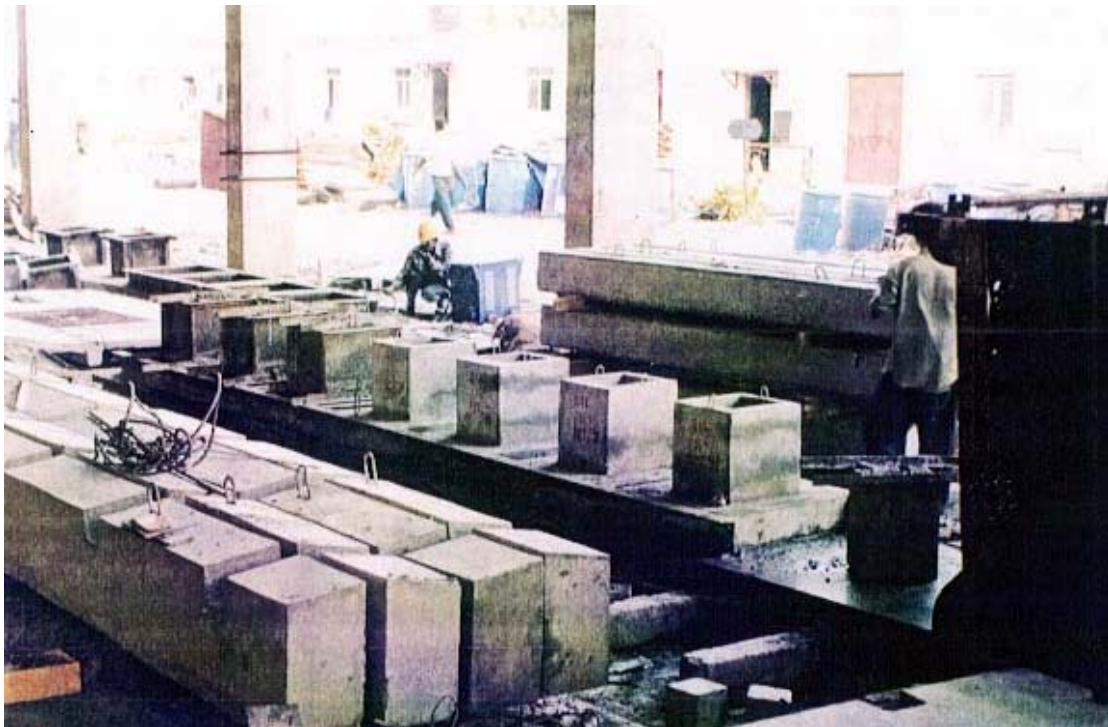
Finished Products: Beam, Footing & columns as on 30/12/01

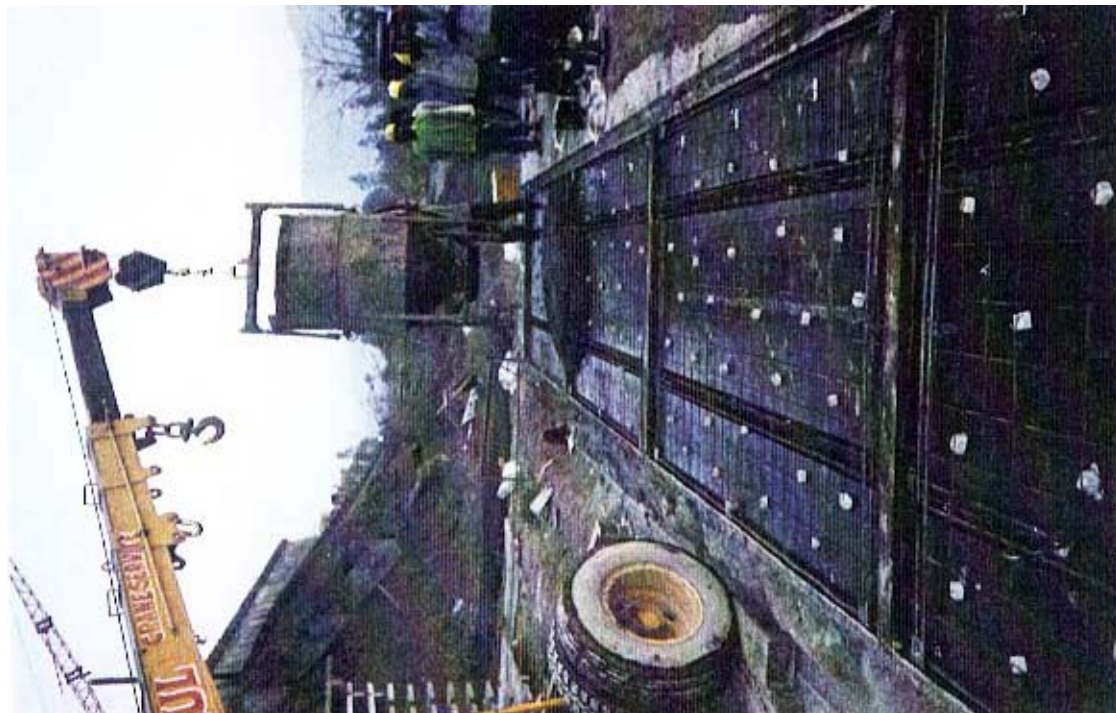
Concrete In Progress of Wall Panel as on 02/01/02, 03/01/02

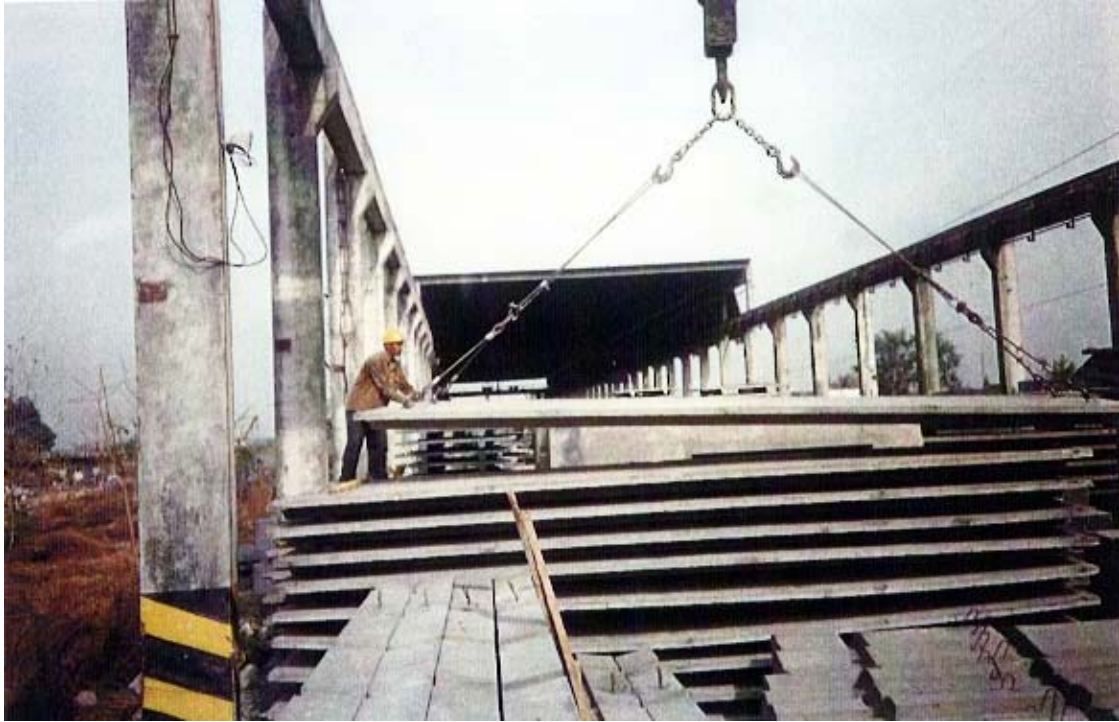
Stacking of Wall Panels 23/01/02

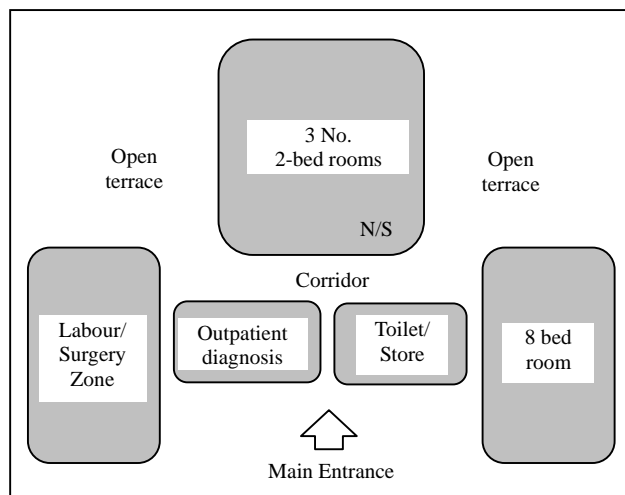
Fig. 7-6 Zone Plan

The building is planned to have one 8-bed ward, and three (3) special 2-bed rooms, with an out-patient diagnosis room and labour/surgery zone, and basically will have the same level of functions and facilities as the original maternity ward building. Fig. 7-5 shows the Zone Plan.

The new Maternity Building is planned to have almost the same floor area as the original, and with the same number of beds (14 no.).

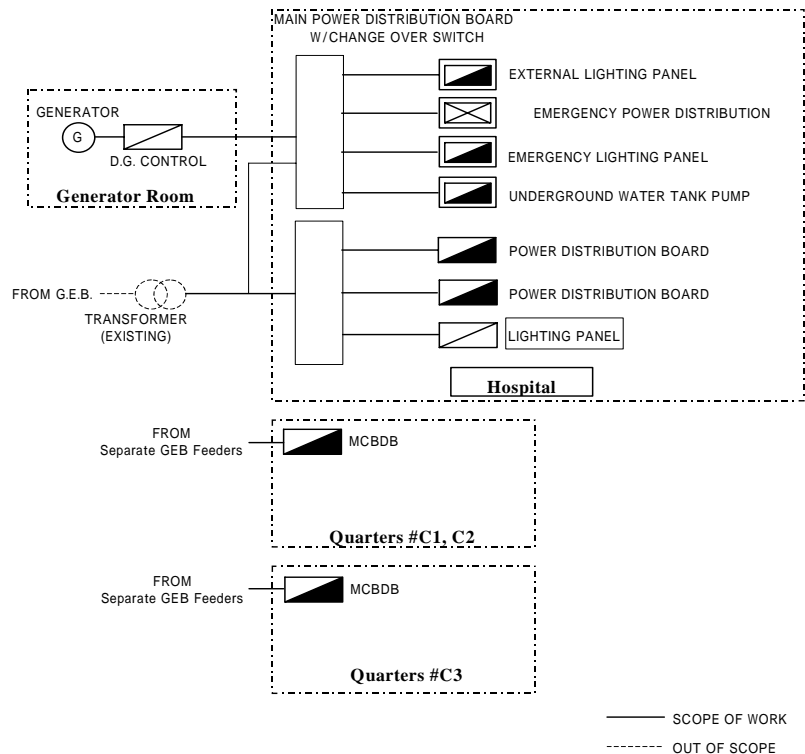
Fig. 7-6 Main Feeder Diagram for CHC Anjar

For the staff quarters, separate low voltage power supply feeder will be provided by the GEB to each staff quarters via their dedicated distribution board. For light sources, high-efficiency fluorescent lamps will be principally used as in the existing facilities, but white ball lamp also used for small rooms. Electrical outlets with 15/5A will be provided for each room and outlets with 15A specially used for air conditioners, water heaters and kitchen equipment in future extensions. The main Feeder Diagram is indicated in Fig.7-6.

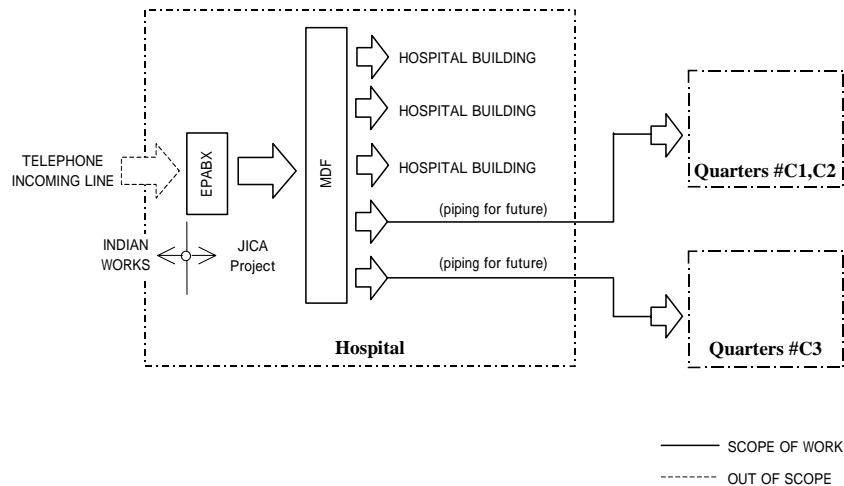
Fig. 7-7 Telephone System Diagram for CHC Anjar

The line capacity assumed to be required for CHC the facility is to be about 2 lines with 30 extensions, so a PABX system will be adopted, which is commonly used locally. The capacity of the PABX will be planned with 10 lines with 70 extensions in consideration of the future staff quarters. For the quarters, one telephone line for each quarter is to be considered for future provision. The telephone system diagram is indicated in Fig. 7-7.

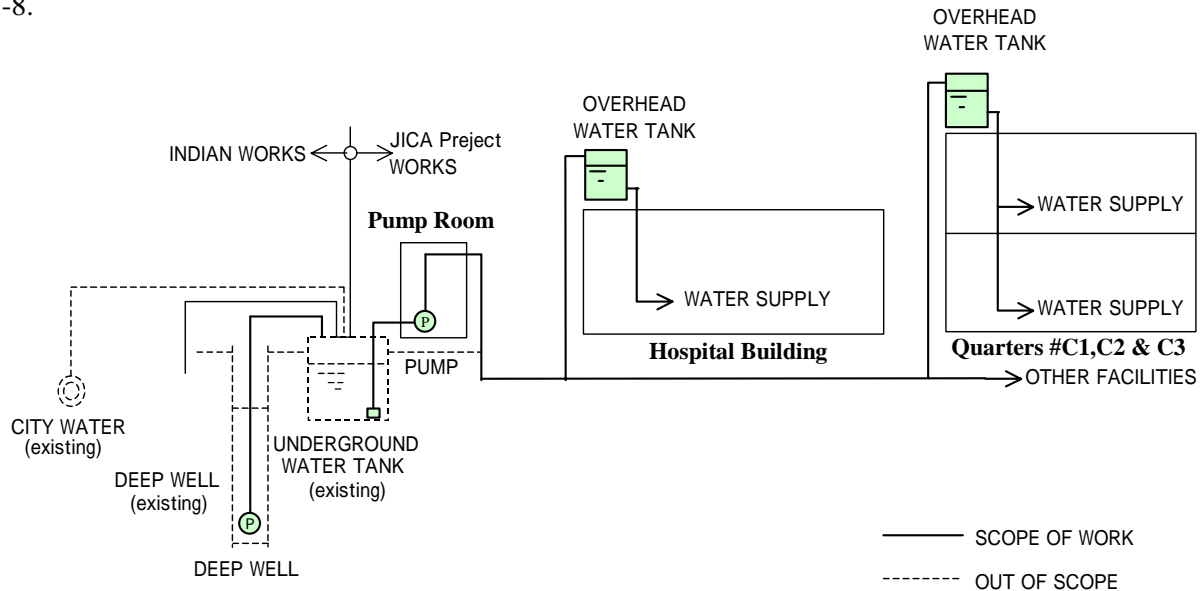
Fig. 7-8 Water Flow Diagram for CHC Anjar

Water from the existing deep well will be used mainly for the CHC facilities, the same as in the previous condition. Since a hospital is not operated without water, the city water will also be used to these facilities. One submersible pump and two water lift pumps will be provided, but the existing under-ground water tanks will be used for the QRS project. Three numbers of overhead water tanks made of plastic will be installed on the roof of the CHC building and the water will be supplied to the expected use point. Galvanized steel pipes, commonly used locally, will be adopted for the QRS project.

For the staff quarters, the water coming from the existing under-ground water tank will be supplied to the staff quarters. Overhead water tanks will be installed on the roof of each quarters and the water will be supplied to the expected use-points by gravity. The water flow diagram is indicated in Fig. 7-8.

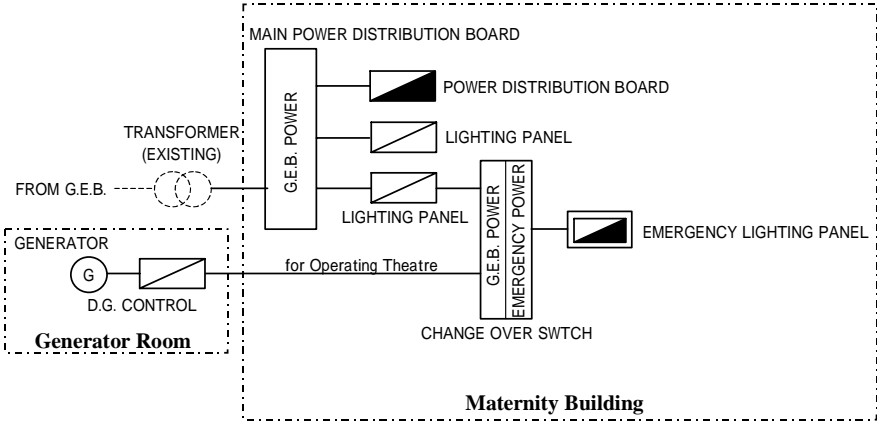
Low voltage power of 415V for the facility in this QRS project will be supplied from the GEB to the main electrical panel. The power will be supplied from the main panel located on the wall at the entrance to the expected lighting fixtures and outlets. In case the GEB power shut down, a diesel generator will be operated as emergency power in order to satisfy the minimum requirements for the CHC functions. The capacity of the generator is estimated at 4KVA. In case of power failures, generator power will be supplied manually to the required load such as for lighting fixtures for the operating theatre.

For light sources, high-efficiency fluorescent lamps will be principally used as in the existing facilities but white ball lamp also be used for small rooms. Emergency lights with batteries will be provided for the corridor and operating room in order to keep the minimum functions for a hospital. The main feeder diagram is indicated in Fig. 7-10.

Fig. 7-10 Main Feeder Diagram for CHC Mundra ——— SCOPE OF WORK
 - - - - - OUT OF SCOPE

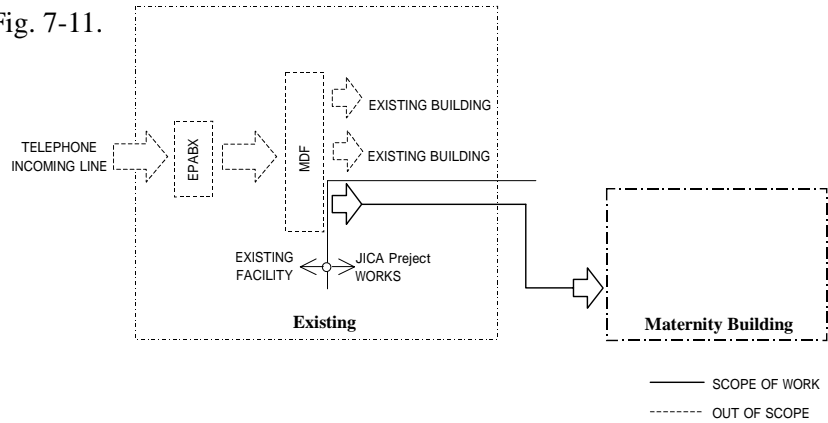
Fig. 7-11 Telephone System Diagram for CHC Mundra

Telephone sets will be provided in the room for the doctor, nurses, operating theatre and delivery. Telephone outlets will be prepared in the wards for future extension. The telephone system diagram is indicated in Fig. 7-11.
