### 3. DISASTER SCENARIO

#### 3.1 Earthquake

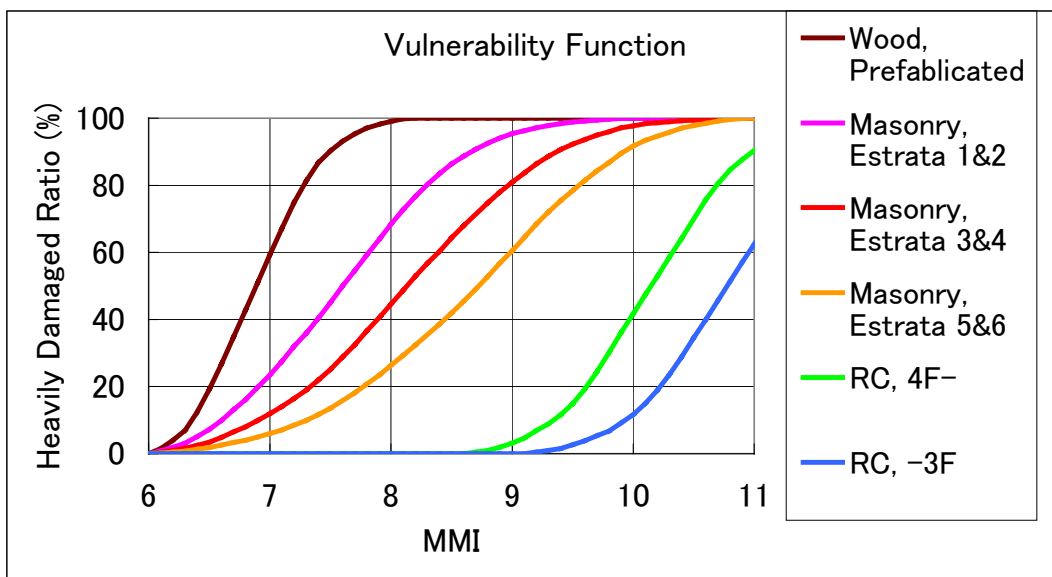
**Figure 8 Estimated Ratio of Heavily Damaged Buildings**

In order to establish damage functions for estimation of seismic damages corresponding to the scenario earthquakes, the studies on the building damages of the 1999 Quindio earthquake were referred to.

Damage function defined for each MMI as a discrete value is finally smoothed as shown in the following figure:

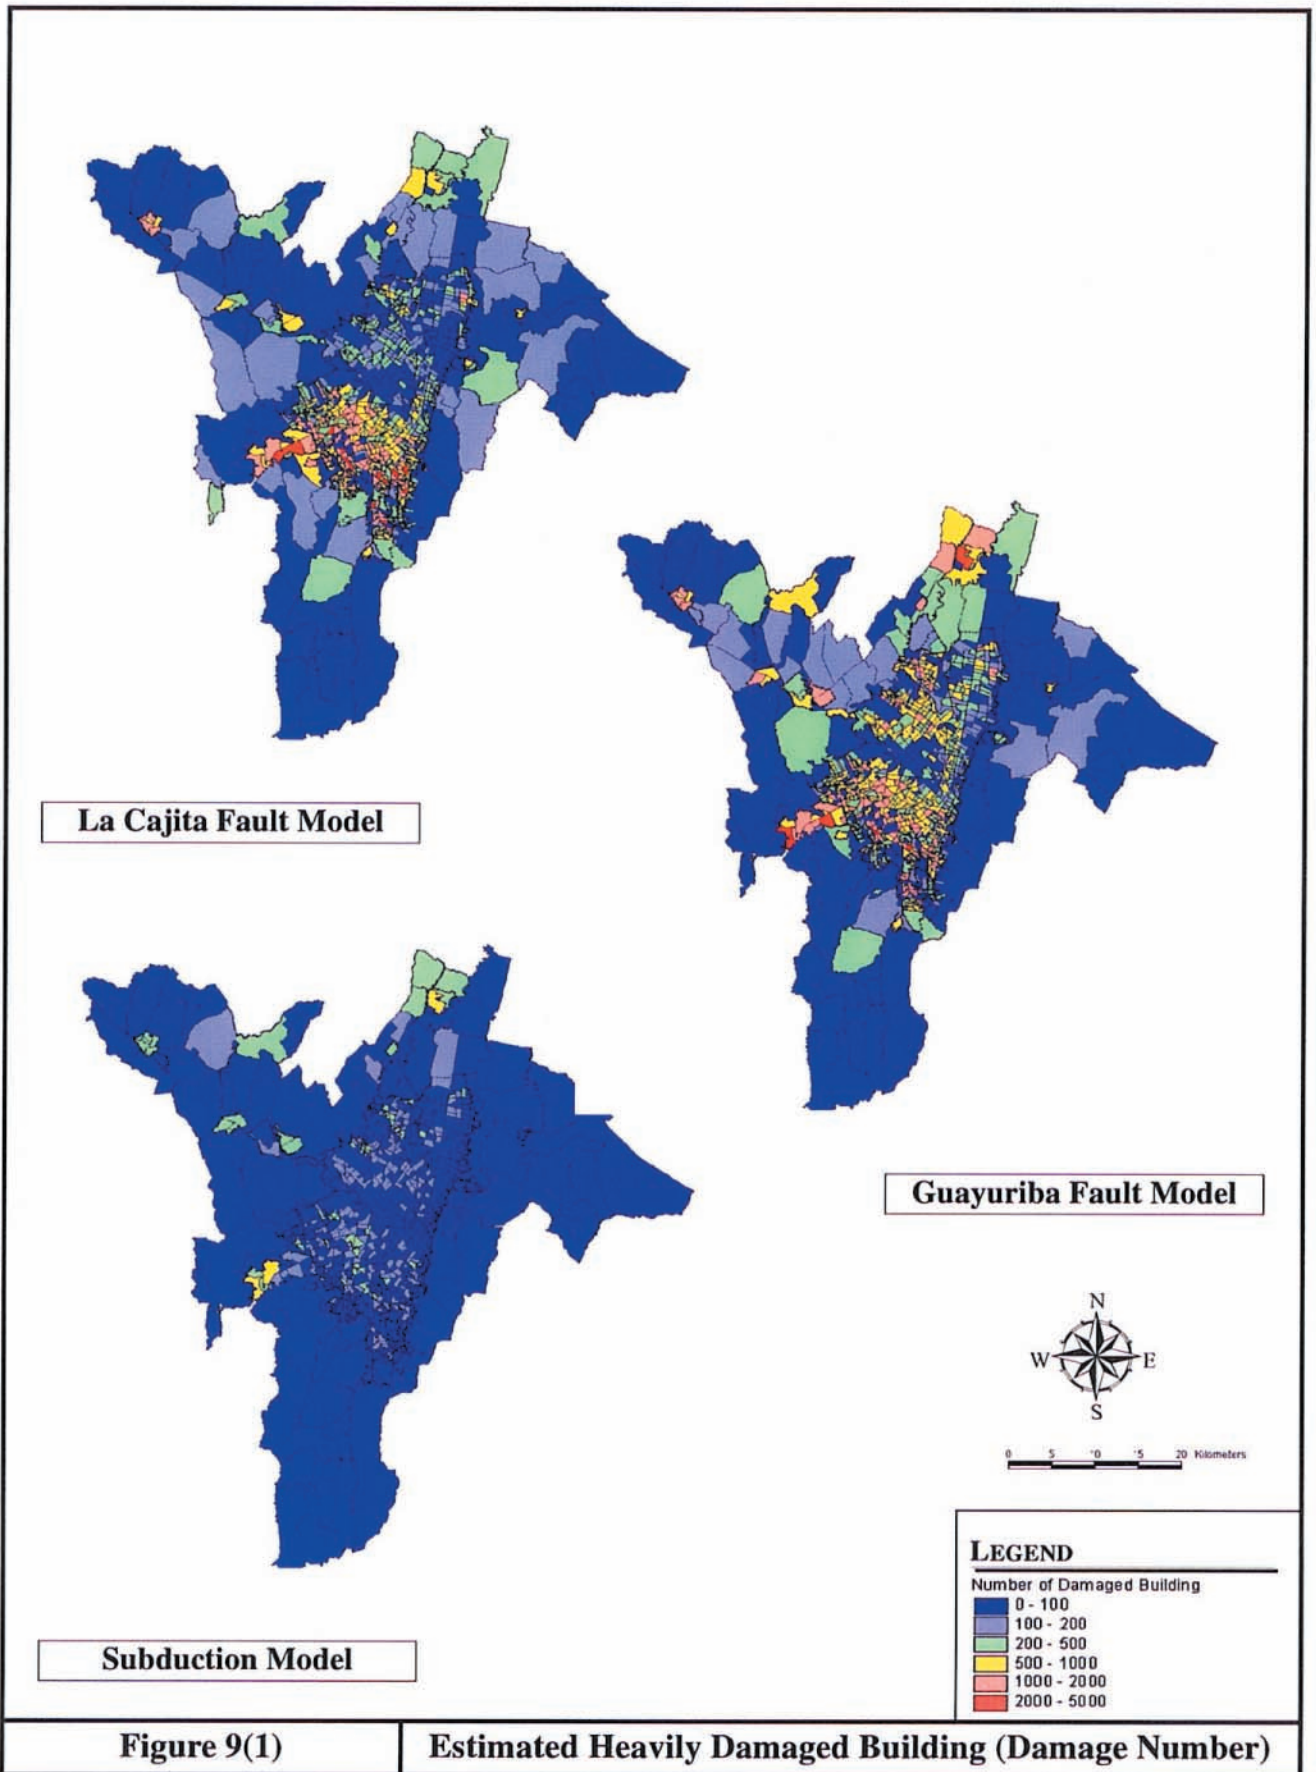
The results of heavily damaged buildings are shown in Figure 9(1) and (2).
