***Chapter 3***  
***Vulnerability Analysis***

### 3.1 Hazard Assessment

#### 3.1.1 Earthquake

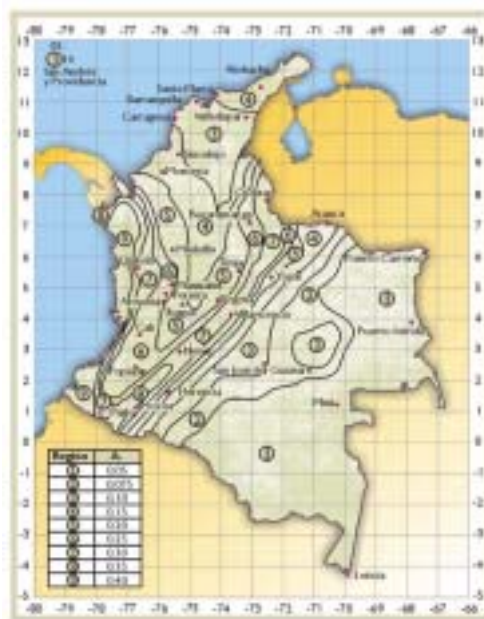
**Figure 3.1.1 Zones for Expected Maximum Acceleration in Colombia**

As the result, the territory of Colombian is categorized into nine zones according to the expected maximum acceleration (Aa) and shown in Figure 3.1.1. The potential of seismic hazards in the Study Area is categorized in the medium level zone and the Aa and Ad values of the city and municipalities are shown in the following Table 3.1.1.

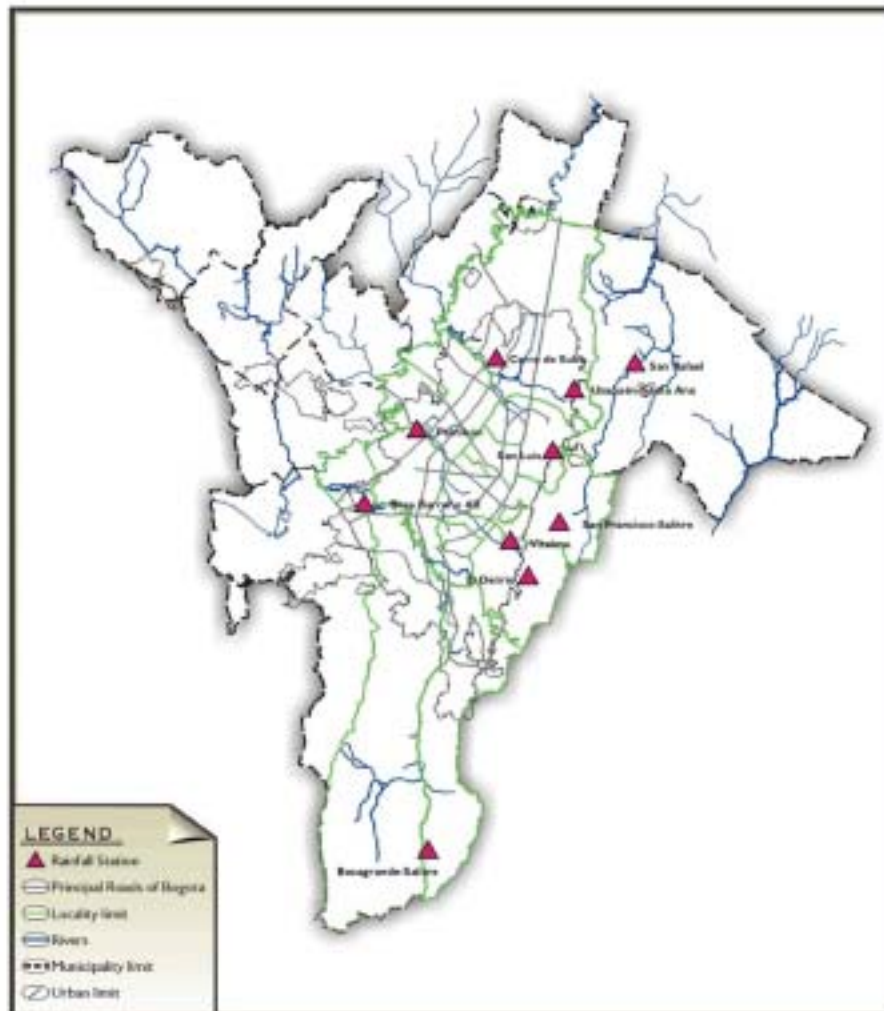
**Figure 3.1.4 Location of Rainfall Station Analyzed**

Among many rainfall gauging stations, with the consideration of distribution and observation period, ten stations of EAAB were selected for analysis of rainfall characteristics (Locations, see Figure 3.1.4.). As for the analysis, one-day rainfall data for these stations were collected.

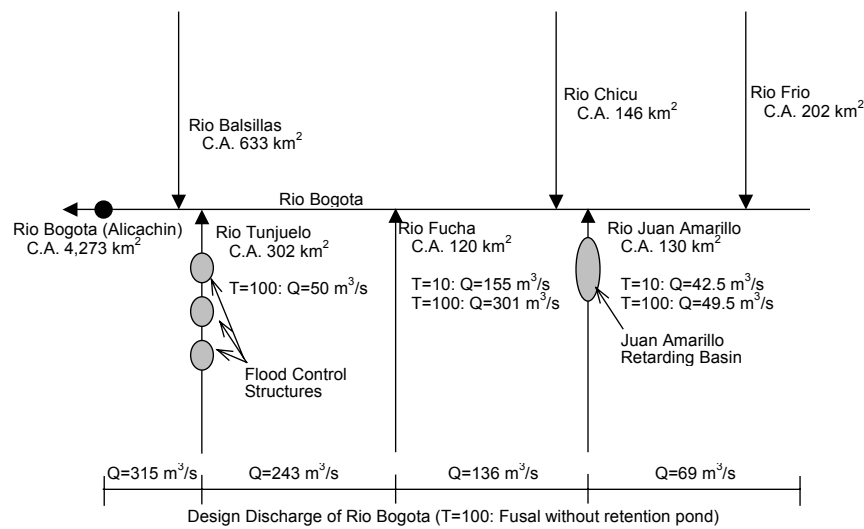
**Figure 3.1.5 Flood Run-off Discharge Distribution (Rio Bogotá System)**

Figure 3.1.5 shows the flood run-off discharge distribution of the Rio Bogotá system in the Study Area. The figure was prepared by combining the several information obtained from the reports

prepared by EAAB and DPAE, because there are no hydrological and discharge analysis which is targeted to the whole river system of the Rio Bogotá.

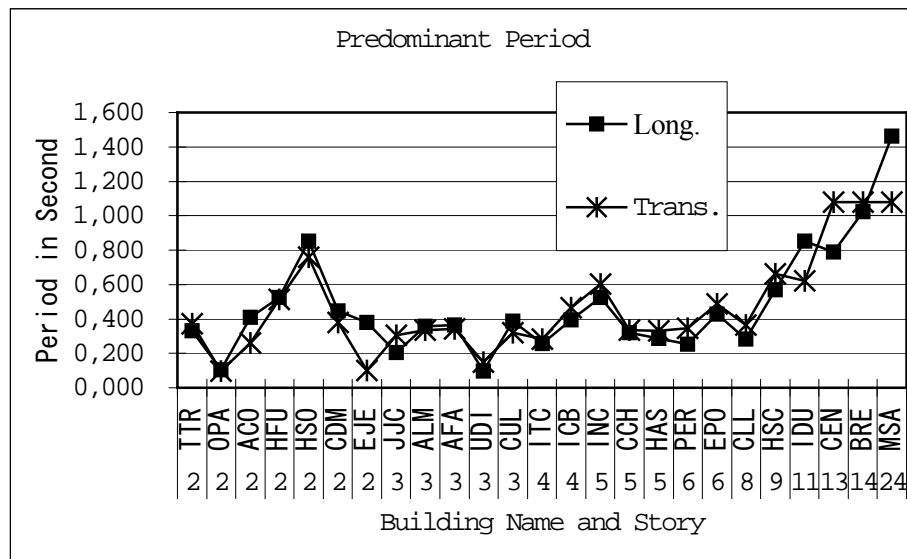
**Figure 3.2.3 Predominant Period**

- Measured vibration periods of 25 buildings are shown in the Figure 3.2.3 below.

From this figure, it is pointed out that 1) There are no general tendencies of the predominant periods of low-rise buildings, lower than 10 stories and that 2) However, predominant periods of high-rise buildings, higher than 10 stories, are proportional to the number of story.

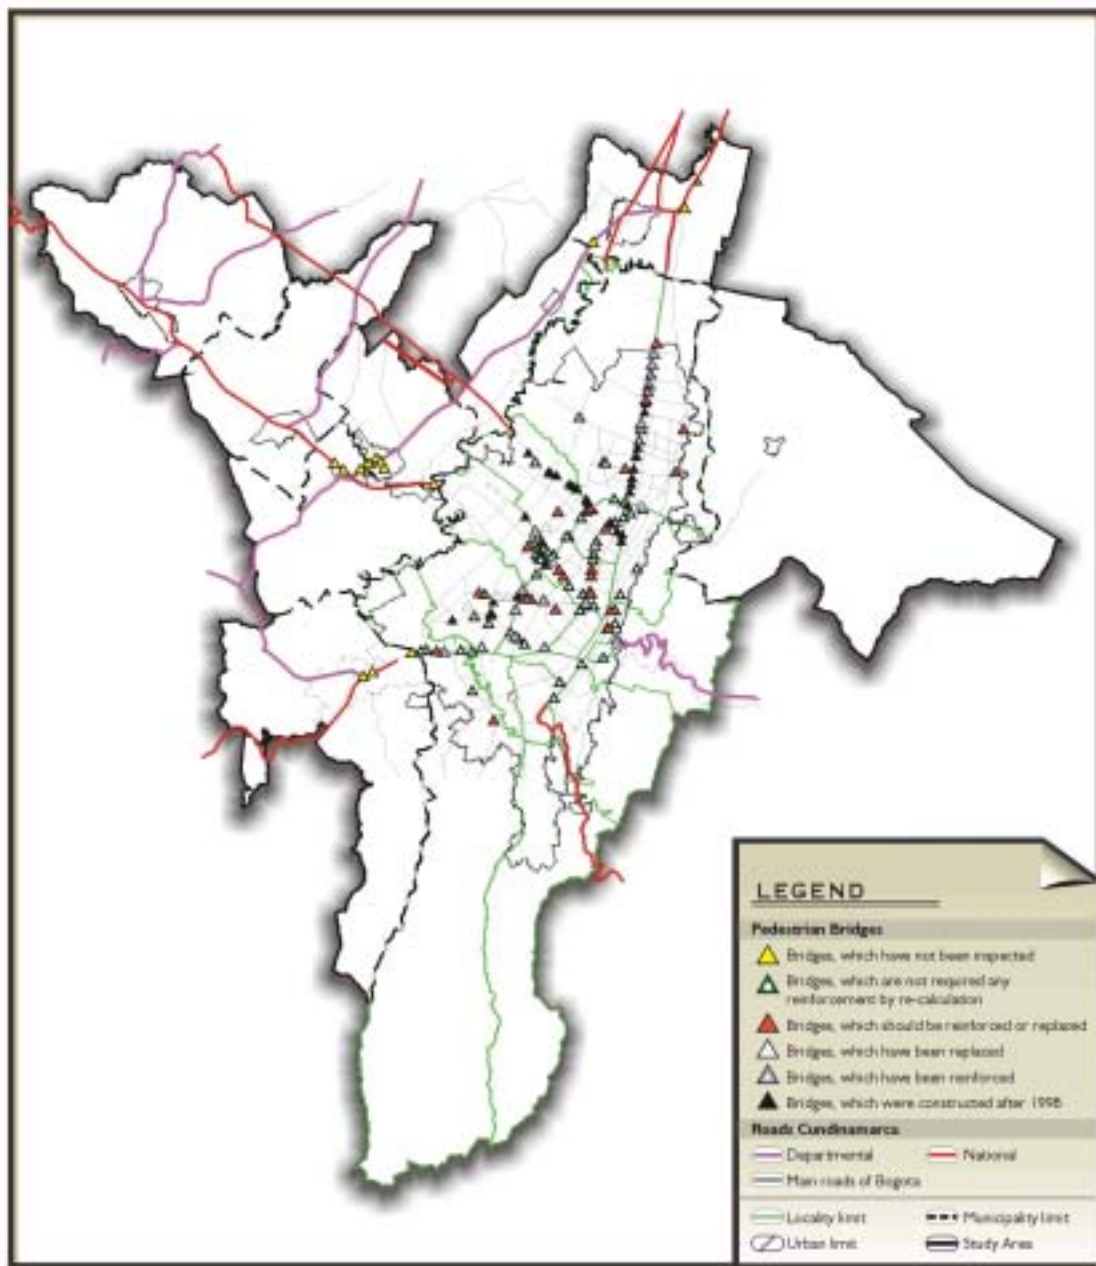
**Figure 3.2.7 Pedestrian Bridge Situation according to IDU Investigation 1998**

All pedestrian bridges in Bogotá have been investigated by IDU in 1998. Earthquake-resistance of all bridge was re-calculated according to proposed ground acceleration of micro-zoning study 1998. A scheme of reinforcement and replacement of pedestrian bridges is on going currently. Figure 3.2.7 shows the current situation of pedestrian bridges according to the result of investigation 1998.

The investigation is appropriate for super structure. However, detail information on foundation and liquefaction is not available during the inspection. Therefore, IDU intends to investigate foundation of all of pedestrian bridges.

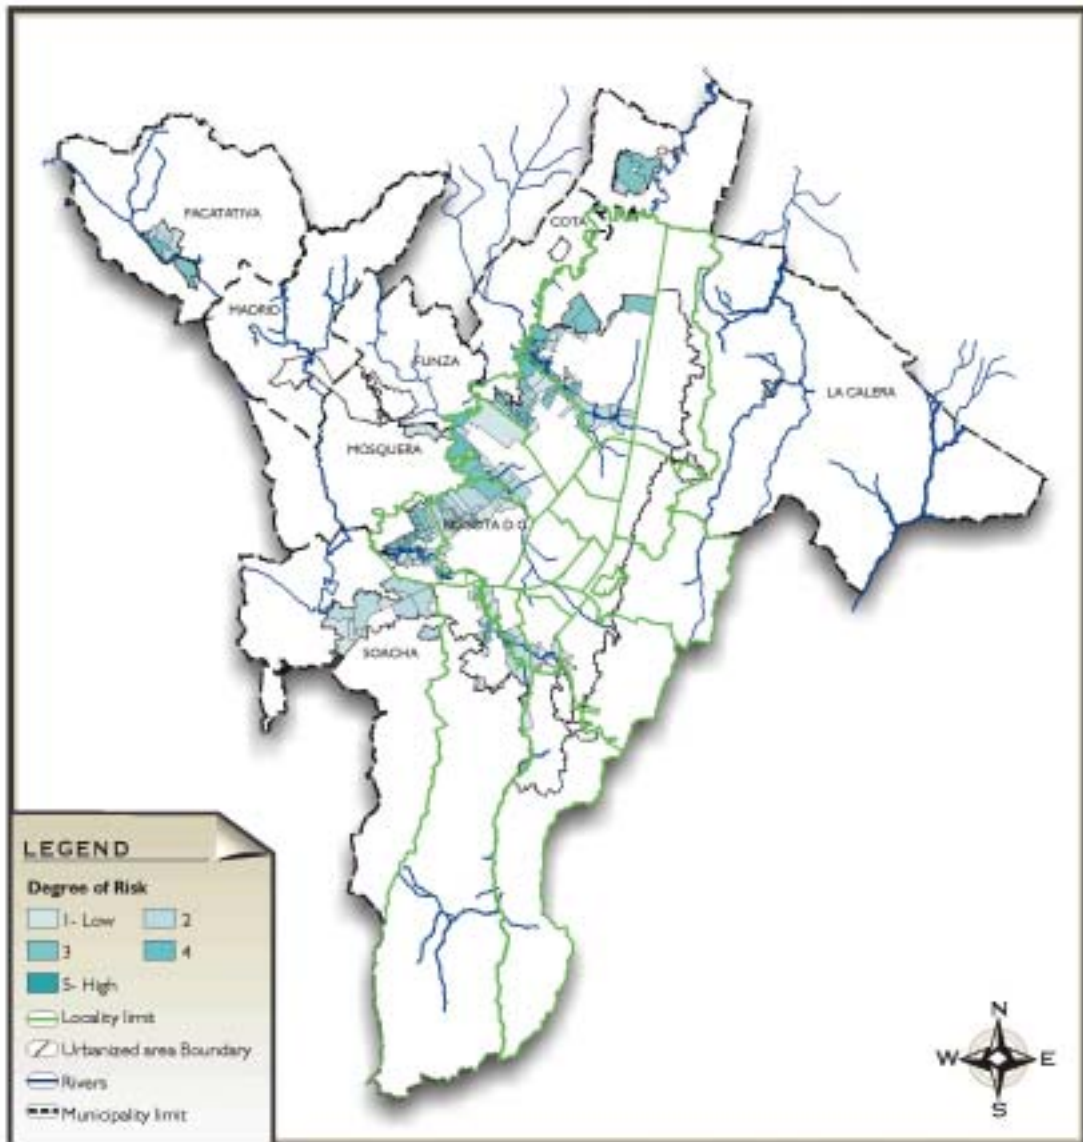
Figure 3.3.4 Degree of Regional Risk for Flood

Figure 3.3.4 shows the result of risk analysis of flood. In this figure, it is clear that all the area near the Rio Bogotá has to consider flood measures; however, the north western part of Bogotá has higher risk as shown by the analysis.
