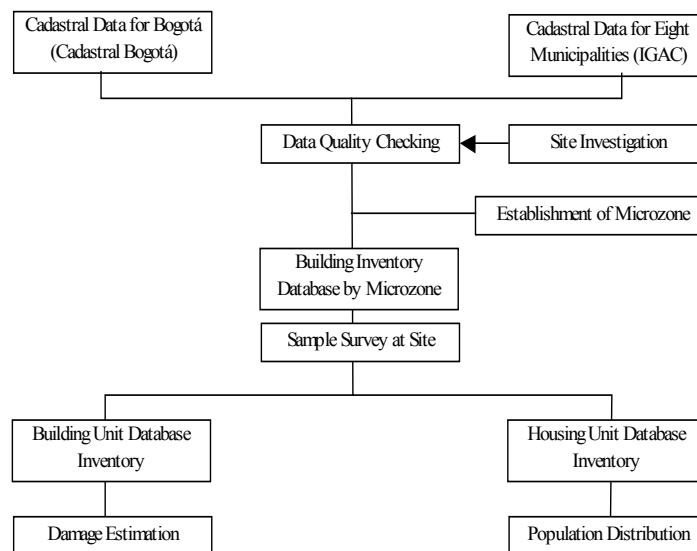
Figure 4.2.12 Building and Housing Unit Database Construction Process

In this study, the building inventory database was prepared based on 2000 cadastral data. In Bogotá City, cadastral data are collected at the Bogotá cadastral office, while Cundinamarca data are prepared by IGAC office, which is the agency responsible for cadastral data collection in Cundinamarca. The flow chart of database preparation is shown in the following Figure 4.2.12.

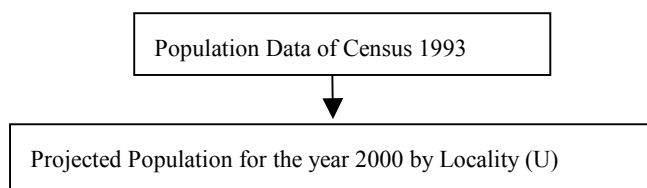
1. Population Projection

2. Housing Units Estimation

3. Population Estimation by Microzone

Figure 4.2.13 Population Projection Procedure

This factor was used to determine the population in each microzone. The process is schematically shown in the next page.

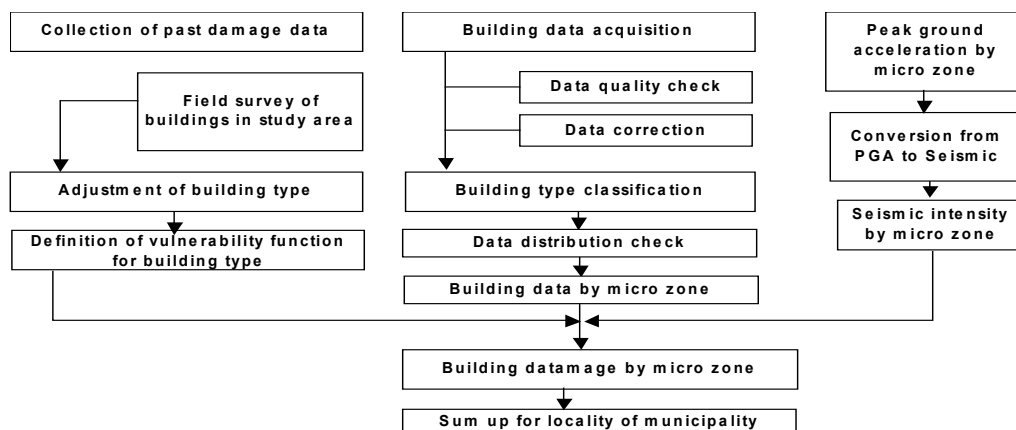
Figure 4.2.14 Flowchart of Building Damage Estimation

Flowchart of the building damage estimation is shown in Figure 4.2.14.

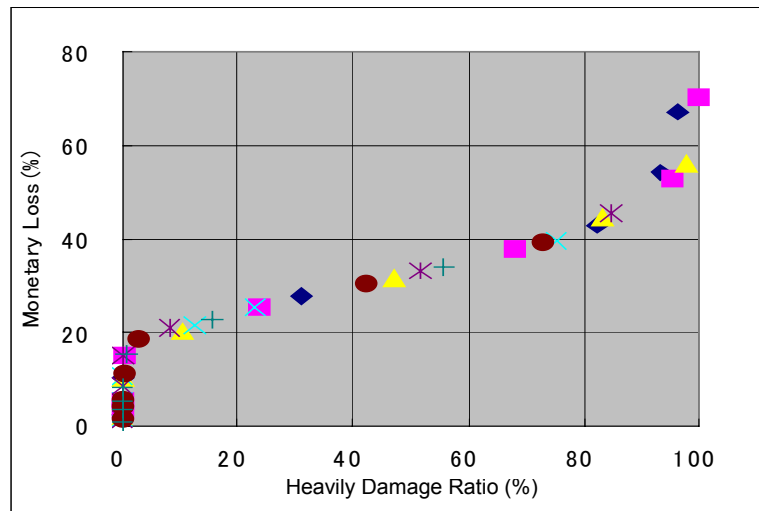
Figure 4.2.15 Relation between Masonry and Heavily Damaged Ratio

Therefore, this study defines “heavily damaged building” as a building with a state of damage severer than “Serious,” i.e. damaged building to be demolished rather than to be repaired. Monetary loss as defined in ATC-13 and physical damage can be converted as shown in Figure 4.2.15. “Heavily (severely) damaged ratio” versus seismic intensity of the building is defined as shown Figure 4.2.16.

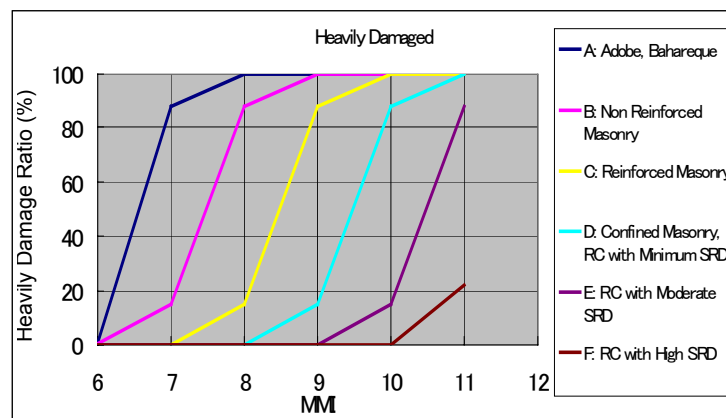
Figure 4.2.16 Heavily Damaged Structures in Quindío Earthquake referred from Figure 3.2.4

Among the heavily damaged buildings for all the types of structures in the 1999 Quindío earthquake, 84% had floors less than three, while buildings higher than 10 floors have a percentage of 0.4%. Though the ratio of RC frame buildings in this statistics is unknown, the damage ratio for type E and type F in Figure 4.2.16 would show the damages of RC buildings with lower stories.

The damage ratio for type F as shown in Figure 4.2.16 is almost the same as that for RC frame structures in general in California. However, few buildings would exist in affected areas having equal quality as that in California. Therefore, type E is taken for setting standard damage function.

In cadastral data, RC frame building is classified into two categories: 3 stories and up and under 3 stories. In general, higher storied buildings are more likely to suffer damage. Damage function for type E shows average damage ratio for RC frame structures. Damage function for type F is defined so that damage ratio is 30% higher on the average, since the difference in damage ratio between E and F is 20% at MMI X and 60% at MMI XI.

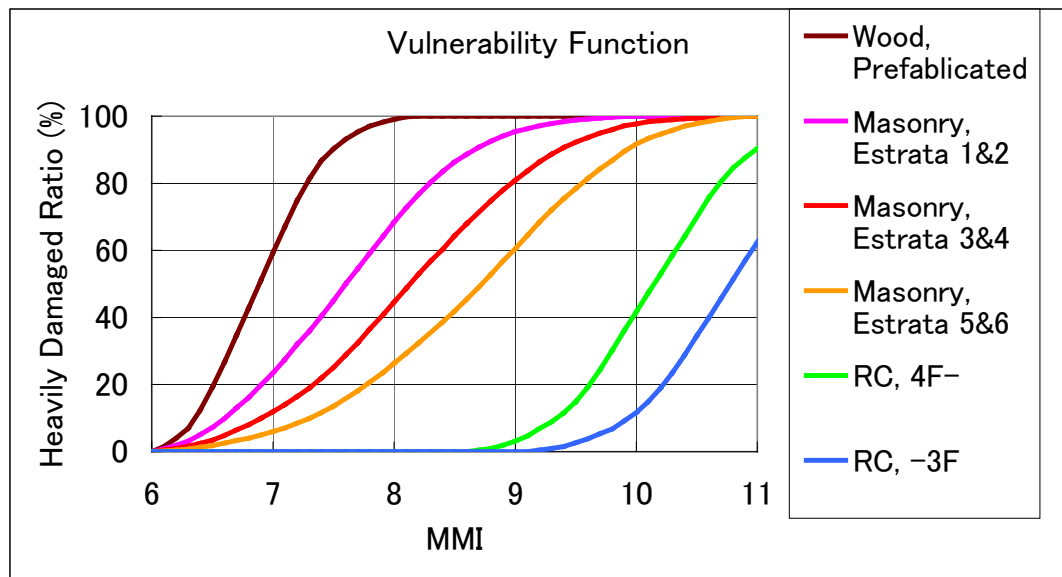
Figure 4.2.17 Proposed Heavily Damaged Ratio of Buildings

Damage function defined for each MMI as a discrete value is finally smoothed out as shown in Figure 4.2.17, because damage ratio should vary continuously according to the seismic intensity that varies continuously as well.
