**THE STUDY ON STORM WATER DRAINAGE PLAN
FOR THE COLOMBO METROPOLITAN REGION
IN
THE DEMOCRATIC SOCIALIST REPUBLIC OF SRI LANKA**

FINAL REPORT

VOLUME III : SUPPORTING REPORT (1)

ANNEX 7 : OUTFALL TREATMENT

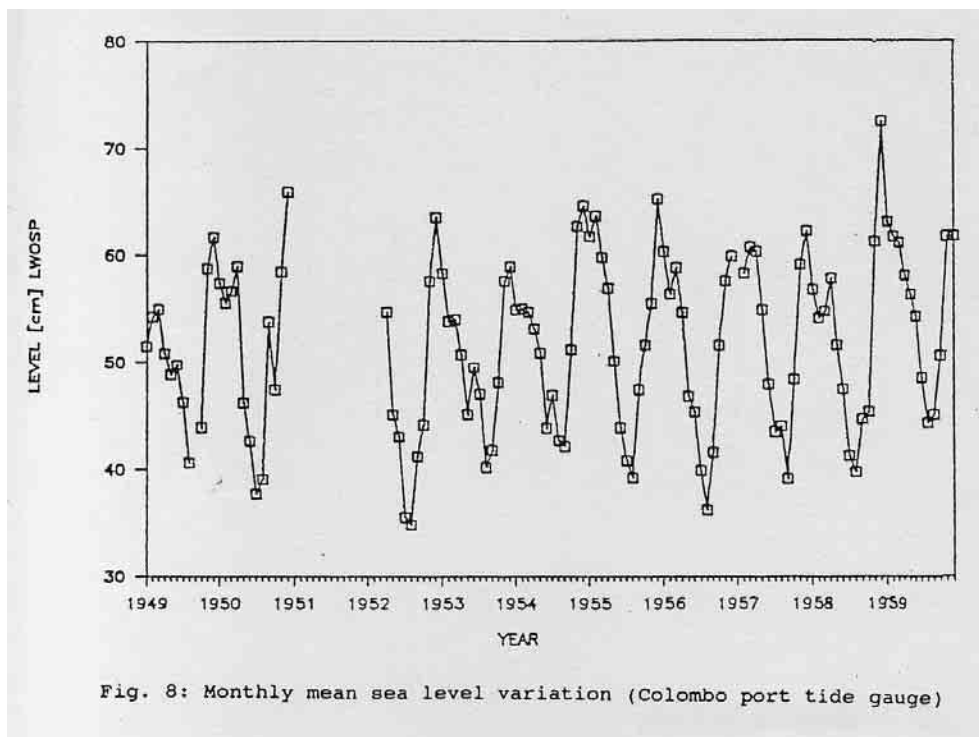
Figure 1.1.3
Tidal Records at Dehiwala and Colombo Port

Tidal Record at Offshore of Dehiwala

Fig. 8: Monthly mean sea level variation (Colombo port tide gauge)

Tidal Record at Colombo Port

An example of offshore tide level was measured at Dehiwala as shown in Figure 1.1.3. (Ref /9/, 2000)

Regarding the seasonal sea level change, the maximum storm causes a high level of about 0.3 m above MSL during a northeast monsoon and a low level of about 0.2 m below MSL during a southwest monsoon (Figure 1.1.3, Ref/6/, 1997). And regarding the long term tendency, the present average annual mean sea level is +0.53m LWOST. That indicates a sea level rise of about 10cm for the last 100 years. (Ref/12/, 2000)
