2.3 Water Sources and Water Quality

2.3.1 Groundwater Sources and Quality

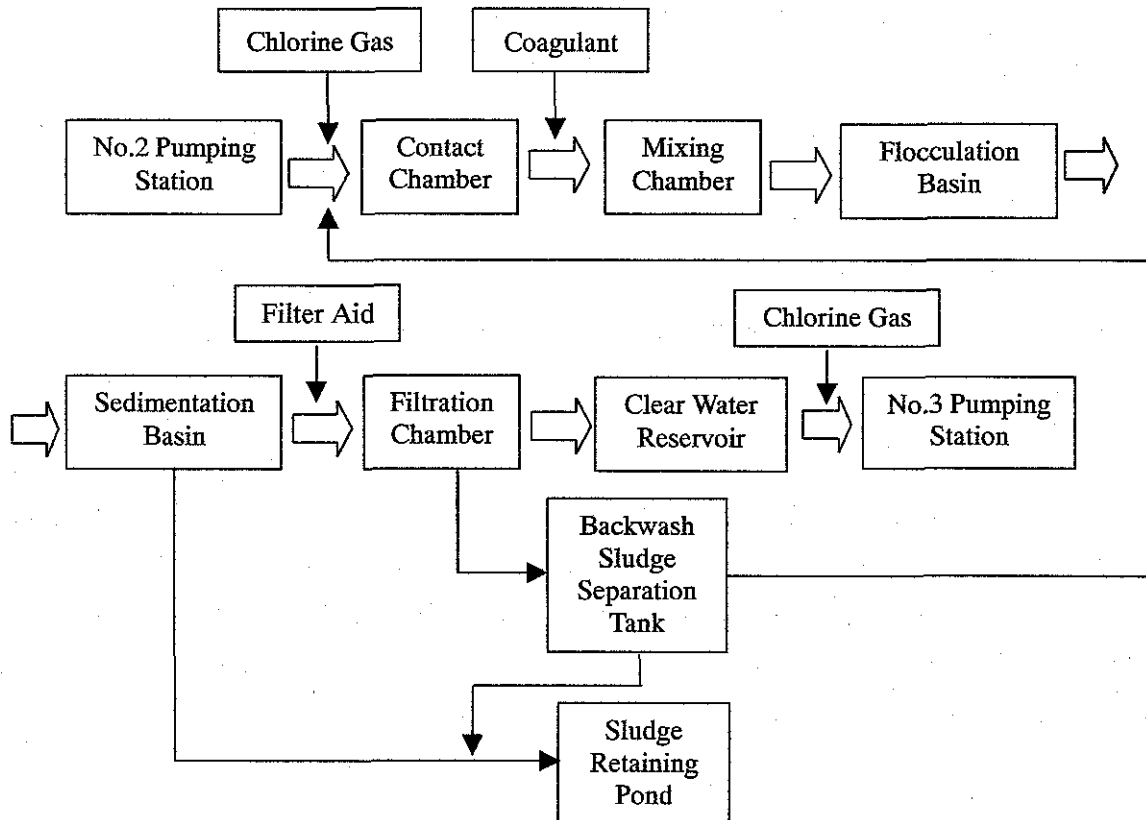
The following figure shows flow diagram of water treatment process.

Chlorine is injected to the raw water transmitted from the PS-2 before the water enters the contact chamber. The coagulant, aluminum sulfite $Al_2(SO_4)_3$, is also injected before the mixer where the coagulation proceeds.
