Chapter 4 Hydrogeology

THE STUDY ON COMPREHENSIVE GROUNDWATER RESOURCES DEVELOPMENT

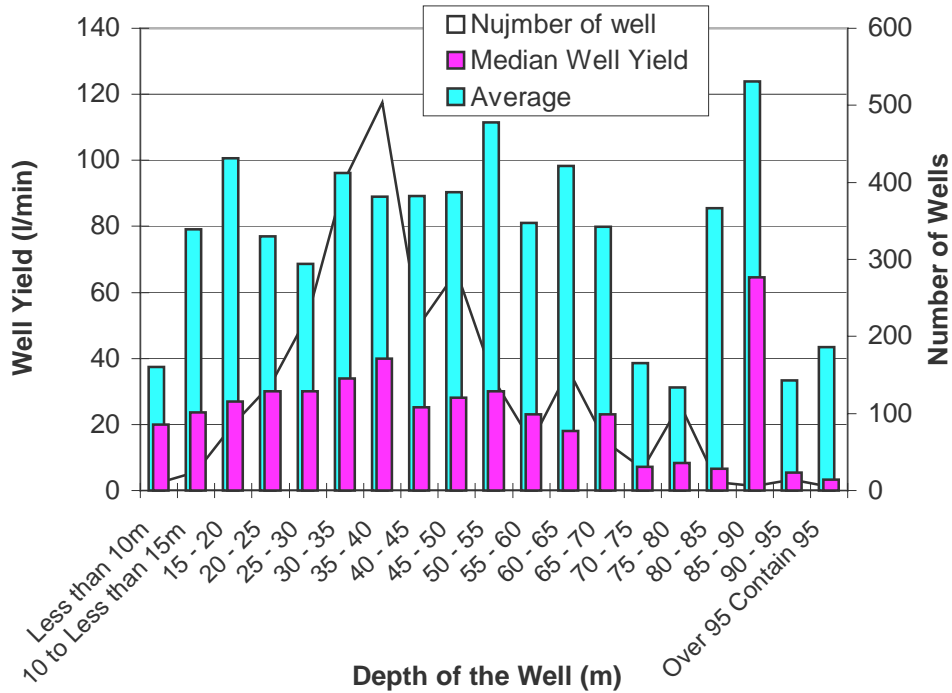
Figure 4.2 Relationship between Average of Well Yield and Well Depth

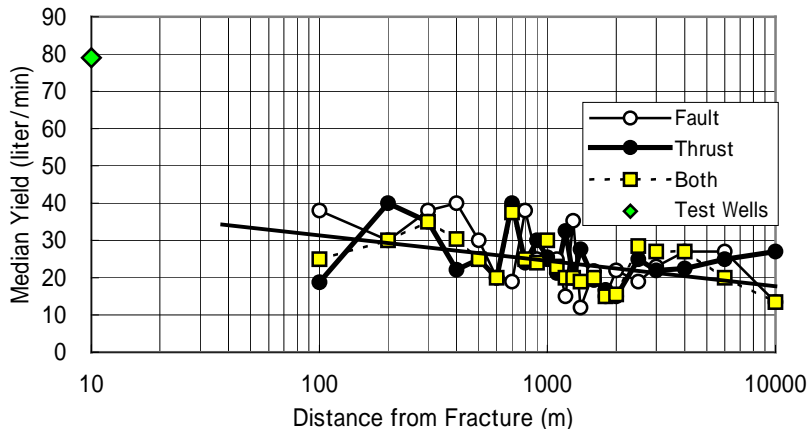
Figure 4.8 Relation between Yield and Distance from the Fracture

- The distance between an existing well and the nearby fault or thrust/shear zone shown in the 1:100,000 geological map issued by GSMB was calculated using GIS. *Figure 4.8* seems to indicate that a well nearer to the fault or thrust/shear zone yields a little more than a distant well.

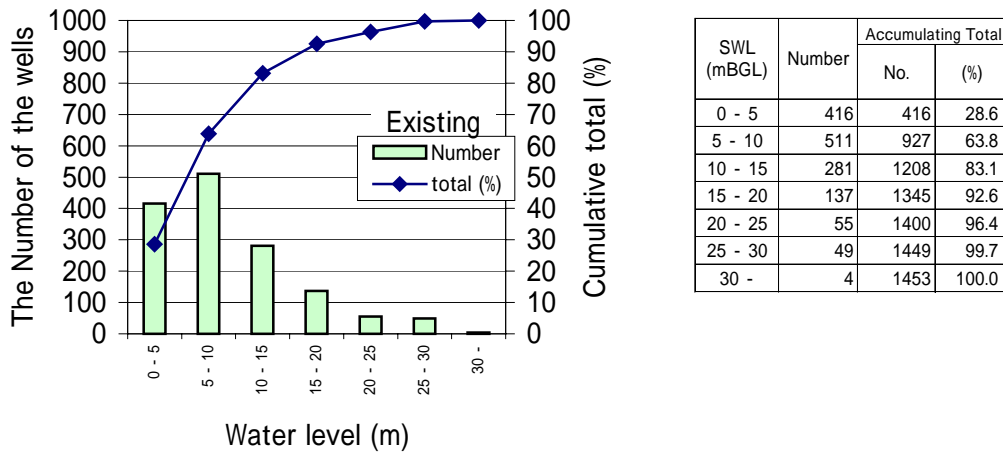
Figure 4.10 Number of wells and water level; Upper fractured aquifer

The number of wells and the depth to water surface of the upper fractured aquifer are graphed below. 63.8 % of the water levels are 10 m or above in depth and 28.8 % between 10 and 20 m in depth. Consequently 92.6 % of the water level is 20 m or above in depth.

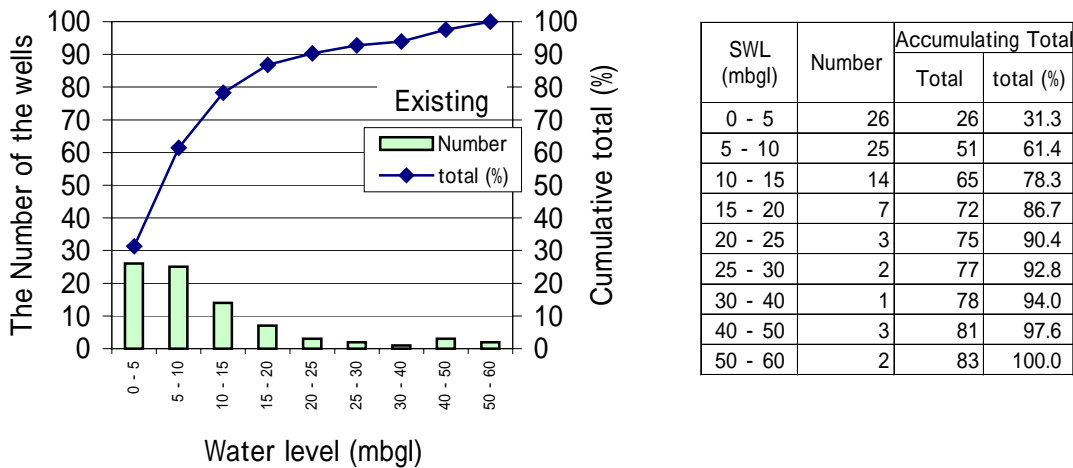
Figure 4.12 Number of wells and water level; Lower fractured aquifer

The number of wells and the depth to water surface of the lower fractured aquifer are graphed below, *Figure 4.12*. 86.7 % of the water level is 20 m or above in depth. The number of wells with the water level 40 m or below is 6.0 %.

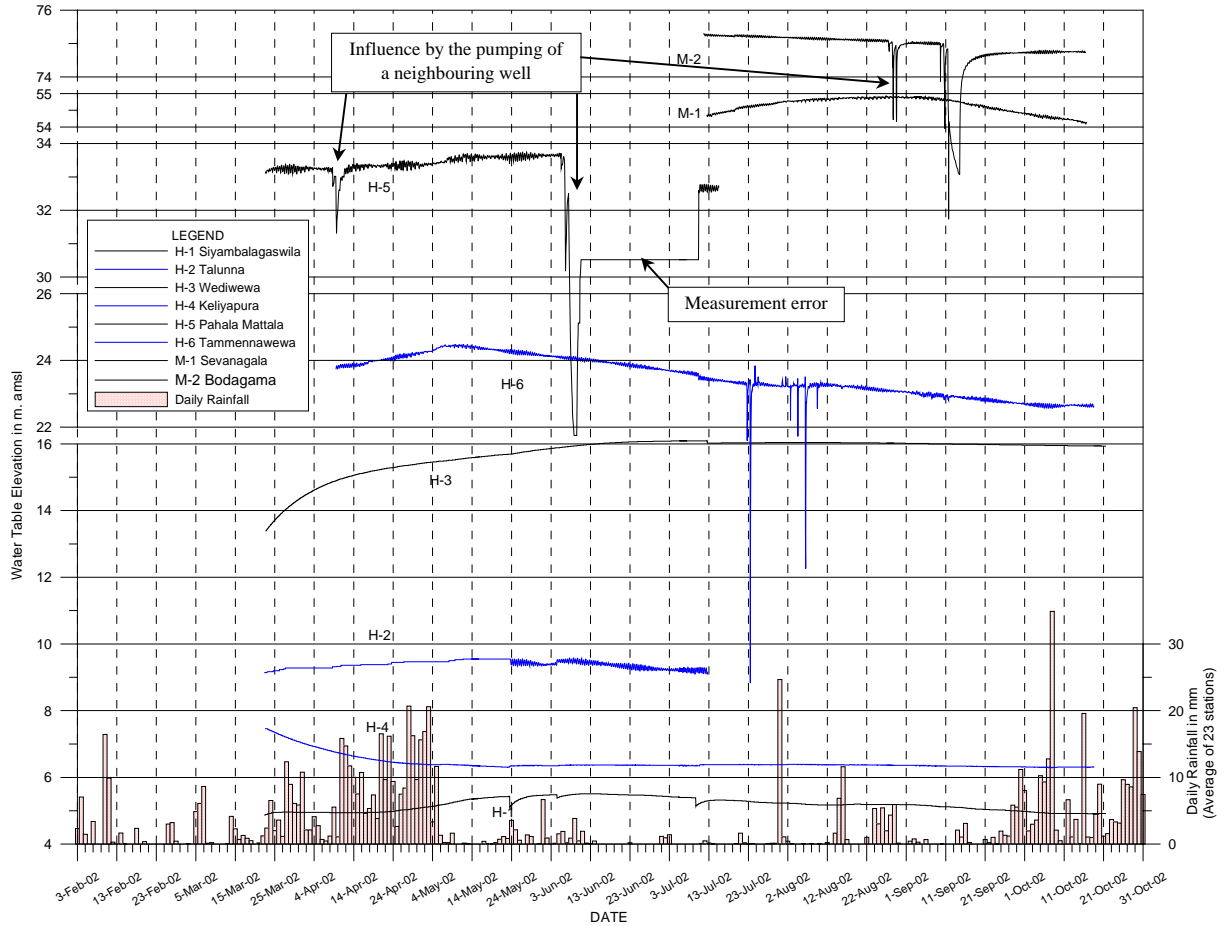
Figure 4.13 Hydrograph of Test Wells

In Hambantota, the water levels of most test wells (excluding No.H-6) were recorded since late March; the level of No.H-6 was recorded since mid April. The records of water levels in the test wells in Monaragala started from September '02. The data is graphed in *Figure 4.13*. Some observations were made as follows:

The bar chart in *Figure 4.13* indicates the mean daily rainfall of 23 stations in the Study area. The figure shows that the recharge by rainfall during from March to May probably caused the rising of the water level from late April.

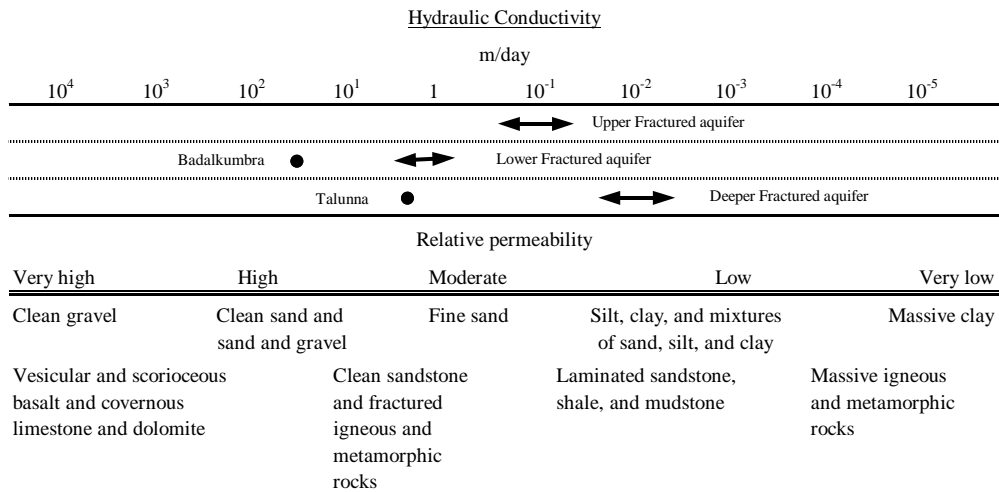
The table below shows the general ranges of hydraulic conductivity for soils and rocks. The values of massive to fractured metamorphic rocks vary from 10^{-5} to 10^1 m/day. The range of the obtained values in the Study area is also shown in the table.

*after Kashef, A.I, GROUNDWATER ENGINEERING, 1987,
(U. S. Bureau of Reclamation, Ground Water Manual, U.S. Department of Interior, Washington, 1977.)*
