FIGURE 3.12(A) RESISTIVITY CROSS SECTION - UNAWATUNA (M4A)

3.3.5 YALABOWA AREA (M5) --- SURVEY LINE, FIGURE 3.13, RESISTIVITY CROSS SECTION, FIGURE 3.14

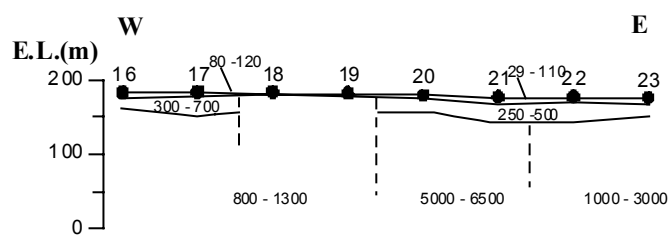
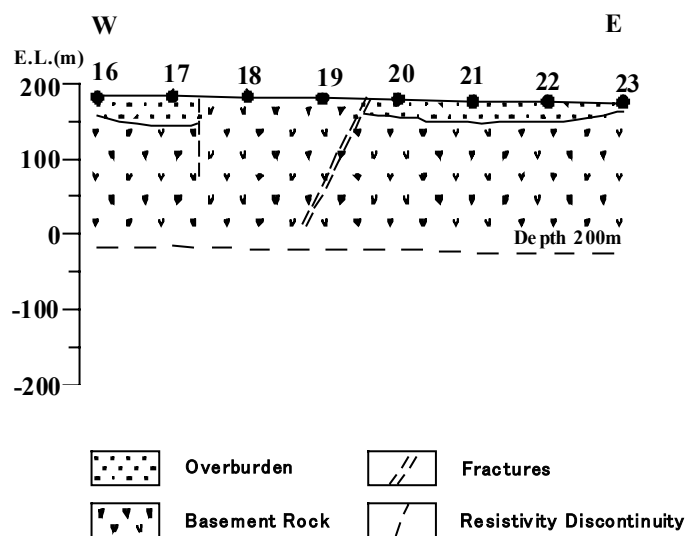
FIGURE 3.12(B) RESISTIVITY CROSS SECTION - UNAWATUNA (M-04B)

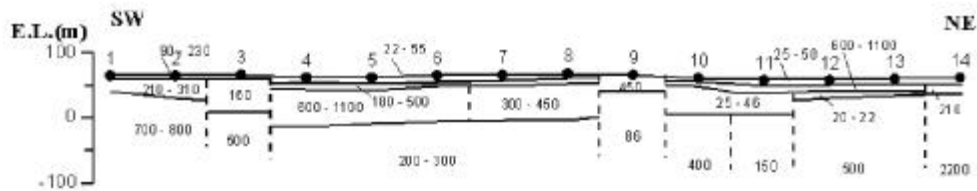
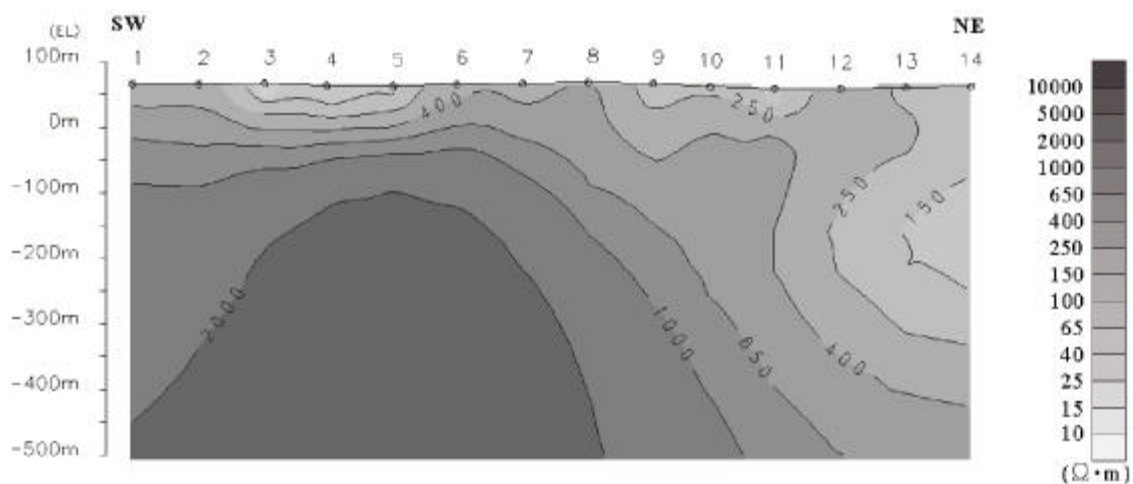
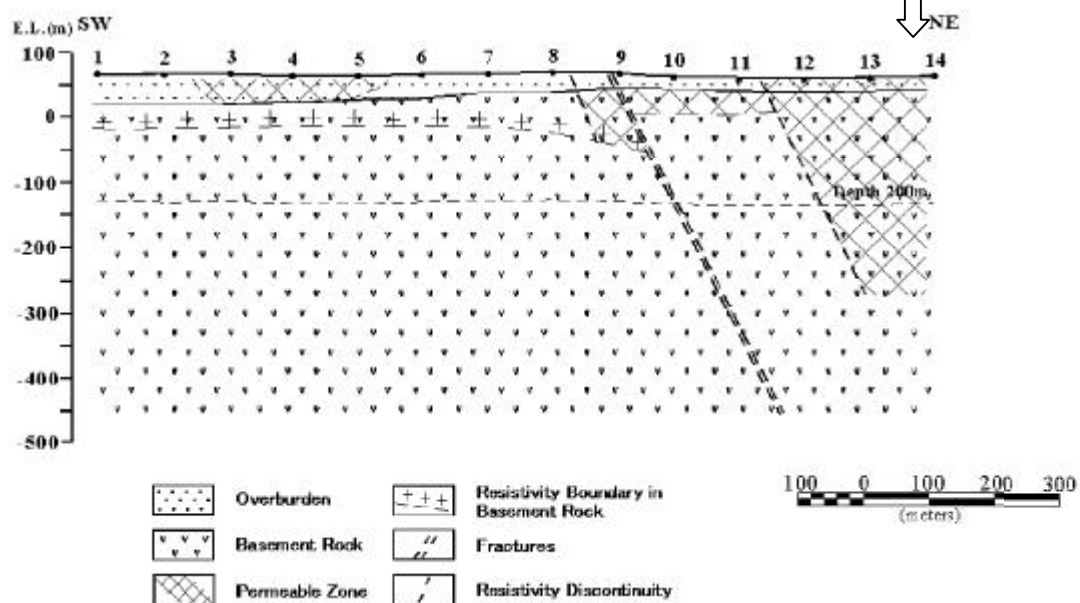
FIGURE 3.18 RESISTIVITY CROSS SECTION - SEVANAGALA (M7)

It is apparent that the western half of the line is highly resistive, which suggests that the bedrock is hard and compact. On the other hand, comparatively low resistivity was detected on the eastern half of the line. A northeast dipping geological boundary is inferred around station 9 and between stations 11 and 12. This area corresponds to a geological syncline. Near the station 11, there is a dug well with a water table almost at ground level, which shows low resistivity values. The Schlumberger result indicated the water-saturated formation at this point. However, at deeper depths of this area, the resistivity of the formation is around 250 Ohm-m according to the CSAMT. In this regards, the eastern end of the line suggests higher potential of deeper groundwater resource, since the area is widely conductive with resistivity anomalies extending to the depths. Accordingly, the most promising site for drilling seems to be around station 13.

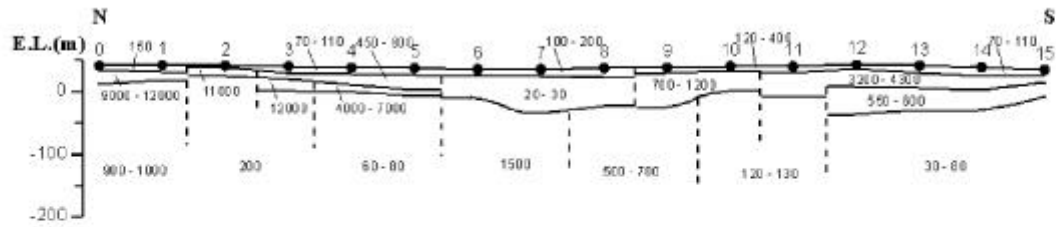
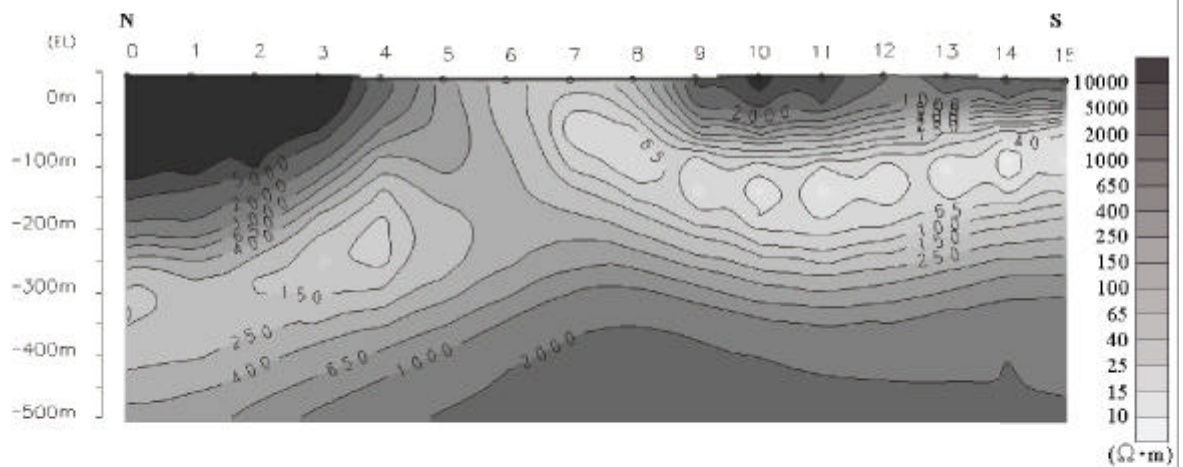
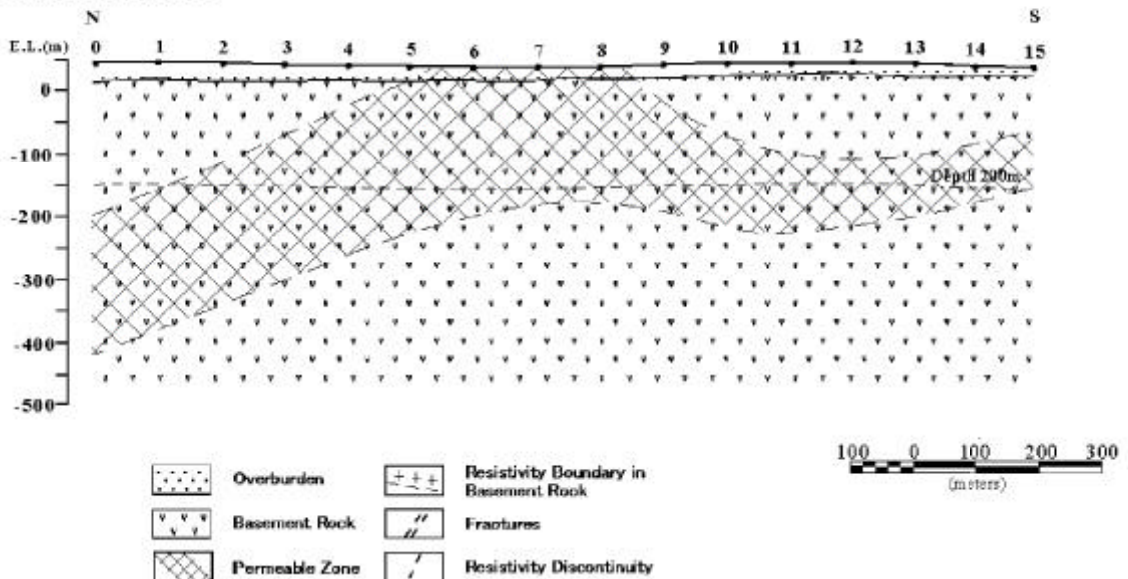
FIGURE 3.20 RESISTIVITY CROSS SECTION - WATER SPRING (THELLULA) (M8)

Water springs out from a tube well beside the road of Route 2 in Thellura area. As seen on the 2-D inversion CSAMT section, the distribution of prominent low resistivity anomalous comes out to the surface at station 7. This anomalous belt with low resistivity less than 150 Ohm-m seems to be reflecting the shape of an aquifer around 200m deep in the southern side of the line, and dipping north to the deeper zones in the northern side of the line. This anomalous belt might be reflecting a NW-SE trending fractured zone containing considerable amount of groundwater.
