CHAPTER 17 DETAILED EXAMINATION OF COUNTERMEASURES

17.1 General

The objectives of this chapter are to review the examination of Part A, and to confirm the stability of cut/ or embankment slopes and bridge foundation scouring in more detail. And most suitable countermeasures are to be selected against the each damage.

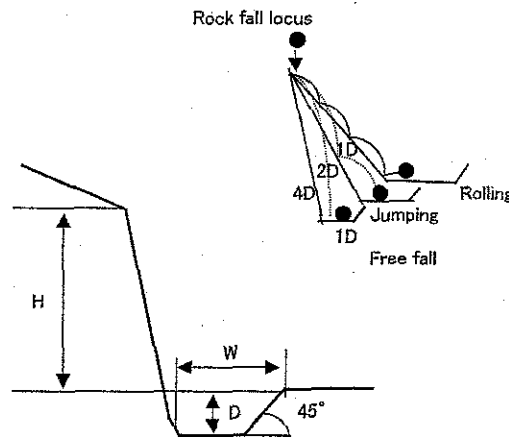
The wet conditions of slope surface induce new fall of rocks due to repeated dry and wet conditions, reduce bearing capacity due to hair crack-based spalling promotion or collapse due to increasing pore water pressure. This weathering process of the tuff group shifts much-cracked andesite rocks overlaid to overhanging blocks or generates toppling, which will soon lead to falling of the andesite rocks as shown in Figure 17.2.1 and Table 7.2.2. In addition, since the andesite rocks were originally produced by lava flow, they include vertical cooling joints (generates shrinkage cracks generated from lava cooling), the development of their weathering provides a causative factor to cause rock fall. The result of calculation for jumping height and rolling distance, and examination of shifting for road alignment are presented in Sub-section 17.3.7.

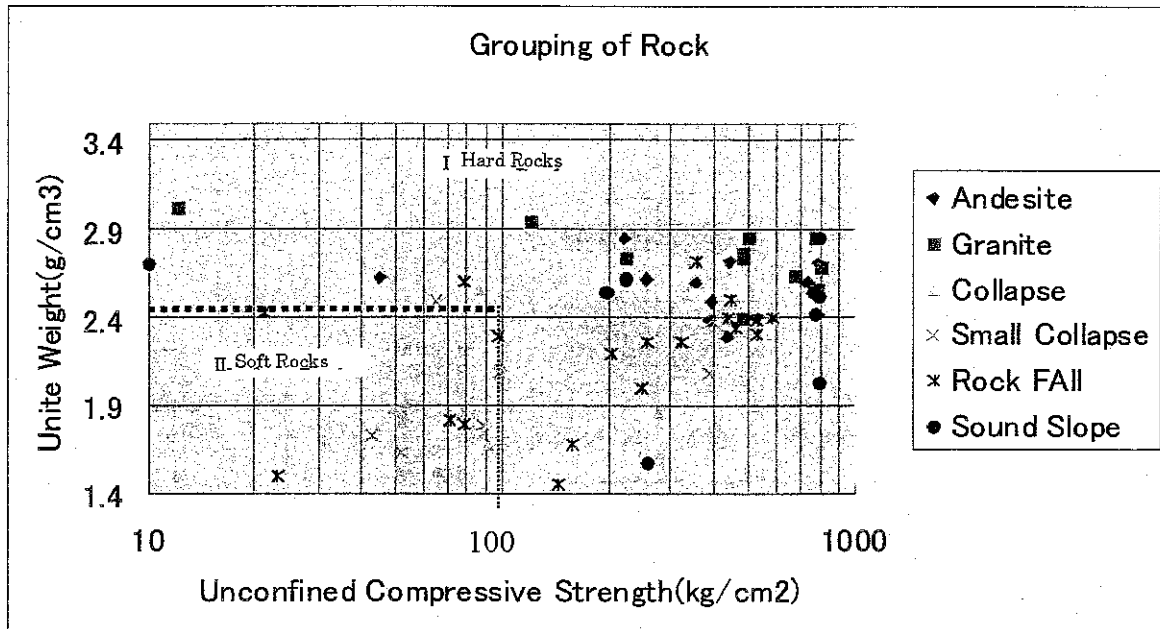
Figure 17.3.2 Grouping of Rock

When incorporating slope condition where test samples were collected into the following correlation diagram of unit weight and uniaxial compression strength, the clear difference between slope collapses was considered on reaching uniaxial compression strength of 100kg/cm^2 and unit weight of 2.5t/cm^3 as shown in Figure 17.3.2.

Based on this figure, it was determined as follows;

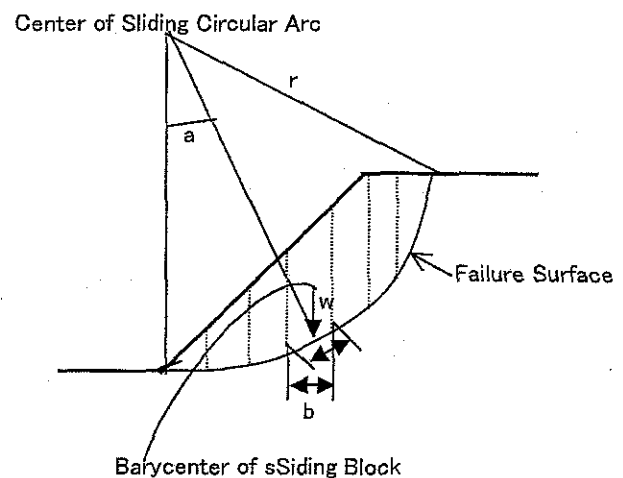
Figure 17.3.4 Stability Analysis by Sliding Circular Arc Method at Non-earthquake Condition

Stability analysis for circular failure is conducted, generally using the slice method assuming a circular sliding surface shown in Figure 17.3.4.

- F : Factor of Safety
 C : Cohesion
 ϕ : Internal friction angle (°)
 l : Sliding surface length cut by a slice (m)
 W : Total weight of slices
 U : Pore water pressure
 b : Slice width
 α : Angle between a line-linking a middle point and a center of a sliding surface and a plumb line

The methods for stability calculation include total stress and effective stress methods. Experience shows that the two methods are currently used appropriately according to drainage environments such as ground materials, structure and target grounds due to easy selection of a strength constant and a pore water pressure.

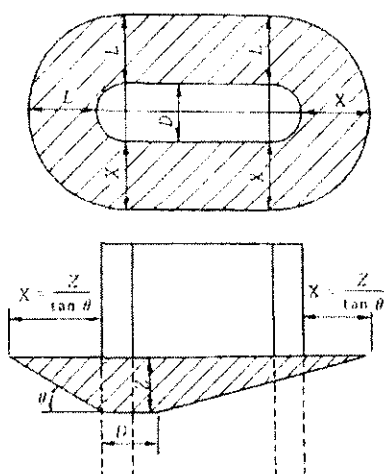
X : Horizontal distance of the range of scouring
 Z : Maximum depth of scouring
 θ : Angle of repose
 D : Width of pier

X=Z/tan?	m	2.96	3.20	2.40	2.07	1.72	3.10	1.54
Result of site survey	Width(X)	m	3.0	3.0	-	2.0	-	-
	Length(L)	m	4.0	4.0	-	2.0	-	-
	Depth(Z)	m	0.7	0.8	-	1.0	-	-

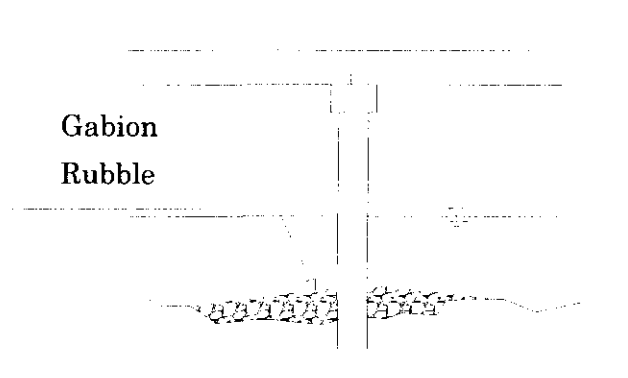
Material	Illustration	Remarks
Rubble and gabion

<p>This measure is for temporary works and for works in rivers with slow velocity.</p> <p>Economically efficient. Facility for construction is simple and easy (manual labor only is basically sufficient).</p> <p>The advantage of rubble is that it can change its form in response to differential settlement of the riverbed if the foundation is soft.</p> <p>Maintenance is necessary.</p>
Protection by the Concrete

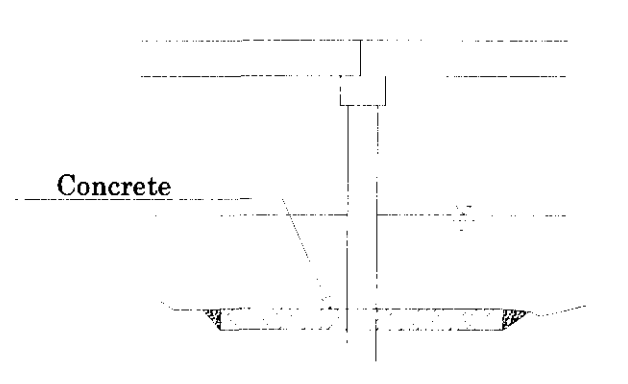
<p>This measure is applied at sites with fast flows and strong riverbed foundations.</p> <p>This measure is inappropriate for sites with soft riverbed foundations because the structure might collapse due to differential settlement.</p> <p>Because, this measure requires the pouring of concrete on site, it is impossible to execute in the rainy season.</p>
Protection by precast concrete block

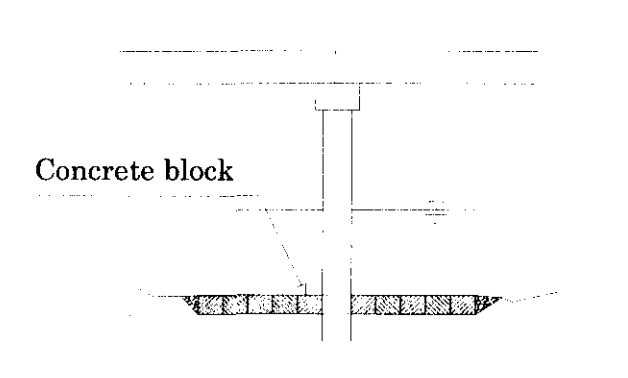
<p>By changing the size of concrete block in accordance with the velocity of water flow, this measure can be applied to all kinds of rivers.</p> <p>Because precast concrete is applied, construction can be implemented at any time except during floods.</p> <p>Maintenance is not necessary.</p> <p>This measure can bear small differential settlement.</p>

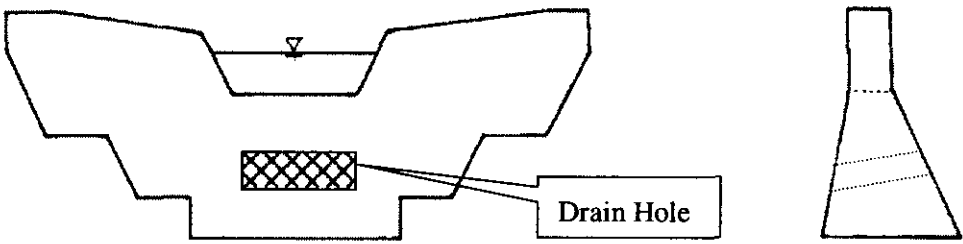
Spot No.	Dam
N003E170

<p>The diagram shows a plan view of a dam with a central spillway. A rectangular area with a cross-hatch pattern is located in the downstream channel, labeled 'Drain Hole'. To the right, a cross-section of the dam is shown, illustrating its trapezoidal shape and the location of the drain hole at the base of the downstream slope.</p>
